**UPGRADE OF JENNINGS ROAD, INKOSI
LANGALIBALELE LOCAL MUNICIPALITY, KWAZULU-
NATAL**

Phase 1 Heritage Impact Assessment

October 2017

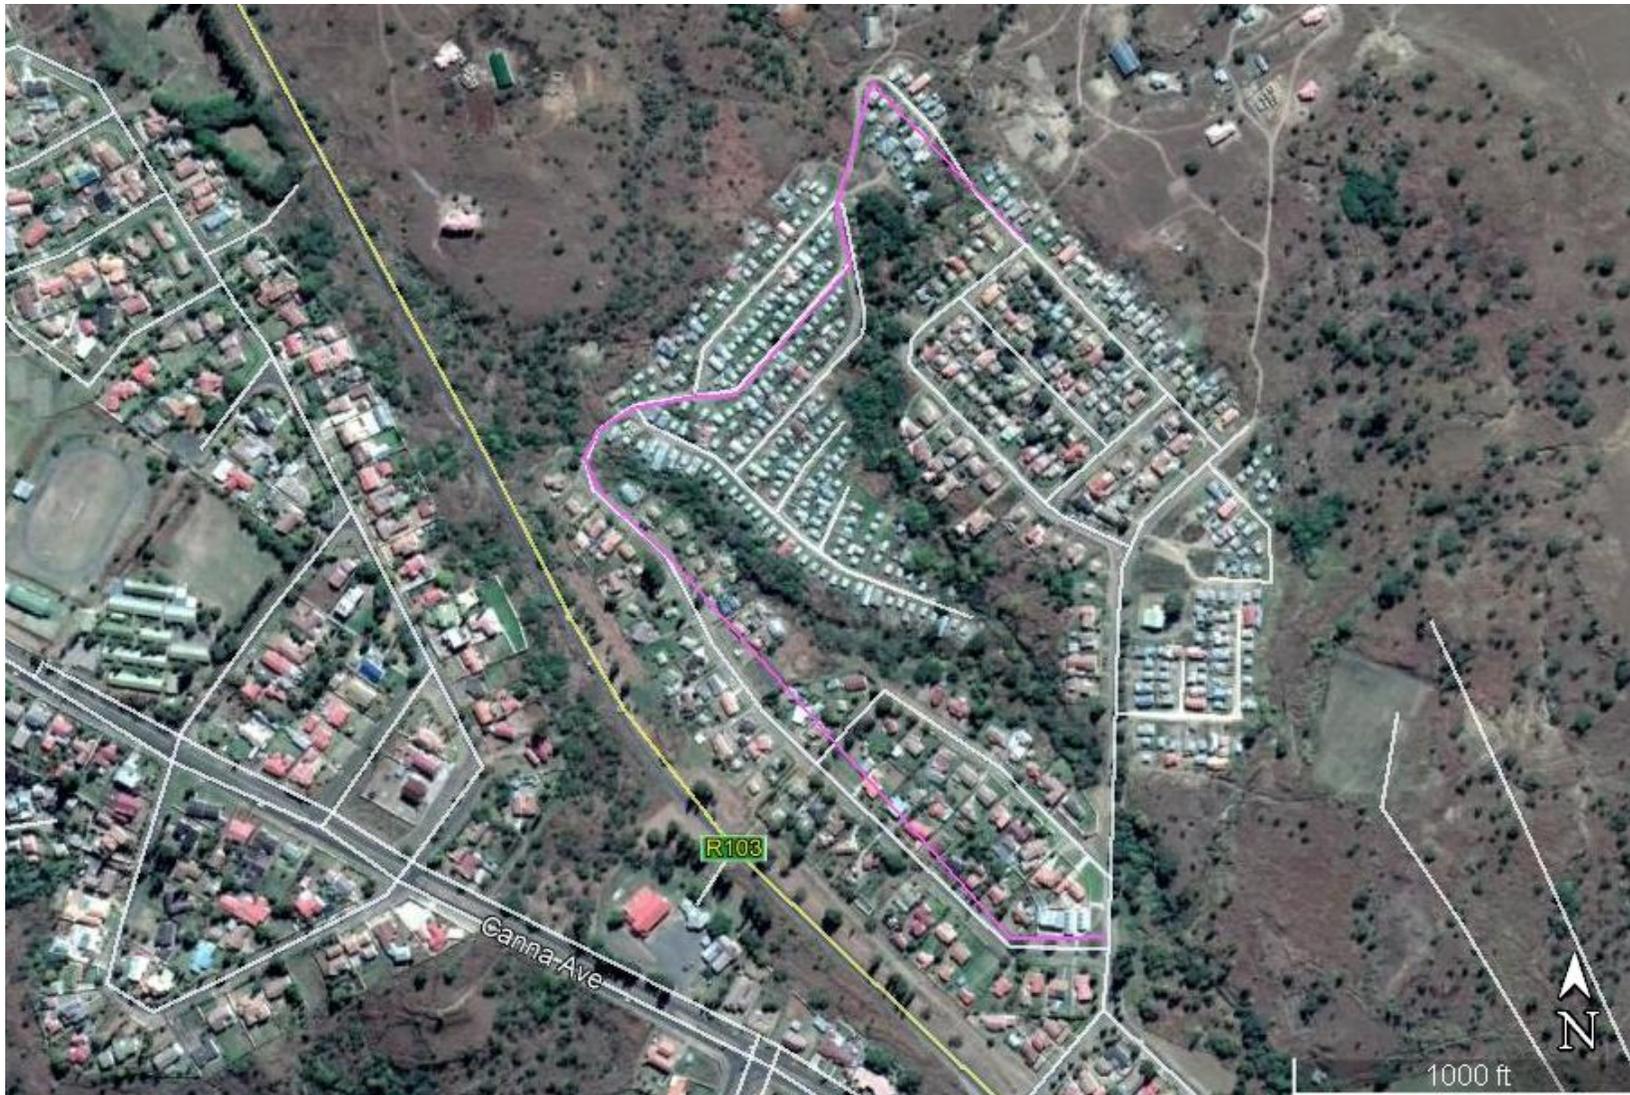
Figure 1: Road upgrade indicated in cerise

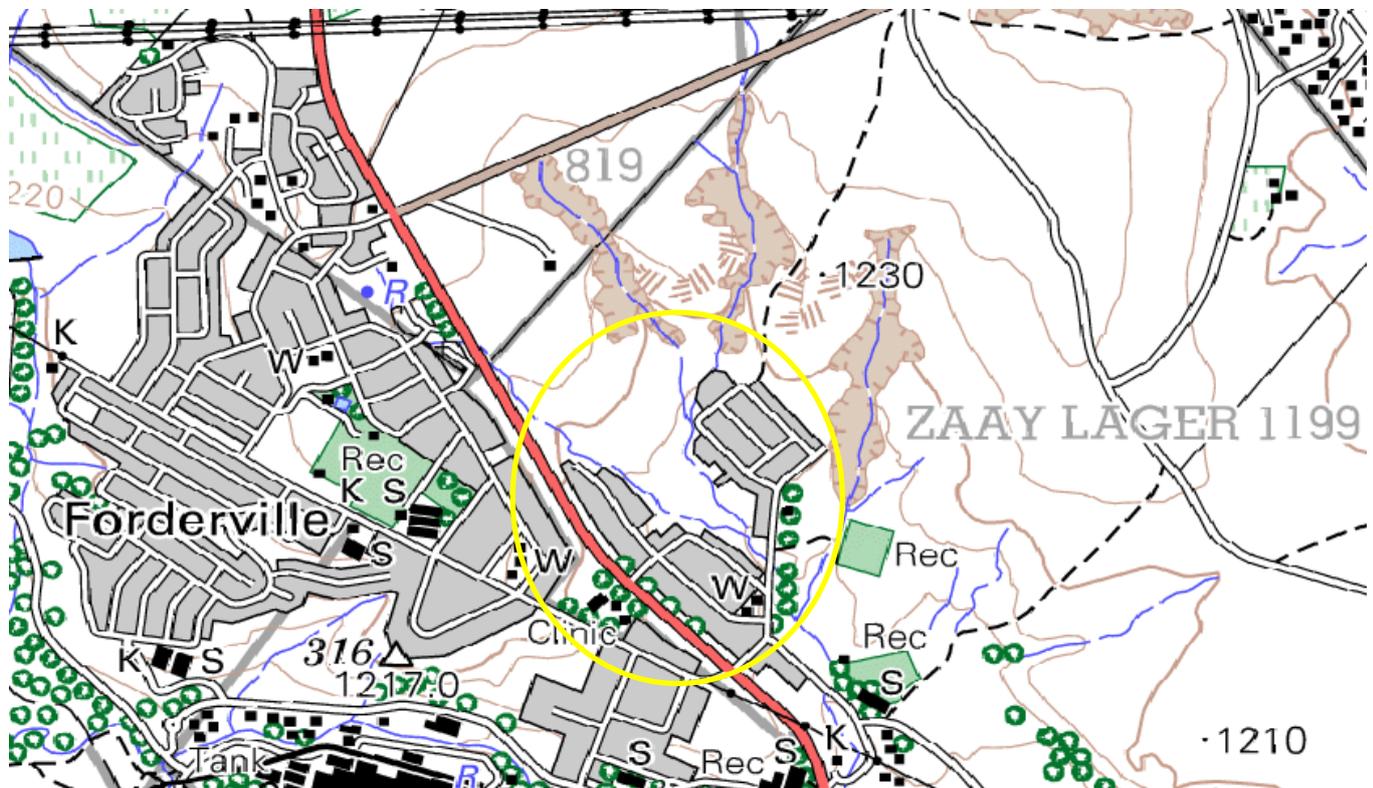
The 1:50 000 (2829DD) map indicates that the northern section or half of Jennings road had not yet been developed in the year 2000 when the map was compiled (see **Figure 2** below).

Figure 2: 2829DD map with project area indicated with yellow circle

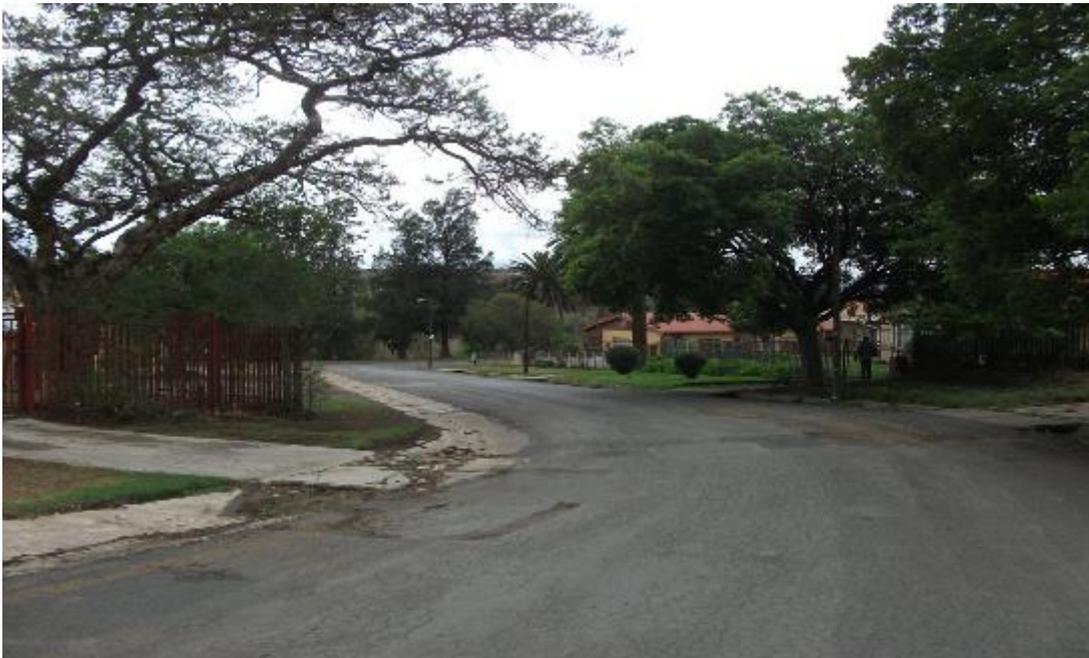
Figure 3: Looking east towards intersection with Canna Avenue

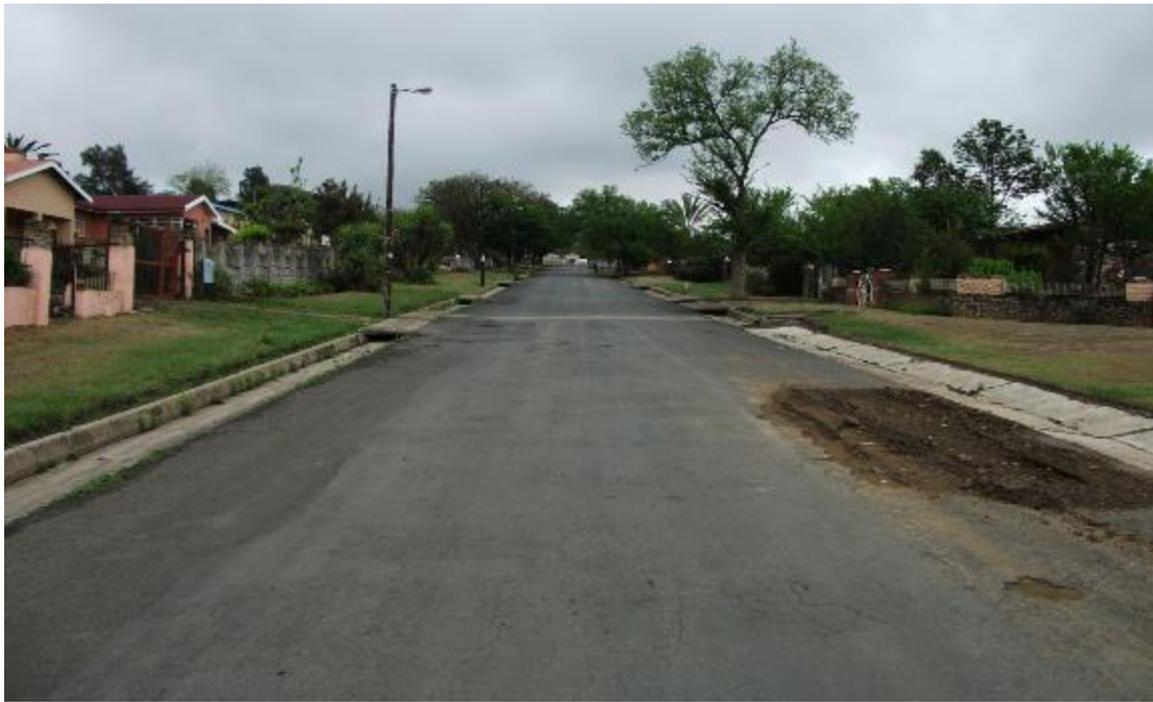
Figure 4: Looking up Jennings road in a north-west direction

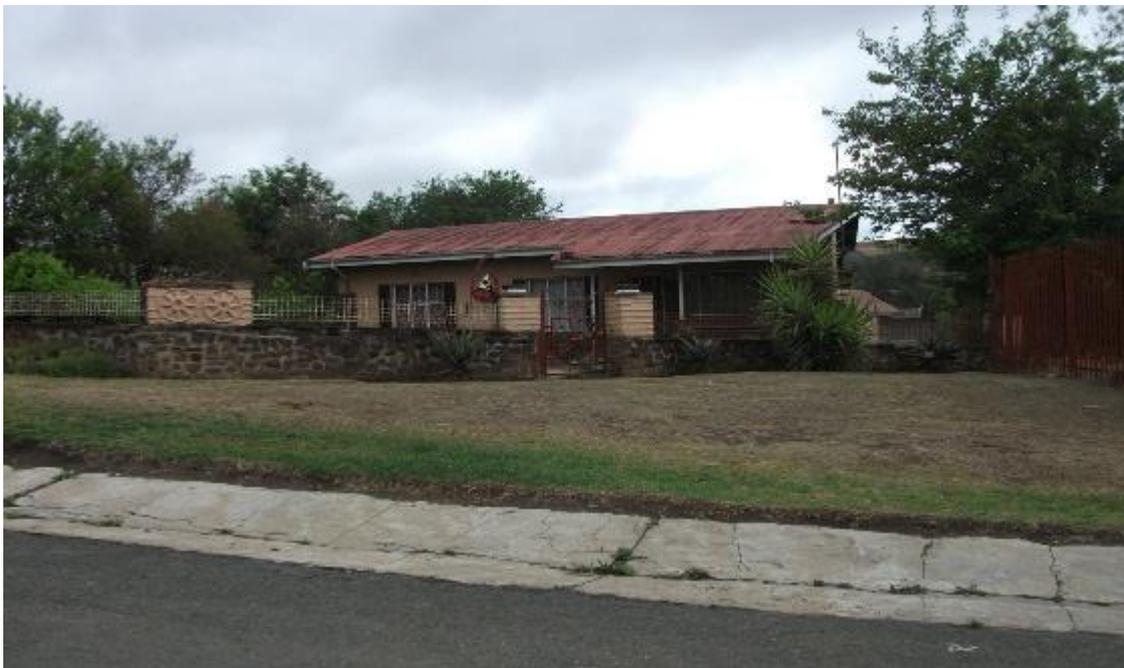
Several of the residences have corrugated iron roofs. The house pictured below has corrugated roofing as well as fencing with wagon wheels depicted thereon which was a popular design in the 1970s.

Figure 5: Corrugated iron roof house

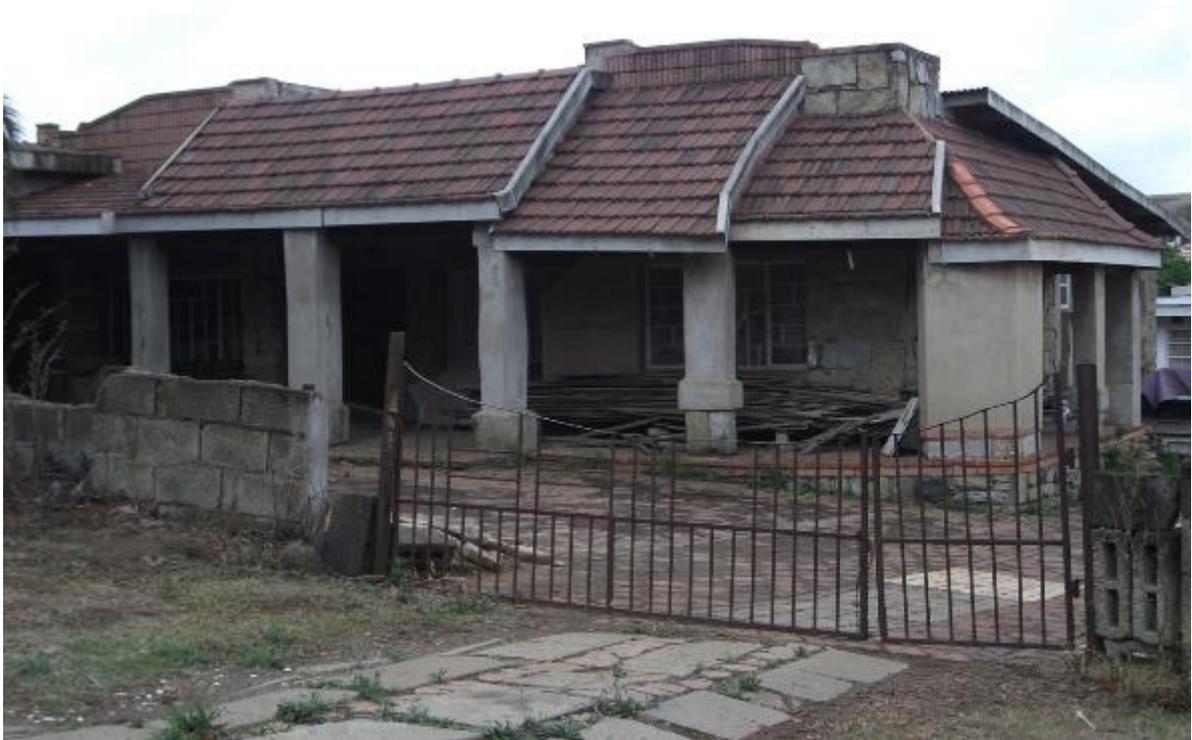
A house made from stone (possibly No. 16 or No. 20 Jennings Road) appears to be older than 60 years. It is, however, understood that no structures will be impacted by the proposed upgrade

of the road. The dwelling is dilapidated and much altered but the original stone work can still be seen in **Figure 6**.

Figure 6: Structure made from stone

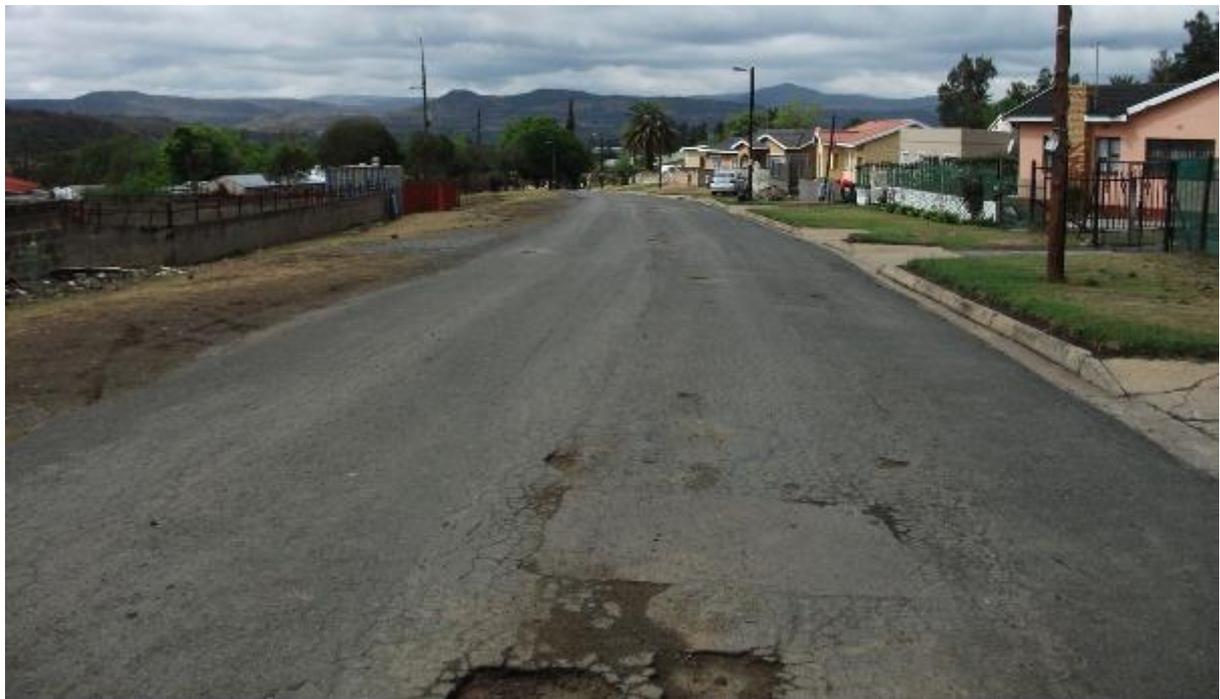
Figure 7: View down Jennings Road

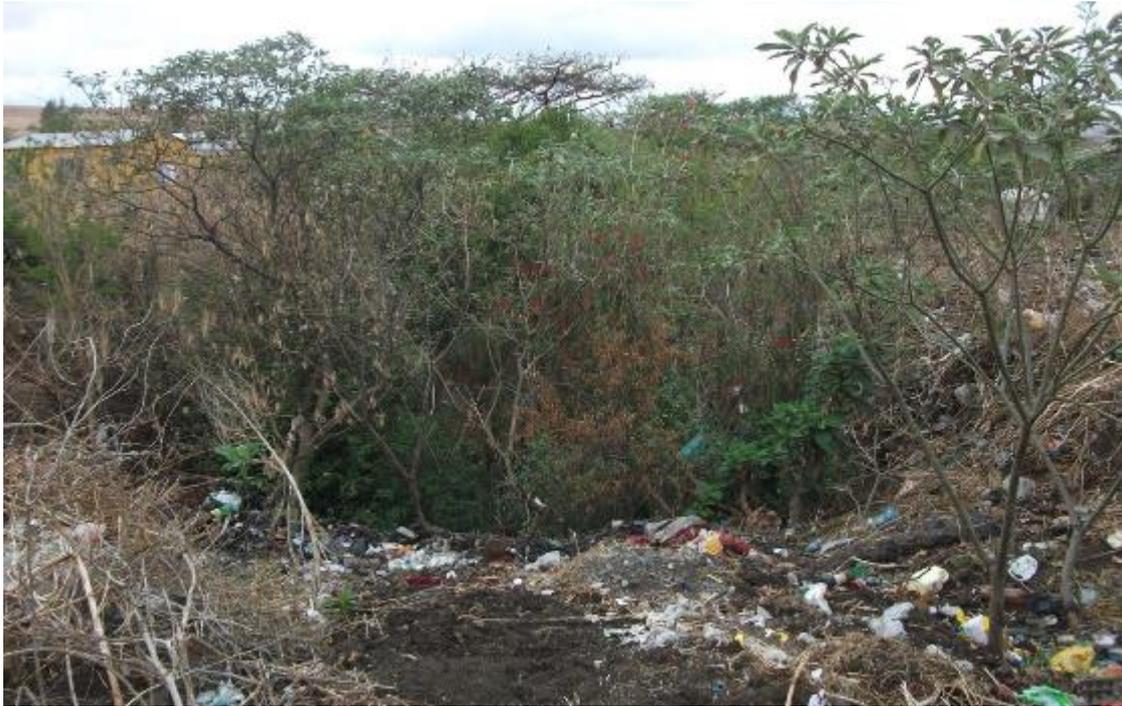
As the road turns to the north-east, it crosses a watercourse and vacant land. This area is highly disturbed with an existing pipeline as well as large-scale dumping of litter taking place. It is

infested with invasive plant species. No heritage sites were found in this area during the site inspection.

Figure 8: Overgrown watercourse

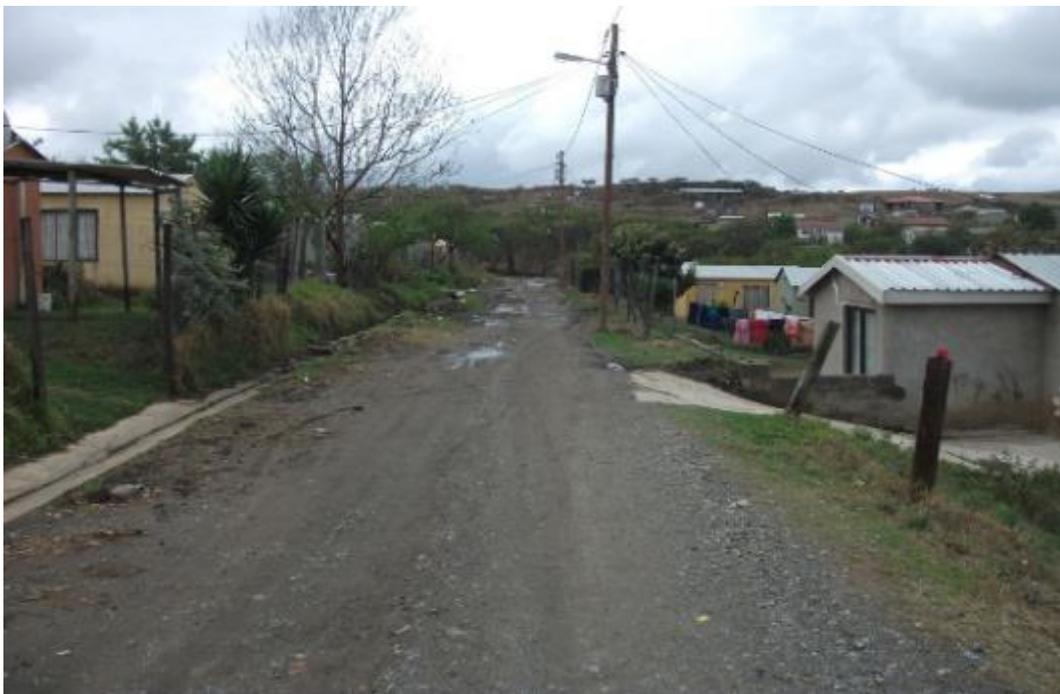
The section from where the road turns to the north-east is untarred and in poor condition. There are houses on either side this section of road as well as power lines. Most of the residences / houses appear to be fairly recently built.

Figure 9: Untarred section of Jennings Road

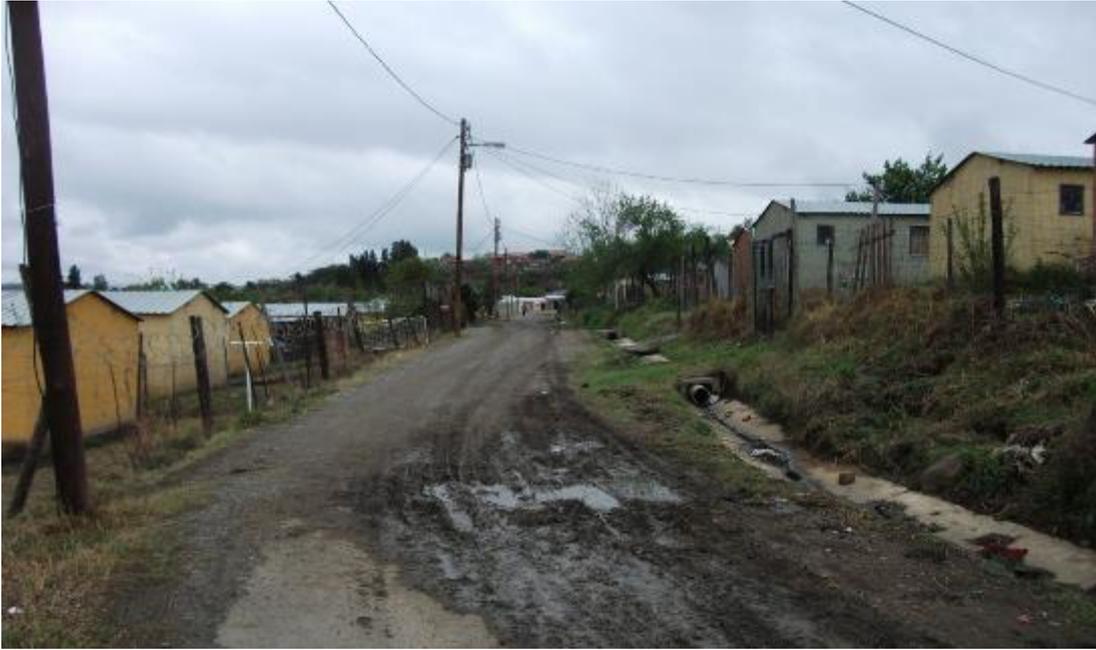
Figure 10: Untarred section looking in a south-westerly direction

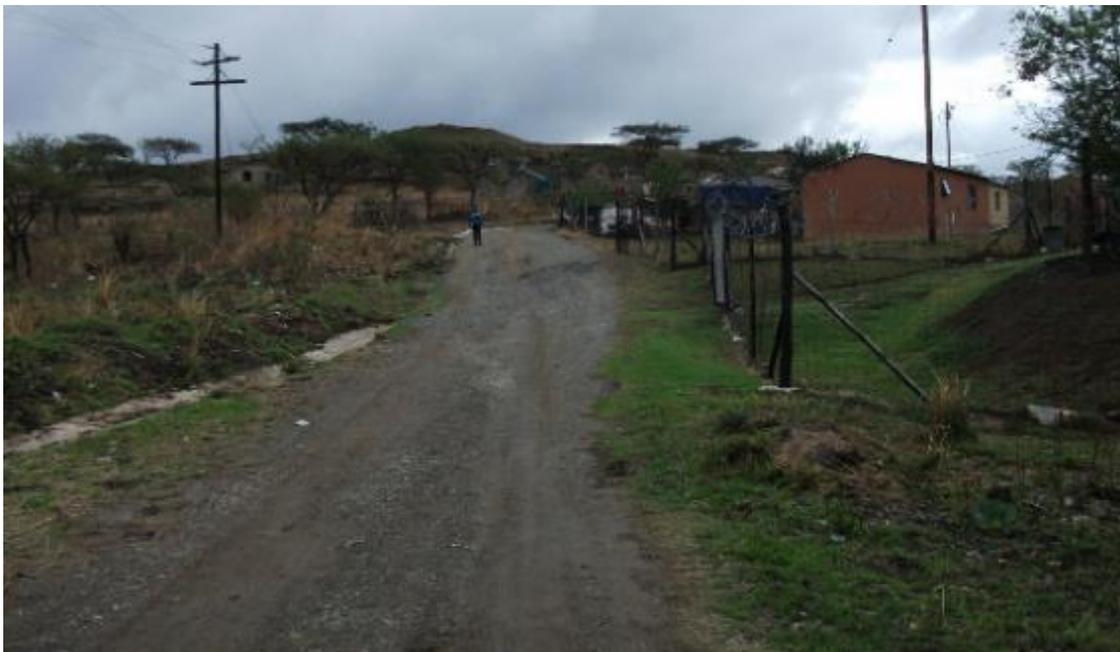
The section of Jennings Road in the more recently developed area where low-incoming housing has been built is also untarred. A section of the road runs next to undeveloped land as seen in **Figure 11** below.

Figure 11: Untarred extension of Jennings Road

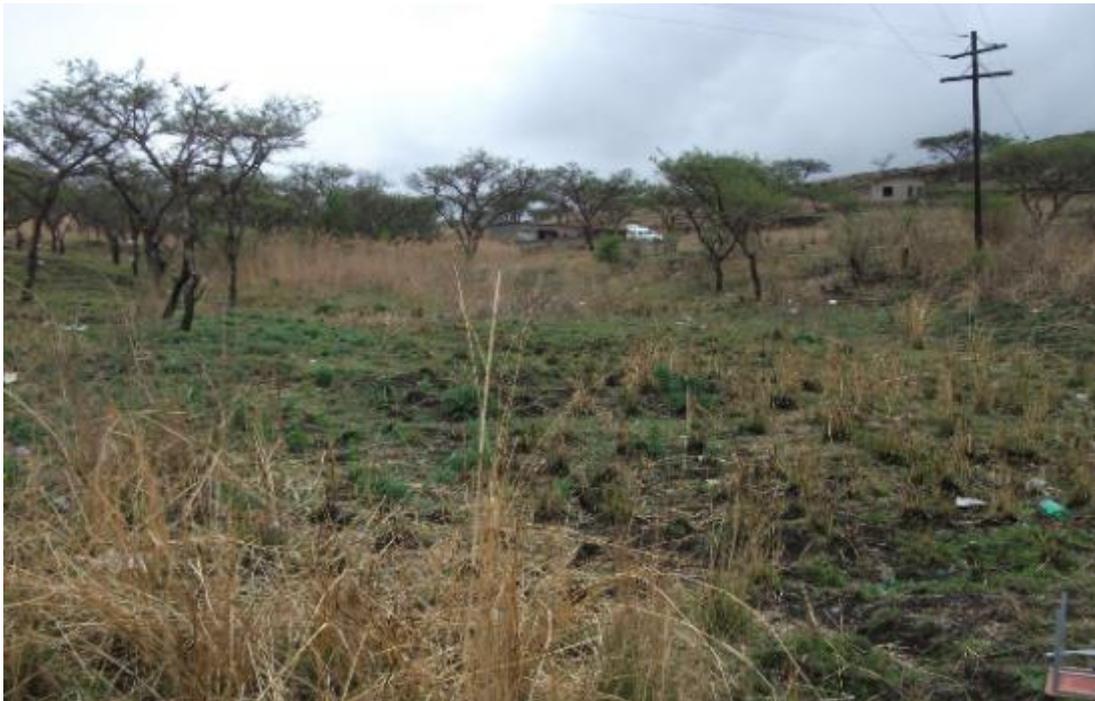
Mr Leon Adams, who identified himself as a community leader, told the specialist that, to his knowledge, there are no graves nor other heritage sites on the vacant land. A house is in the

process of being built on this parcel of land some distance from the gravel road as can be seen in **Figure 12**. No heritage resources were found on the vacant land.

Figure 12: Vacant land with a house being built in background.

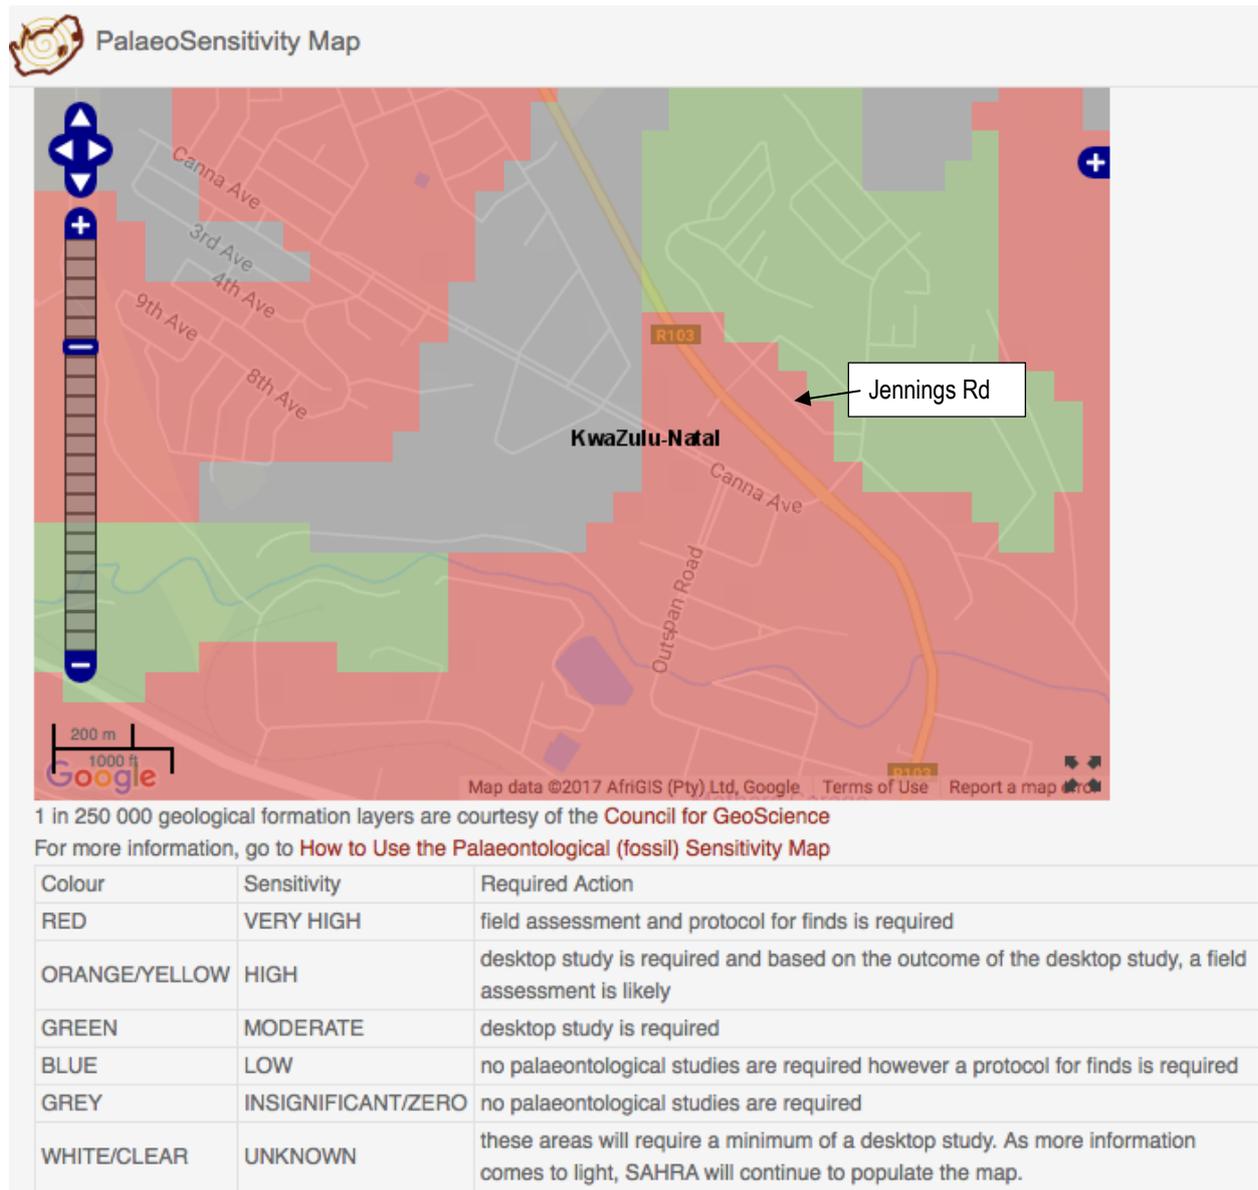
The South African Fossil Sensitivity Map indicates that the project area is situated in an area coloured in red that indicates an area of very high palaeontological / fossil sensitivity (see **Figure 13** below) as well as an area of moderate fossil sensitivity (indicated in green). As indicated in the legend in the figure below, an area of very high fossil sensitivity requires an on-site field assessment and an area of moderate fossil sensitivity requires a desktop palaeontological assessment. Due to the highly disturbed environment of Jennings Road it is recommended no further palaeontological studies are needed for this project.

Figure 13: Fossil sensitivity of Jennings Road

- The following should be followed in terms of chance fossil finds:
 - When the upgrade of the road begins, rocks must be given a cursory inspection by the environmental officer or designated person. Any fossiliferous material (trace fossils, plants, insects, bone, and coal) should be put aside in a suitably protected place. This way the upgrading of the road will not be interrupted.

- Photographs of possible fossils should be sent to a palaeontologist for preliminary assessment.
 - A qualified palaeontologist should visit the site to inspect the selected material and check dumps where feasible. The frequency of inspections should be dependent on the finding of any potentially important fossil material.
