Basic Assessment for the Proposed
Construction of Electrical Grid
Infrastructure to support the juwi Skeerhok
PV 1, 2 and 3 Solar Energy Facilities (SEF),
Near Kenhardt, Northern Cape

**HERITAGE IMPACT ASSESSMENT:
BASIC ASSESSMENT REPORT FOR THE PROPOSED
DEVELOPMENT OF A TRANSMISSION LINE AND ASSOCIATED
ELECTRICAL INFRASTRUCTURE TO SUPPORT
THE PROPOSED SKEERHOK SOLAR ENERGY FACILITIES, KENHARDT,
NORTHERN CAPE PROVINCE**

Dr Jayson Orton

15 February 2018

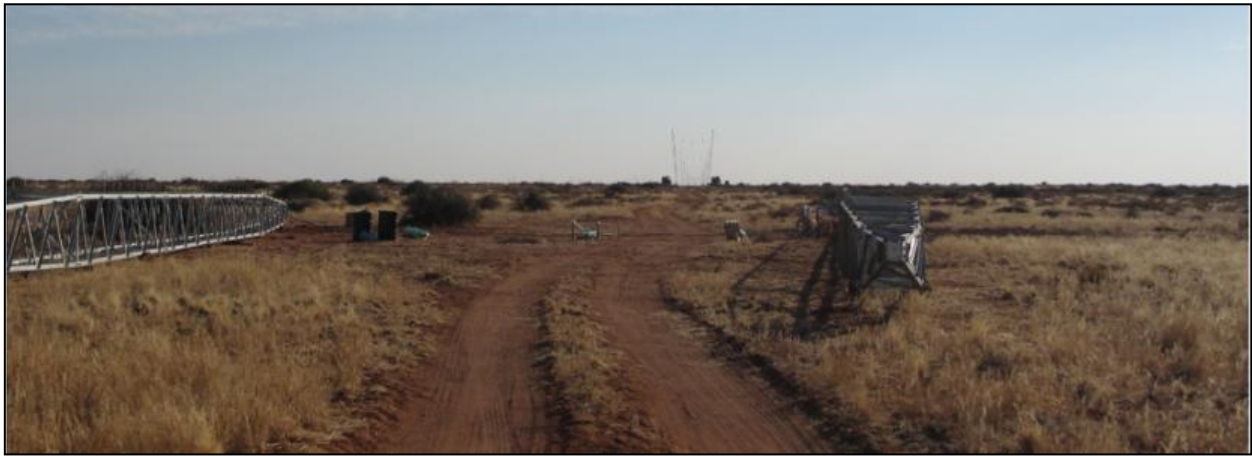
Figure 7: View northwards along the north-western margin of the study area showing a new power line currently under construction (during July 2017) parallel to part of Alternative 1.

Like much of the broader landscape in this area, the study is generally very flat (Figure 4), but a few low rocky hills do occur sporadically (Figure 5). Vegetation consists of grass and low bushes punctuated by occasional taller bushes, especially in ephemeral drainage lines and around pans (Figures 6). Rare quiver trees also occur in the vicinity. The surface is generally sandy, but gravel (calcrete and other rocks) does occur in places. A new gravel road had been graded along a new power line that was busy being installed at the time of the survey and which crosses through the study area along parts of Alternatives 1 and 2 (Figure 7).

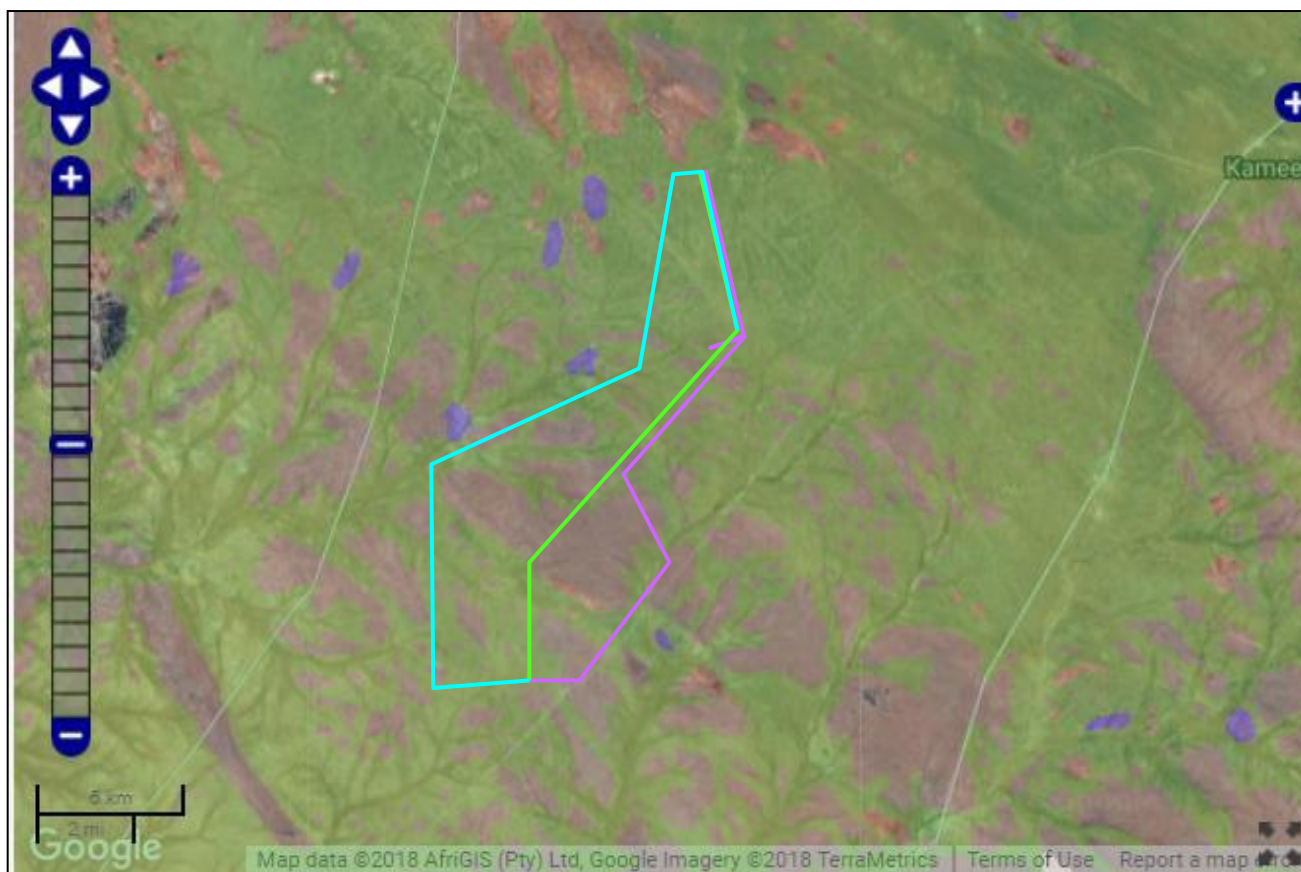
Figure 46: Extract from the SAHRIS Palaeosensitivity map showing the study area to be of generally moderate (green shading) and zero palaeontological sensitivity (grey shading). Alternative 1 is in turquoise, Alternative 2 in green and Alternative 3 in purple.

The SAHRIS Palaeosensitivity Map (Figure 46) shows the study area to be largely of moderate sensitivity, but with a large strip of zero sensitivity running from northwest to southeast through the general study area. Despite the moderate sensitivity, the nature of the area in terms of palaeontology is such that a full palaeontological study was not deemed necessary by the appointed specialist. Nevertheless, because SAHRA had requested an evaluation of the palaeontological impacts, a desktop study was compiled for the greater project and is briefly summarised here.

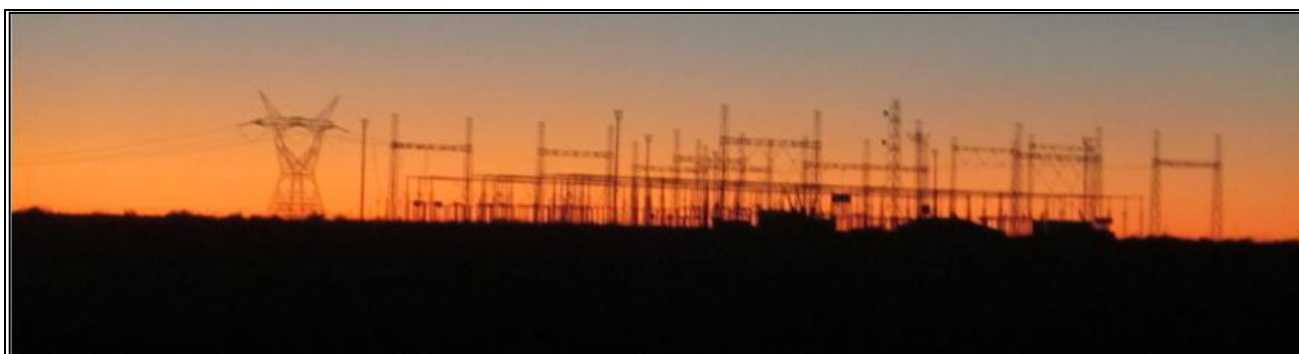
Figure 49: Evening view of the large Eskom substation located some 16 km south of the proposed project.

It is notable that the landscape in the vicinity of the study area already has an electrical layer comprised of a large substation and several power lines (Figure 49). It is because of the substation that the development location has been chosen.
