**CONSTRUCTION OF CLEARWATER PIPELINES FROM
SANDILE WATER TREATMENT WORKS TO THE
BURNSHILL AND BRITISH RIDGE RESERVOIRS**

FOR EOH COASTAL ENVIRONMENTAL SERVICES

DATE: 21 AUGUST 2017

**Umlando: Archaeological Surveys and Heritage
Management**

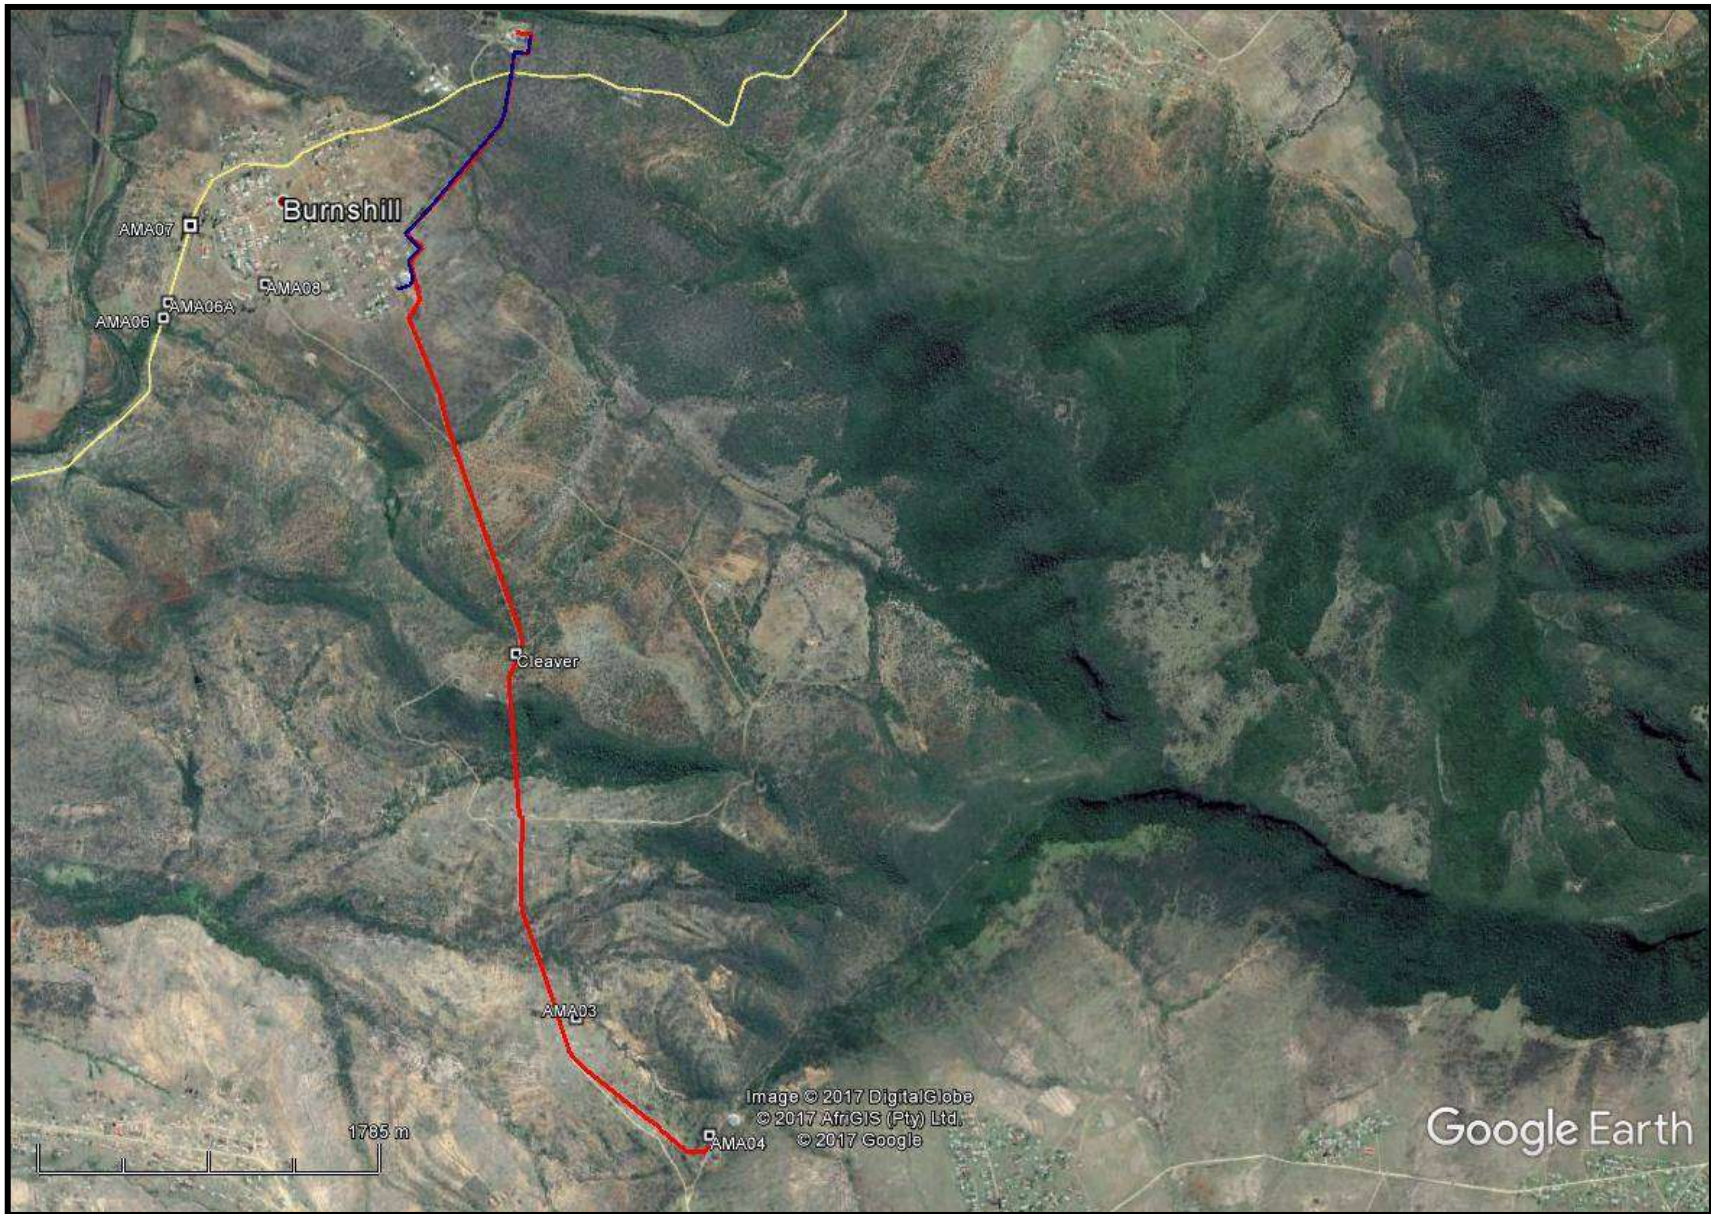
FIG. 6: LOCATION OF RECORDED SITES

The field survey was undertaken in February 2015. Parts of the line adjoining had been previously surveyed (Anderson 2012 a-c). Most of the line follows the existing road reserve. In some areas it crosses farmlands, rivers and river valleys. The line links up to several reservoirs of which some have already been built. Table 3 summarises these sites while Figure 6 shows their location.

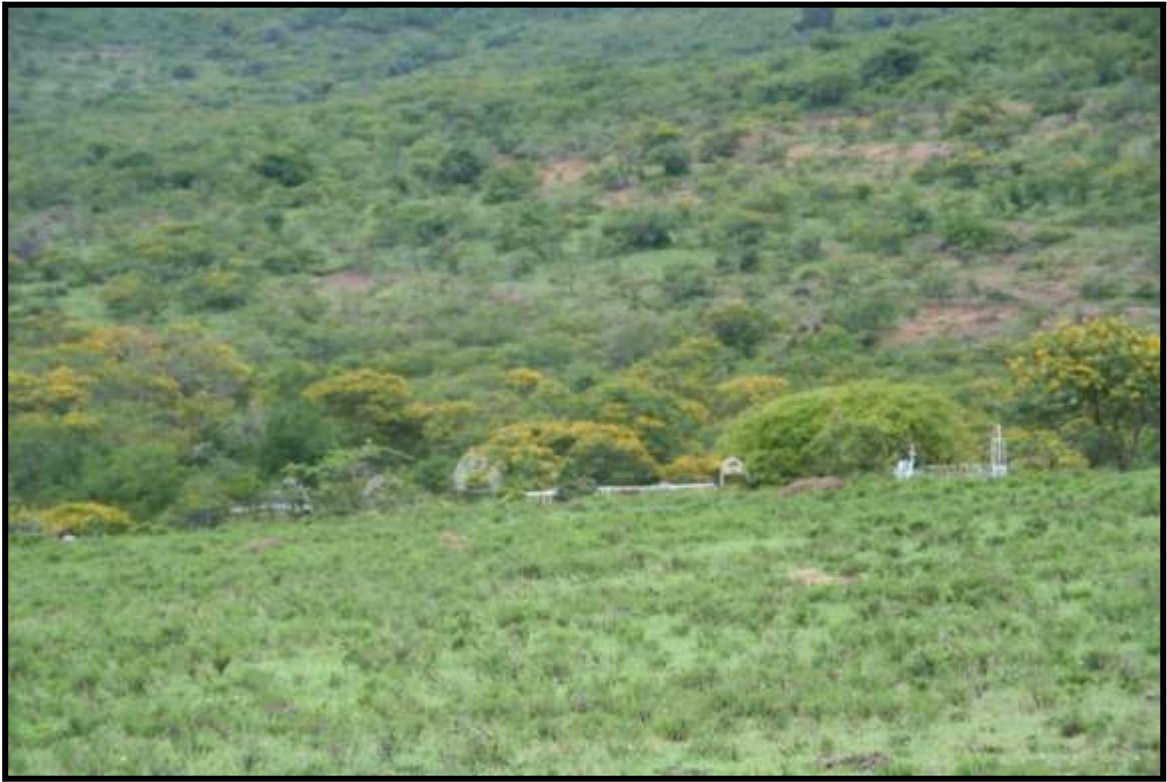
FIG. 7: CEMETERY AT AMA03

AMA03 is a cemetery on the eastern side of the road (fig. 7). The cemetery occurs ~100m from the pipeline. The cemetery will thus not be affected by the current position of the pipeline footprint.

Significance: The site is of high significance

Mitigation: A minimum of a 25m buffer needs to be erected. The pipeline should not be moved from its current position.

SAHRA Rating: 3A

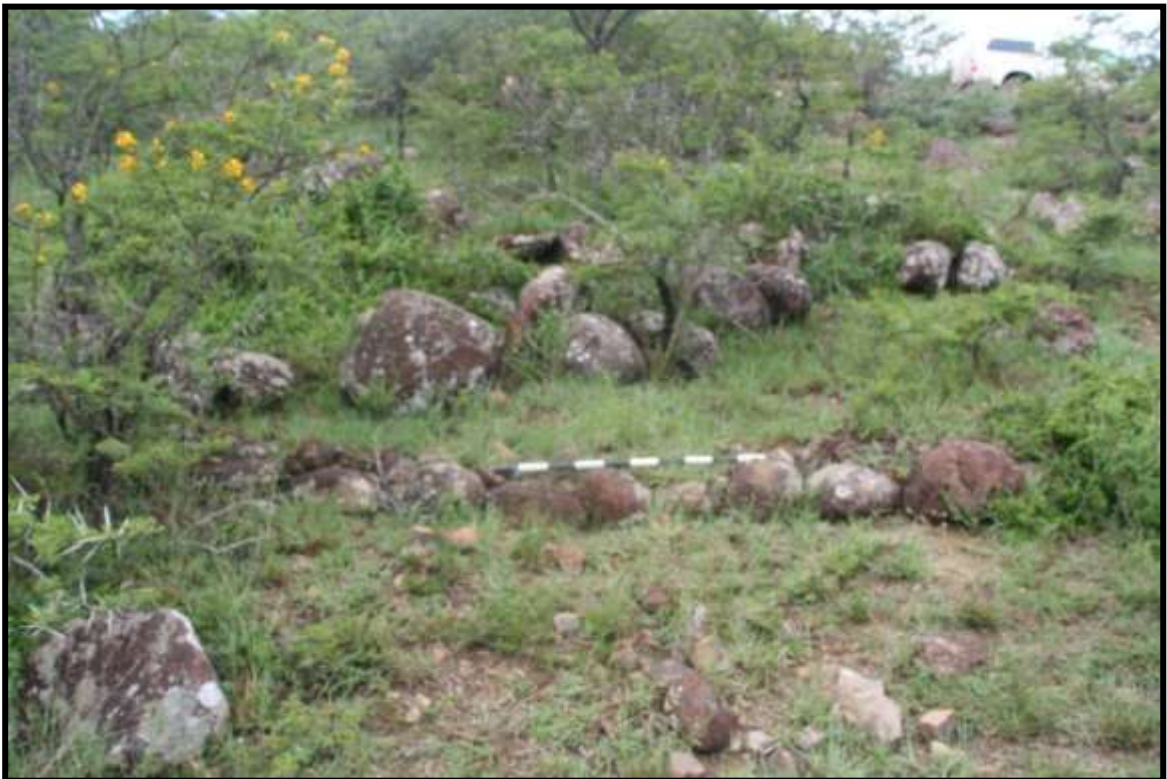
FIG. 8: TERRACING AT AMA04

AMA04 is located on the slopes of a hill leading to the British Ridge Reservoir. British Ridge itself is located ~1km to the southwest. The slopes have been surveyed by Kruger (2014) who noted that several features had already been destroyed by the construction of the reservoir. The features that I observed were anti-erosion walls and/or supports for terracing (on the lower slopes). In one area, the terracing leads down to a small historical dam, and thus some of the terracing may have been used to direct water flow to the dam. The terracing is low stone walling often with a single row of stones (fig.8). The pipeline will be missing the rest of the features as recorded by Kruger (fig. 9)

Significance: The site is of low significance.

Mitigation: No mitigation required as these have already been mapped.

SAHRA Rating: 3C

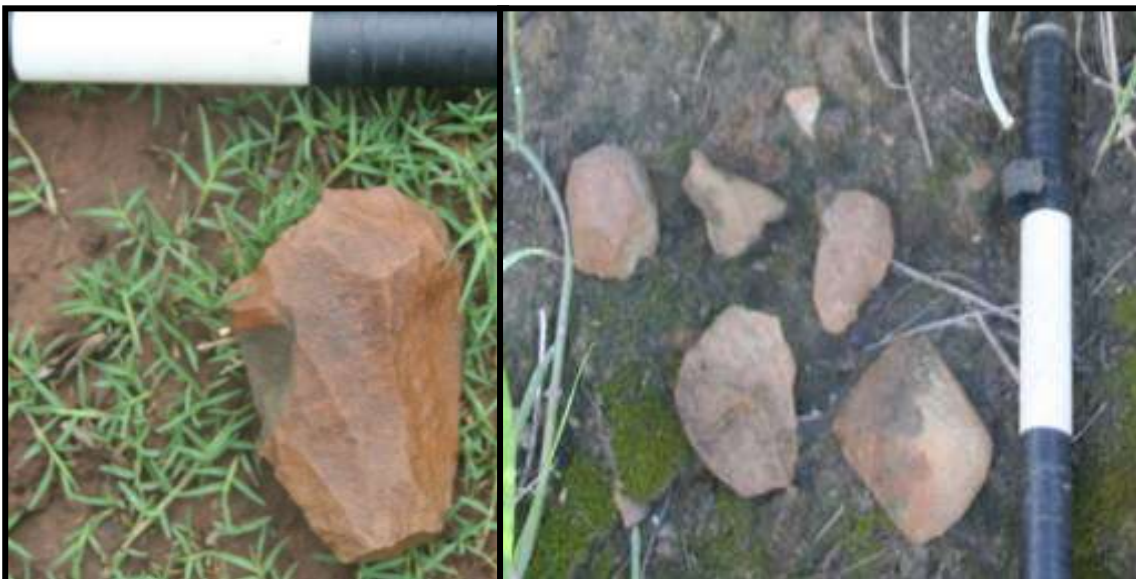
FIG. 34: GENERAL STONE TOOLS ALONG THE ROOT

The stone tools are open scatters and often disturbed and in a secondary context. They do not form sites rather general occurrences of tools. At times they are isolated artefacts otherwise they may be a small group of tools exposed by a cutting, or a scatter of tools at the base of a hill. The stone tools along the route date to the Early Stone Age, Middle Stone Age and Late Stone Age. A cleaver was recorded near the side of the road along the pipeline. There are general stone tools on all of the hills in the area.

Significance: These scatters are of low significance and do not constitute a site *per se*.

Mitigation: No further mitigation is required.

SAHRA Rating: 3C
