**HIA STUDY OF THE PROPOSED CONSTRUCTION OF  
OFFTAKE 6C POTABLE WATER PIPELINE  
SIYAPHAMBILI TO NONOTI, ILEMBE DISTRICT  
MUNICIPALITY, KZN  
A PROJECT OF ILEMBE DISTRICT MUNICIPALITY**

**EDTEA REF NO: DC29/0041**

**DATE: 22 JANUARY 2015**

**Umlando: Archaeological Surveys and Heritage**

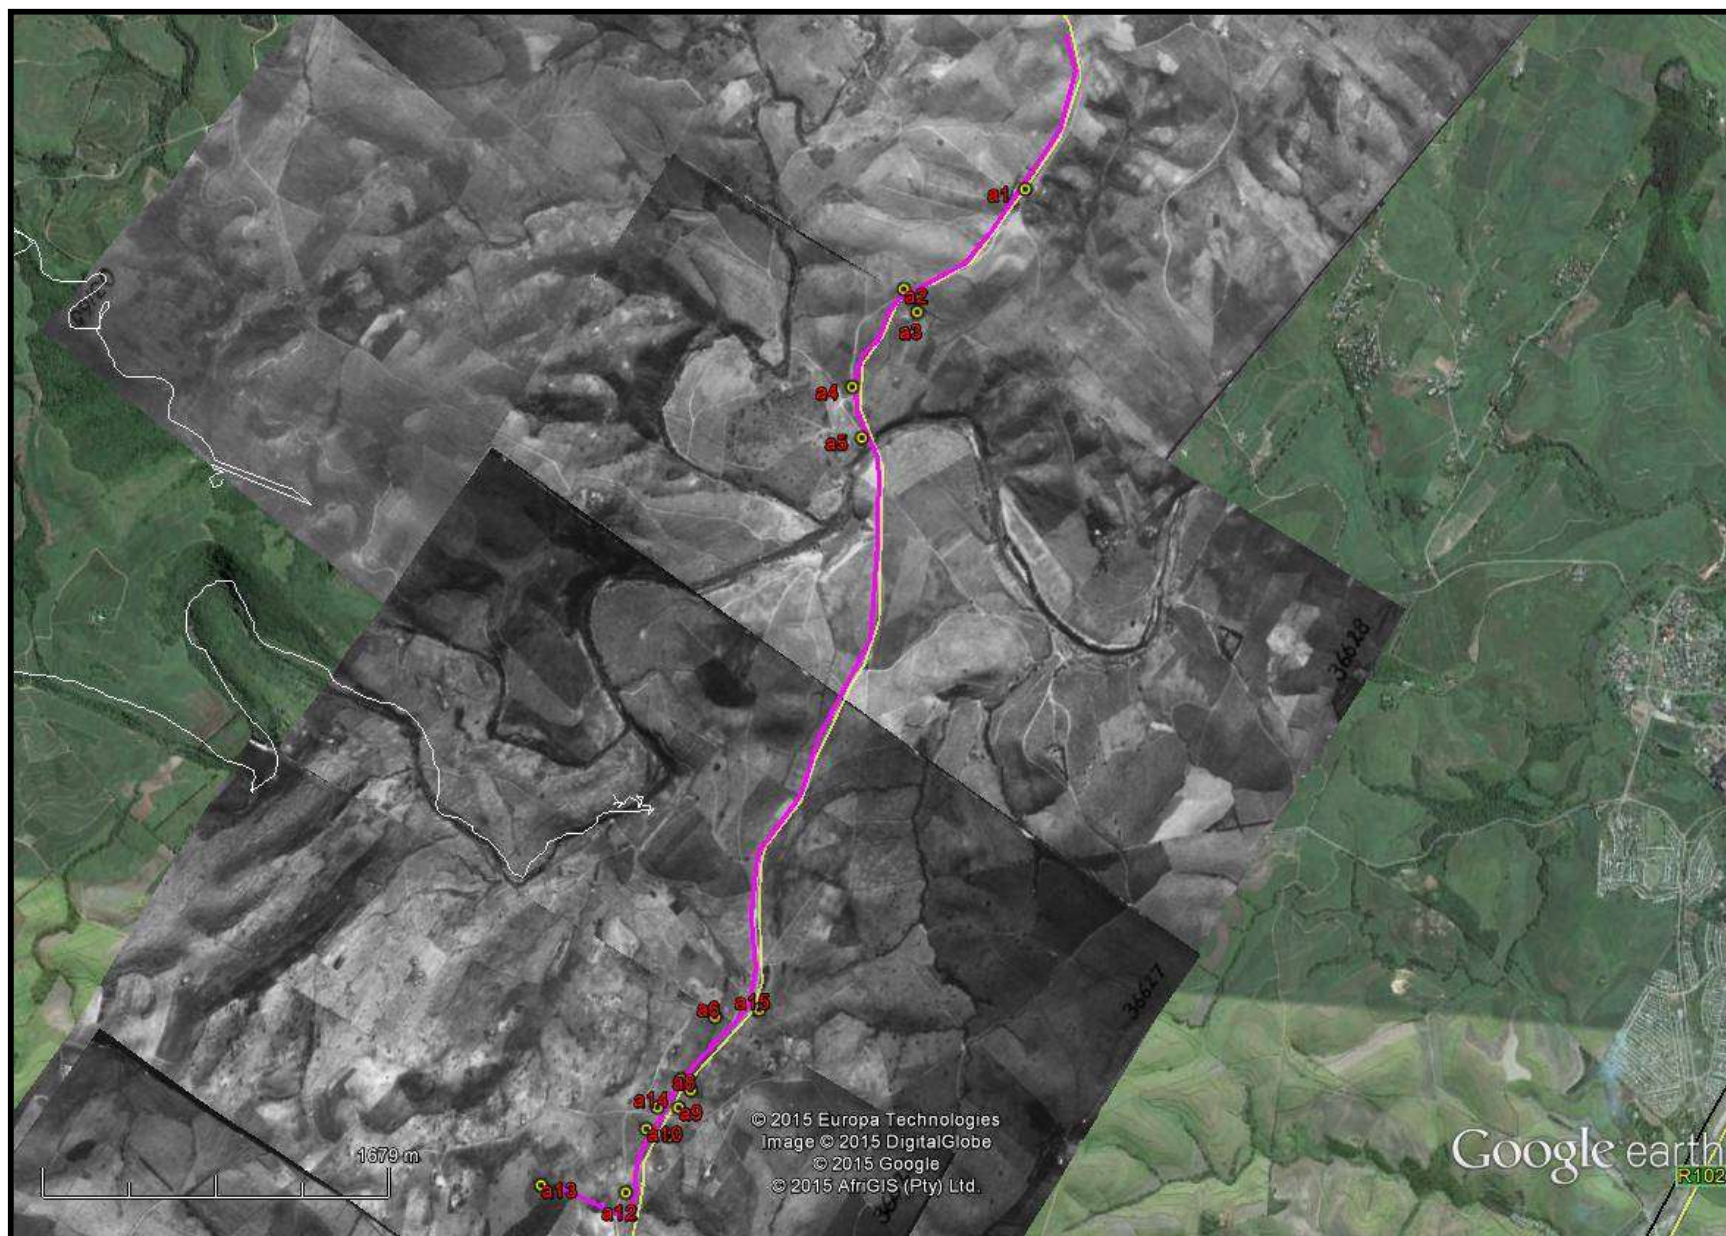
FIG. 5: STUDY AREA IN 1937

The 1937 aerial photographs indicate that there are fifteen buildings and human settlements near the pipeline. These include farm buildings, sheds, farm

and labourers' houses. The settlements appear to be in a traditional Zulu design and would thus be associated with have human graves. Most of these have been built over and/or ploughed by 2104. A13 might be well preserved underneath the surface. A13 occurs where a reservoir will be placed.

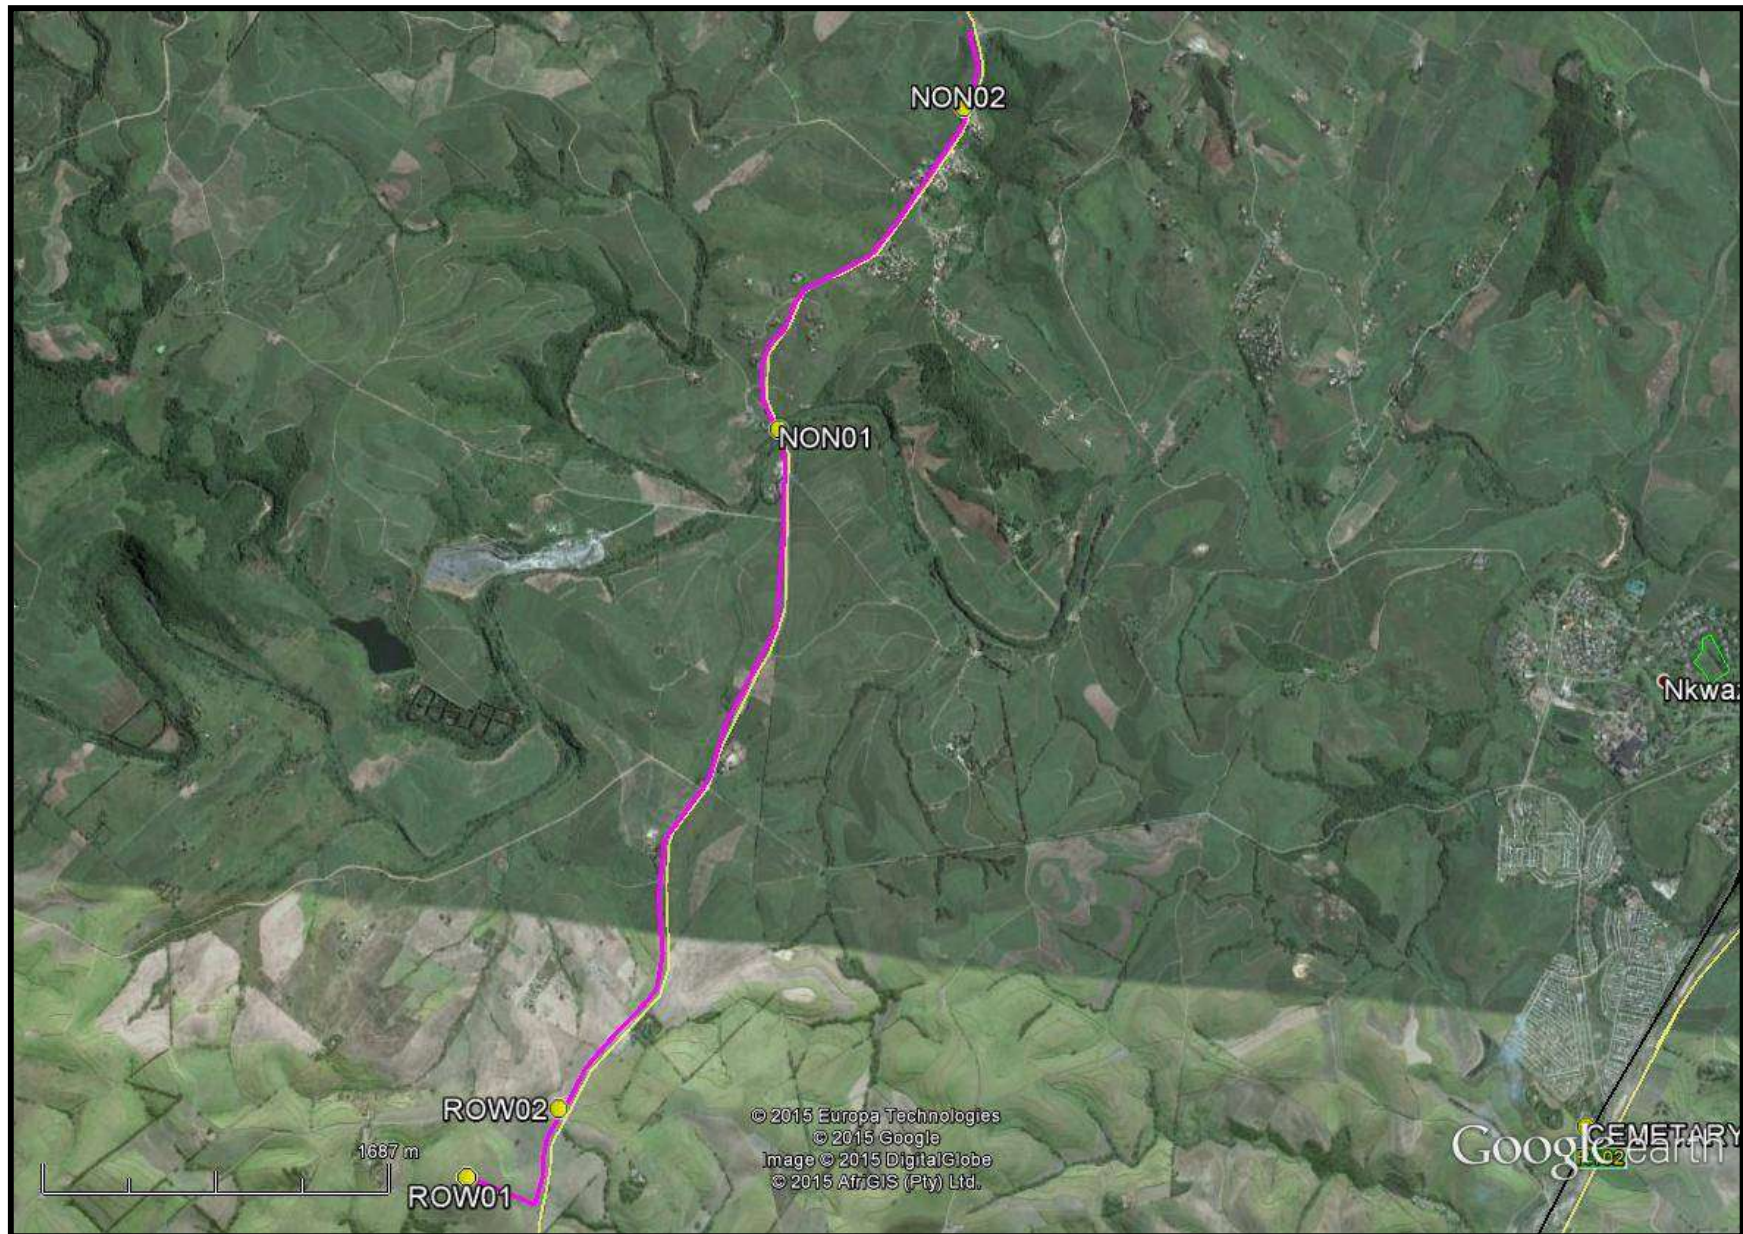
FIG. 7: LOCATION OF RECORDED SITES

Table 2 lists the locations of these sites while figure 7 shows their location.

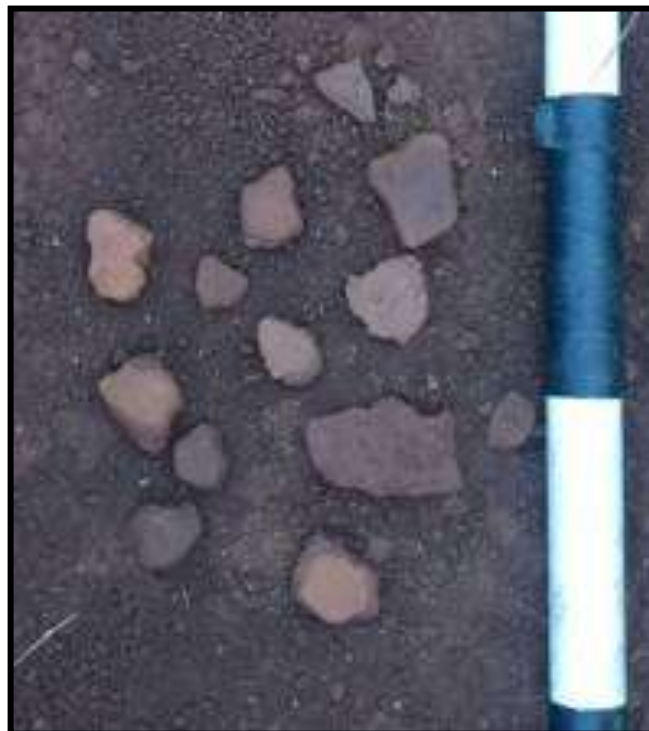
**FIG. 9: POTTERY SHERDS AT ROW01**

ROW01 is located on the top of a hill where a reservoir will be built (fig. 8 – top left). The main site is on the top of the hill where the deposit is deeper and with soil that is more fertile. The site consists of an extensive scatter of Late Iron Age pottery of various colours and thickness (fig. 9) over an area of 150m x 150m. I did not observe any decorated pottery sherds, although some fragments had rims and lips. A few upper grinding stones were noted. The deposit appears to have been effected by sugar cane farming and it is unlikely that intact features would occur below the surface. There is however a possibility that human remains could occur on the site.

The site 'a13' from the 1937 historical map also occurs on this hill. However, the pottery sherds appear to be older than this site. No artefacts directly related to 'a13' could be found.

Significance: The site is of low significance unless human remains occur.

Mitigation: No further mitigation is required. The client will need to apply for a permit from Amafa KZN to damage the site.

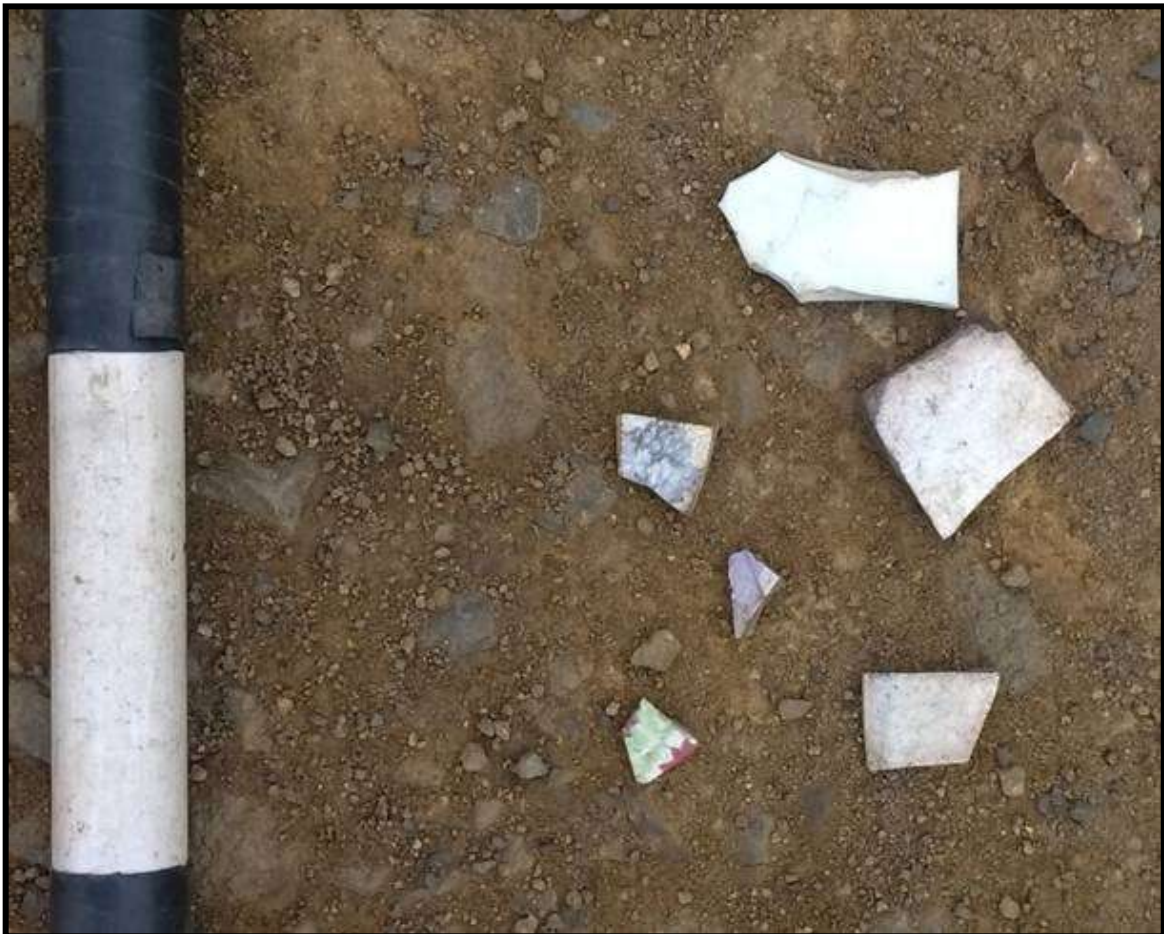
**FIG. 10: EUROPEAN CERAMICS AT ROW02**

ROW02 is located near the base of the hill for ROW01. The site is on a relatively flat area. The soil is not deep and there has been extensive sugar cane farming. This would have destroyed most of the deposit and features. Very few artefacts were noted in the area, except for European ceramics (fig. 10). Two of the ceramics had transfer print designs and appear to be from plates. One porcelain teacup fragment and two general plate fragments were noted.

Significance: The site is of low significance.

Mitigation: No further mitigation is required. A permit will be required to go through the remains of the site.

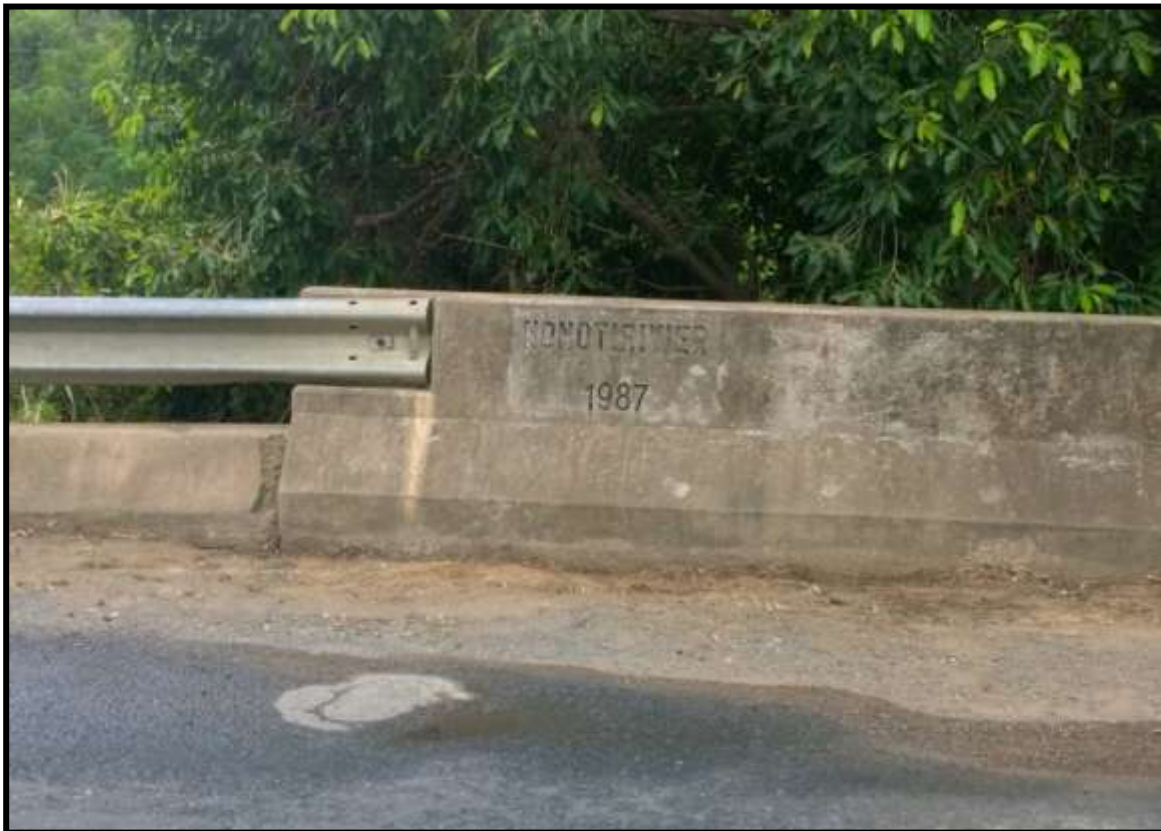
**FIG. 11: BRIDGE ON THE P107 OVER THE NONOTI RIVER**

NON01 is a bridge over the Nonoti River on the P107. The bridge occurs on the 1937 aerial photographs and the 1968 topographical map. The current bridge is a concrete structure that dates to 1987 (fig. 11). The bridge is less than 60 years in age and is thus not protected by heritage legislation.

Significance: The site is of low significance.

Mitigation: No mitigation is required.

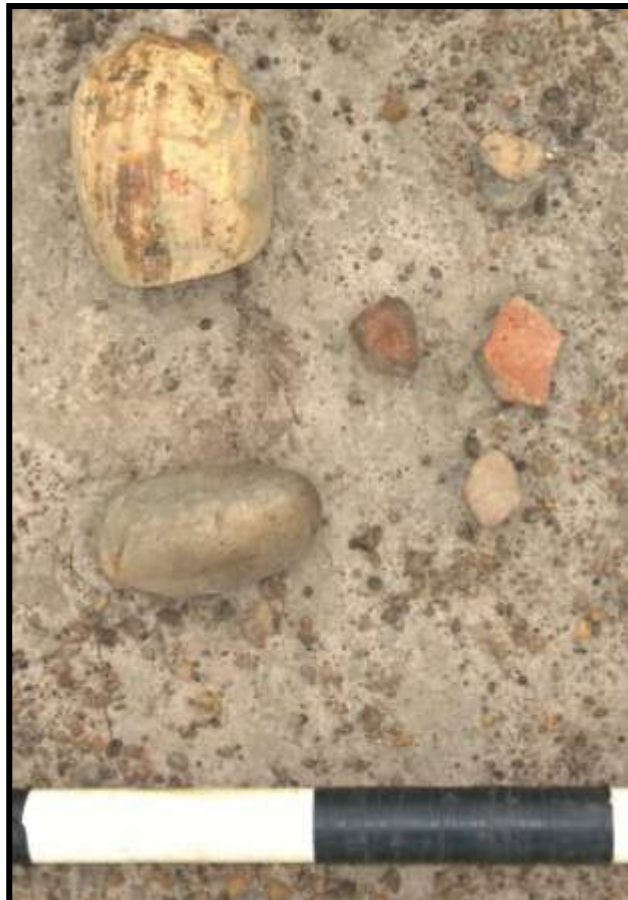
**FIG. 12: ARTEFACTS AT NON02**

NON02 is located at the northern end of Off take 6C, where a presumed reservoir will be built. The site is on a hill, with shallow soils and sugar cane. The site has an area of ~70m x 80m. The site consists of an ephemeral scatter of Indeterminate Iron Age sherds. The sherds are orange-brown and brown in colour and are mostly thin-walled. This suggests they are probably Late Iron Age or Historical Period sherds. A few upper grinding stones form quartzite river pebbles were also noted. The artefacts are shown in fig. 12.

Significance: The site is of low significance. The soil is too shallow to have an intact archaeological deposit

Mitigation: No further mitigation is required. The client will need to apply for a permit to damage the site.
