**HIA STUDY OF THE PROPOSED CONSTRUCTION
OF OFFTAKE 8D POTABLE WATER PIPELINE AS
PART OF THE LOWER THUKELA BULK WATER
SUPPLY, DARNALL, ILEMBE DISTRICT
MUNICIPALITY, KZN**

FOR TRIPLO4 SUSTAINABLE SOLUTIONS

DATE: 5 FEBRUARY 2015

**Umlando: Archaeological Surveys and Heritage
Management**

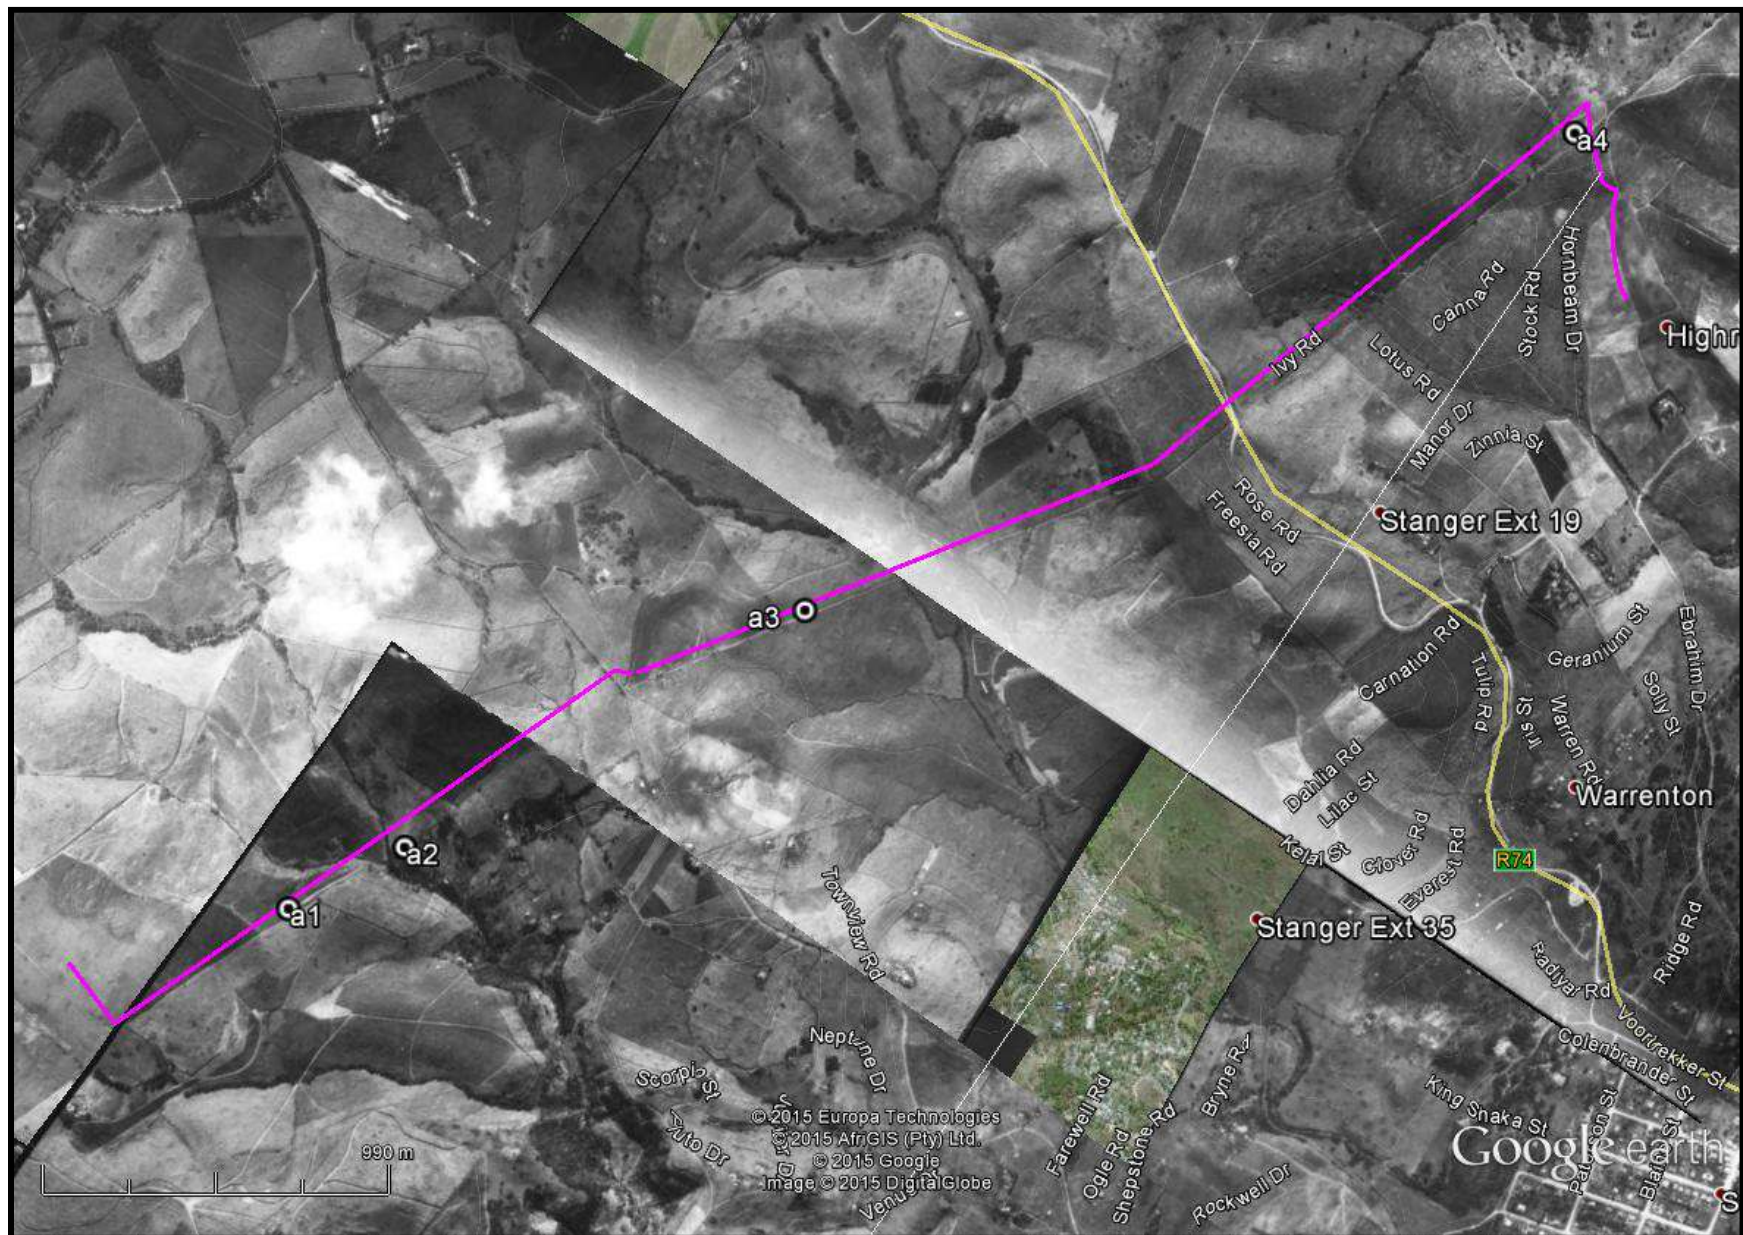
FIG. 6: STUDY AREA IN 1937

The 1937 aerial photographs indicate that there are four areas that have heritage sites within 50m of the servitude (fig. 5). All of these are settlements that could have human graves. The settlements are in a traditional Zulu settlement pattern, and thus graves are expected.

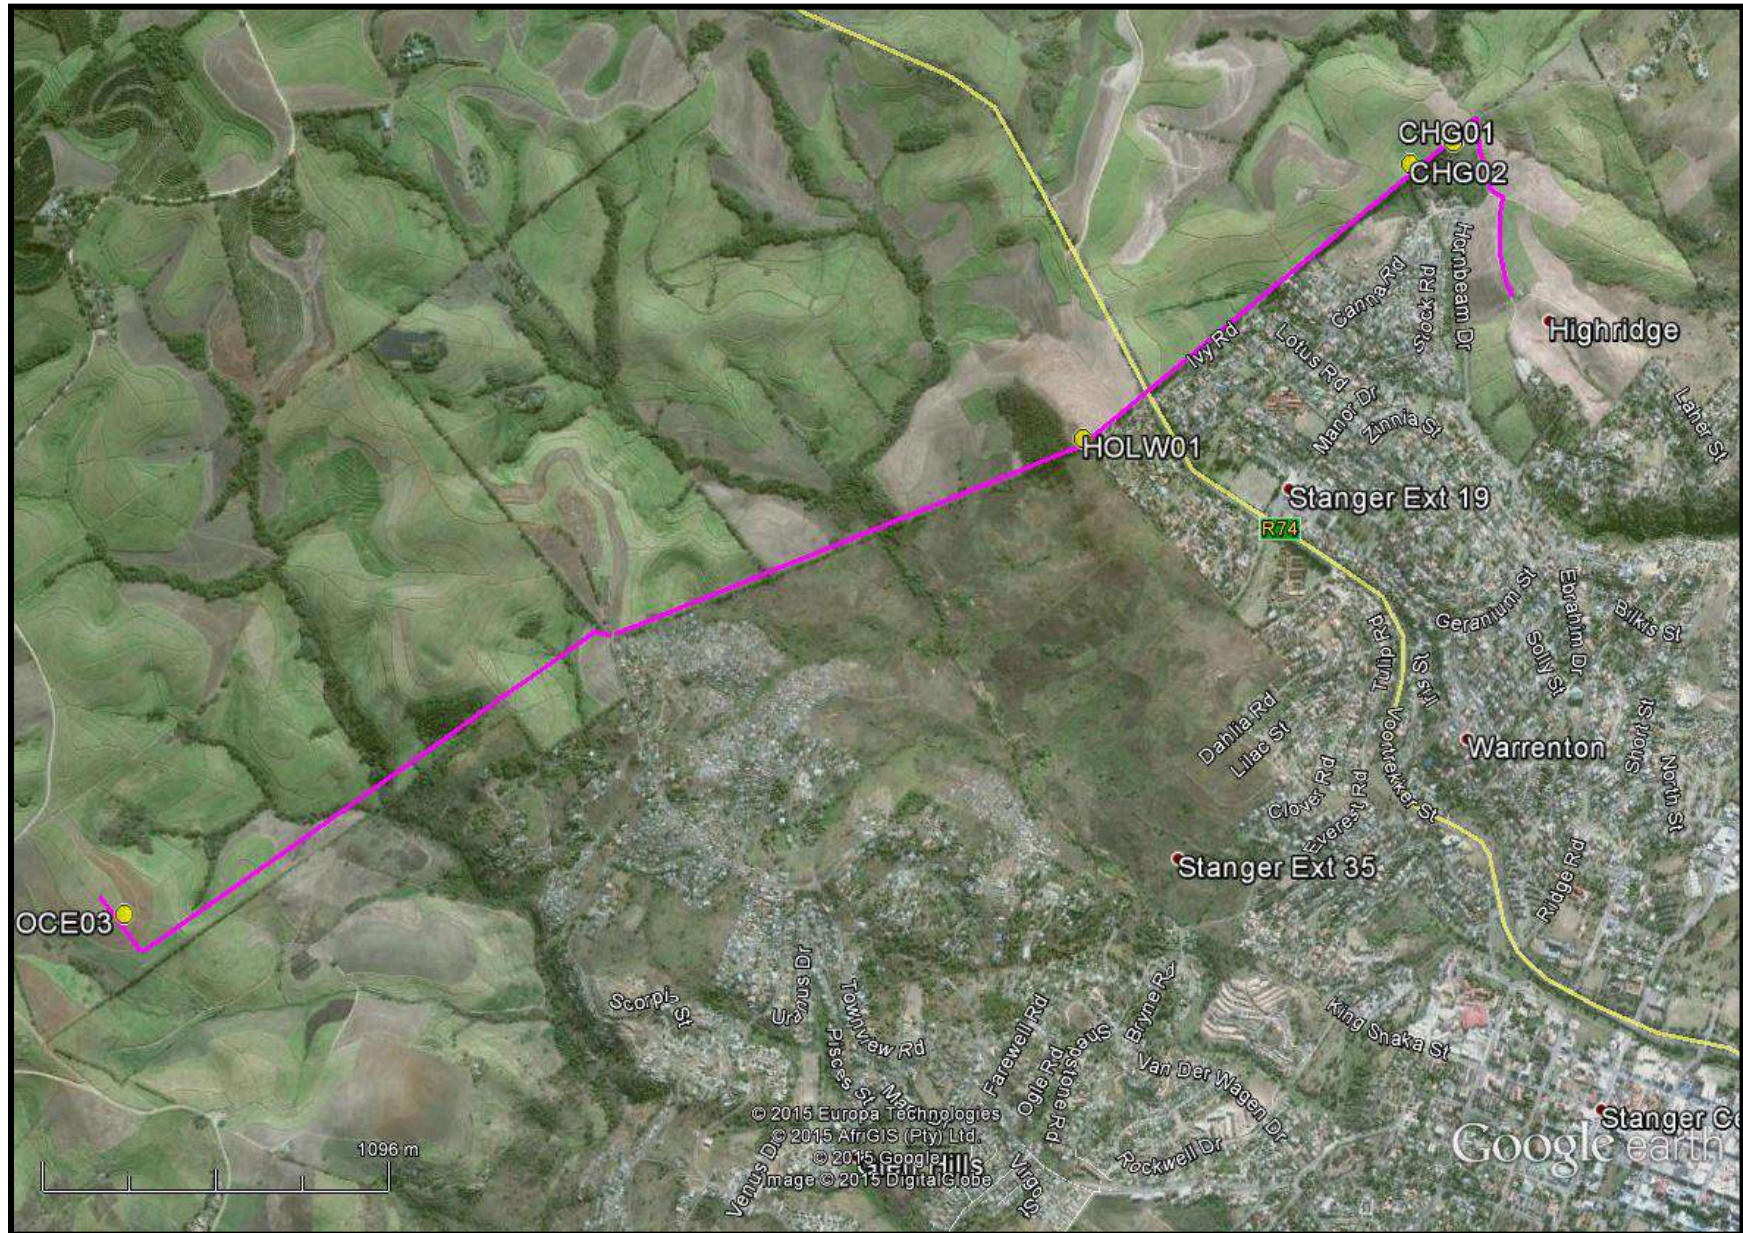
FIG. 8: LOCATION OF RECORDED HERITAGE SITES

Table 2 lists the locations of these sites while figure 8 shows their location. Figure 9 shows the general line.

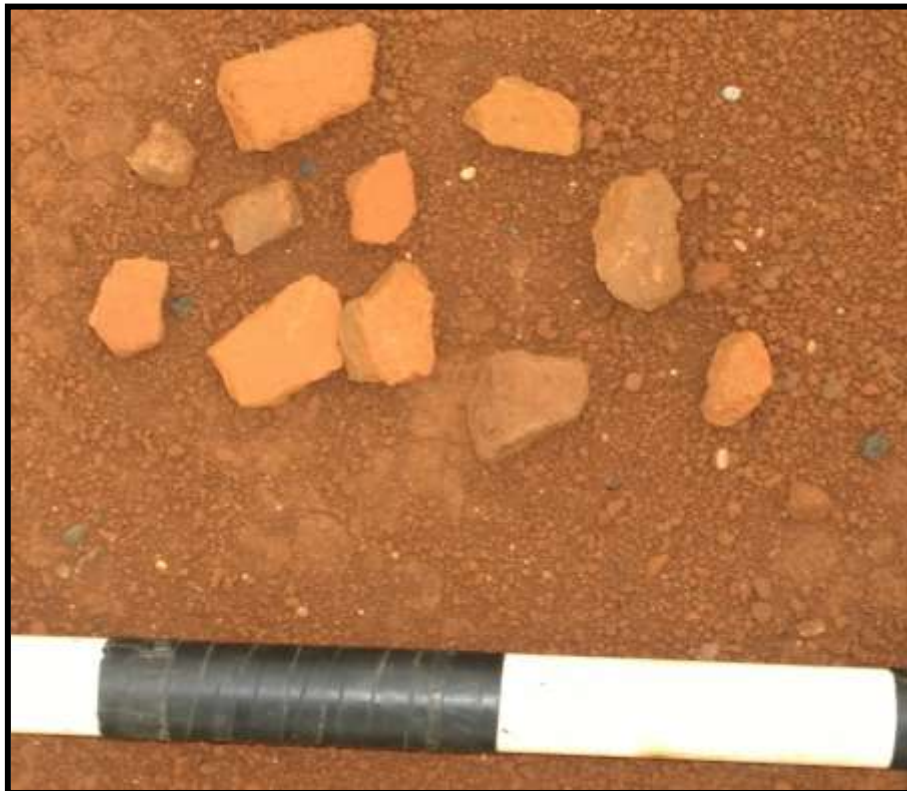
FIG. 12: POTTERY SHERDS AT OCE03

OCE03 occurs on a long hill overlooking the valley towards Stanger. The site occurs over an area of 160m x 150m in size; however, the artefacts tend to be concentrated along the southeastern side of the hill. The site consists of an extensive scatter of Late Iron Age, or Historical Period, pottery sherds (fig. 12). These sherds occur in small concentrations along the hill. Fragments of possible upper grinding stones occur. The soil appears to be deep in this area and thus there is a potential archaeological deposit. This implies that undisturbed subsurface features could occur. A reservoir will be constructed on the site.

Significance: The site is of medium significance. There is a potential archaeological deposit, and a possibility of human remains.

Mitigation: The site should be monitored during the construction phase of the reservoir. The client will need to apply for a permit to damage the site.

OEC03 will require monitoring by a qualified archaeologist during the construction of the reservoir. Both the archaeologist and the client will require a permit from Amafa KZN before construction begins. Subsurface features exposed by construction may require excavation or sampling. Any human graves will require full excavation. The client will need to add this into their management plan for possible delays,

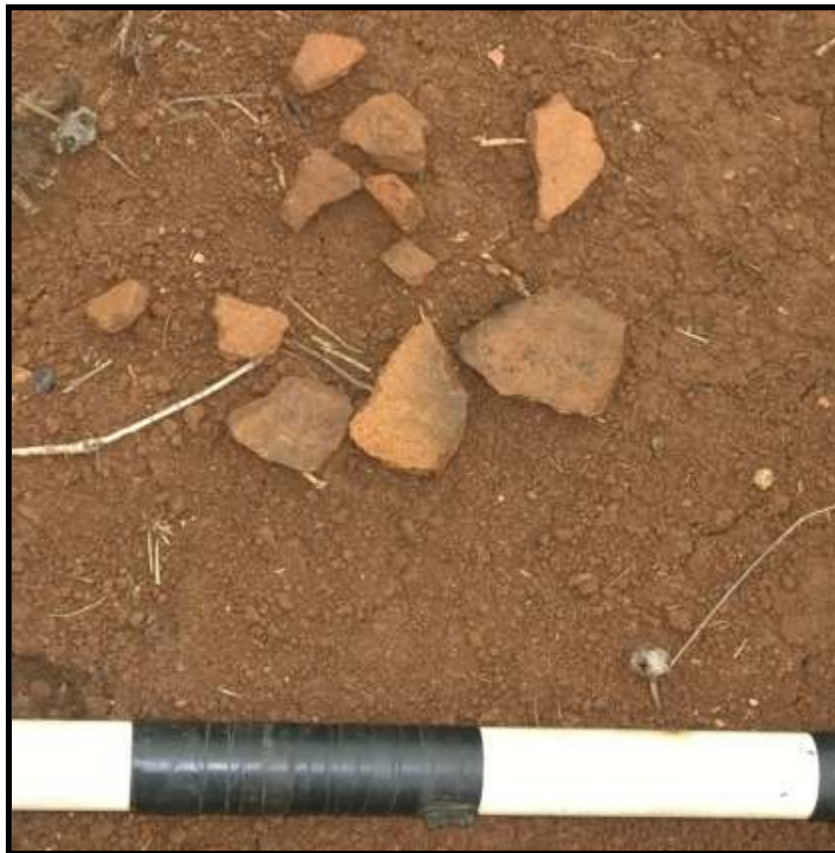
FIG. 13: ARTEFACTS FROM HOLW01

The site is located on the top of the highest hills in the area. Only a small section of the original site remains, as the rest has been built over with formal housing and/or a reservoir. The remaining field is currently under sugar cane. The site consists of an ephemeral scatter of pottery sherds (fig. 13). No other artefacts were observed.

Significance: The site is of low significance.

Mitigation: No further mitigation is required. The client will need to apply for a permit to damage the site.

HOLW01 will require a permit from Amafa KZN for its partial damage.

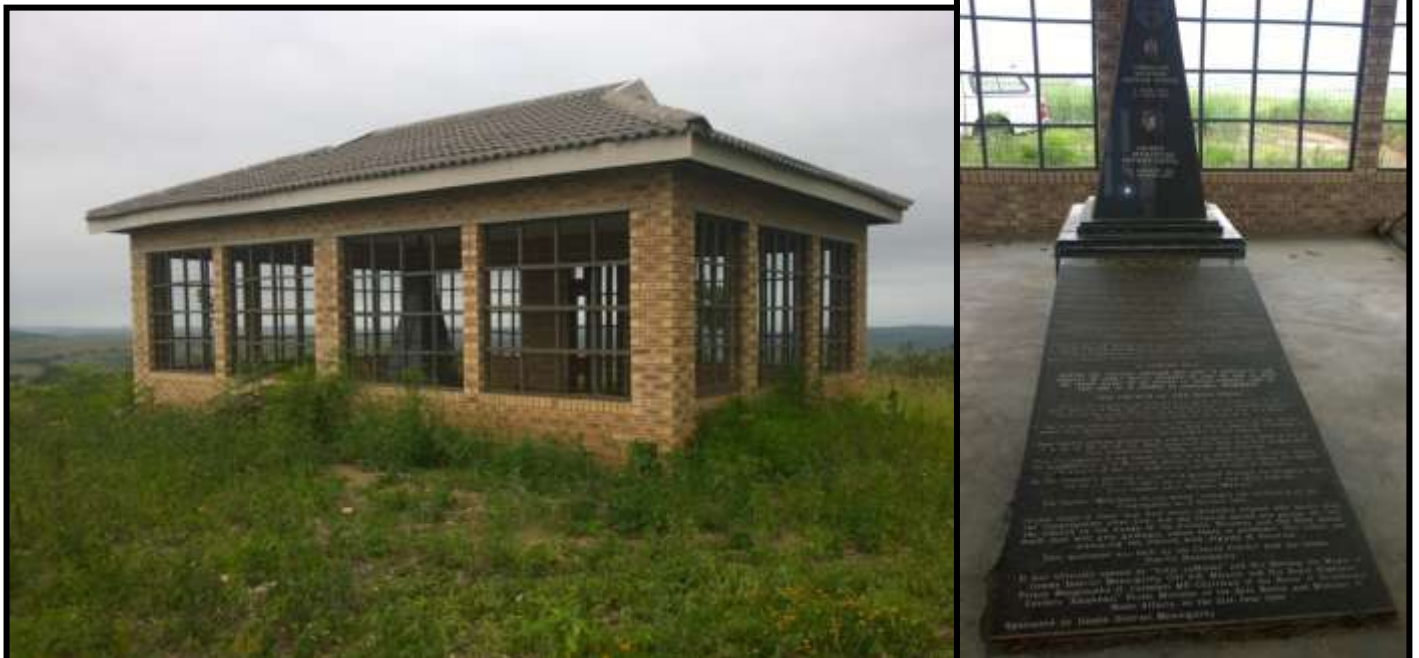
FIG. 14: MONUMENT AT CHG01

CHG01 is a monument for the founders of the Church of the Holy Ghost in 1917. This memorial is built over the original building noted as 'a4' from the desktop study. According to the oral history of the church, the founders and 'prophets' of the church were visited by an angel nearby at CHG02.

Isolated pottery sherds were observed around the top of the hill.

Significance: The site is of high significance for the Church of the Holy Ghost and it has oral history and living heritage status.

Mitigation: the memorial will need to have a buffer from the pipeline footprint. The normal buffer would be ~20m; however, this might not be possible in this area. I would suggest a 5m – 10m buffer between the building and the edge of the footprint. There is an existing pipeline line in front of the church and thus the area for work is small.

CHG01 and CHG02 will require buffers between the pipeline footprint and the building and tree. The buffers should be 5m and 10m respectively.

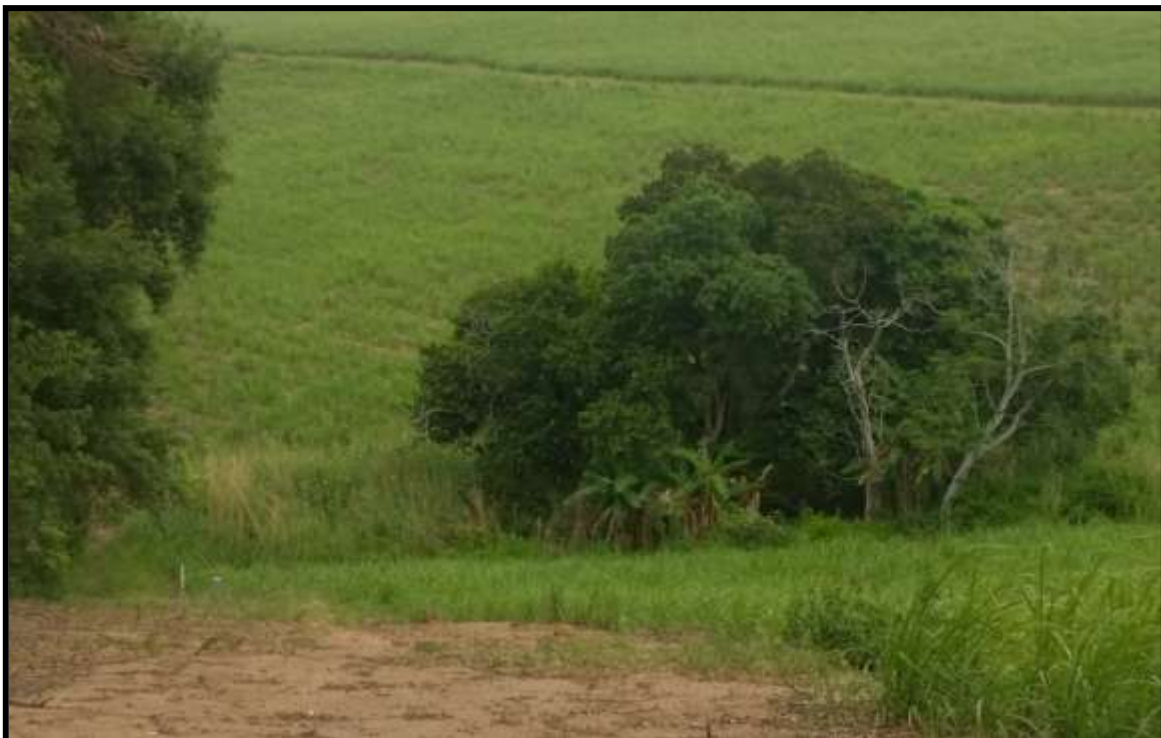
FIG. 13: TREE AT CHG02

CHG02 is located 145m southwest of the memorial. It is a large tree surrounded by cabbage trees (fig. 13). The memorial stated that the angelic visitation occurred ~300m to the west. There is no tree at that distance; however, another group of tree occurs 400m to the west (fig. 14). These latter trees do not appear to be old enough as those at CHG02. Until the exact location can be determined, I suggest CHG02 is viewed as the tree referred to in the memorial and this would avoid any potential mishaps.

Significance: The tree is falls under the living heritage and oral history and is thus protected by heritage legislation. The tree has high significance to the Church of the Holy Ghost

Mitigation: A 10m buffer should be placed between the tree and the pipeline footprint.
