**SURVEY OF THE PROPOSED THOMASVILLE DAM,
CURRYS POST, KWAZULU-NATAL**

**FOR THE INDEPENDENT ENVIRONMENTAL
ADVISOR**

DATE: 9 MARCH 2016

**Umlando: Archaeological Surveys and Heritage
Management**

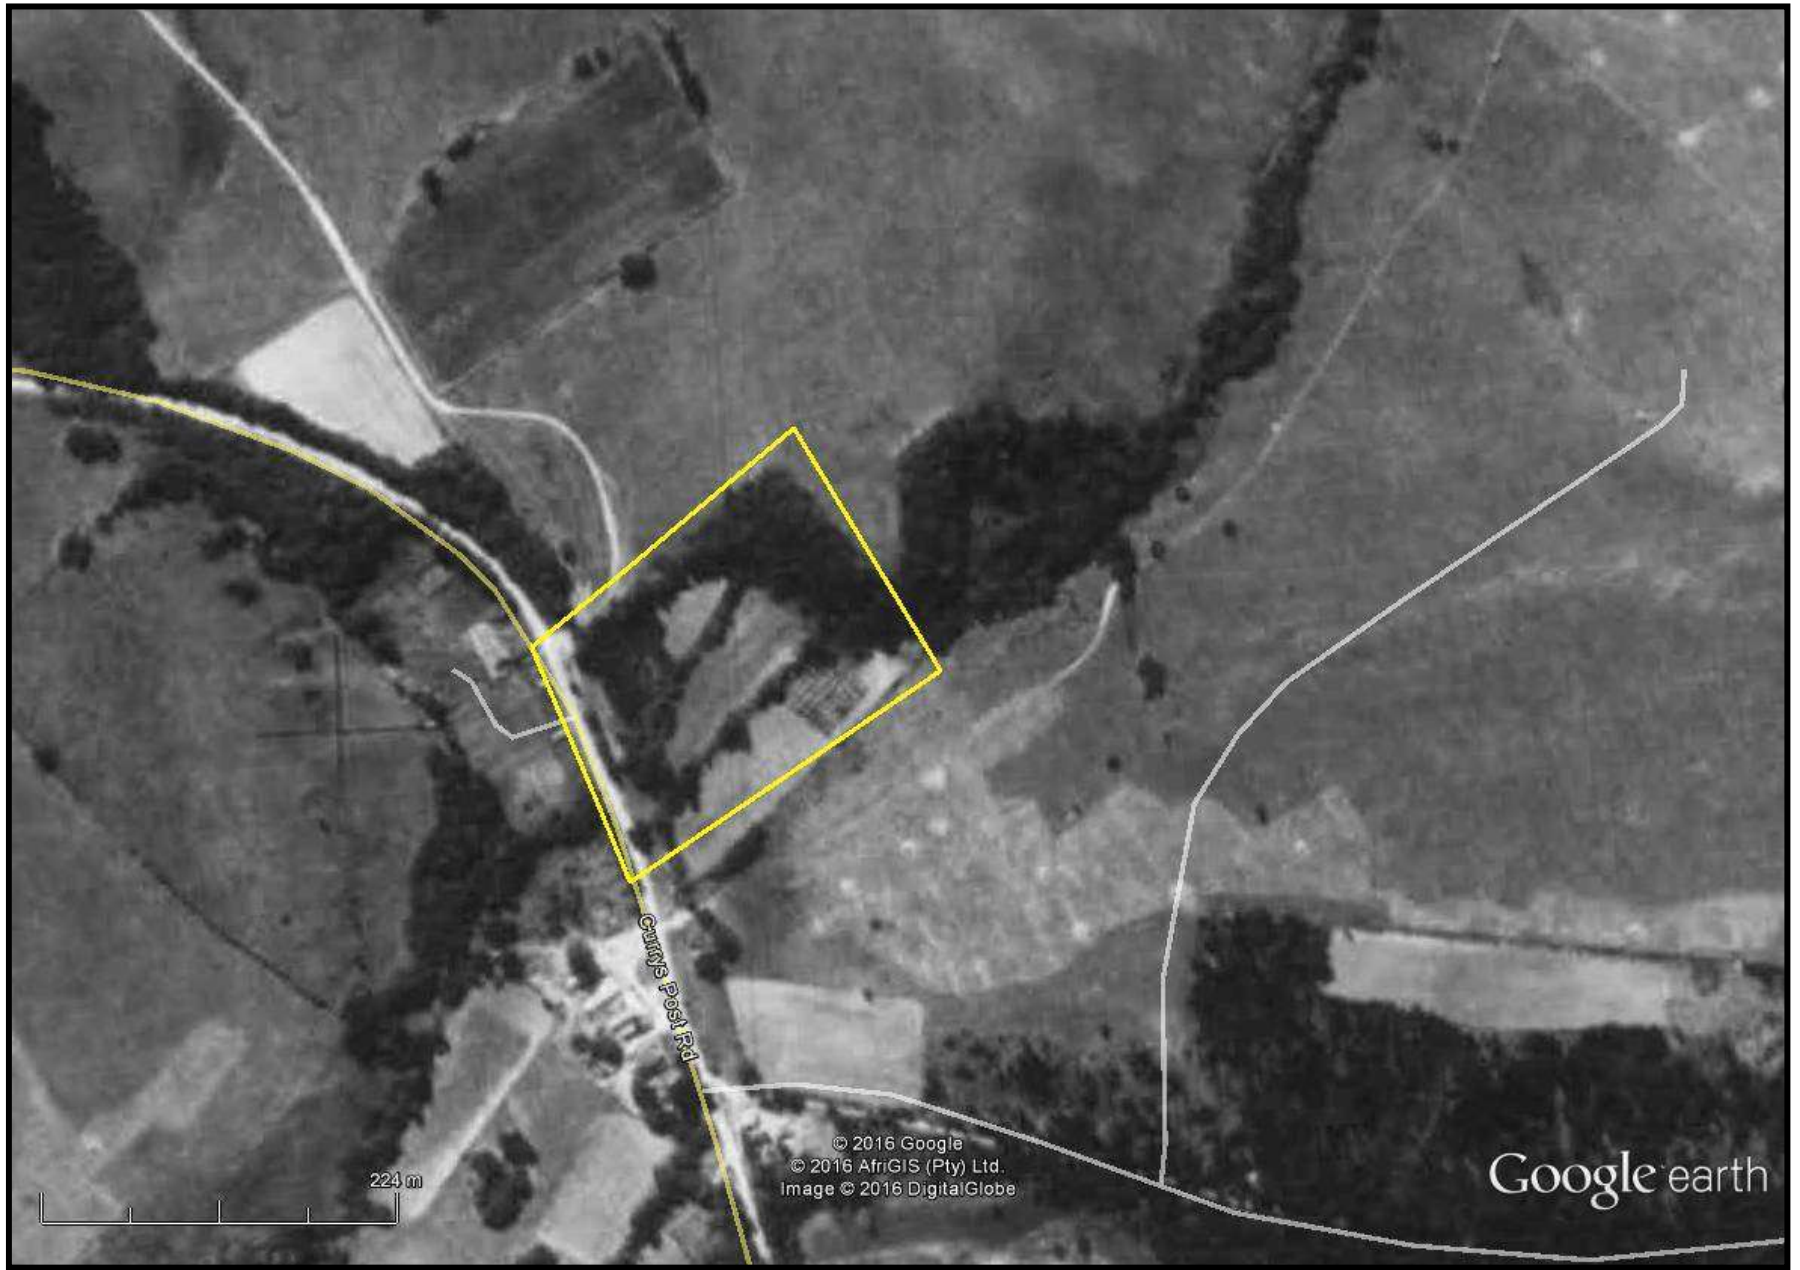
FIG. 7: STUDY AREA IN 1937

The 1937 aerial photographs show the farm buildings and the walling that is now covered in bushes and surrounded by trees (fig. 7). The walling forms two 'paddocks'.

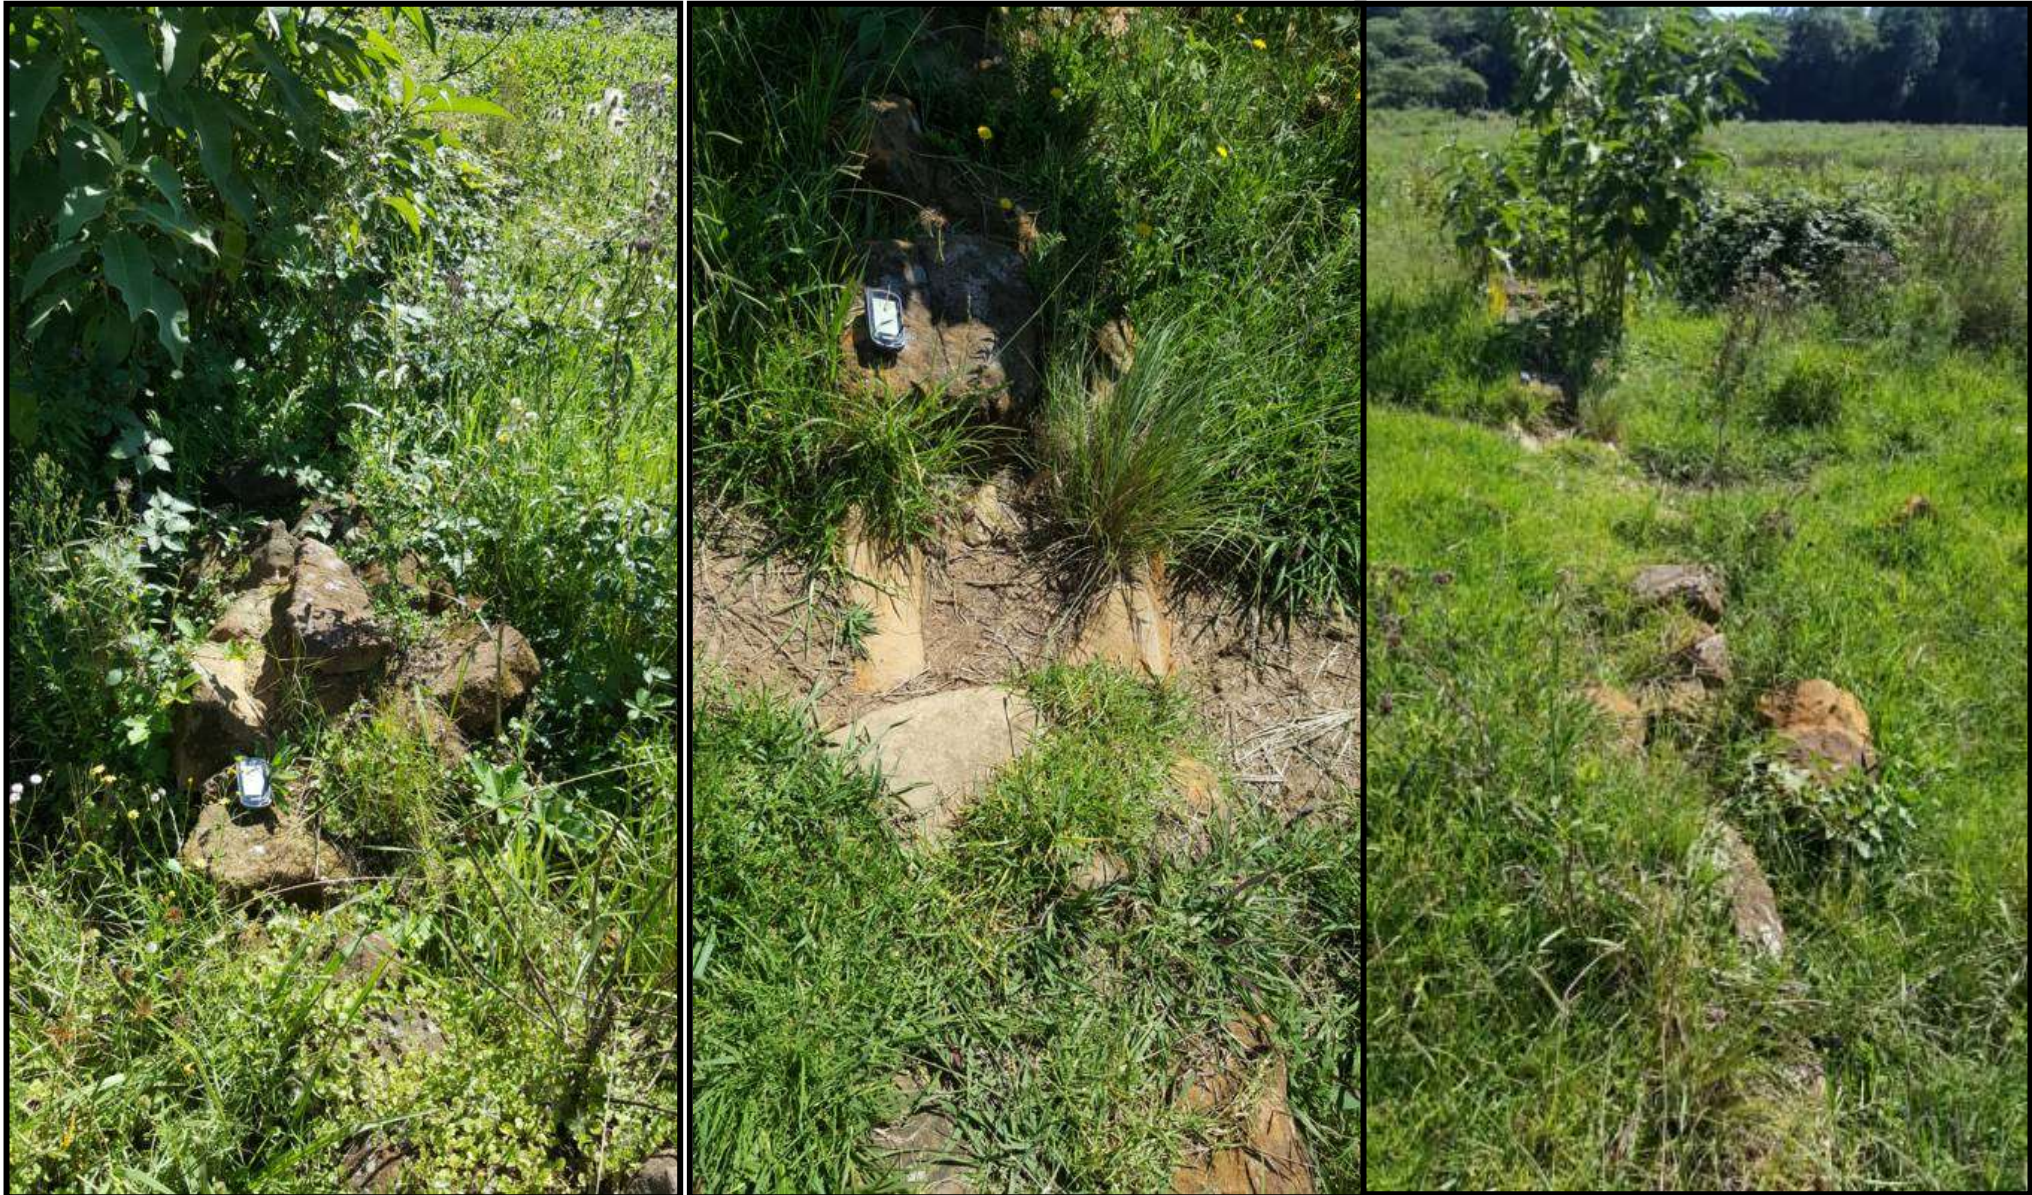
FIG. 9: NORTHEASTERN WALLING¹

The field survey was undertaken in February 2016. The only heritage site that was recorded was the walling noted in the 1937 photographs. The walling is mostly in ruins and only partially intact along the north-eastern corner. The walling consists of various sized rocks that have been placed on top of each other to form a low wall. Most of the north-western side of the wall is very broken and ~50cm in height (fig. 9). The north-eastern section is higher but has been broken by the older trees (fig. 10). The far north-eastern corner is ~1m high and appears to be linked to two smaller walls (fig. 11).

There is no existing evidence that the original wall was plastered to retain water; however, this could have eroded over the decades. The wall is made from local dolerite boulders.

Significance: The walling is of low significance and is in a poor state of preservation.

Mitigation: The walling should be mapped and photographed.

Management Plan: The walling has been mapped (fig. 12), and photographed (fig.'s 9 – 11). The locations of the GPS points are given in Table 1.

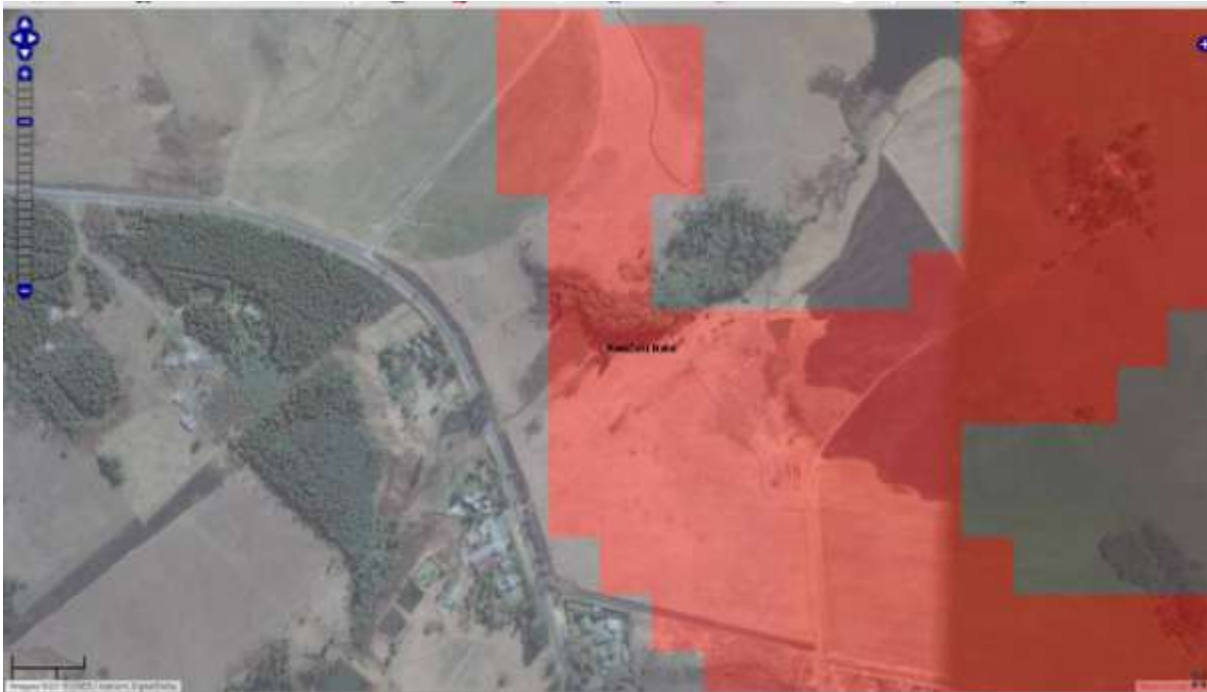
FIG. 13: PALAEOLOGICAL SENSITIVITY

Part of the dam occurs in the highly sensitive area for palaeontological sites (fig. 13). A Palaeontological Impact Assessment was not undertaken for the dam, as any paleontological levels will not be affected.

“Up there the weathering profile in mud rock/shale/siltstone should be quite thick. Within 2m of the surface there might be an irregular transition from clayey saprolite to fresh shale” (Dr Greg. Botha, pers. Comm. to Sarah Allan).

The basin will not affect these shale layers as it does not extend beyond 2m in depth. No further PIA is required.
