**PROPOSED UMKHOMAZI WATER PROJECT PHASE 1,  
RAW WATER COMPONENT**

**Phase 1 Heritage Impact Assessment**

**May 2015**

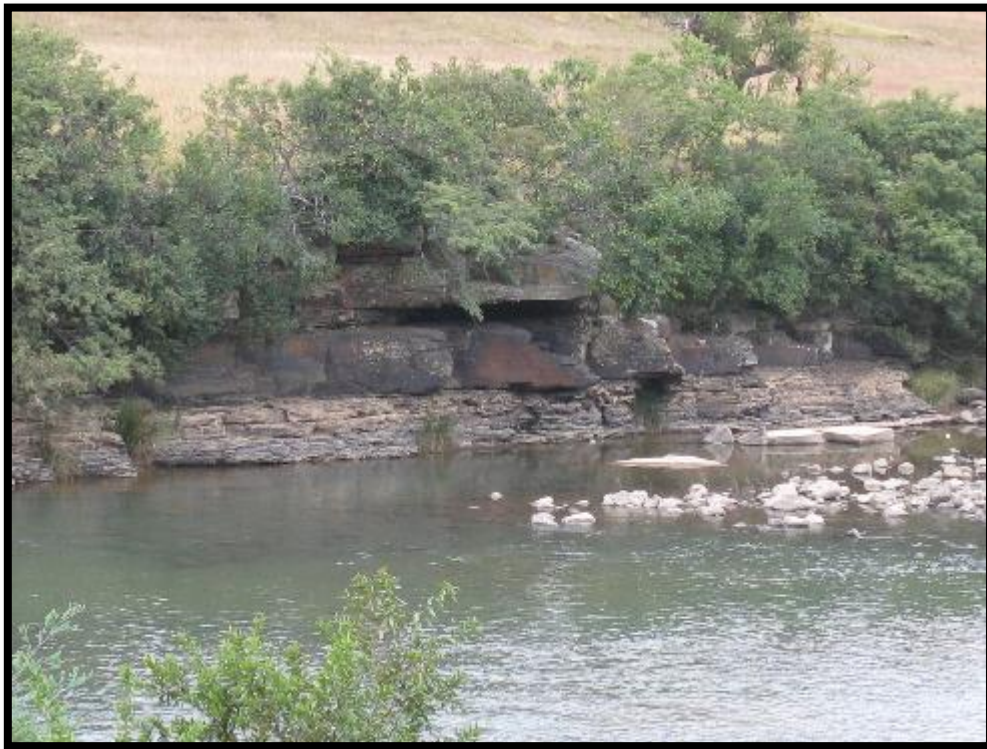
Although various significant archaeological sites, such as rock art occurrences, occur in the greater Boston and Bulwer areas none were located the areas that were accessed during the site visit. Small shelters that were noticed adjacent to the Umkhomazi River were investigated but these all are located within the river flood zone and no archaeological deposit would remain (Fig 4).

**Figure 4: Small shelter adjacent to the Umkhomazi River**

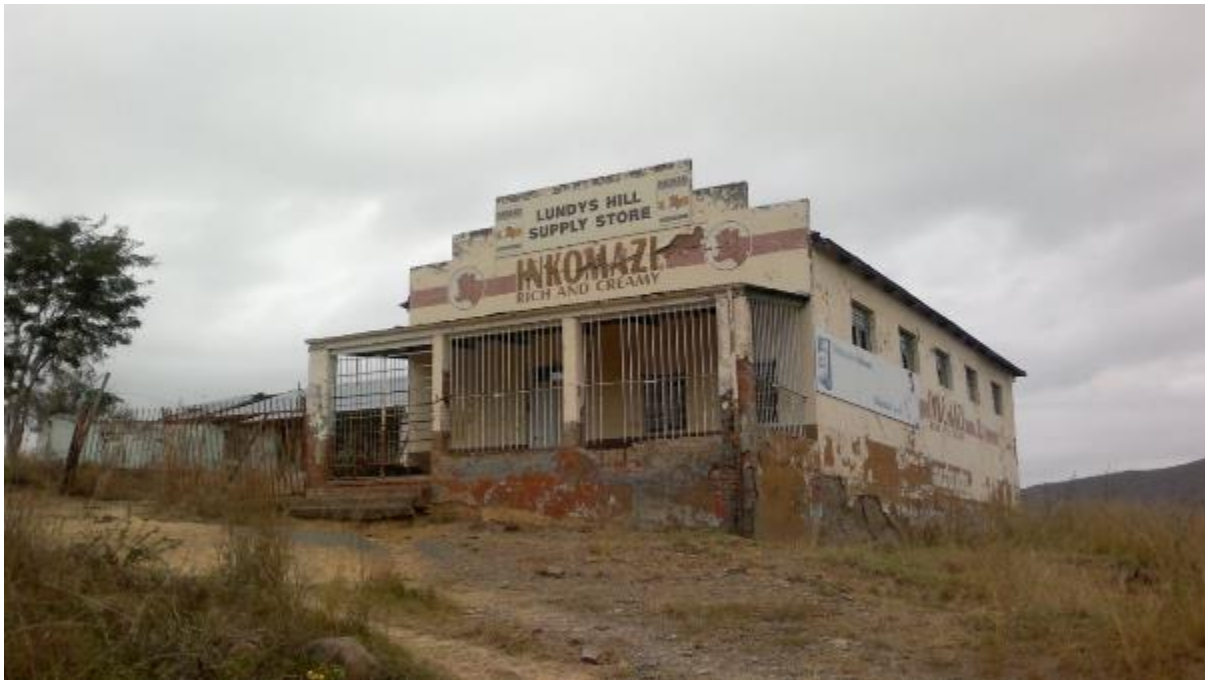
Close to where the R617 will be inundated by the proposed Dam, the Lundy's Hill Supply Store can be found. It forms part of a complex of buildings. The store is situated at 29°44'28.97"S / 29°54'53.75"E. Although in poor condition, the building is older than 60 years and is protected by section 33 of the KwaZulu-Natal Heritage Act. It is understood that the building will not be inundated by the proposed dam. It is however recommended that the store is protected by a 10 m fenced buffer to prevent any accidental damage in terms of passing construction vehicles, etc.

**Figure 6: Lundy's Hill Supply Store**

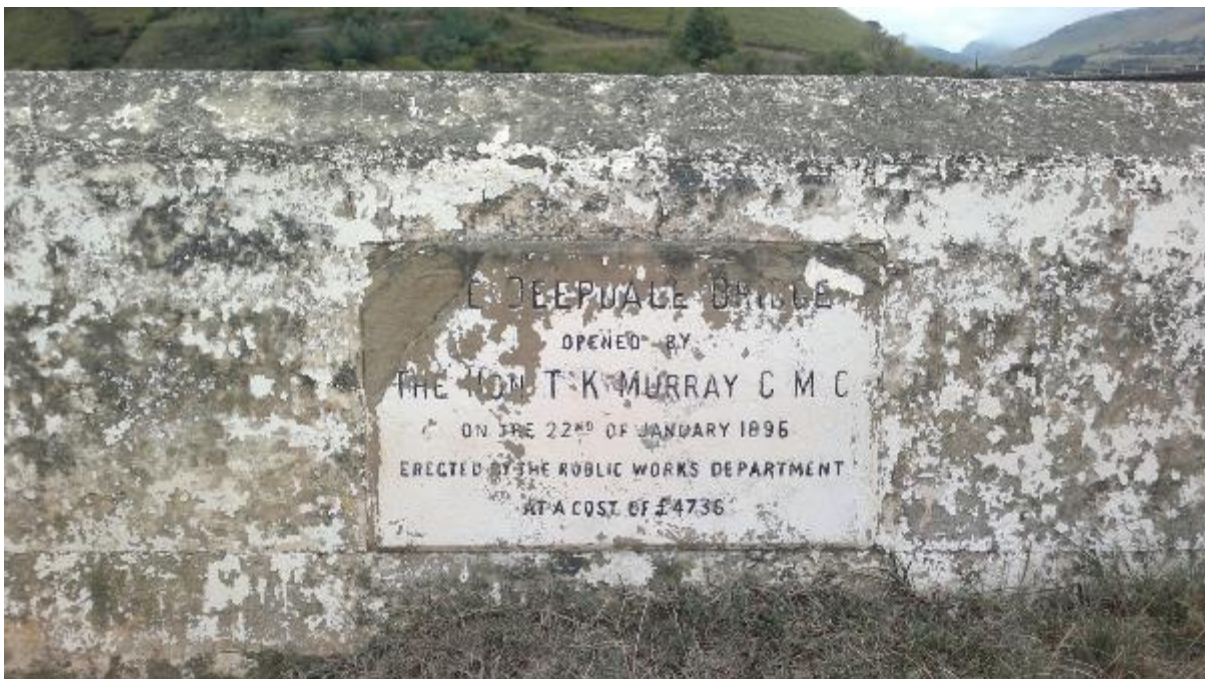
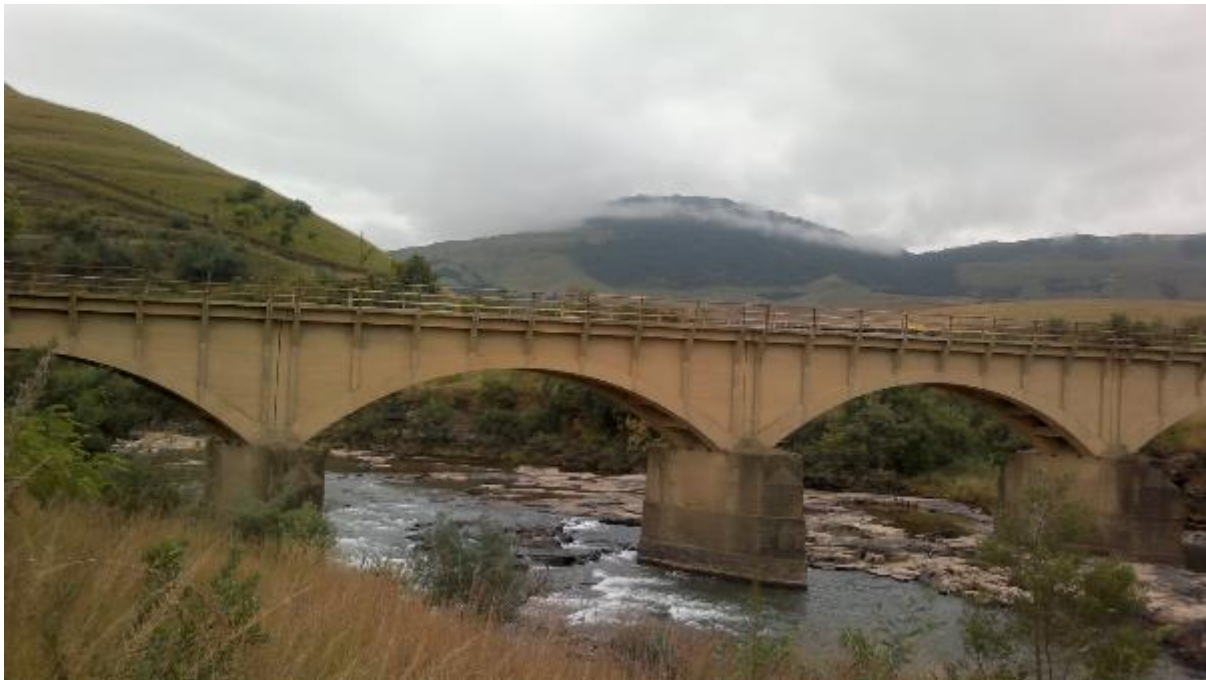
Immediately west of the store is the Deepdale Bridge which was built in 1896 and reconstructed in 1913. The single lane bridge on the D1212 is a reminder of the economic development of the Colony of Natal in the 19<sup>th</sup> Century with the spread of roads to the interior of the Colony. The bridge is a protected structure and it is recommended that inundation of the structure is avoided if possible due to its significance as one of the few remaining bridges from that era. The centre of the bridge is located at 29°44'28.75"S / 29°54'40.07"E.

**Figure 7: Plaque on Deepdale Bridge**

**Figure 8: Deepdale Bridge**

It is recommended that the Deepdale Bridge which is over 100 years old not be inundated as it is an example of the road infrastructure that was built in the late 19<sup>th</sup> century which is in

remarkably good condition. If inundation cannot be avoided, then a full recording of the bridge must take place and a permit must be obtained from Amafa for the destruction of the bridge.

If inundation of the bridge cannot be avoided, a permit in terms of Regulation 2 of the KwaZulu-Natal Heritage Regulations of 2012 (Regulation No. 40 of 2 April 2012) will have to be obtained from Amafa prior to inundation and a complete recording of the structure must be undertaken to preserve its history. Two additional bridges on the R617 will be inundated by the proposed dam. These bridges were built more recently in the 1960s and have no heritage significance

It is recommended that the inundation of the Deepdale Bridge which is over 100 years old not take place as the bridge is an example of the road infrastructure that was built in the late 19<sup>th</sup> century and which has remained in remarkably good condition. If inundation cannot be avoided, then a full recording of the bridge must take place and a permit must be obtained from Amafa for the destruction of the bridge.

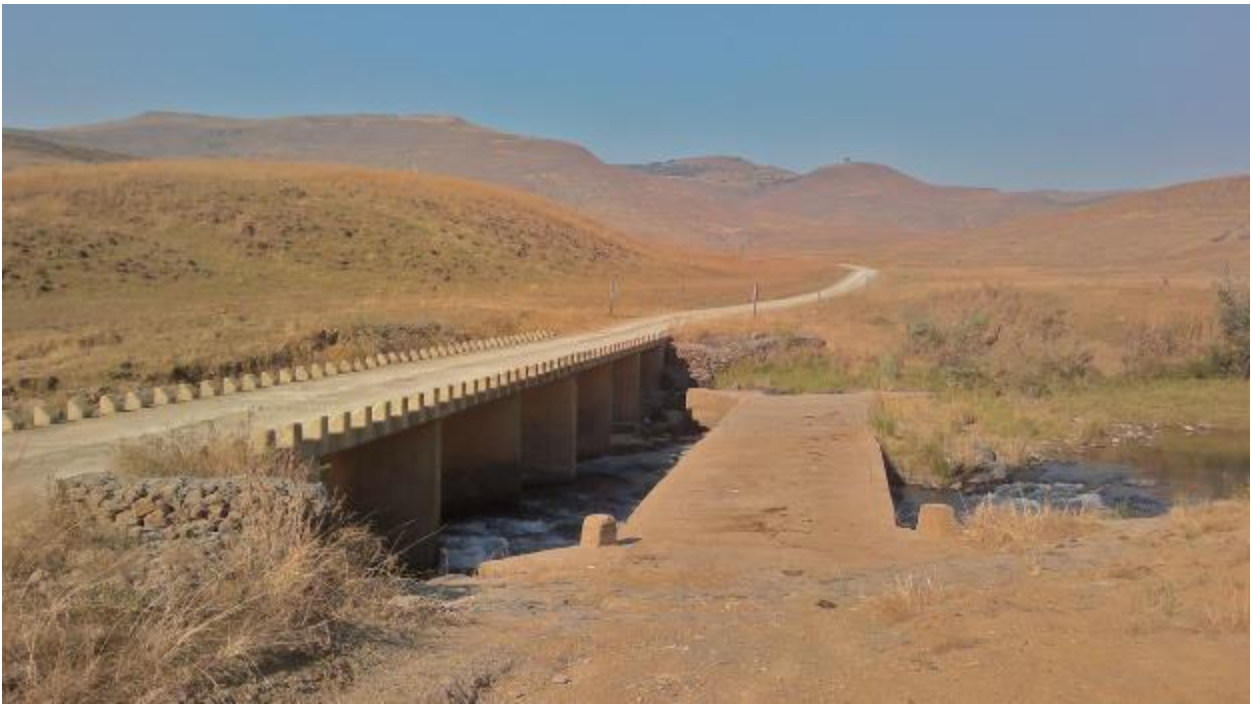
Two causeways on the gravel road to KwaZashuke that cross the Luhane River, a tributary of the uMkhomazi River, will be inundated by the proposed dam. The causeways are located at 29°46'20.23"S / 29°54'36.17"E

The date of when the structures were built is unknown. The lower causeway could be older than 60 years (especially in light of the fact that construction of bridges was already taking place in 1896 in the area). It is therefore recommended that an application for the destruction of both causeways is made to Amafa.

**Figure 9: Causeways on the Luhane River**

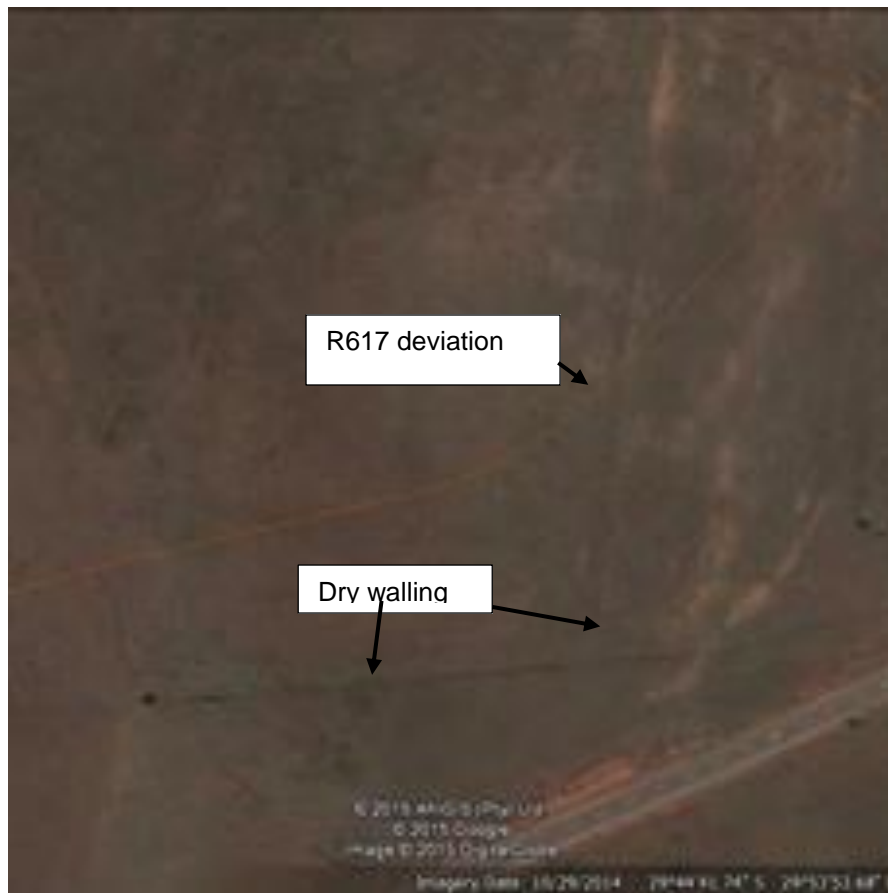
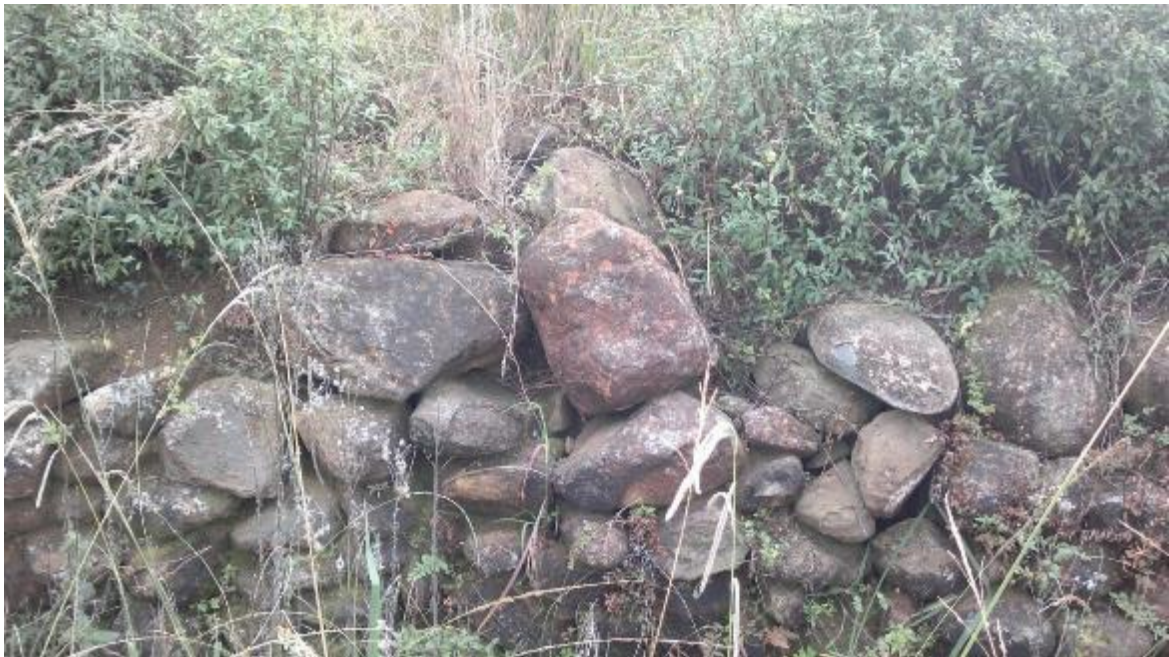
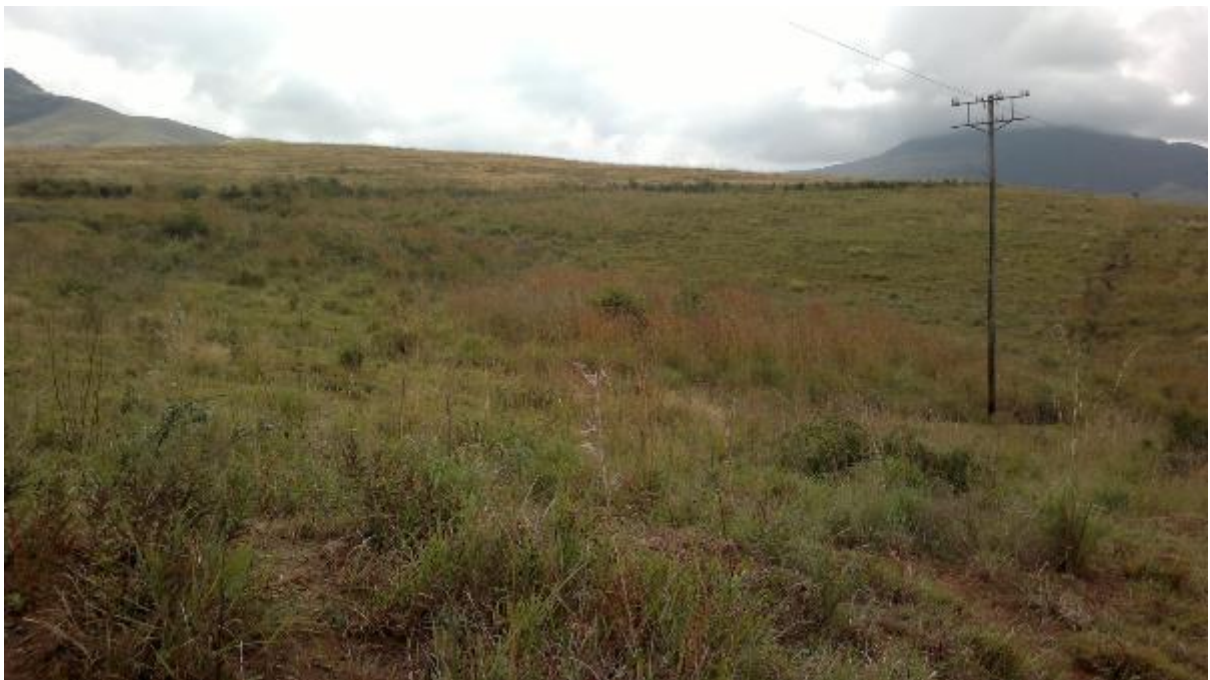
Some 50 m north of the R617 and on the other side of the valley to the above-mentioned terraced area, an old drystone wall was found. The wall was used to either keep animals in a secure area or to demarcate fields / pastures. These types of walls have their origins in the stone walling found in the British Isles.

The drystone wall will be impacted by the proposed deviation of the R617 at 29°44'40.57"S / 29°53'56.16"E. Although the wall appears to be no longer utilised, it is recommended that the R617 deviation avoid the wall as there are few reminders of this type of farming technique in KwaZulu-Natal let alone the country.

**Figure 10:** Google image of outline of drystone wall

**Figure 11: Section of drystone wall**

**Figure 12: View of raised area indicating drystone walling**

It is recommended that the proposed deviation follow the existing gravel road instead of looping southwards towards the river. This re-alignment would not only avoid the stone wall but would also keep the proposed realignment to an area that is already disturbed and where the possibility of finding intact heritage resources is low.

It is recommended that a 15 m buffer is placed around the wall during the construction of the R617 deviation to avoid any damage that may be caused to the wall from construction activities.

The drystone wall found north of the R617 and uMhkomzi River is one of very few examples of a farming technique that was used extensively in the British Isles. The wall is also in good condition although overgrown by vegetation. It is therefore recommended that the proposed R617 deviation that would impact on the wall be moved northwards to run along an existing gravel road thereby avoiding the wall and keeping the impact of the new road to an area disturbed by an existing road.

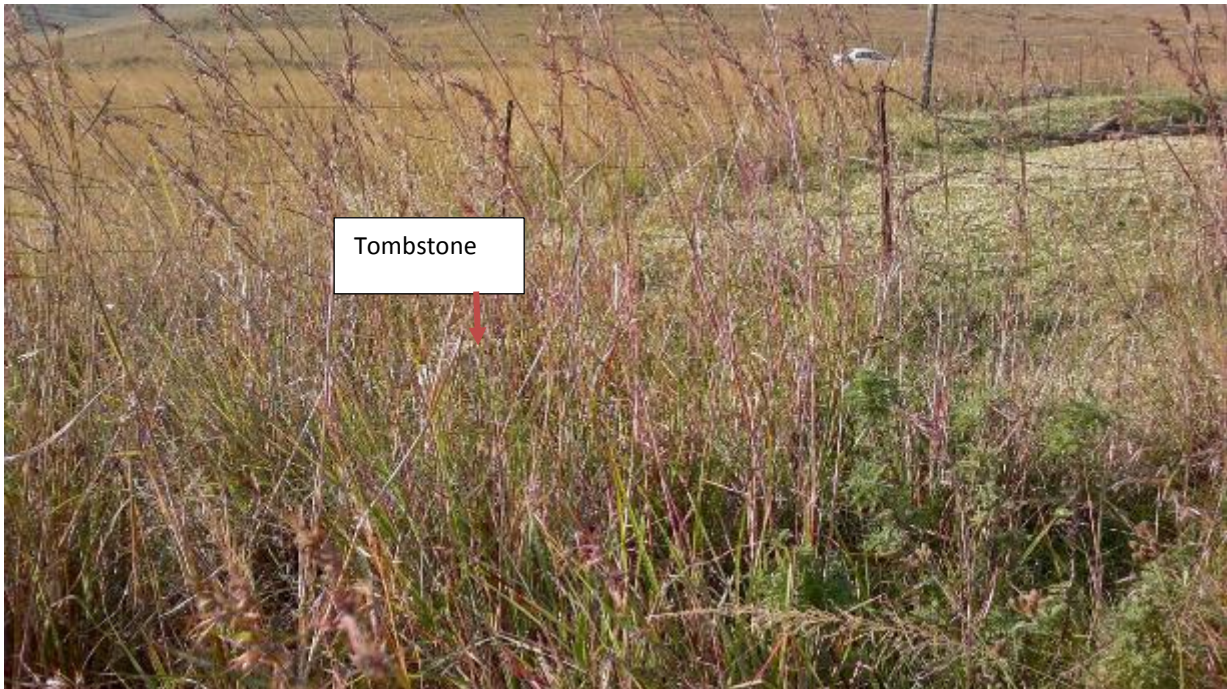
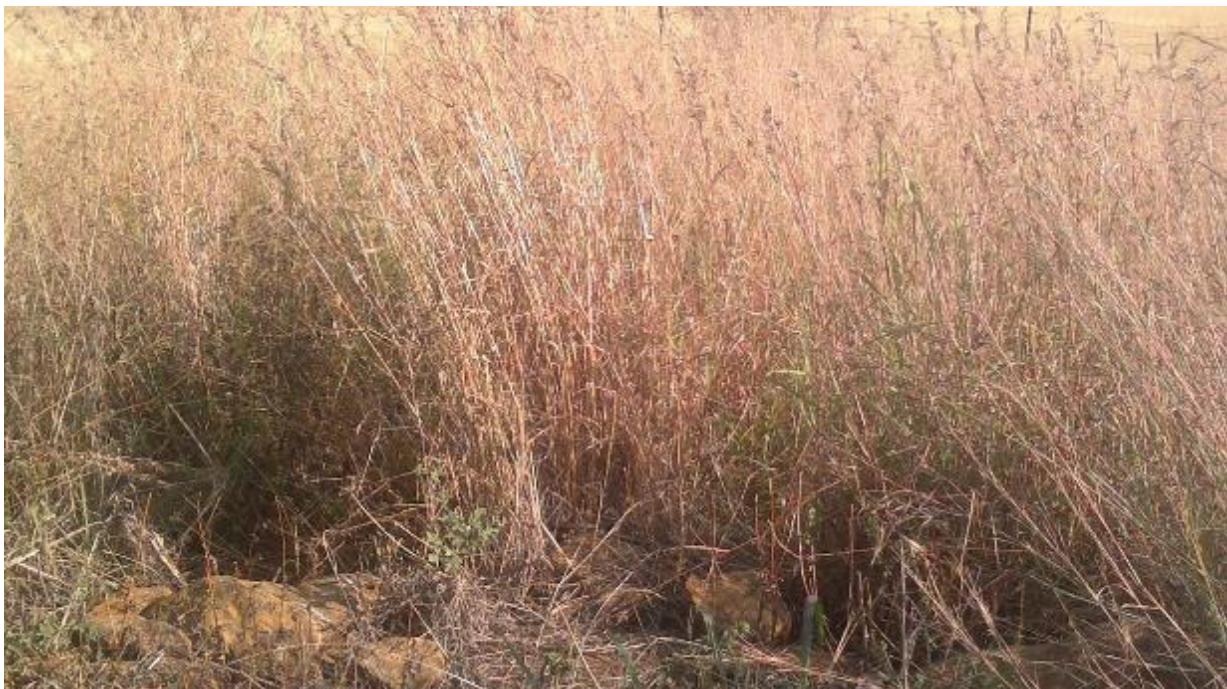
At Kheswa's Kraal, six graves were found in a fenced off area (29°45'20.26"S / 29°56'36.33"E) which was overgrown with grass. There was no-one at the homestead so the people buried in the small informal cemetery are unknown but are most probably family members. The

neighbours' provided the name of the owner of the property. The remains of a small tombstone can be partially seen in Fig. 14 below.

**Figure 13: Graves at Kheswa's Kraal**

**Figure 14: Outline of grave at Kheswa's Kraal**

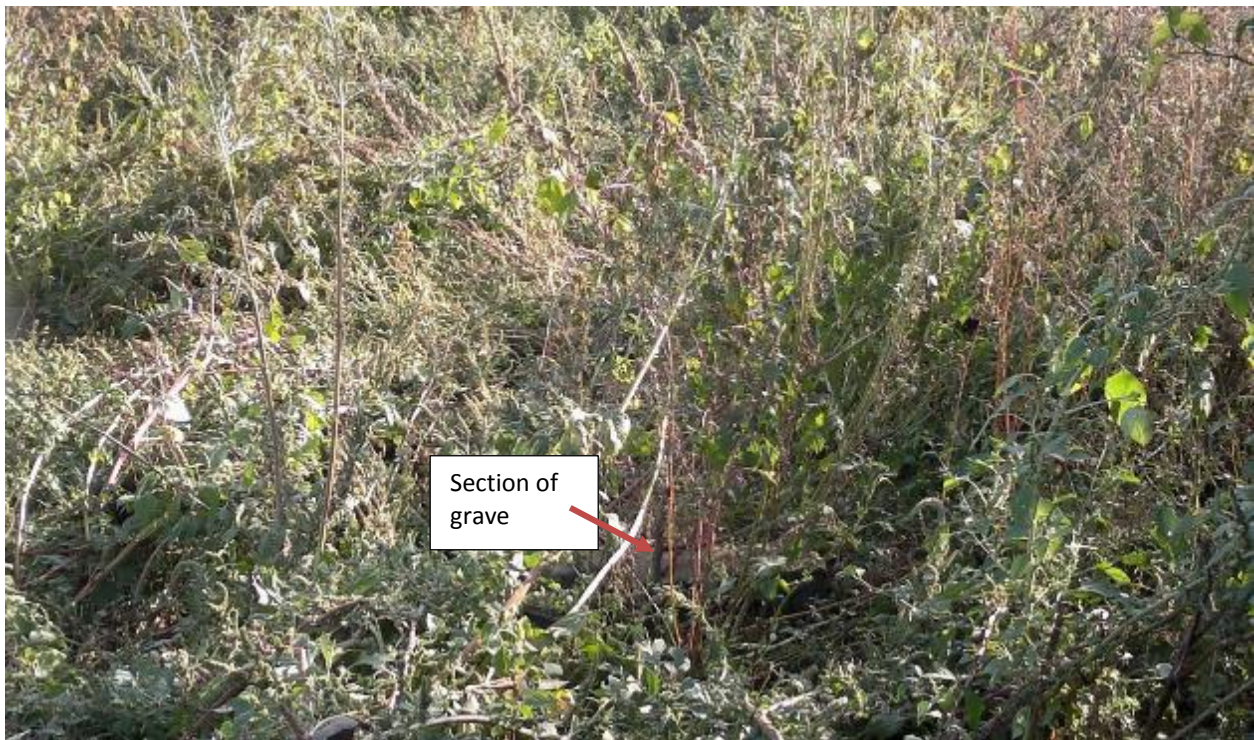
At Mbele's Kraal, the family at the homestead indicated that there was one grave of a family member which is located in the vegetable garden (29°45'26.49"S / 29°56'41.50"E) which was densely overgrown with vegetation. A small section of the grave can be seen in Fig. 16 below.

**Figure 15: Grave at Mbele's Kraal**

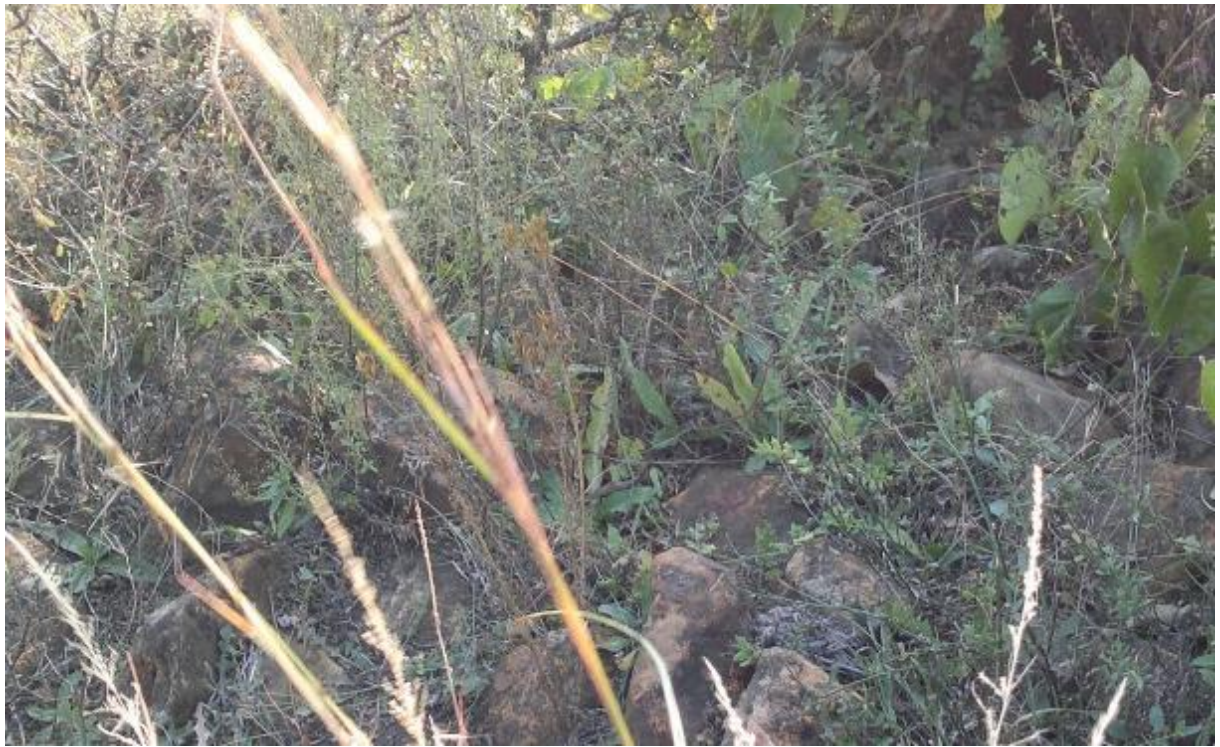
At Mncwabe's Kraal, two graves of family members were pointed out by Mr. Mncwabe. The two graves are situated next to one another in a vegetable garden (29°45'24.67"S / 29°56'49.44"E).

**Figure 16: Graves at Mncwabe's Kraal**

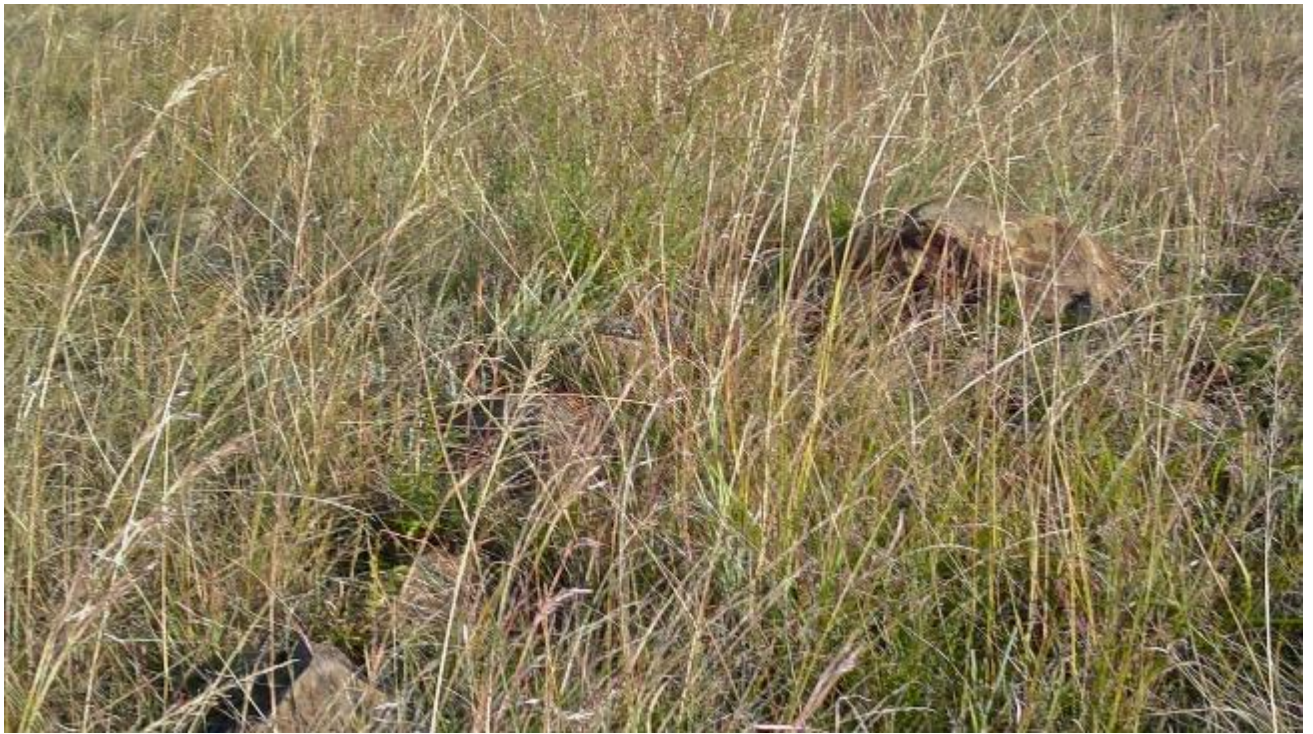
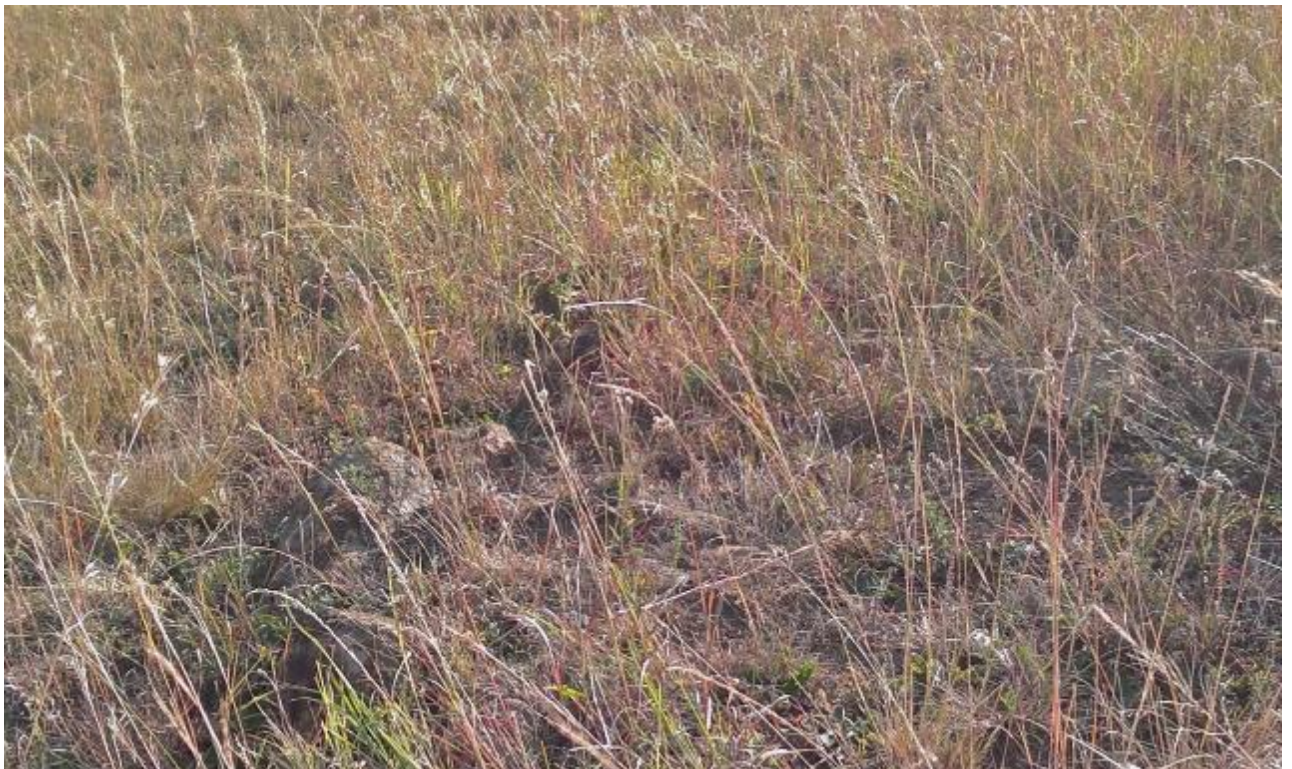
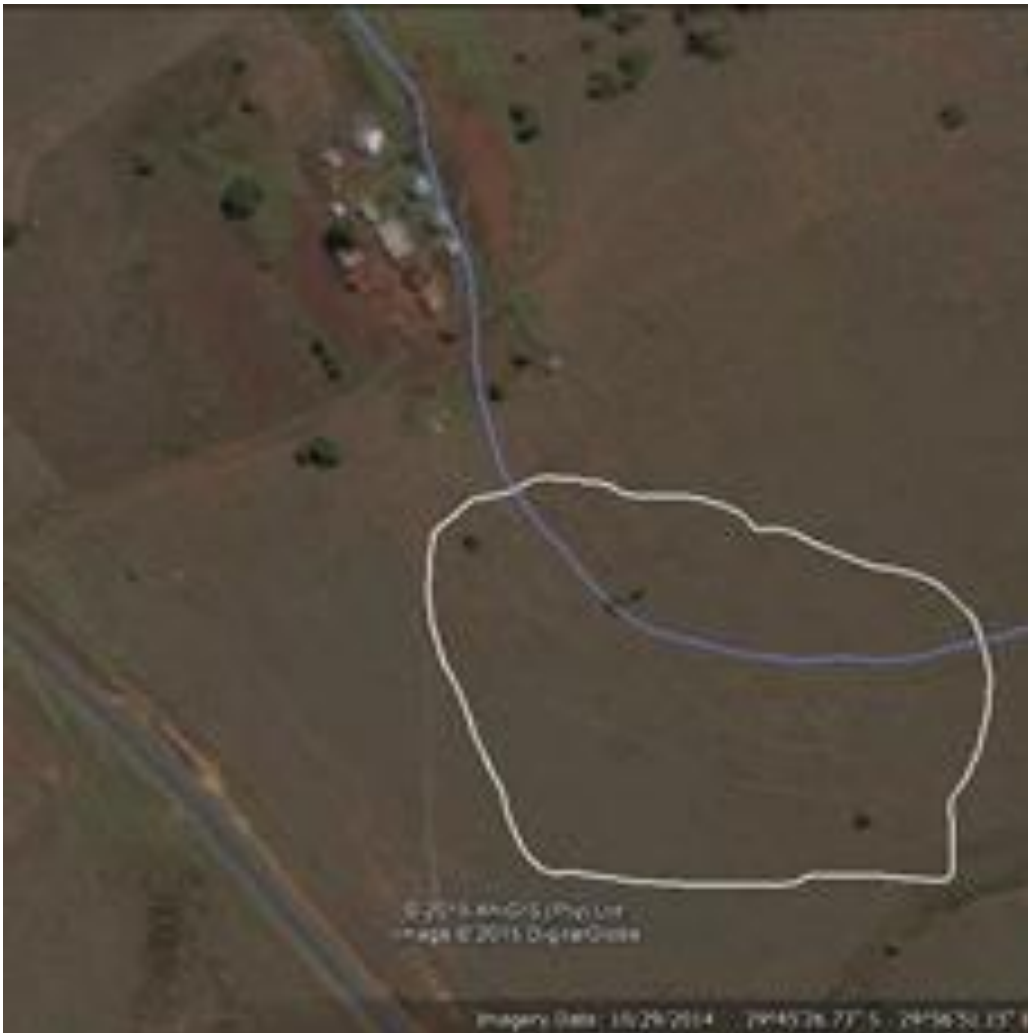
Mr. Mncwabe then mentioned that there were many graves situated directly east of his homestead where he said the old people were buried. The grass cover was very thick but an inspection revealed between 10 and 20 graves stretching several metres eastwards together with the remains of structures. Some of the graves are outlined with stones and some are covered with stones. There are no identifying tombstones. The graves are located roughly between  $29^{\circ}45'25.72''\text{S} / 29^{\circ}56'50.41''\text{E}$  and  $29^{\circ}45'29.92''\text{S} / 29^{\circ}56'54.58''\text{E}$ . The Google Earth image below contains a rough outline of where the graves are located.

**Figure 17: Outline of grave adjacent to and east of Mncwabe's Kraal**

**Figure 18: Remains of a grave**

**Figure 19: Google image showing rough outline of location of graves**

It is believed that the structures are from the historic period and application must be made to Amafa for their destruction as they will be inundated by the proposed dam.

The inlet portal to the proposed tunnel is situated not far from the graves found east of the Mncwabe homestead mentioned above. Due to the proximity of the inlet portal to the large amount of graves found close to it, it is recommended that during the Phase 2 investigation, specific attention be given to the inlet site to ascertain the presence of heritage resources. Due to the thickness of the vegetation, a limited investigation of the area was undertaken during the site inspection and no sites were identified during this inspection. .

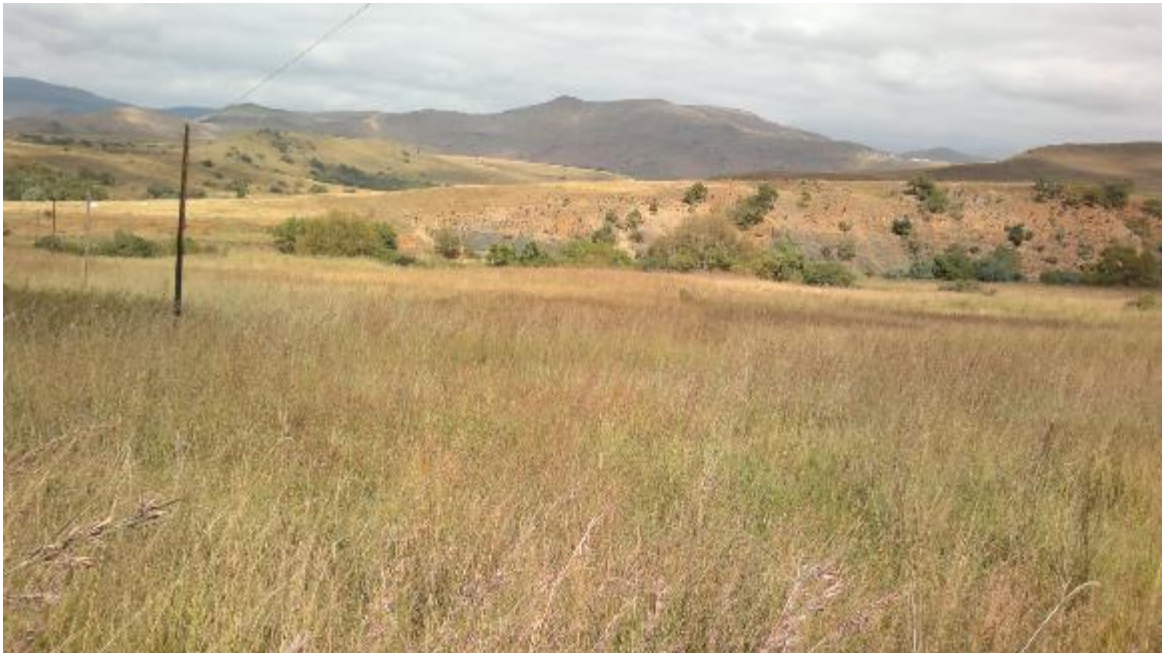
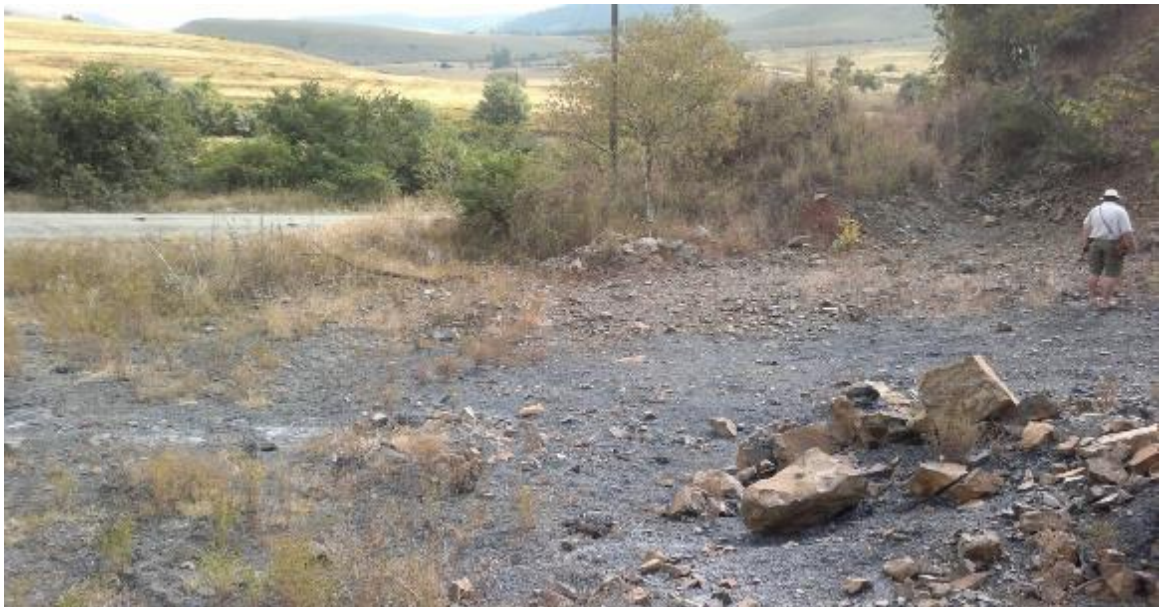
The alternative sites for the proposed borrow areas / quarries for Smithfield Dam were inspected. Sites A and B will impact on areas that are used for small scale subsistence farming. Some of the land is currently farmed and some of the land is lying fallow. It is recommended that instead of impacting on these areas, an existing quarry situated on the eastern side of the Deepdale road at 29°44'40.57"S / 29°53'56.16"E be used as it is already highly disturbed (see Fig. 22 below).

**Figure 20: View of part of Borrow Area B**

**Figure 21: Existing quarry with Deepdale gravel road in background**

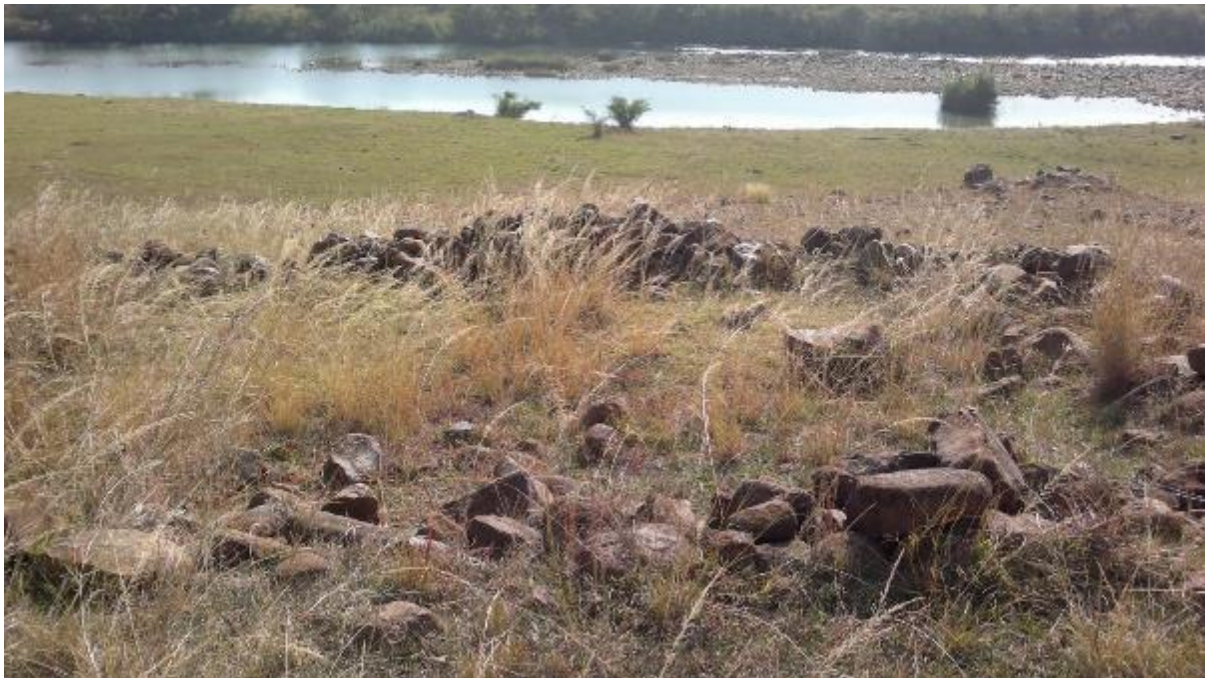
An inspection of the uMkhomazi River valley north east and below KwaZashuke revealed the remains of a structure and at least two graves at approx. 29°46'06.39"S / 29°55'21.41"E. This site falls outside the full supply level (FSL) of the proposed dam. However, the site must be clearly fenced off with a 10 m buffer to avoid any possible impacts due to their proximity to the dam and associated activities.

**Figure 22: Remains of a structure**

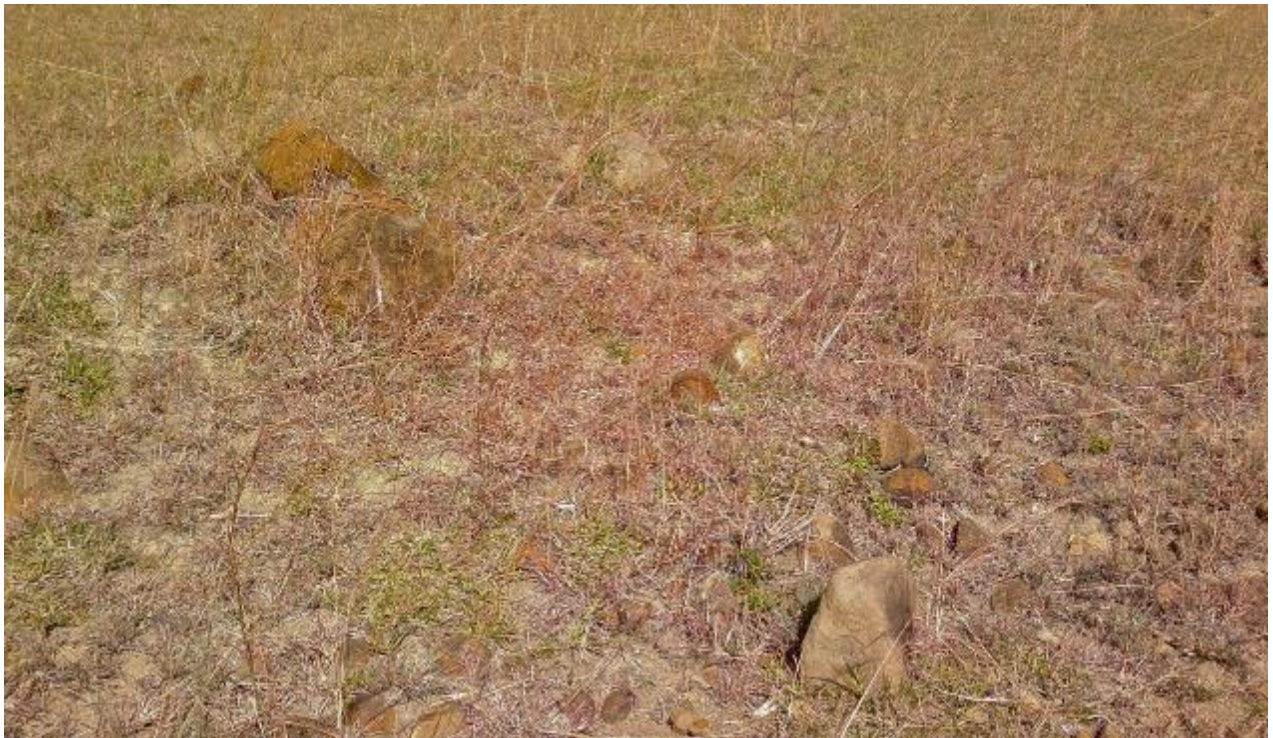
There are at least two graves ( $29^{\circ}46'05.19''\text{S} / 29^{\circ}55'14.35''\text{E}$ ) located at what was known as Hlope's Kraal. There is only the outline of a structure. The graves will be inundated by the dam therefore an application for the removal of the graves will have to be made to Amafa.

**Figure 23: Possible grave site at Hlope's Kraal**

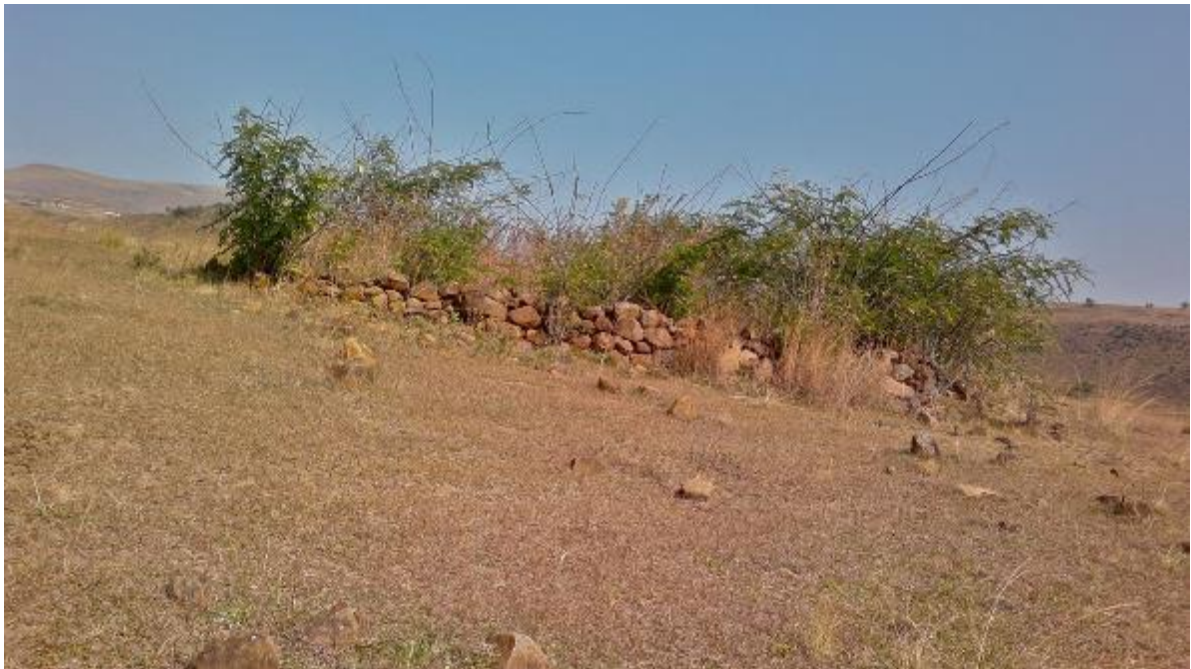
Alongside the above site, the remains of a stone structure were found and at least one grave site. The site is known locally as Ngcobo's kraal ( $29^{\circ}46'7.09''\text{S} / 29^{\circ}55'11.21''\text{E}$ ).

**Figure 24: Ngcobo's Kraal**

The square structure suggest European influence and possibly dating from the late 1890s / early 20<sup>th</sup> Century. The structure is regarded to be of medium to high significance as explained above. It is recommended that a second phase Archaeological Impact Assessment be undertaken and a permit is obtained from Amafa for rescue excavation of the site prior to inundation.

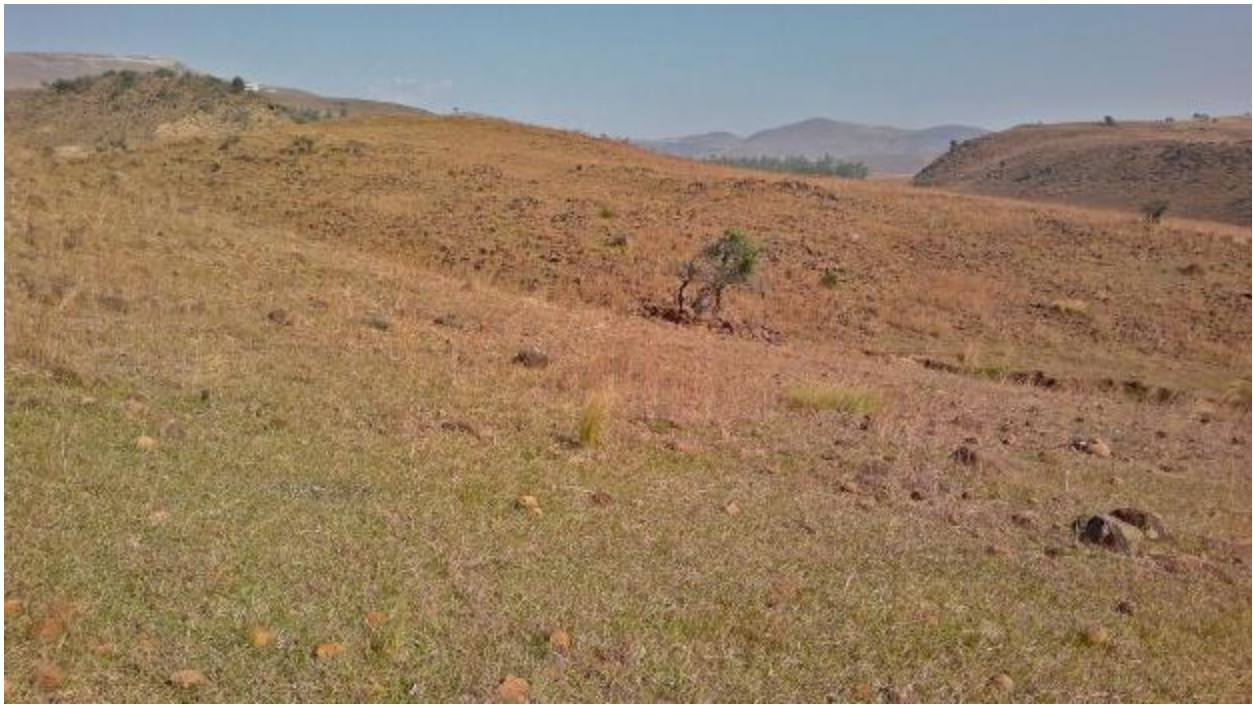
The remains of a small stone structure can be found a short distance from the above site at (29°46'9.08"S / 29°55'11.2"E). The structure could date from the Late Iron Age / early historic period and, according to Prins, was possibly used by Sotho herders whilst looking after animals. The structure is regarded to be of medium to high significance as explained above. It is recommended that a second phase Archaeological Impact Assessment is undertaken and a permit is obtained from Amafa for rescue excavation of the site prior to inundation.

**Figure 25: Small stone structure**

During the Phase 2 assessment of the area, it is recommended that a more detailed inspection of the Luhane River valley be undertaken as there may be more structures and graves in the area that will be inundated by the dam.

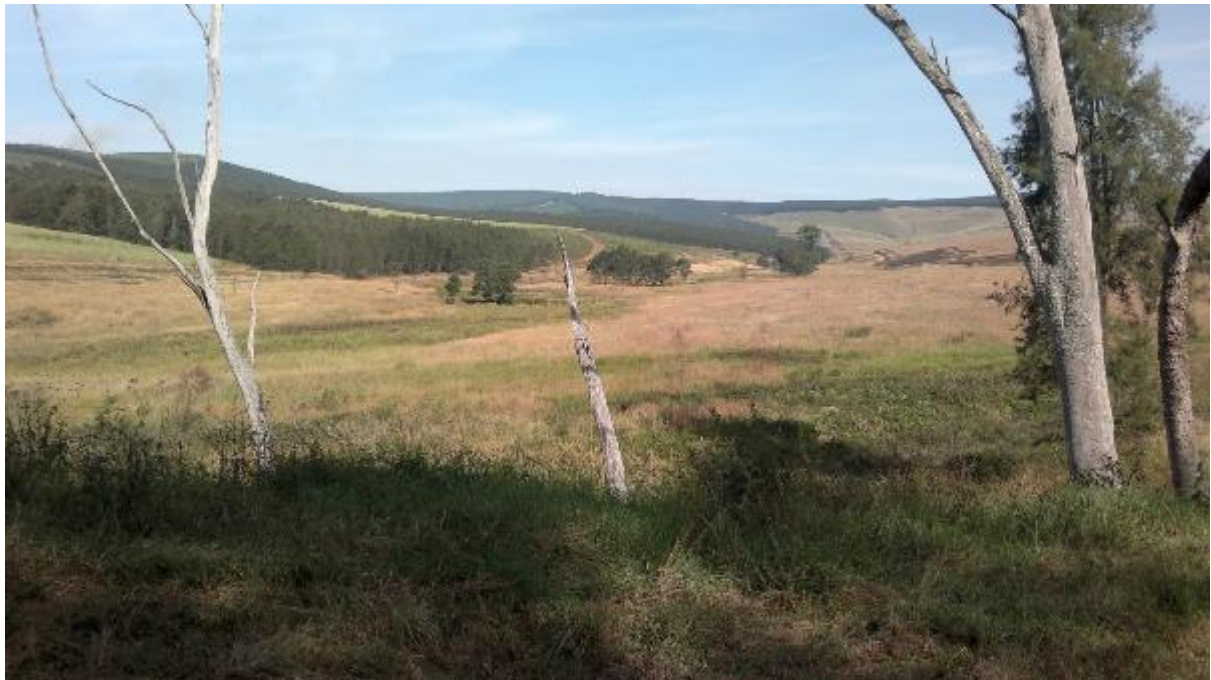
**Figure 29: Upstream area of Mbangweni River showing plantations and cultivated fields**

The area upstream from Mbangweni Dam, apart from the Mbangweni River and associated wetland, is transformed by maize cultivation on one side and sugar cane and tree plantations on the other side. No heritage sites were identified during the site visit.

All the raw water pipelines cross heavily impacted areas where intensive agricultural activities take place including the growing of avocados, sugar cane and maize as seen in Figures 29 and 30 above.

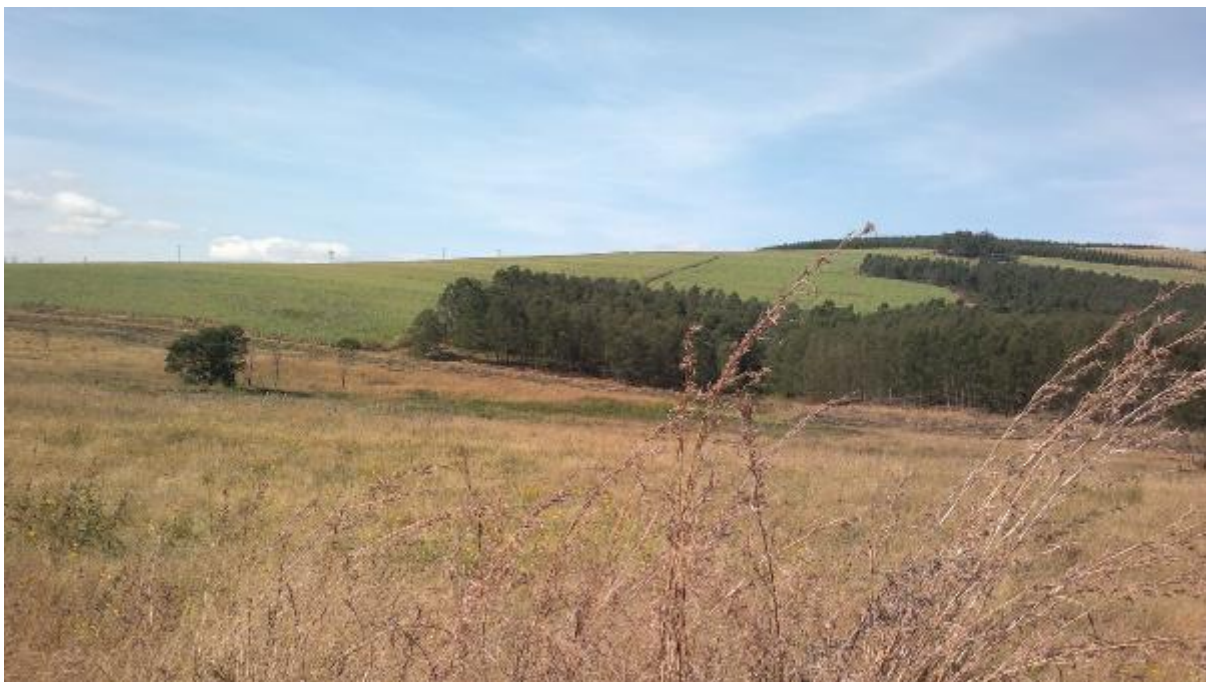
**Figure 30: Upstream of the Mbangweni River**
