**PROPOSED UMKHOMAZI WATER PROJECT PHASE 1,  
RAW WATER COMPONENT**

**Phase 1 Heritage Impact Assessment**

**May 2015**

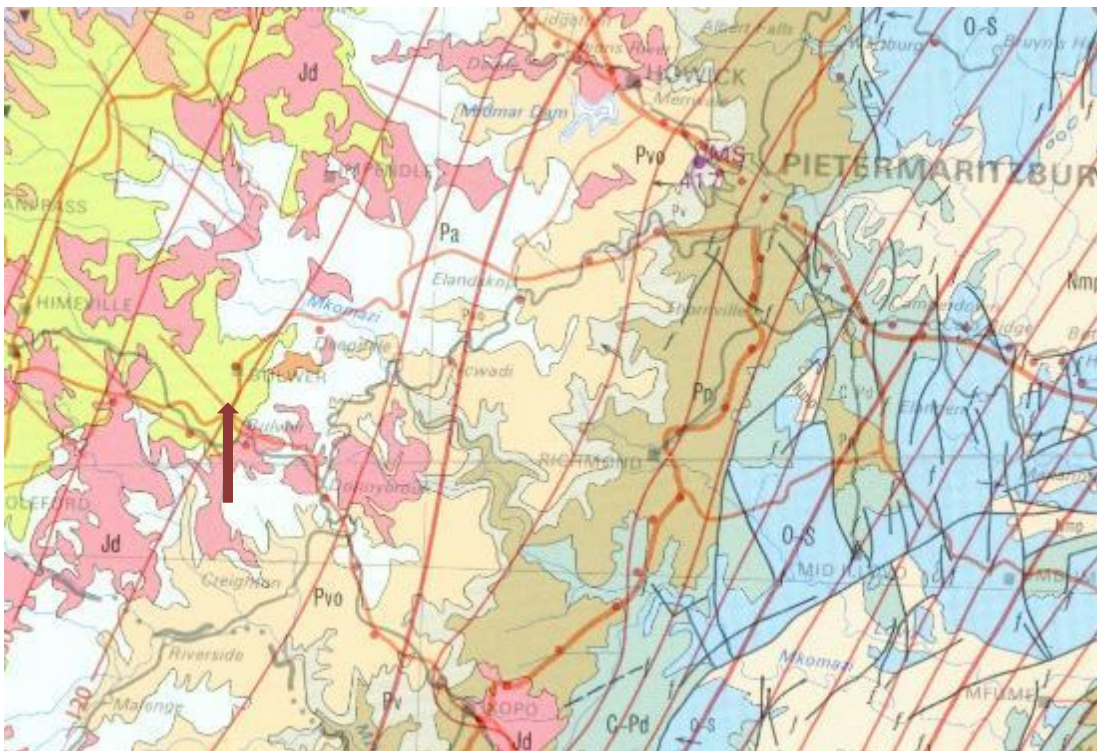
The sites lie in eastern margin of the Karoo Basin, in the Volksrust Formation and Adelaide Subgroup in particular, which are of early Permian Ecca age and known to include fossil plants associated with the coal flora (see Fig.21 below). The distribution, however, is patchy. Plants of this age include Glossopteris leaves, cordaitalean leaves, ginkgophytes, ferns, sphenophytes, lycopods. According to the palaeo-sensitivity map produced by SAHRIS, the central and eastern sections of the Raw Water component fall in the green area which means that there is a moderate risk of fossils occurring there and a desktop study is required. Accordingly: there are no records of fossils from this region on the ESI database or published records (Anderson and Anderson, 1985; Plumstead, 1969).

**Figure 31: Geological map of the area along the uMkomazi River where the development will take place**

No further palaeontological impact assessment is required for the central and eastern section of the project because there are no records of fossils from there. If, however, fossil plants are discovered during any excavations, a professional palaeontologist must be called to rescue them (after obtaining the appropriate Amafa permit).

Due to the high fossil sensitivity of the Smithfield Dam / western section of the Raw Water component, a Phase 2 PIA is recommended. This is not required for the eastern section of the component.
