**UMKOMANZI DRIFT HOUSING PROJECT,
CRAIGIEBURN, ETHEKWINI MUNICIPALITY,
KWAZULU-NATAL**

Phase 1 Heritage Impact Assessment

30 October 2020

**Author: JLB Consulting
Jean Beater**

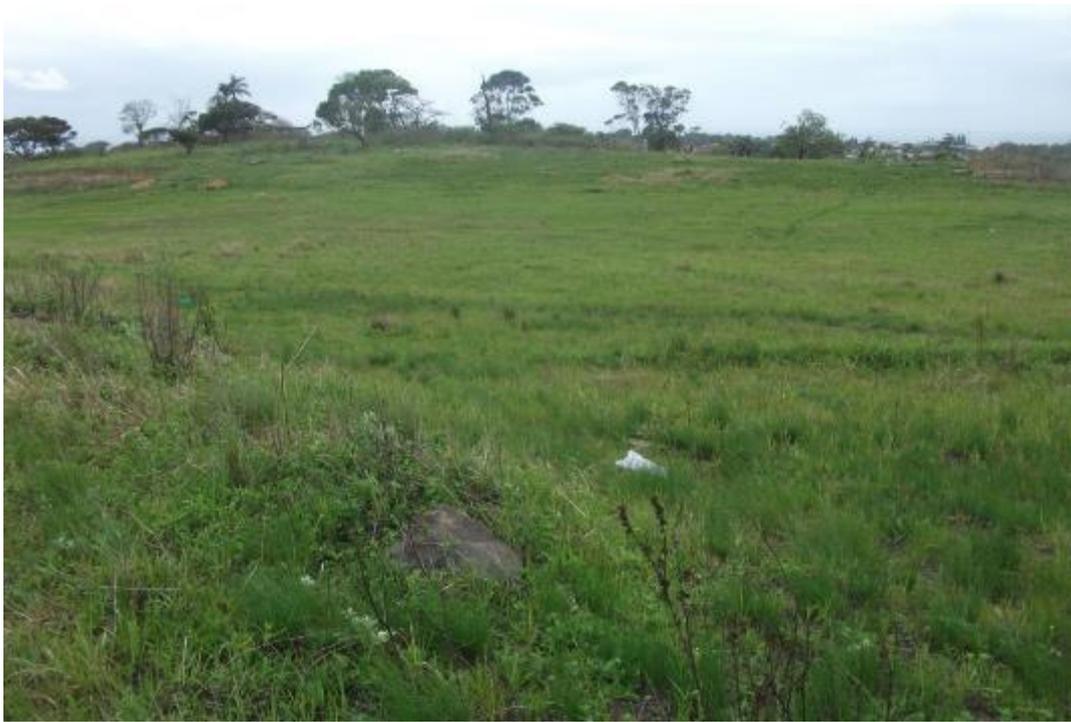
Figure 5: View across project area

The area west of the tarred road is situated between existing housing and a ridge overgrown with eucalyptus and other trees. There is some informal housing on the project site as well as the remains of brick and mortar structures.

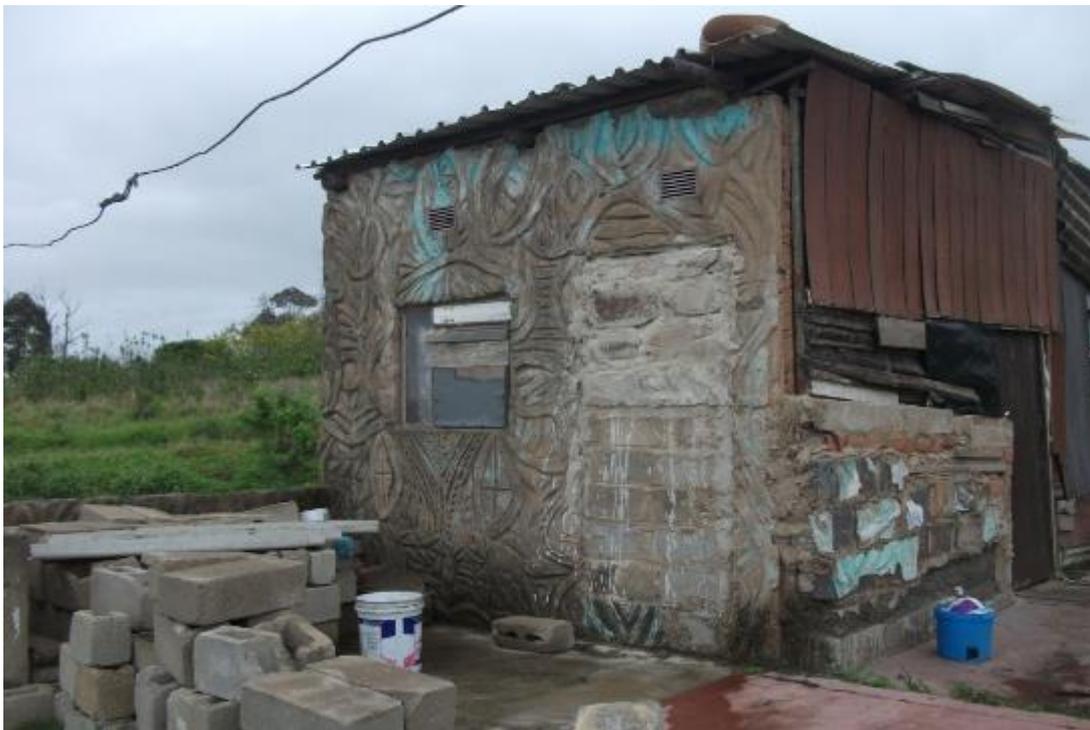
Figure 6: Derelict structure

A resident living at the back of the one structure shown below stated that he was 42 years old and the house had been there all his life.

From the 1937 aerial map (3030BA) (see **Figure 7** below) of the project area, it appears this structure (indicated as ST1 on **Figure 7**), possibly together with other buildings, has been in

existence for over 60 years thus it is protected by section 37(1)(a) of the KwaZulu-Natal Amafa and Research Institute Act, 2018 which states that no structure which is, or which may reasonably be expected to be older than 60 years, may be demolished, altered or added to without the prior approval of the Institute. Although it is of high heritage significance due to its age, the preservation of the structure is not recommended due to its derelict condition.

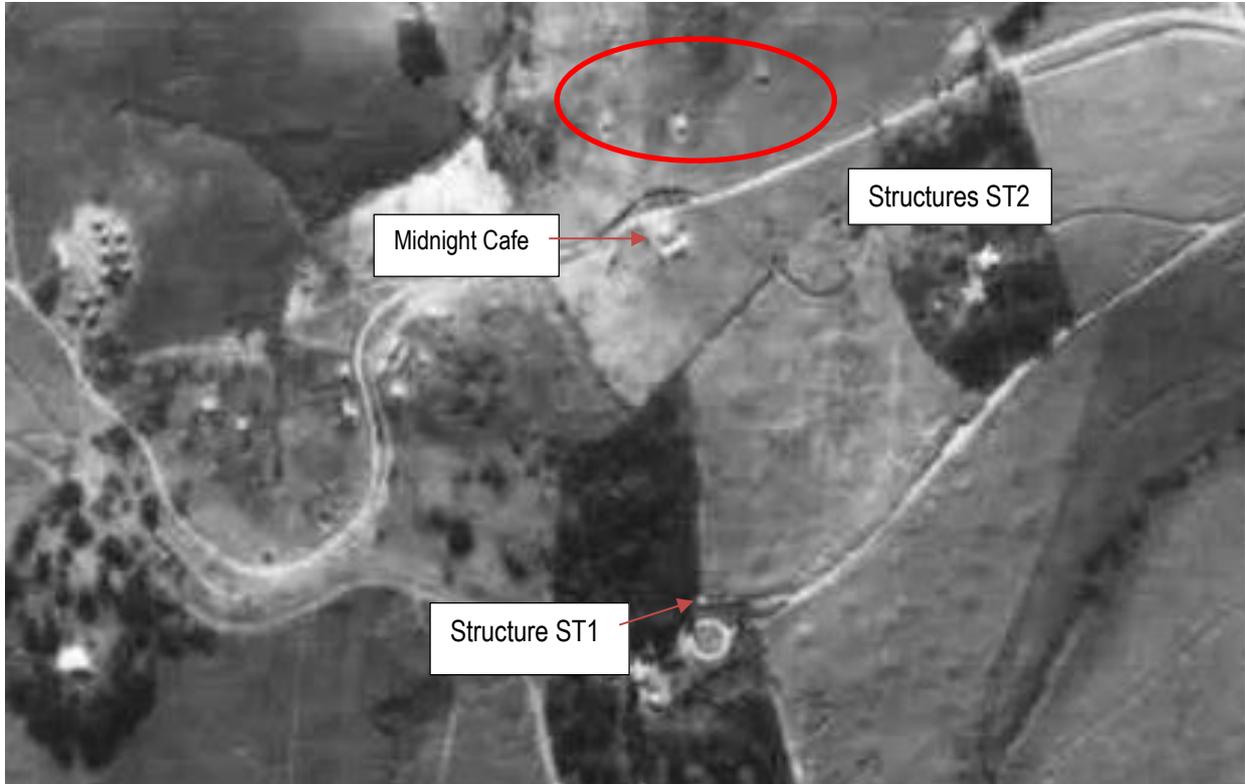
Figure 7: Aerial map of Umkomanzi Drift 1: 1937

In the 1937 aerial map, three structures are visible in this area. They are indicated in **Figure 7** within a red circle. It is unclear whether these structures have survived and whether they were made from corrugated iron.

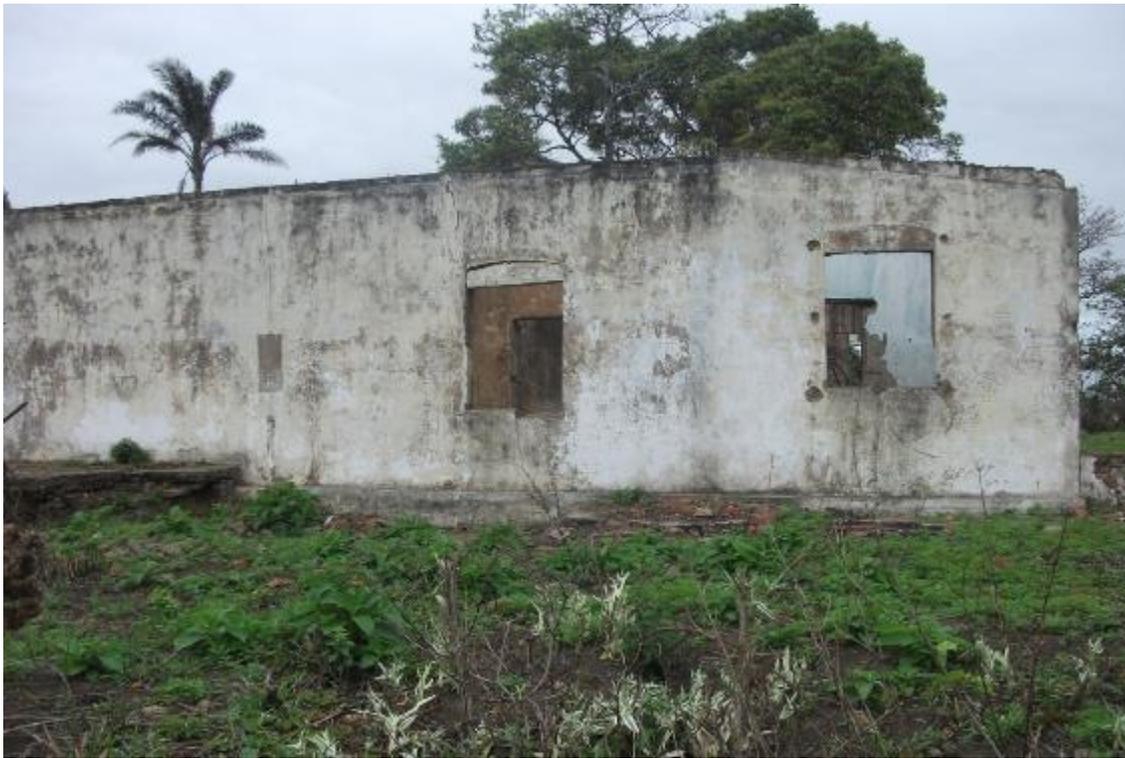
Figure 8: Remains of main dwelling

There is a complex of houses situated towards the middle of the project site. The remains of at least 3 structures are still visible and these are indicated as ST2 on **Figure 7** above. They appear to make up a homestead of sorts. The remaining walls and foundations are over 60 years as they appear on the 1937 map and an application for a permit to demolish the structures will be required from the Institute prior to demolition. A recent wall has been built onto the remains of the main structure as can be seen in **Figure 9**. The structures are of high heritage significance as the remains signify previous residential activity of many years (since the 1930s) of the project area. However, the derelict condition of the structures would allow for their demolition.

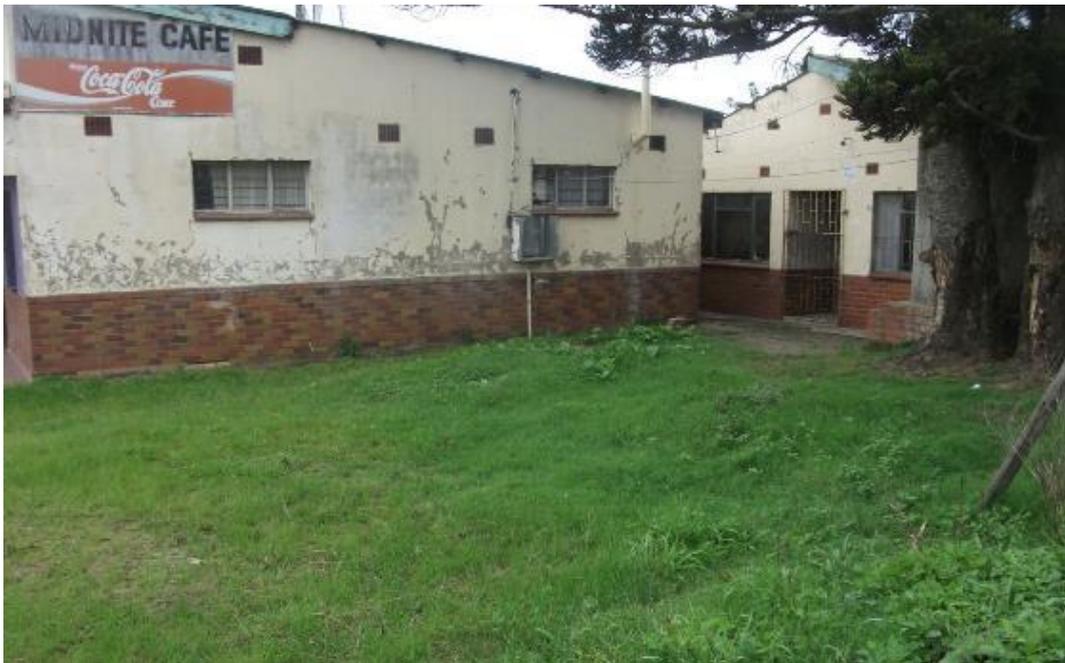
Figure 11: Midnight Café and a partial view of structure behind it

The Midnight Café building falls within the project area and is situated adjacent to the tar road. It is no longer in use as a café but is appears to be currently used for accommodation. The café and the associated building behind the café are over 60 years as they appear on the 1937 map. The café is of high heritage significance because of its age and that it provided a service to the surrounding community. However, it is no longer in use and could possibly be demolished. However, the architectural significance of both the café and dwelling behind it needs to be provided by a built heritage specialist prior to any action being undertaken.

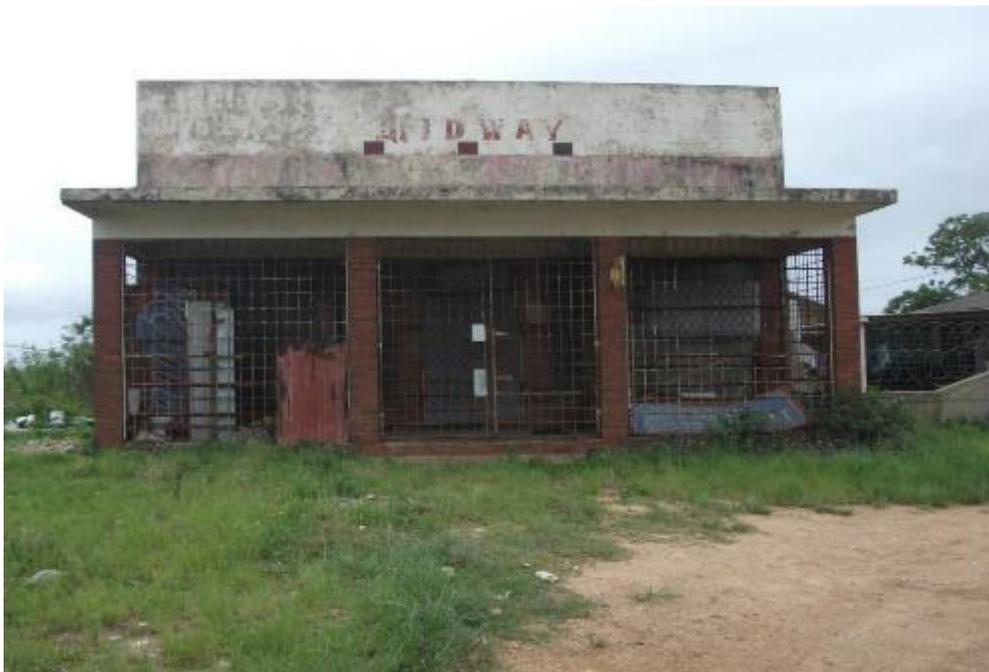
Figure 13: Midway Store

Across the road from the Midnight Café and within the project area are two structures, one of which is the Midway store with a duplicate structure next to it. These structures do not appear on the 1937 map. The specialist could not obtain maps of the project area for the 1940s and 1950s. These structures do not appear in the 1968 topographical map (3030BA) of the project area but are visible in the 1983 aerial image. These structures are less than 60 years old. The structures are no longer in use; however, the back of the structures is currently been used as accommodation. They are of a low heritage significance.

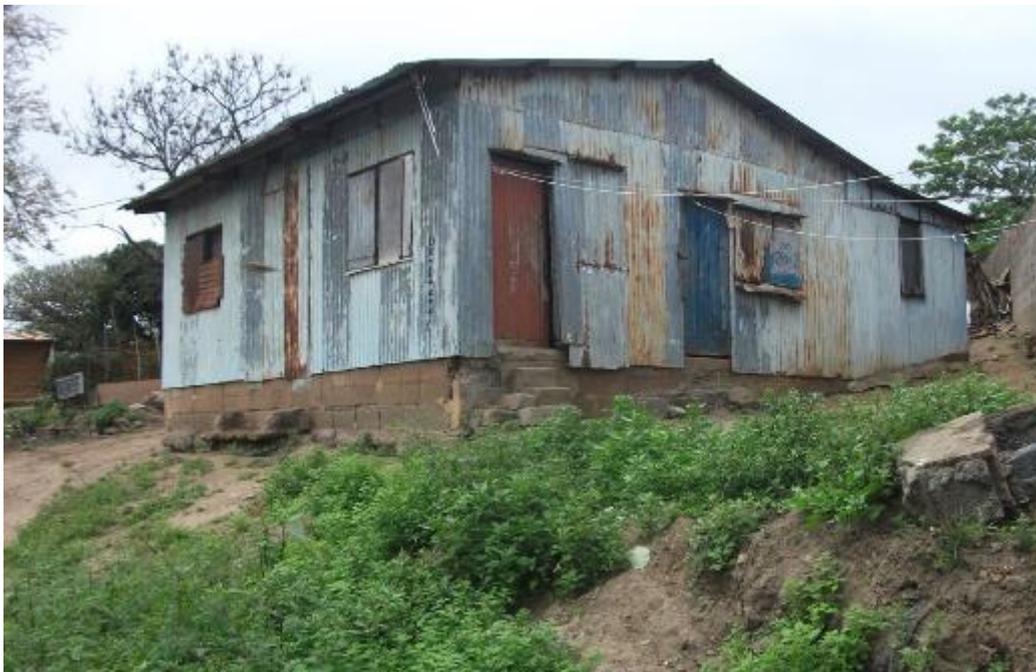
Figure 15: Structure made from corrugated iron

The project area extends behind the two structures discussed above in a north-easterly direction. The area already has formal and informal housing and is highly disturbed by residential activity. Within this area there are several houses made from corrugated iron. The specialist could not establish the age of the structures nor their architectural significance. This will need to be done by a built heritage specialist as the use of corrugated iron is an old method of building structures.

The specialist who undertook the Phase 1 HIA is not a built heritage specialist hence confirmation of the age and significance of the structures made of corrugated iron will need to be obtained from a built heritage specialist prior to any action been undertaken (such as the demolition or alteration, of these structures.) In addition, the architectural significance of the Midnight Cafe will also need to be obtained from a built heritage specialist.

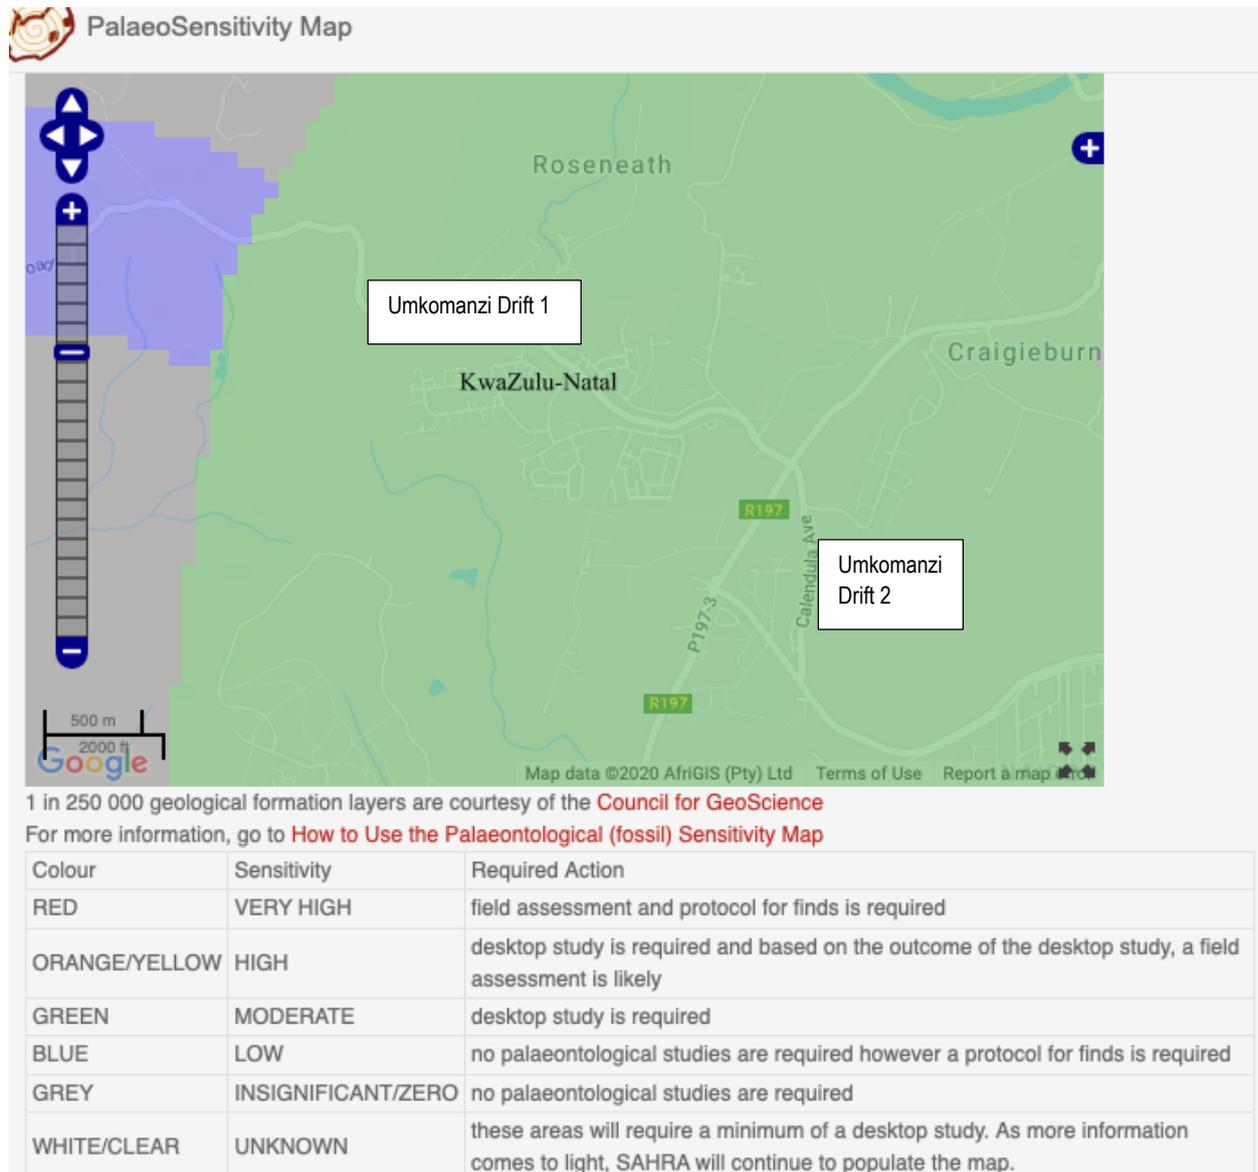
Figure 24: Fossil sensitivity map

The South African fossil sensitivity map indicates that the two sites fall within an area of moderate palaeontological / fossil sensitivity as indicated with the green colour in **Figure 24** below. An area of moderate sensitivity requires a desktop palaeontological assessment.
