**HERITAGE SURVEY OF THE ETHEKWINI WATER  
AND SANITATION WESTERN AQUADUCT:  
"VOORTREKKER ROAD"**

**FOR KNIGHT PIESOLD**

**DATE: 25 JULY 2013**

**Umlando: Archaeological Surveys and Heritage  
Management**

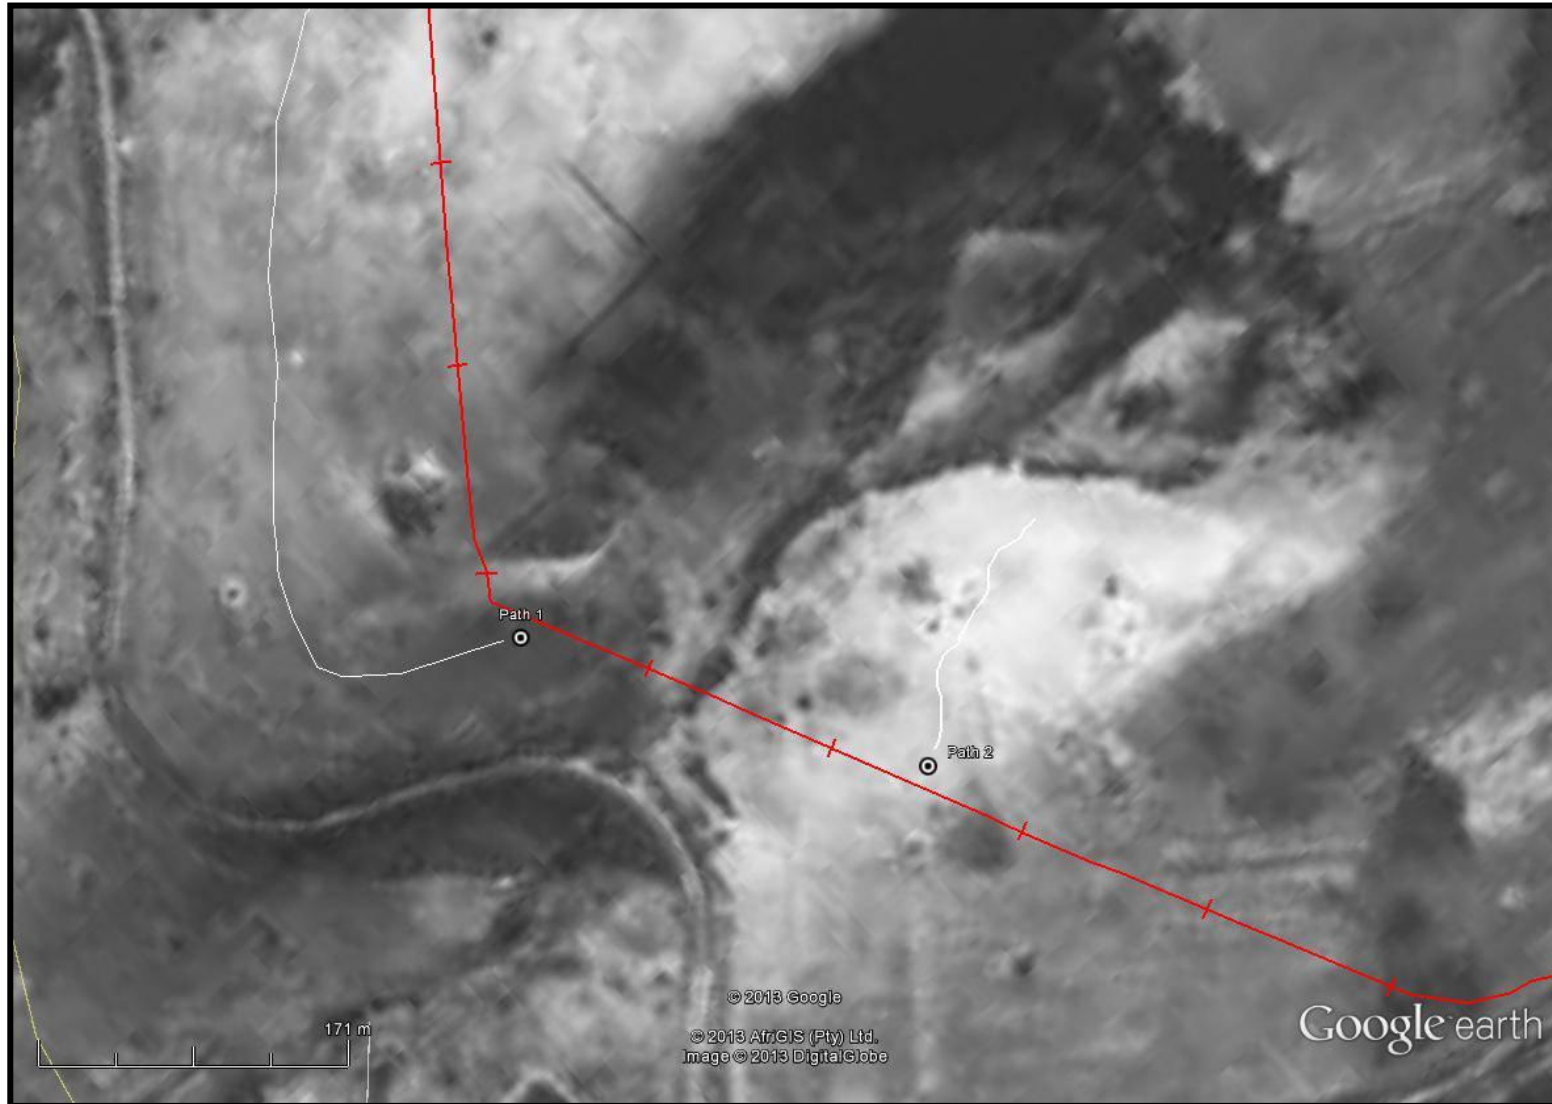
FIG. 5A: STUDY AREA IN 1937

The 1937 aerial photographs (fig. 5 a - b) do not clearly show the road. In fact, it is not visible in most areas. There is a slight indication of a road to the east of the area marked 'Path 2'. Other roads and tracks are visible on the 1937 aerial photographs. This would suggest that the road did not exist in 1937; alternatively, it does not show on the map. If the road had not been used for a while, it would be overgrown and not show on the map.

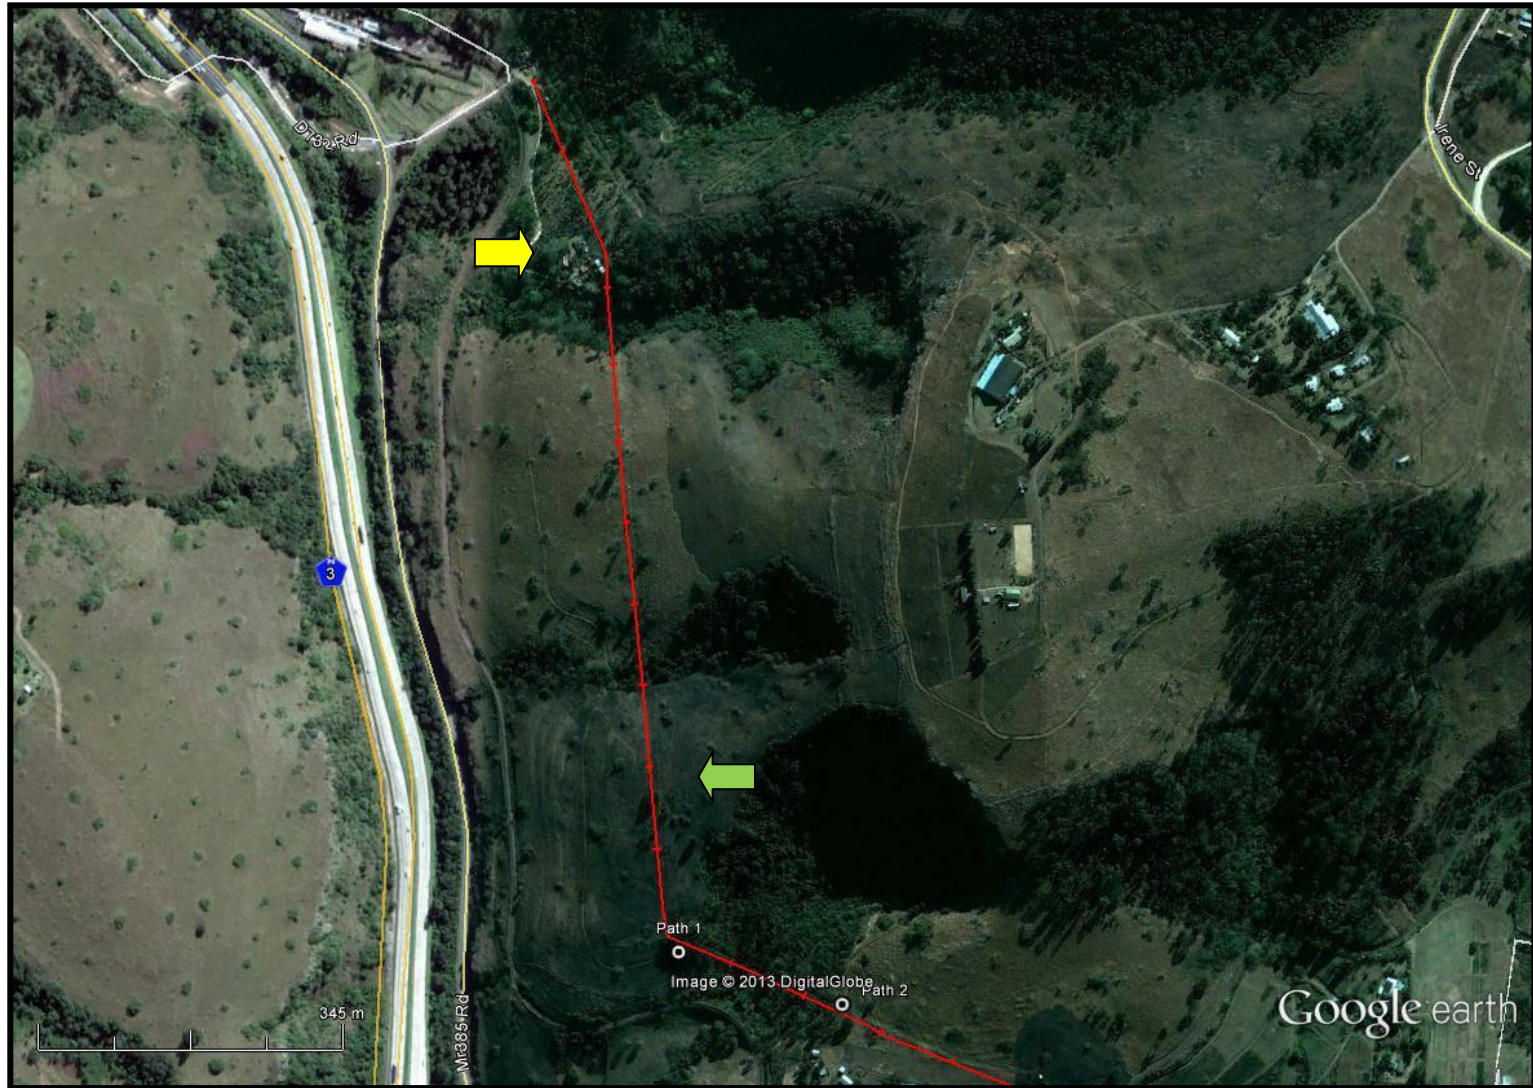
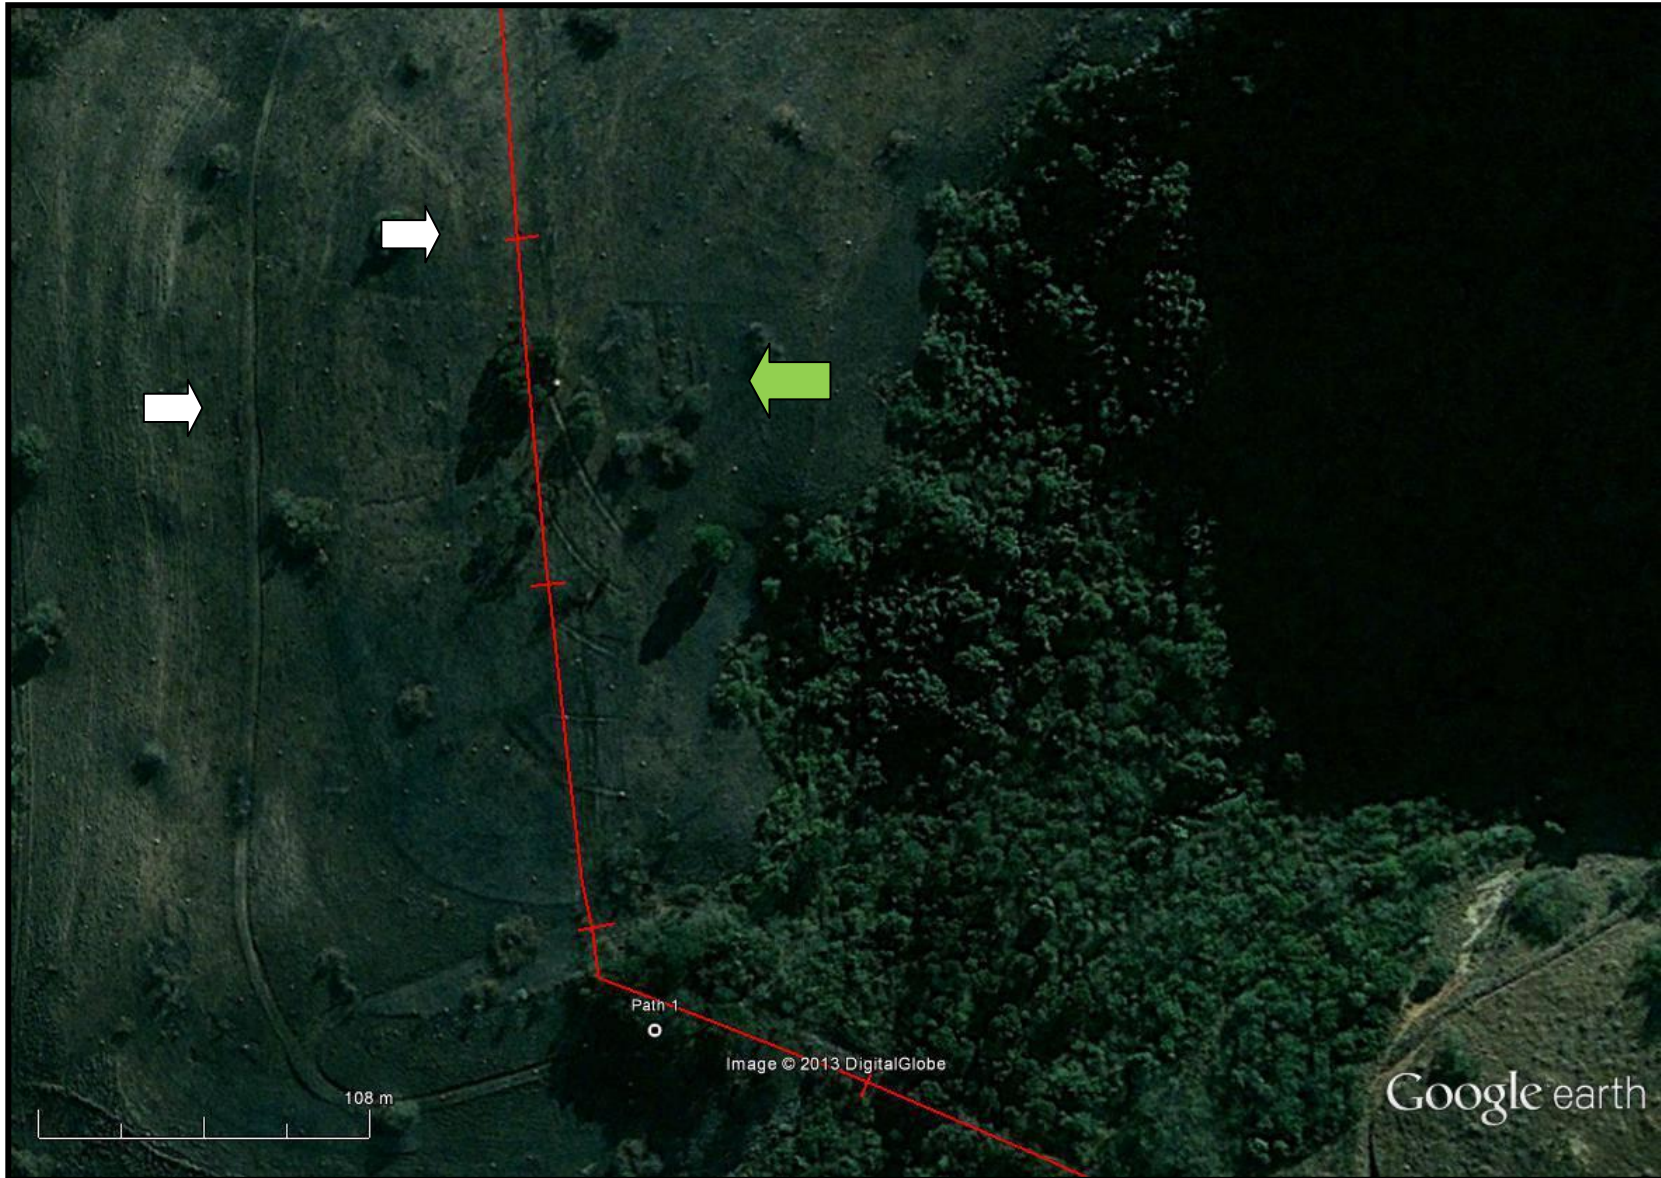
FIG. 7: STUDY AREA IN 2012

The 1968 topographical map (fig. 6) does not indicate any road or track in the study area. The maps do indicate a road to a house (yellow arrow) and a presumed labourer's settlement (green arrow) without a track. Figure 7 shows these buildings and paths in general, while normally tracks, or old roads are indicated in these maps. Figure 8 shows a close up image. The settlements indicated by the green arrow would have been partially destroyed by the original water aquaduct. The white arrows in Figure 8 indicate the location of the road.

The 2002 to 2013 Google Earth maps clearly show the road cutting, as well as the road leading to the settlement. These are not shown in the 2000 topographical map.

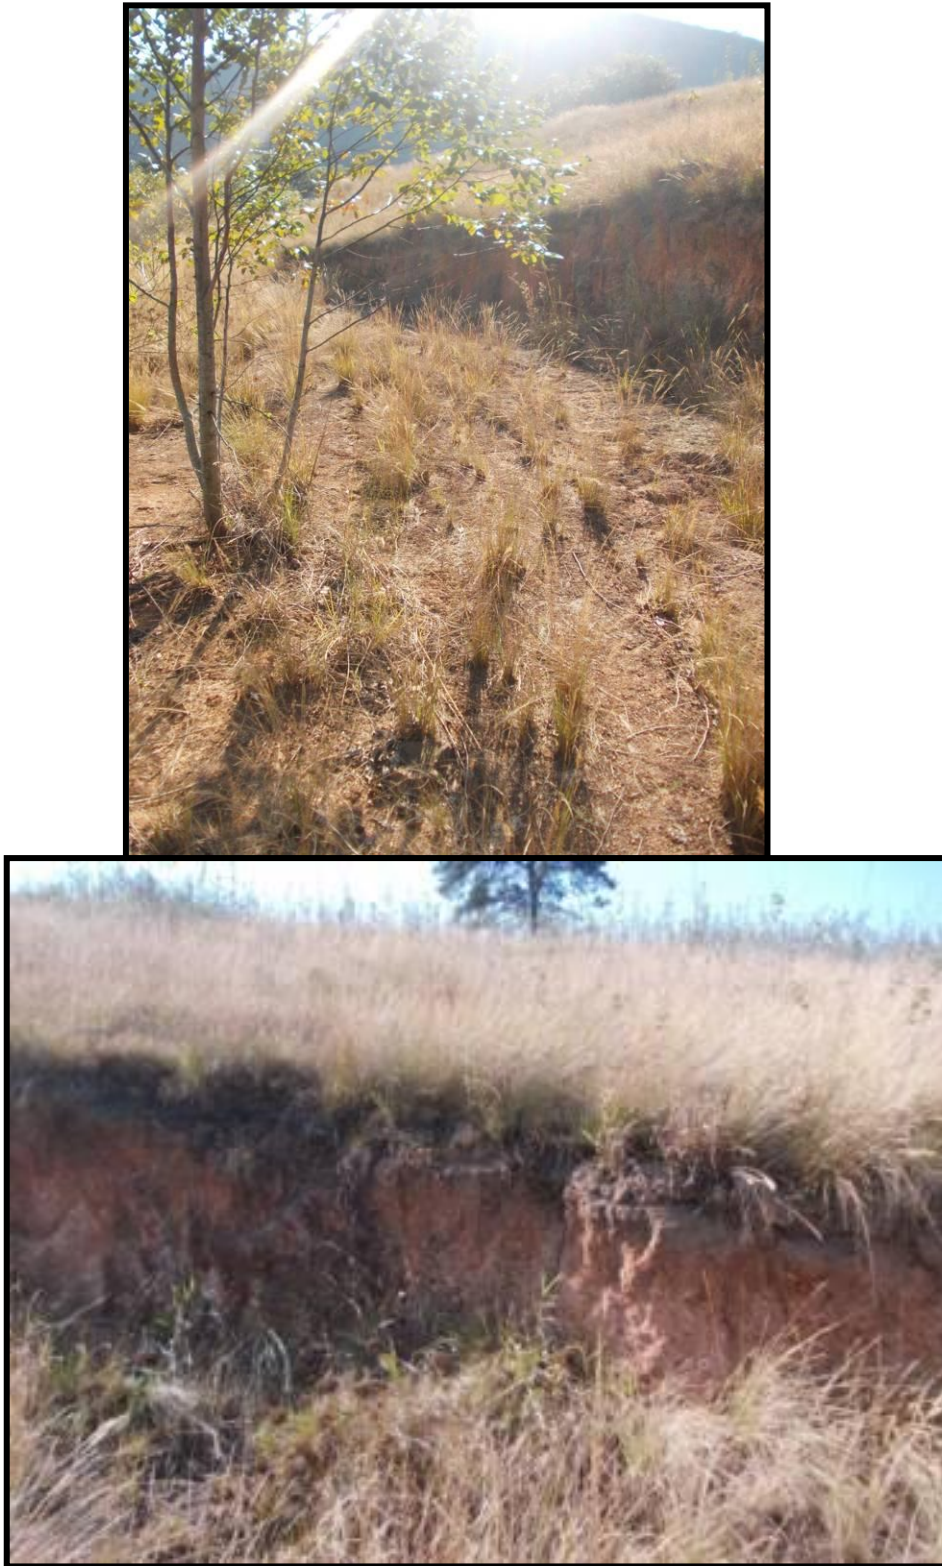
**FIG. 9: EXISTING ROAD CUTTING**

The current road is a cutting into the side of the hill and varies between 1m – 1.5m in depth (fig. 9). The road is made into a sandy clay-like geological deposit, and in several areas there is evidence of modern material being used on the road. For example, there were several stones, used on the railway, on the road, and/or rocks used as anti-erosion features (fig. 10).

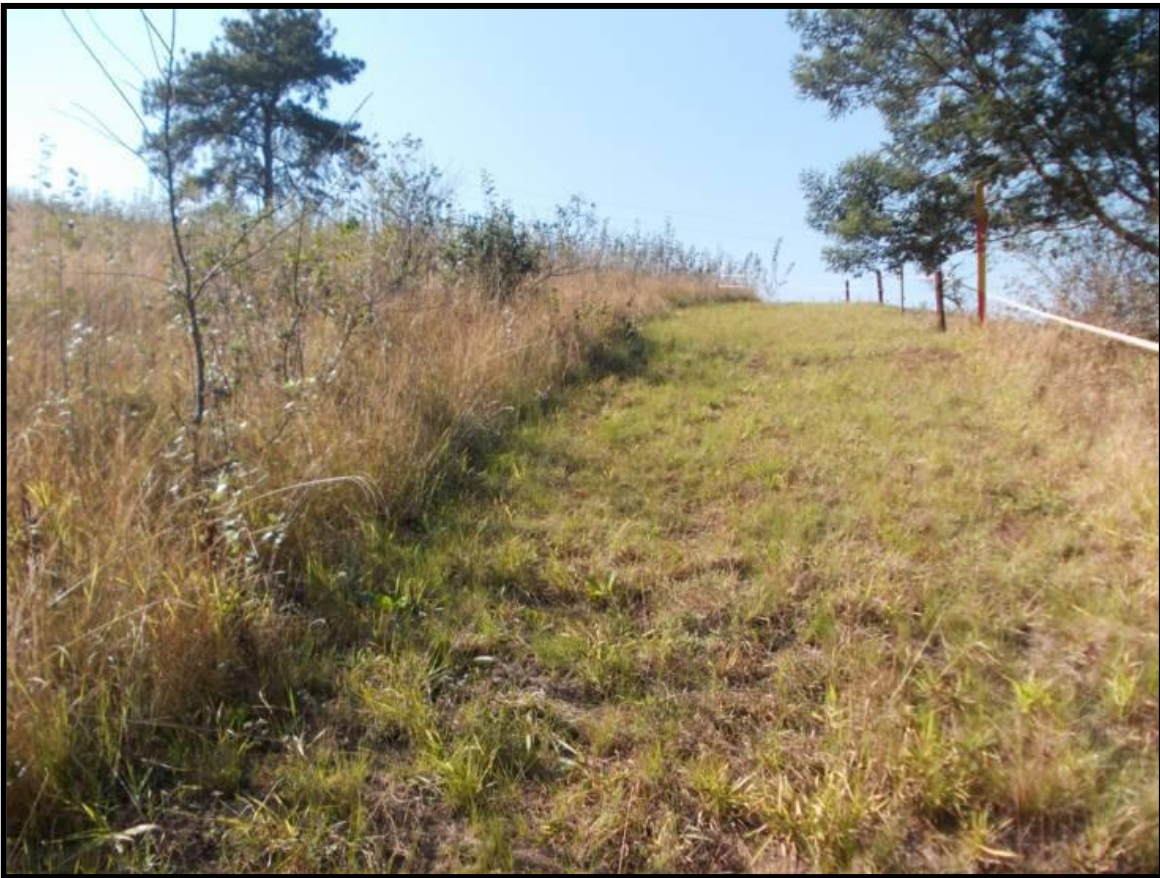
**FIG. 11: CROSSING AREA FOR THE WESTERN AQUADUCT<sup>1</sup>**

At Path 1, the Western Aquaduct will pass through an area already disturbed by the existing aquaduct (fig. 11). There are no features relating to wagon tracks in this section. The area where the road has been supported with anti-erosion features occurs ~50m away from the aquaduct and will thus not be affected. As a precautionary measure, this area will be barricaded during construction and demarcated as a no-go area.

<sup>1</sup> The Western Aquaduct will occur to the right of the photo

There are two areas of the road that will be affected. These have been labelled as Path 1 and Path 2. The area of impact around Path 1 is in existing pipeline servitude and has been damaged already. The road repairs occur 50m uphill from the Western Aquaduct and will not be affected. This area will, nonetheless, be barricaded during construction.

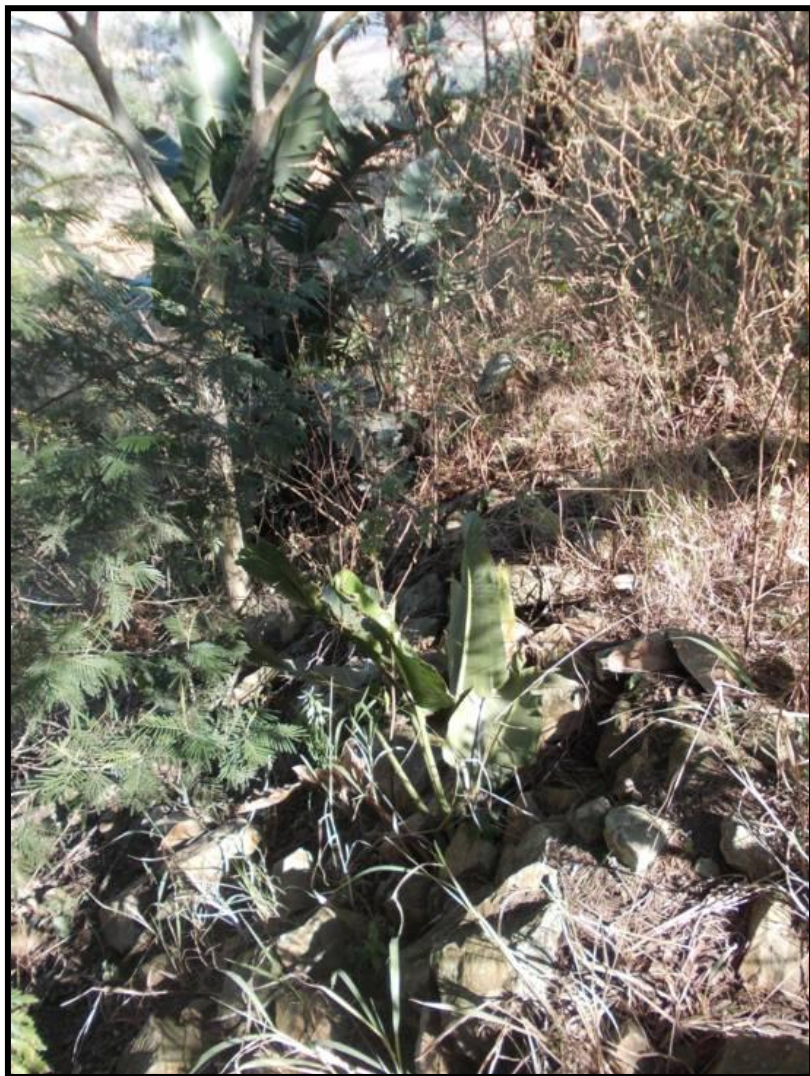
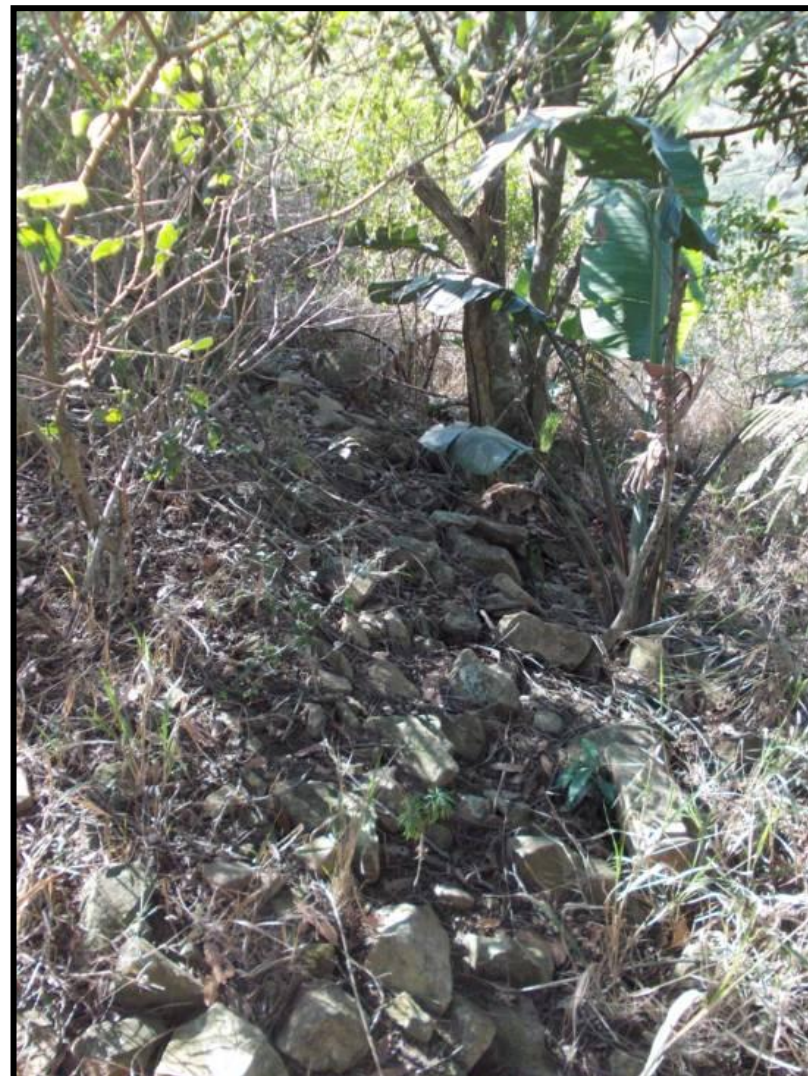
FIG. 12: ROAD SUPPORTS AT PATH 2<sup>2</sup>

Path 2 occurs across the valley. In this section, the rocks from the cutting have been placed on the outer side of the road to support the road along the edge (fig. 12). The rocks are loosely packed and there is little sand infill. This suggests that this is a more recent activity. If the rocks had been placed along this road 100+ years ago, then they would be filled with sand and other debris. My opinion is that this road support is a recent phenomenon and not related to the alleged Voortrekker Road.

<sup>2</sup> The width of the “support” is 1m – 1.5m wide

The area around Path 2 has remnants of supporting road structures on the outside, or downhill, of the road. While this feature is probably not older than 60 years, the impact will be limited to the width of the pipeline, i.e. 2.5m. In this area, the road support will be partially damaged by the pipeline. I suggest the impact area is kept to a minimum, and all excavation spoil heaps are placed on the uphill side of the road. This will prevent the rest of the road support structures being damaged during the backfilling stage. This area needs to be demarcated before construction and an ECO should be on site during construction to ensure that this policy is maintained.
