Nautical Archaeological Society

Report Course Part II

February 2011, Robben Island, Cape Town

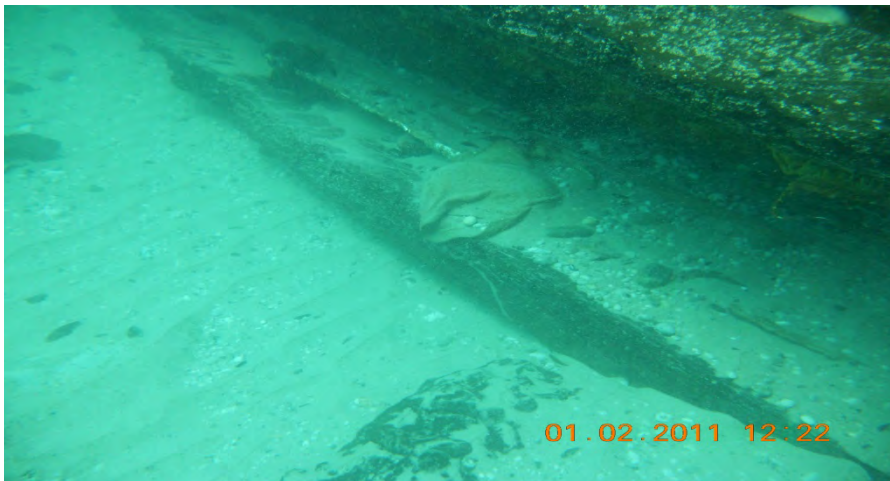
The wooden planking which probably belonged to the hull is in four main layers. The outer layer is approximately 2 cm thick and may act as a sacrificial layer, this is followed by the outer hull plank, the frames and the inner ceiling. A small section of the bow had 5 mm thick metal sheathing, possibly lead. The rest has been removed by salvors. This is a good clue as to the date of the vessel, as copper was generally used in vessels after 1780.¹³

Fig. 2. Section of wreck showing hull planking (Photo: Maitland 2011).

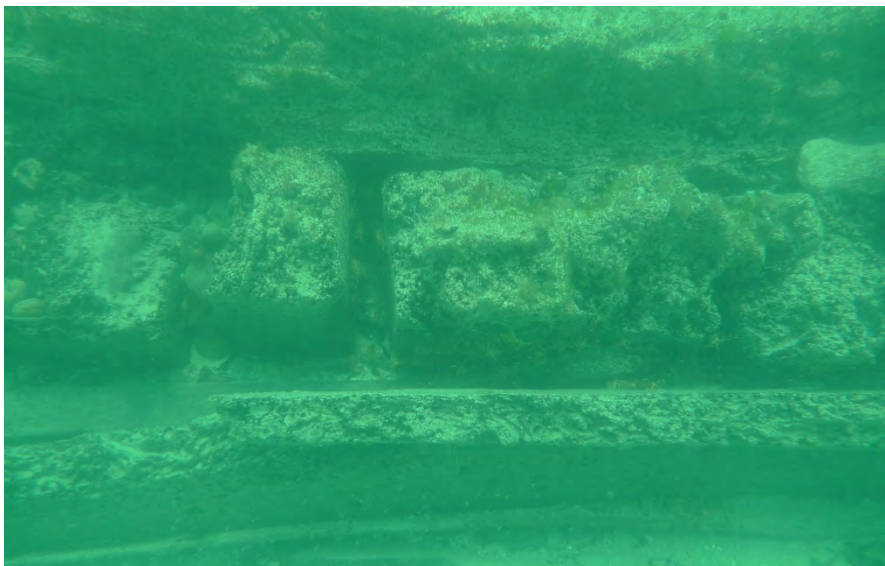
The main outer hull planking is also about 2cm thick. Between the outer and inner planking are frames approximately 35 centimeters square.

Fig. 3. Cross section of hull showing outer planking, frames and hull ceiling. (Photo: Jeffery 2011).

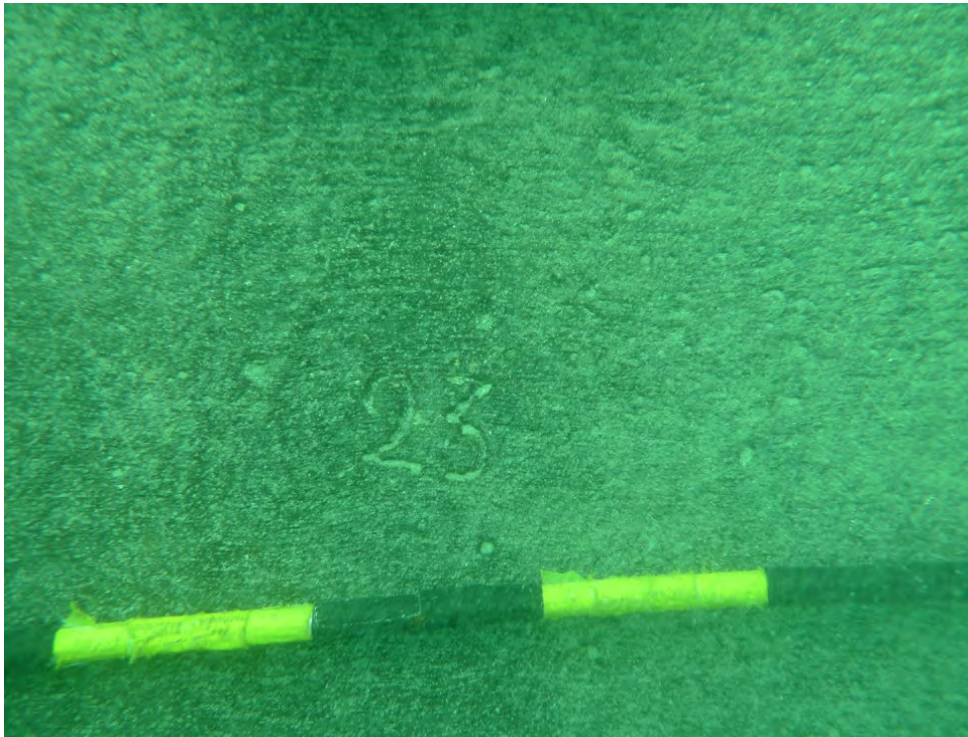
The keel had the numbers 21, 23 and 27 carved into it. These numbers could possibly indicate where the frames would have been connected. The distance between 23 and 27 was 4,2 m.

Fig. 4. Number inscribed on keel. (Photo: Jeffery 2011).

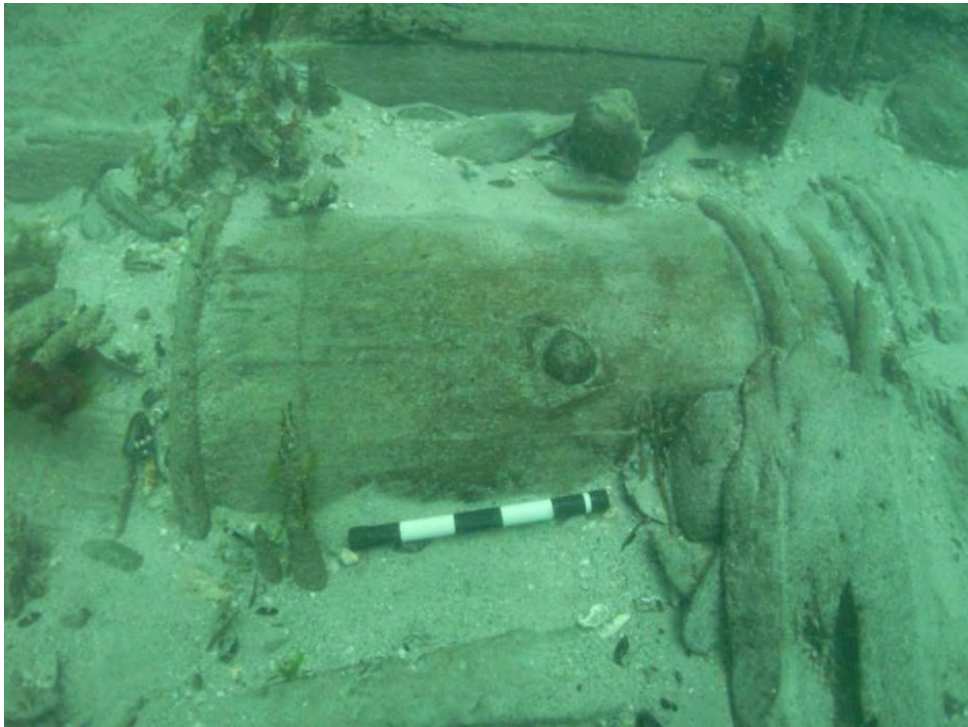
Fig. 5. In-situ barrel. A bung hole is visible in the middle of the barrel. (Photo: Sharfman: 2011).

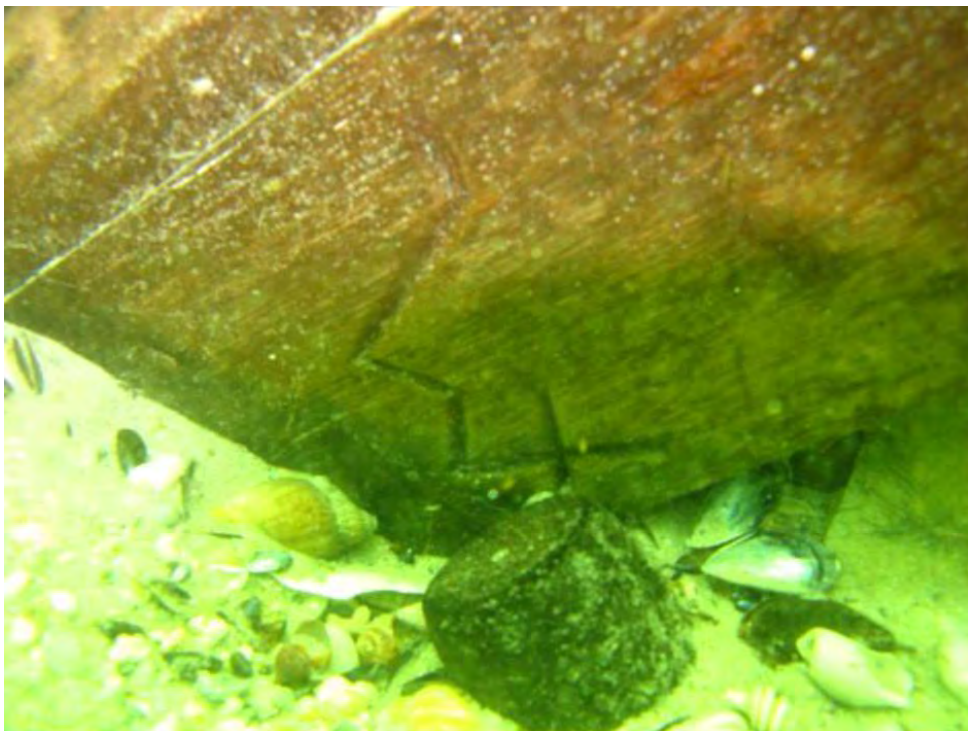
uses of tar was to preserve wooden vessels against rot.¹⁵ The markings found on one of the barrels were probably for identification purposes (Fig. 7).

Fig. 6. In-situ barrel with markings on the lid. (Photo: Evans 2011).

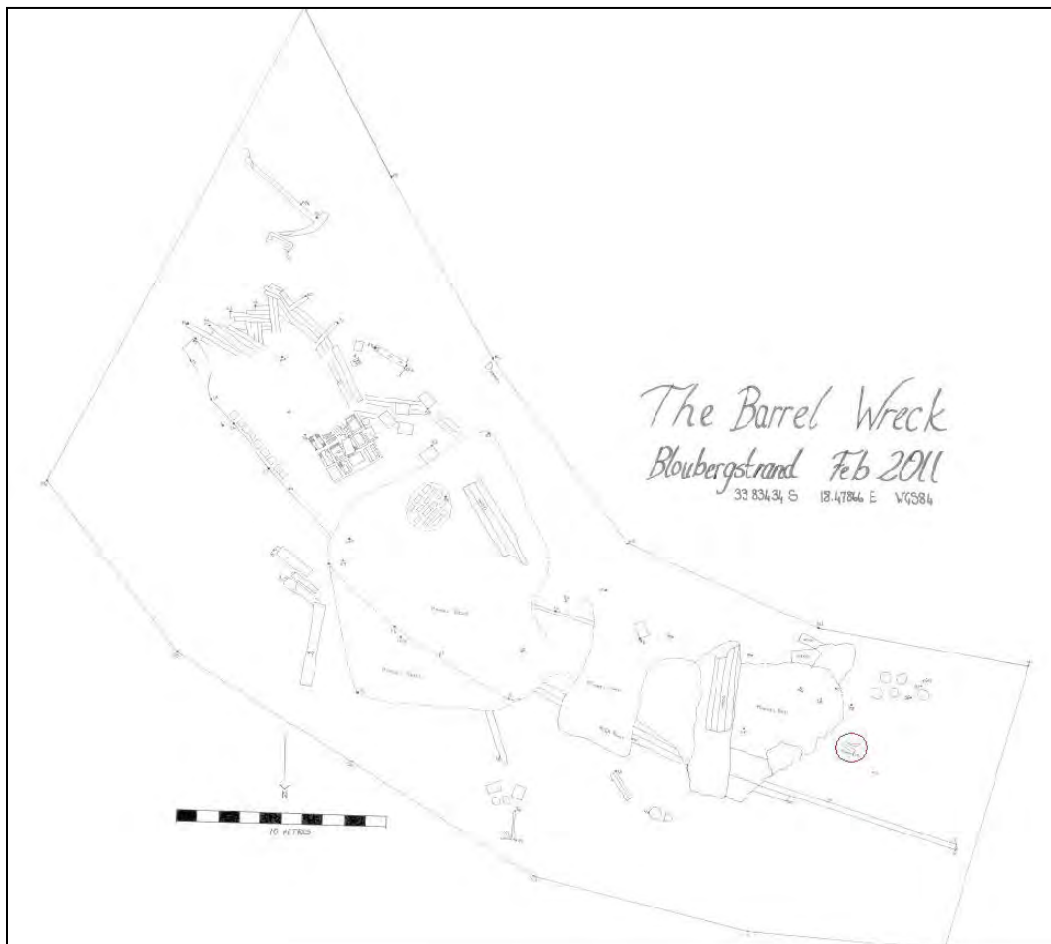
According to the 2010 Robben Island NAS II Report, the Barrel Wreck muskets salvaged in the 1980's revealed some interesting possibilities. Some of these parts were restored by the salvors and cobbled together to make complete muskets. Unfortunately the parts used for this purpose came from different muskets so that unmatched parts now form new muskets. Only 3 of the conserved muskets were still in the original state they were found in. Besides the restored and original muskets there were also muskets that weren't restored or conserved. Despite the incorrect restoration and bad conservation, these muskets also give some information.¹⁷ The muskets we discovered this year were situated on the west side of the wreck (Fig. 7) near the bow.

Fig. 7. Site plan of the Barrel Wreck. The red circle shows the location of the muskets (Arkesteijn 2011.)

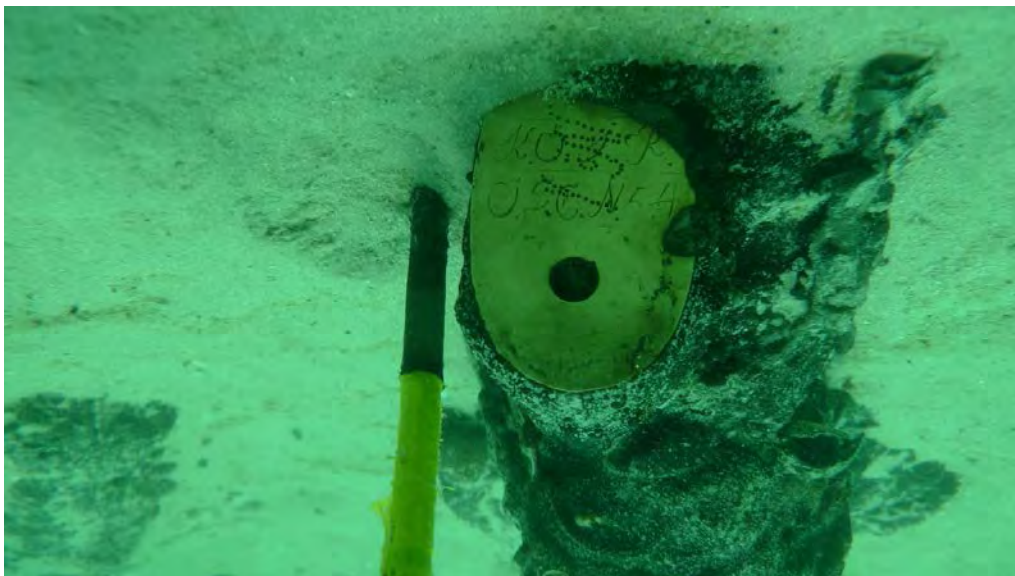
The engravings on the brass butt plate of one of the muskets we recorded are KÖIR ÖLC N54. The KOIR engravings were probably the initials of the KOI Regiment. Possibly the OLC engravings were the initials of the OL Company. N54 may be the weapon issued number. The dotted engravings YN on top of the KÖIR ÖLCN54 may be the initials of the soldier that used the weapon (Fig. 9). According to M. Willemsen (weapon specialist of the Army Museum, Delft) this weapon might be of German origin because of the umlaut mark. Further investigation is necessary.

Fig. 8. Engraving on the brass butt plate of recorded, partially covered musket stock. (Photo: Jeffery 2011).

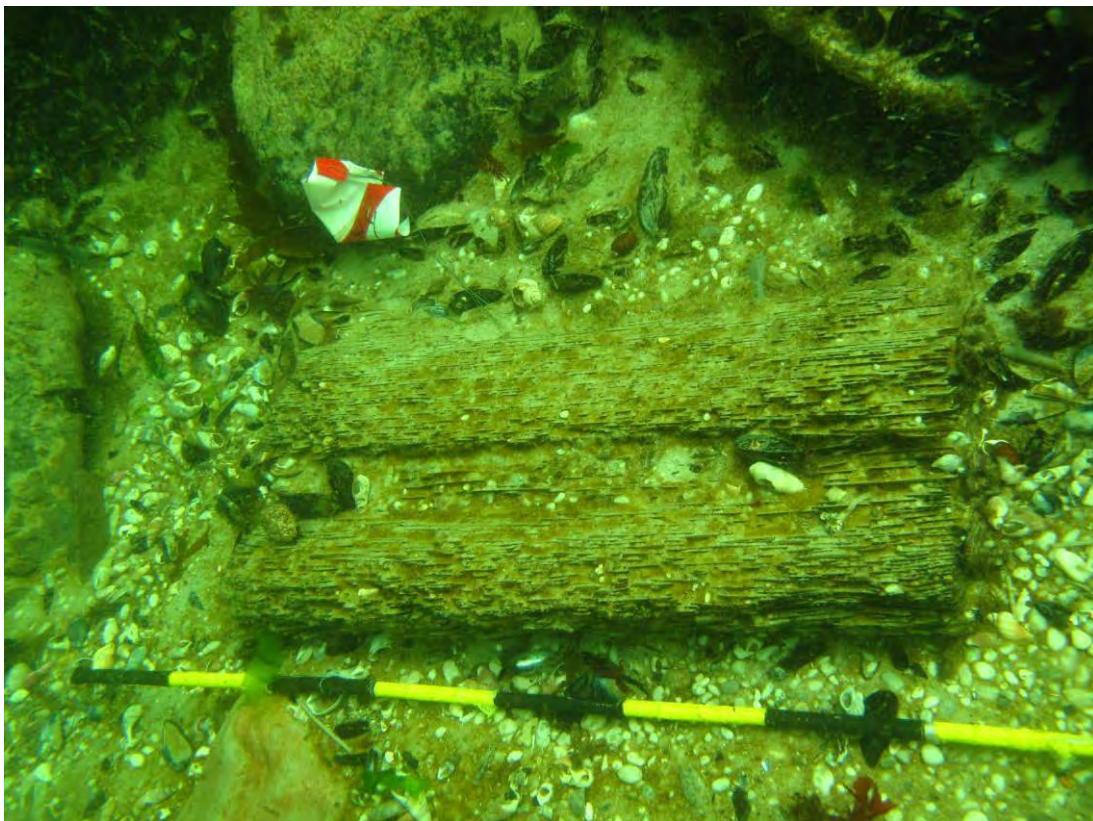
Fig. 9. Picture showing the glass sheets conglomerated together (10cm scale). (Photo: Evans 2011).

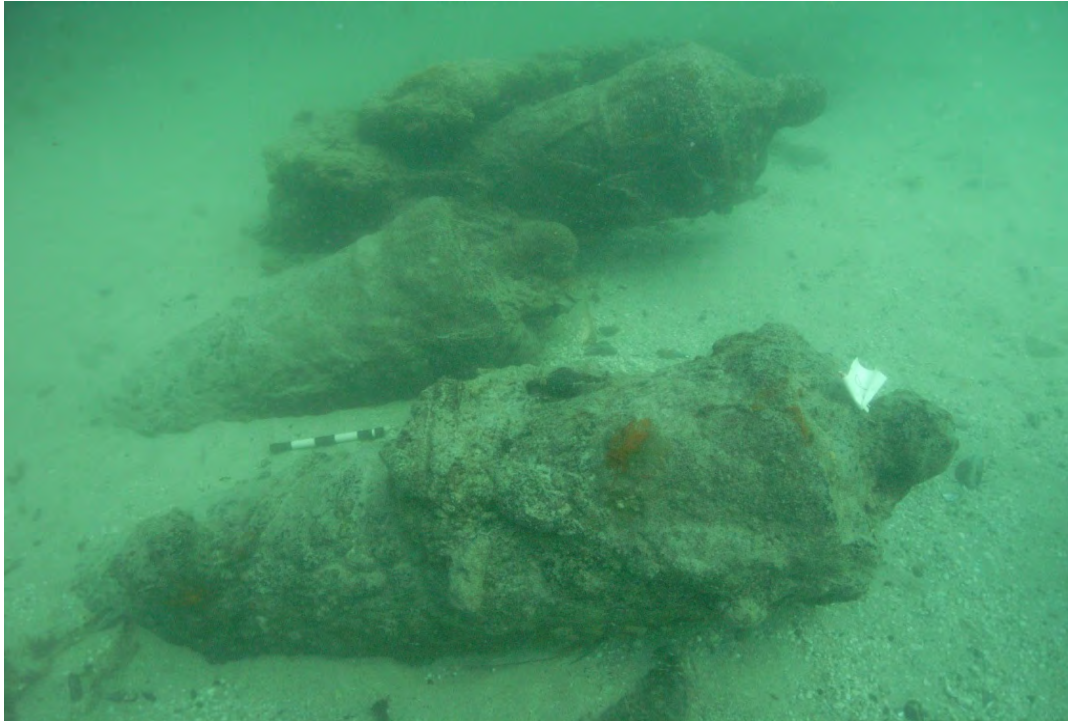
Fig. 10. Three guns found on the “Barrel wreck” (Photo: Carpenter 2011).

The anchor is located on the south-eastern side of the site, near the N5 datum point. The guns are situated at the north-eastern side of the site, near the datum points S4 and S5. During the survey, detail drawings of the of the guns and the anchor were made and measurements taken (Appendix V).

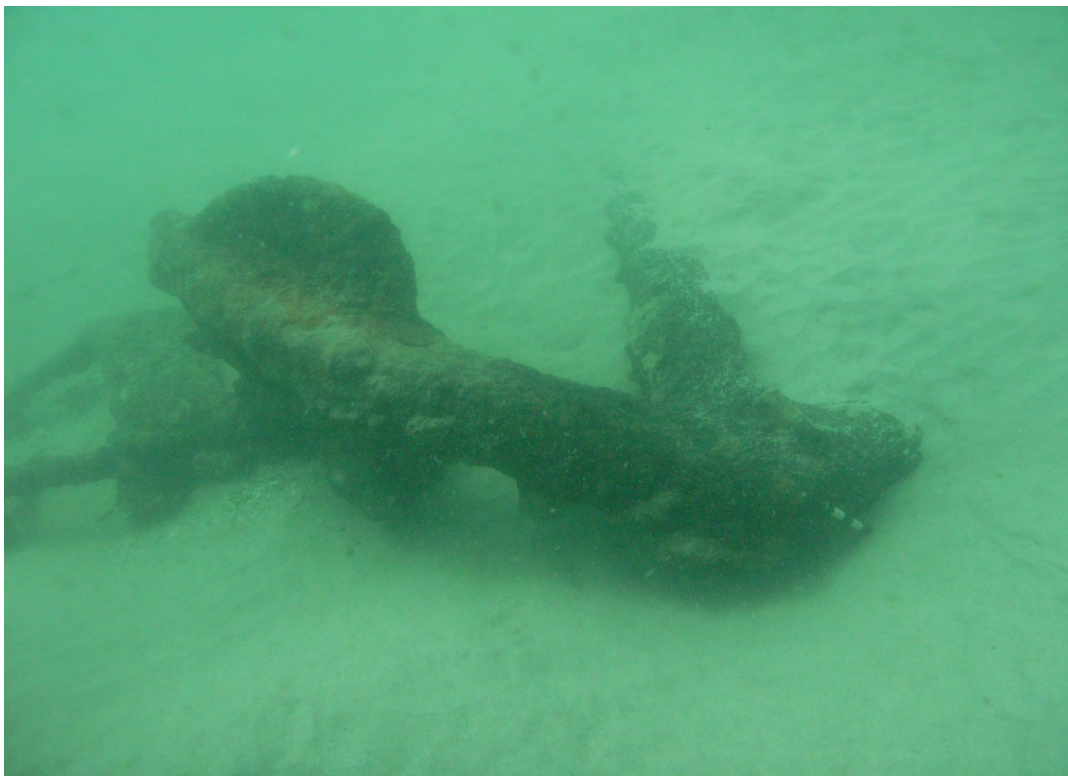
Fig. 11. Visible part of the anchor (Photo: Carpenter 2011).

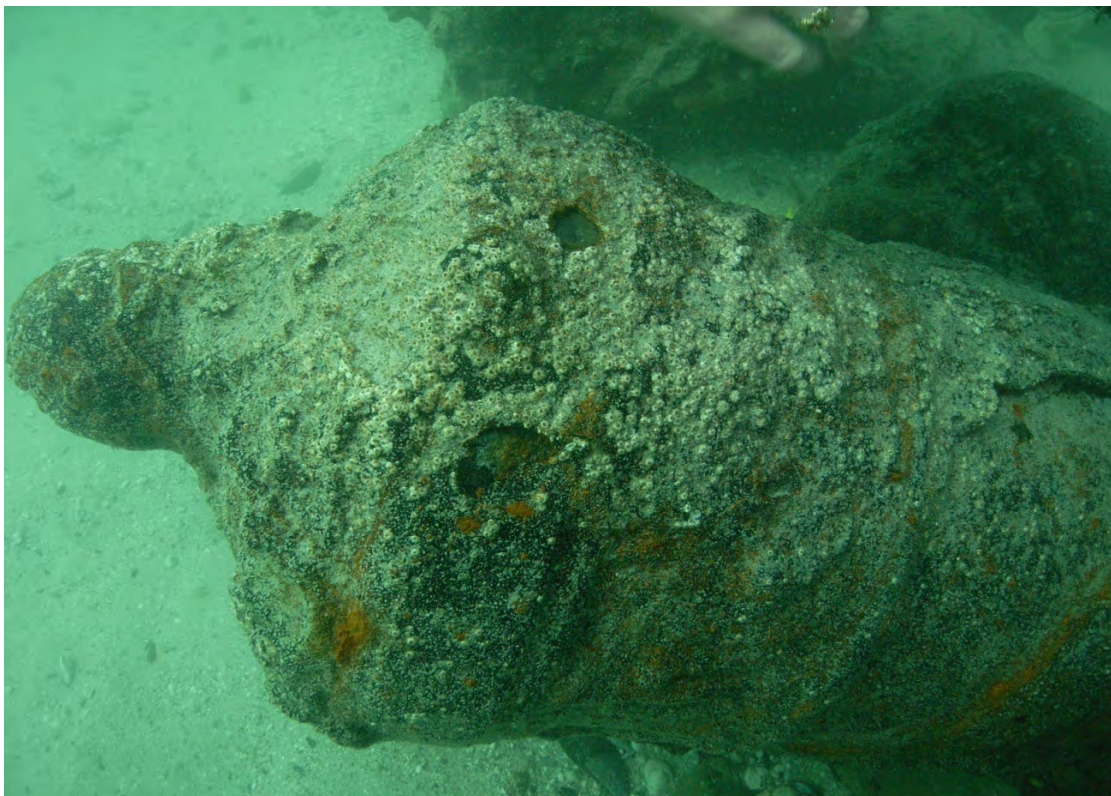
The integrity of the metal artifacts for i.e. the guns and anchor was assessed using PH measurements and corrosion potential. PH measurements were obtained by drilling a hole through the concretion and the corrosion layer. The PH level is measured immediately after drilling next to the uncorroded metal. The lower the PH, the more the object is corroding. Thereafter the platinum electrode is placed in the same hole to measure the corrosion potential. For this test good electrical contact with the surface is important. These results are later entered into a pourbaix diagram. The thickness of the concretion and the corrosion was measured. This can tell us about the dynamics of the wreck site. The hole was afterwards filled with Pratleys Putty to prevent further corrosion.

Fig. 12. Hole drilled into gun to measure corrosion levels (Photo: Carpenter 2011).

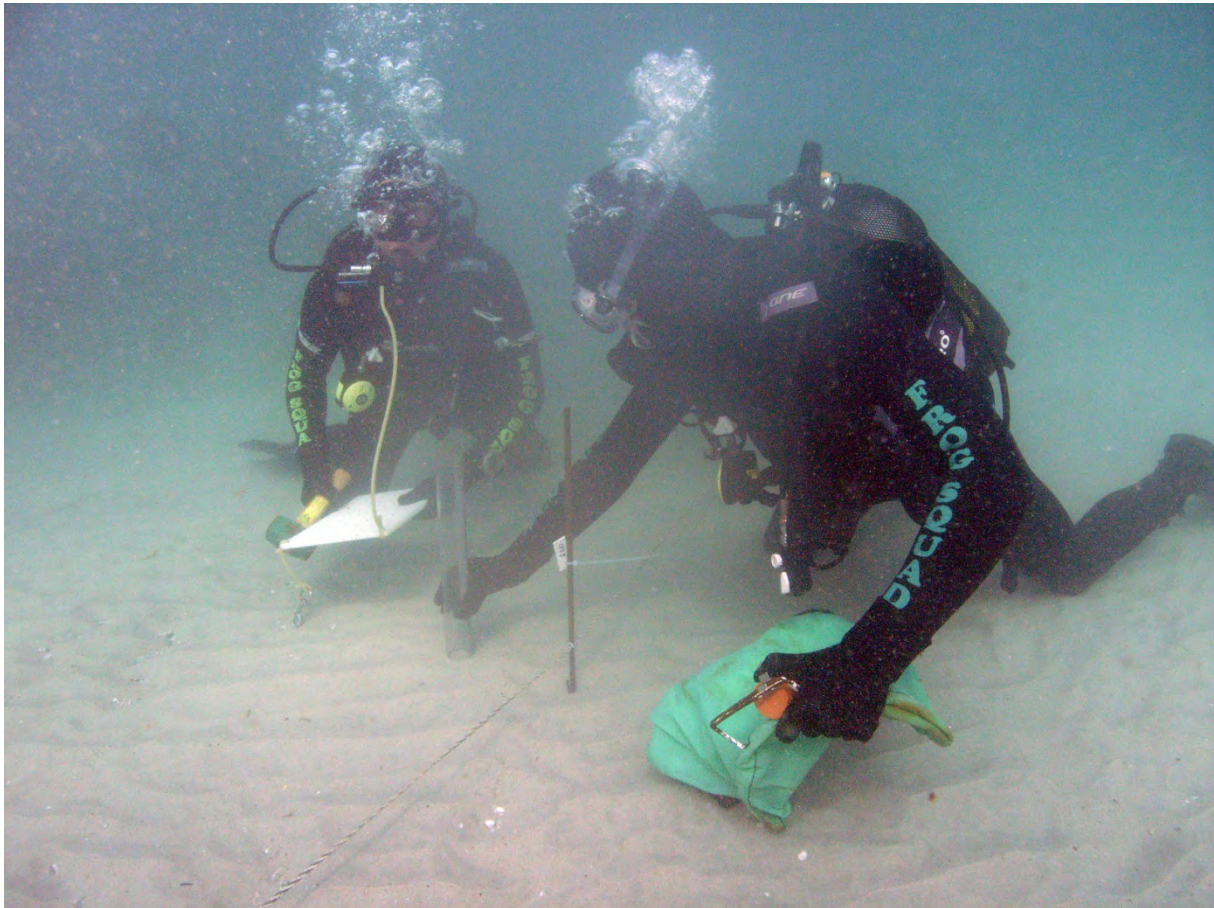
These samples were taken by hammering a transparent tube into the sediment. A stopper is put into the top end, this creates a vacuum and prevents the sediments from falling out. After the removal a stopper is placed into the bottom end. The sediment sample is removed to the boat and documented.

Fig. 13. Students taking sediment samples to gain information about micro-biological activity in the seabed. (photo: Carpenter 2011).

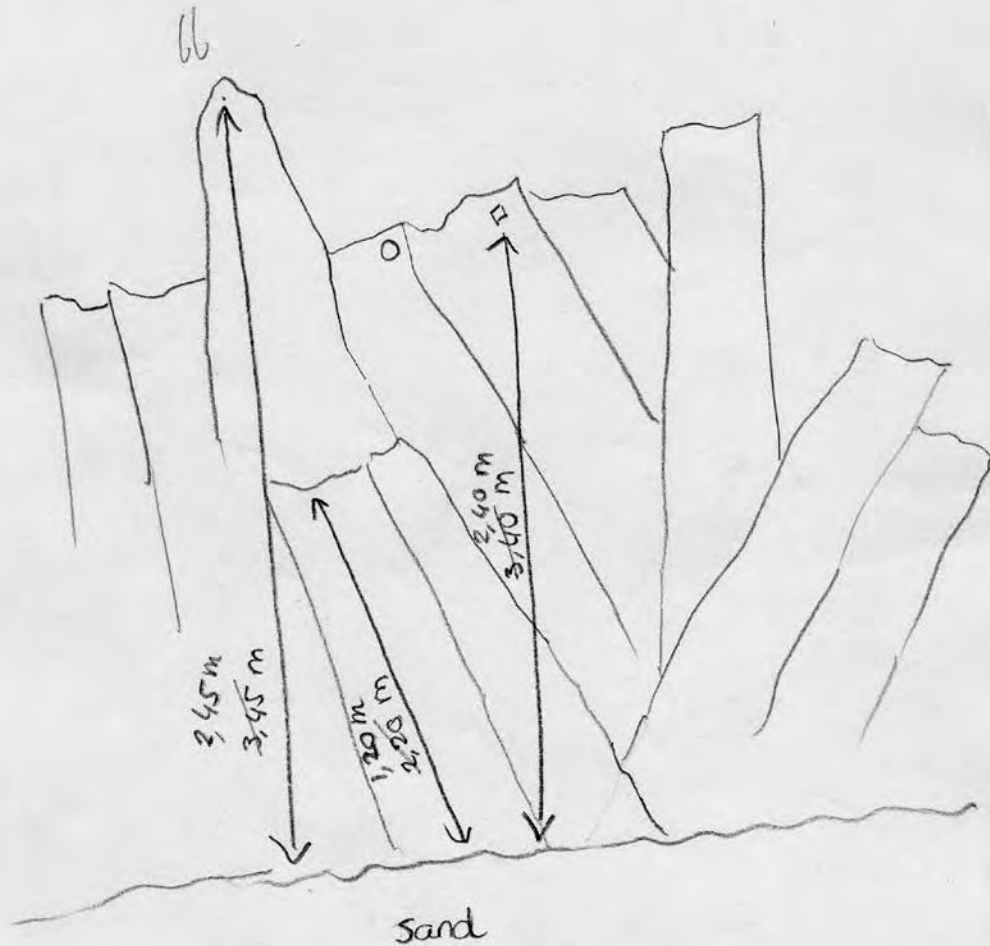
distance between numbers 23 and 27
on keel near S₁ - S₂

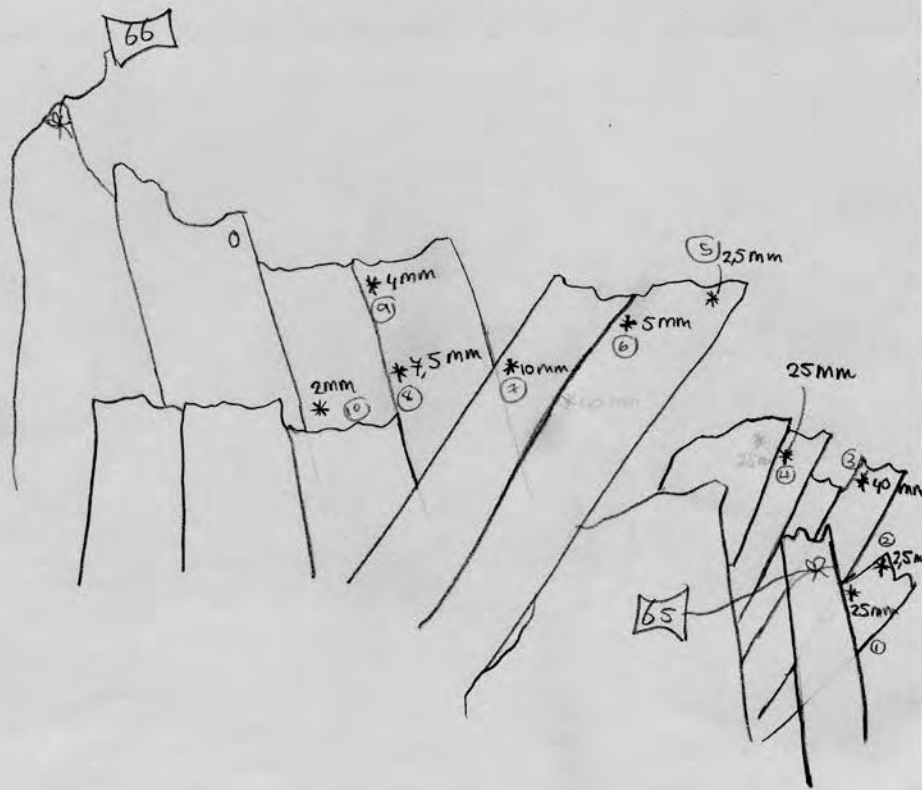
Drilling & Voltage Measurements.

PE (mVolts)	depth (mm)
Canon	-333	17
Bar	-1.25	28
