**KINROSS EXT 30 RESIDENTIAL DEVELOPMENT, GOVAN MBEKI LOCAL  
MUNICIPALITY, MPUMALANGA PROVINCE**

**PHASE II HERITAGE IMPACT ASSESSMENT  
&  
INVESTIGATION ACCIDENTALLY EXPOSED BONES**

**CLOSEOUT REPORT**

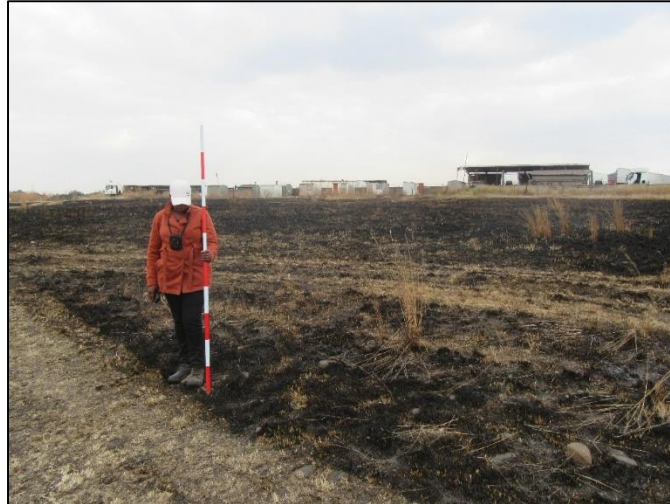
Figure 1: Ground survey at Kinross Ext 30 as part of level 2 screening of the development are for the presence of heritage resources.

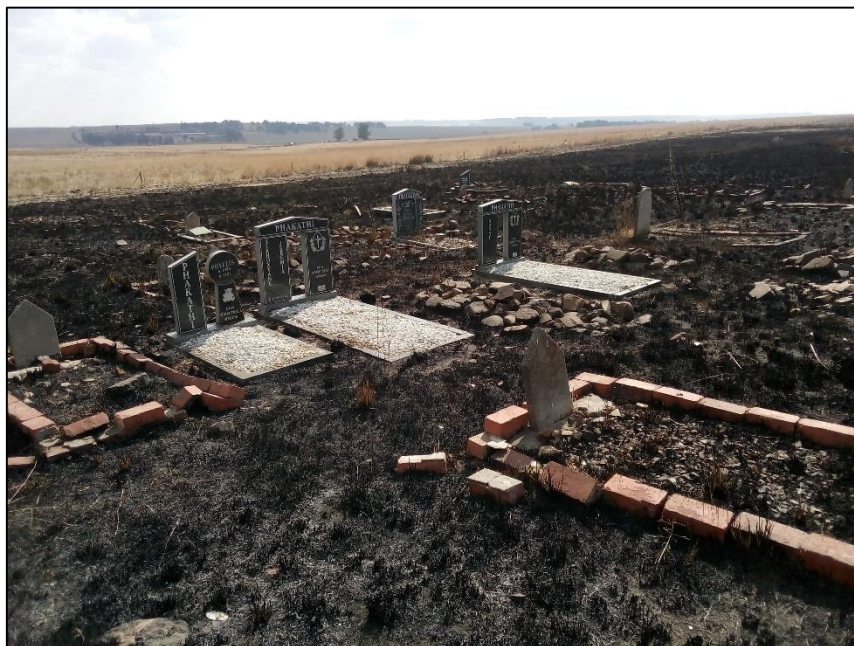
Figure 5: Old Embhalenhle burial ground will not be affected by the Kinross Ext 30 residential development.

The old Embhalenhle burial ground is located c. 100m east of the development area. A brief study was conducted; the youngest graves date to the late 1950s and early 1960s, roughly indicating the time of the forced removals. The burial ground will not be affected by the development (Figure 5).

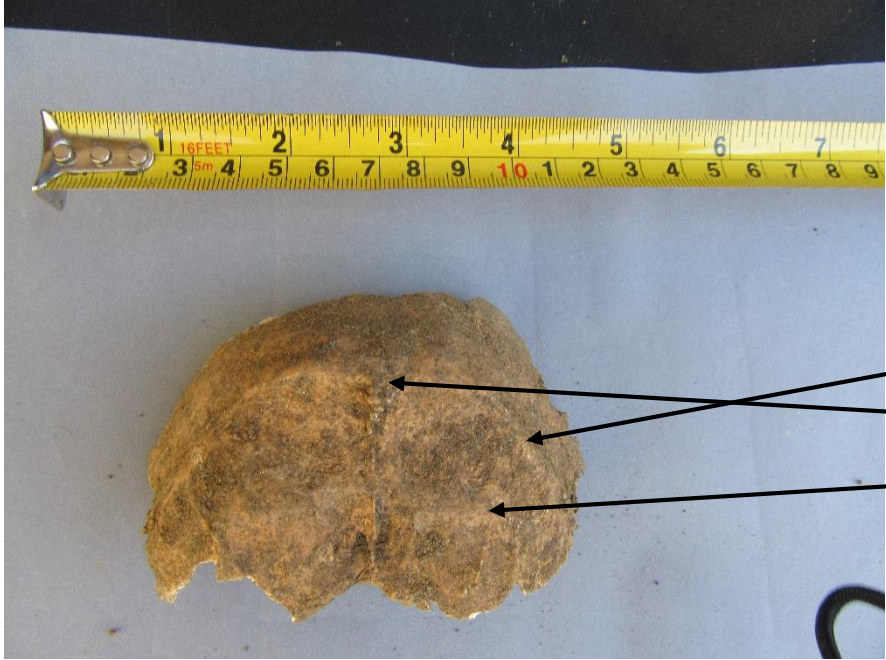
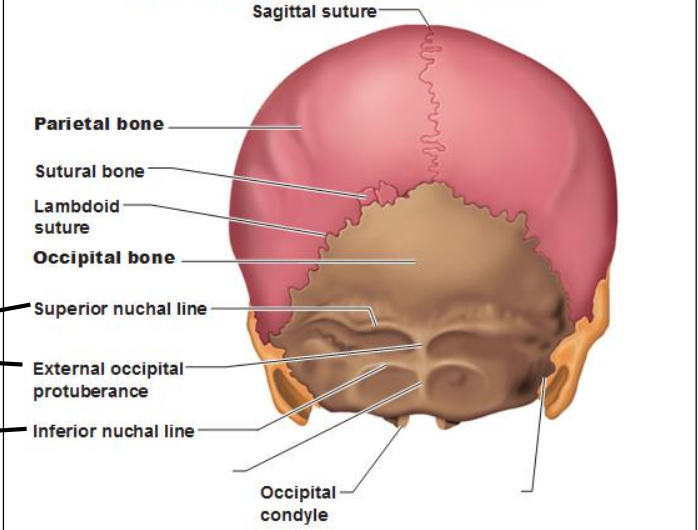
Table 1: Human bones.

It has been concluded beyond reasonable doubt that all the bones numbering >30 from Site 2 possibly come from a single human skeleton which has been positively identified from four diagnostic bones namely:

- An occipital bone
- Upper end of a femur bone
- Lower end of a femur bone; and
- Lower end of a tibia bone

The confidence rating of these findings are 99.999%, which in clinical terms means 100% certainty (Table 1).

<p data-bbox="1330 309 1756 341" style="text-align: center;"><b>The Skull— Posterior View</b></p>

- (i) As the finds from Site 2 have turned out to be human skeletal material, relocation to a formal cemetery is necessary.
- (ii) This matter required to be carefully managed in particular the stakeholder engagement process
- (iii) The need to have a stakeholder strategy is underlined. Furthermore given the many demands which local residents have been making, we are operating in a high risk socio-economic environment which entails that the stakeholder strategy be supported by a risk management strategy.

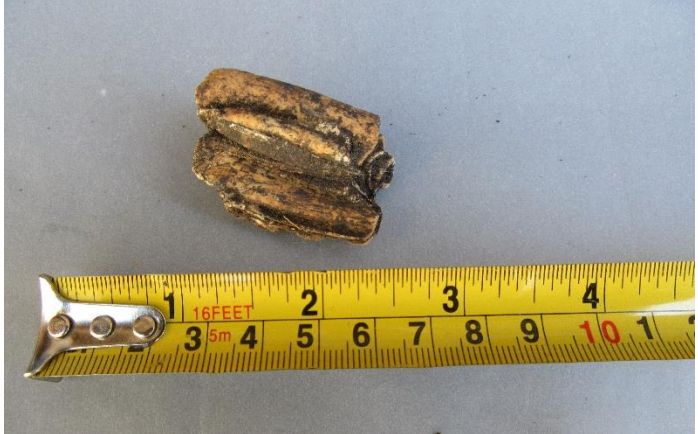
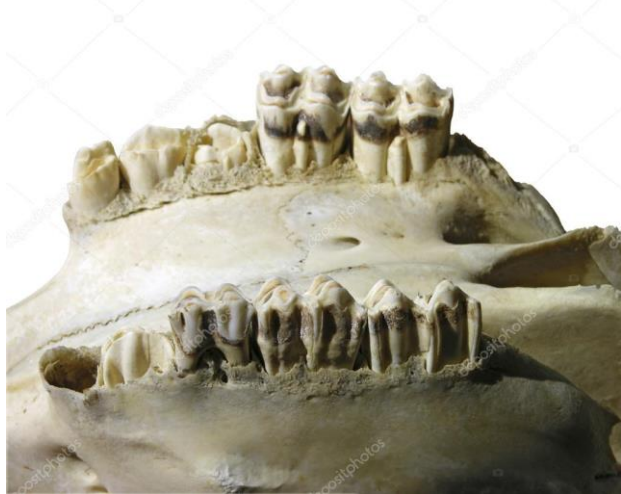
Table 2: premolar of cow found at Site KIN001.

The bone fragments from Site 1 are undiagnostic except for a complete tooth identified to the premolar of a cow (Table 2).

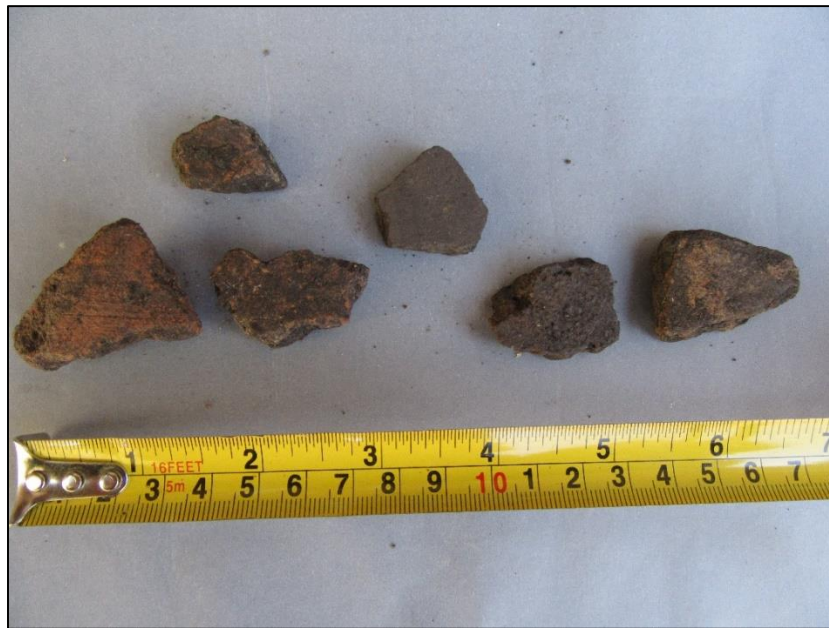
Figure 7. Potsherds found may date to the Later Iron Age

Pottery fragments also found at Site 3 are testimony of a precolonial Later Iron Age horizon (Figure 7). It is tempting to speculate that the burial 120m to the south could date to the same time period before the establishment of the town.
