PHASE 1 HERITAGE IMPACT ASSESSMENT FOR THE PROPOSED LOW SULPHIDE TAILINGS FACILITY SITUATED ON PORTION 7 OF THE FARM ONVERWACHT 611-JT, MPUMALANGA PROVINCE

ARCHAEOLOGY AFRICA CC
P.D. BIRKHOLTZ

NKOMATI MINE (PTY) LTD

April 2008

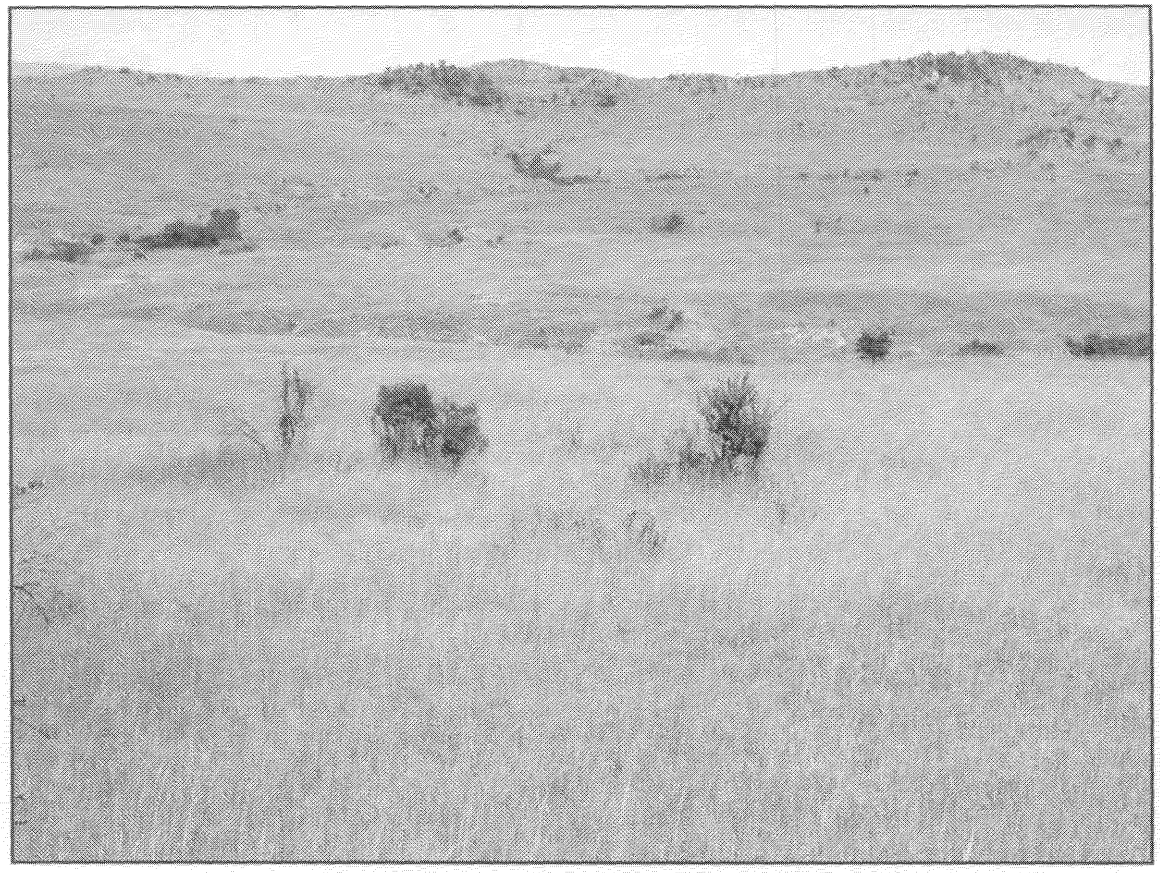
Plate 11 General view of **ONV-3**.

As the site is situated inside the development footprint for the proposed Nkomati Mine Tailings Dam, it would be impossible to conserve the cemetery *in situ*. As such full grave relocation is recommended. Such a process must always be undertaken in full cognisance of the relevant legislation, and must include a detailed social consultation process to try and identify the family of the deceased.

The Nkosi family was consulted with regards to the proposed relocation of their graves and they have provided permission for the graves to be relocated.

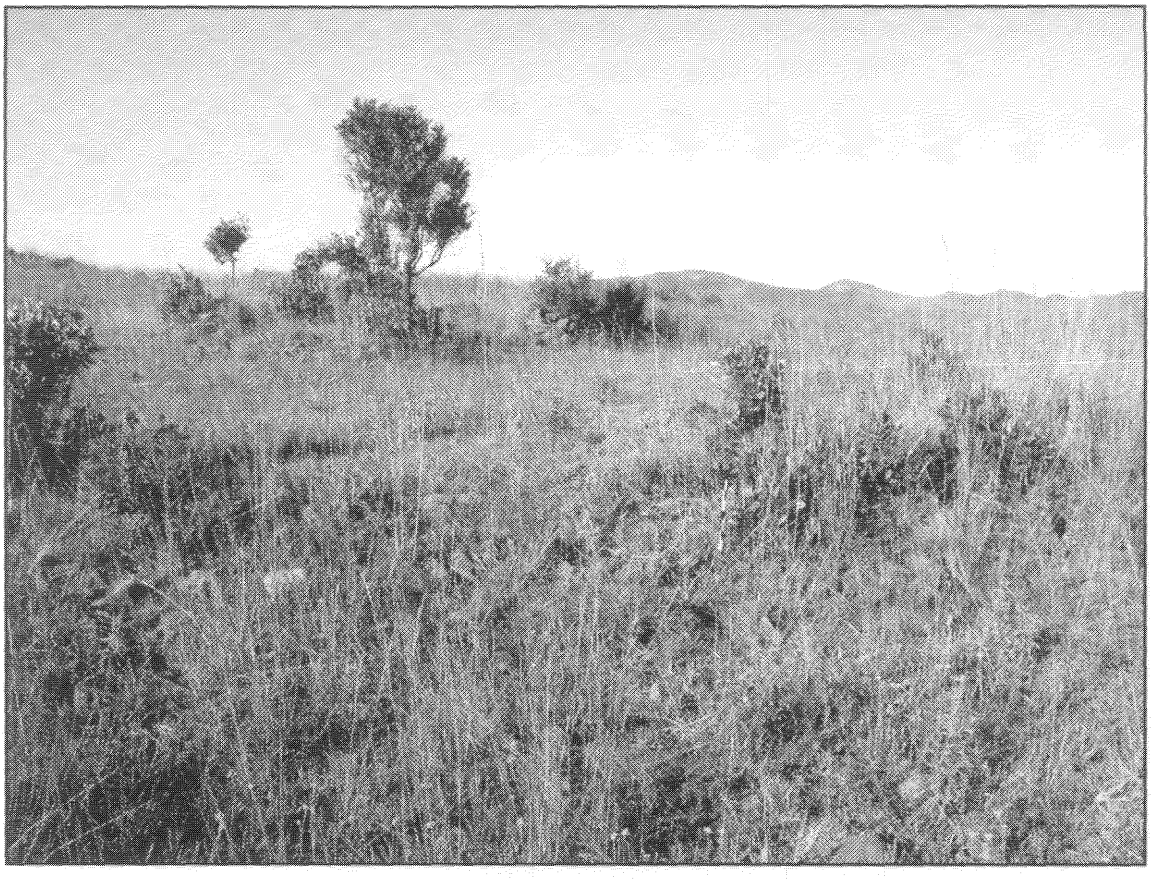
Plate 29 General view of **ONV-12** with the outer wall in the foreground.

Plate 30 One of the small circular dwelling structures at **ONV-12**.

Documentation of settlement layout by surveying and drawing a detailed Site Layout Plan.

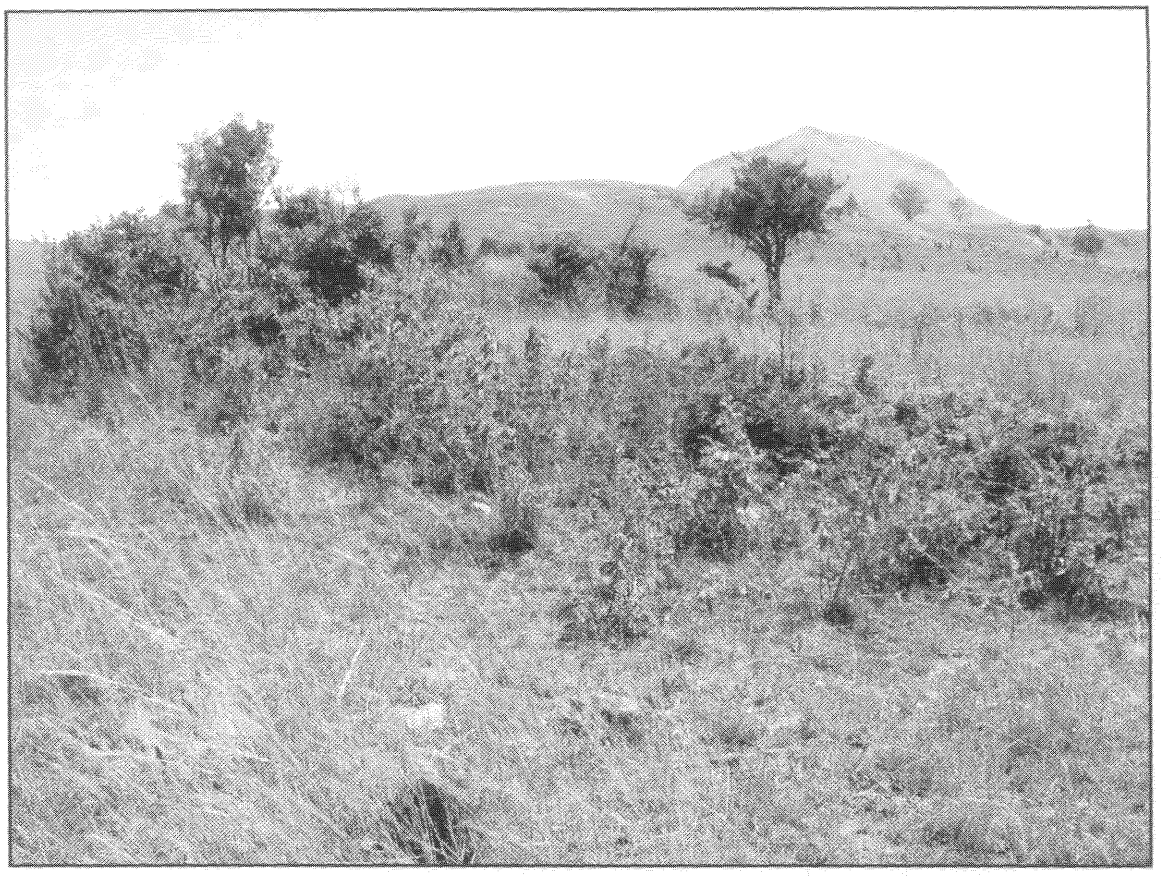
Artefacts such as a lower and upper grinder as well as undecorated ceramics were observed on the surface of the site. No archaeological deposits could be found.

Plate 31 A section of the outer wall from site **ONV-13** can be seen.

Plate 32 Cross-section view of walling from the site.

Documentation of settlement layout by surveying and drawing of a detailed Site Layout Plan.

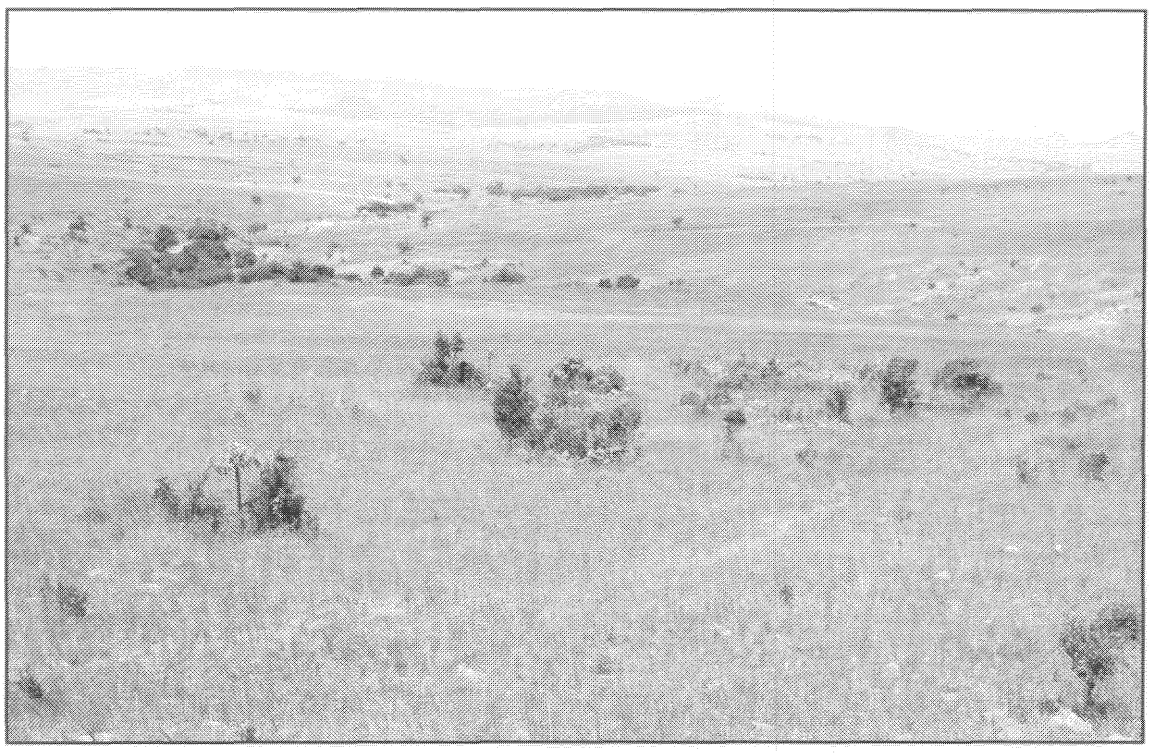
An historic site is situated here. It is situated on slightly sloped land between the southern foot of a low ridge and a non-perennial stream. It is comprised of a large rectangular stone enclosure (± 12m x 15m) with ten small circular stone structures (± 4m x 4m) and one small rectangular structure directly associated with it. Two small circular structures were also observed a short distance to the north of the site.

Plate 44 General view of **ONV-18**. Photograph taken in a south-eastern direction.

Plate 45 Section of walling from one of the circular structures.

The mitigation of the historic structures consists of the documentation of the settlement layout by surveying and drawing of a detailed Site Layout Plan.

As the site is situated inside the development footprint for the proposed Nkomati Mine Tailings Dam, it would be impossible to conserve the grave *in situ*. As such full grave relocation is recommended. Such a process must always be undertaken in full cognisance of the relevant legislation, and must include a detailed social consultation process to try and identify the family of the deceased. The Duma family was consulted with regards to the proposed relocation of their grave and they have provided permission for the grave to be relocated.

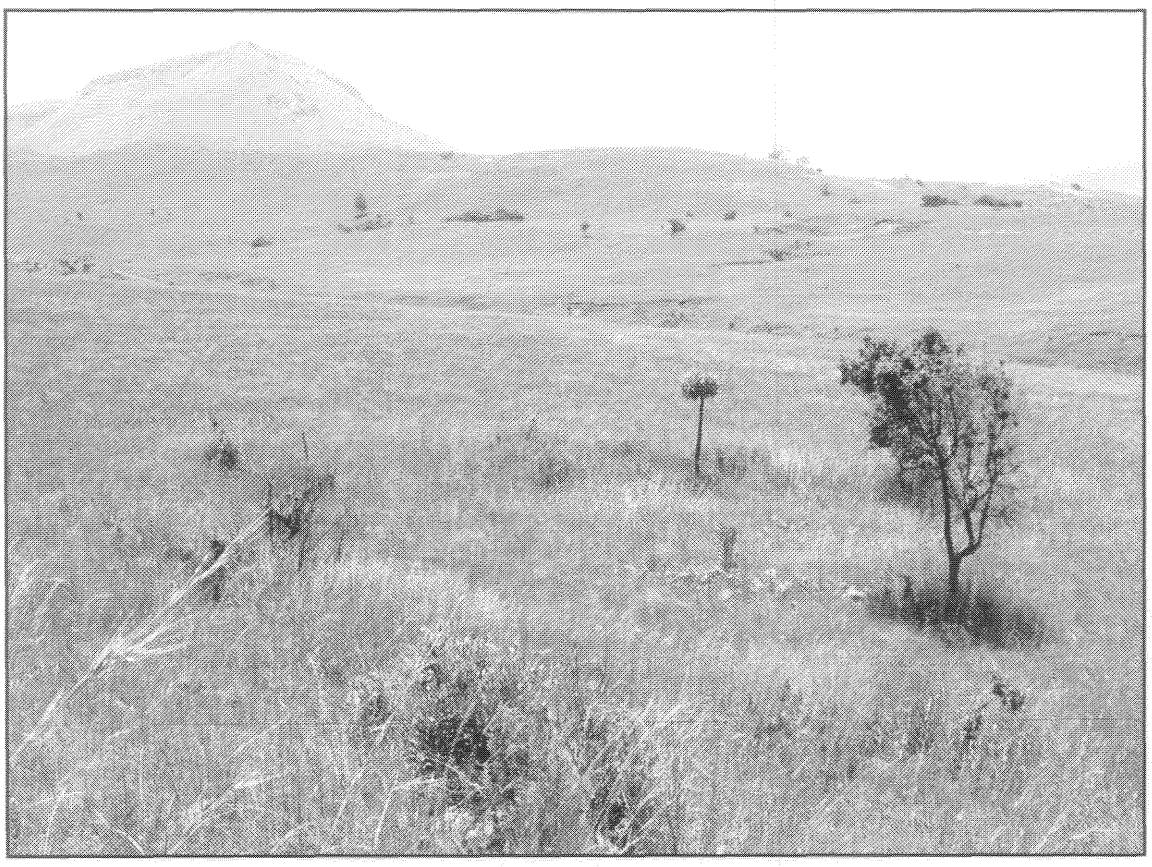
The site is reasonably well preserved and contains a number of features which are not found on many of the other Late Iron Sites from the study area such as the terraced section with stone platform. The site is of **Medium Significance**.

Plate 48 General view of **ONV-19**. Photograph taken in a northern direction.

- Documentation of settlement layout by surveying and drawing a detailed Site Layout Plan. This will be followed by limited test excavations in certain areas of the settlement. These activities are aimed at documenting, recovering and recording enough data for future research before a destruction permit is issued for this site, with special emphasis placed on collecting a representative sample of cultural remains to identify the occupants of the site.
- Compilation of a report containing all the research and findings of the study indicated above.
- Submission of this report with the permit application for the site to be destroyed.

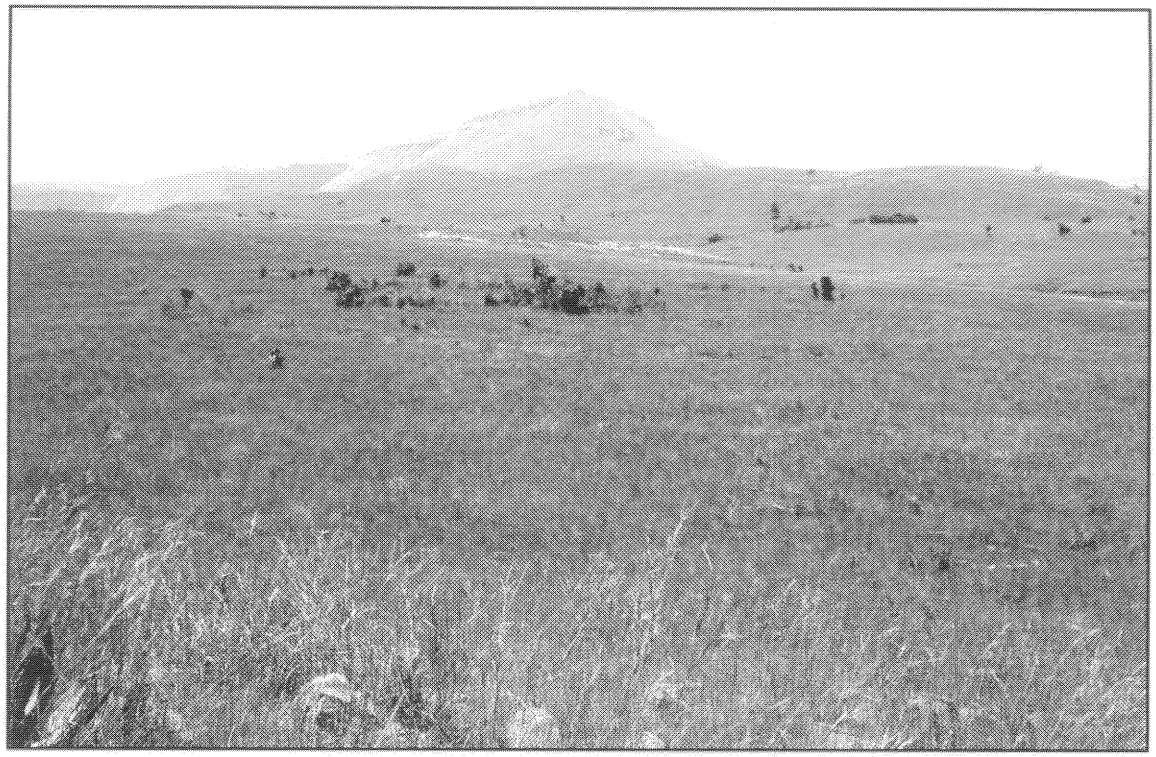
The site is reasonably well preserved and one of the larger sites found within the study area. It also has a well defined settlement layout. The site is of **Medium Significance**.

Plate 51 General view of **ONV-21**. Photograph taken in a northern direction.

- Documentation of settlement layout by surveying and drawing a detailed Site Layout Plan. This will be followed by limited test excavations in certain areas of the settlement. These activities are aimed at documenting, recovering and recording enough data for future research before a destruction permit is issued for this site, with special emphasis placed on collecting a representative sample of cultural remains to identify the occupants of the site.
- Compilation of a report containing all the research and findings of the study indicated above.
- Submission of this report with the permit application for the site to be destroyed.

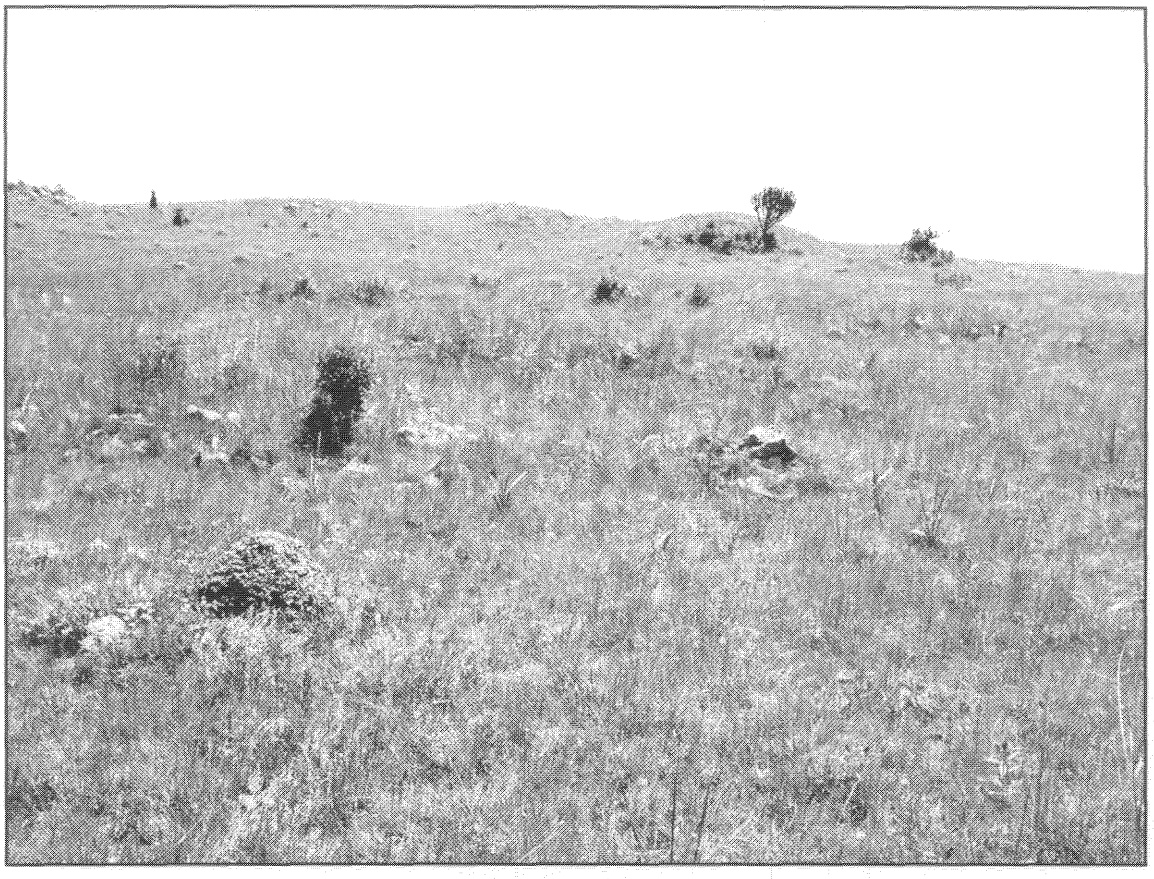
Plate 55 General view of **ONV-22**. Photograph taken in a western direction.

Plate 56 Monolith observed along **ONV-22's** outer enclosing wall.

Documentation of settlement layout by surveying and drawing a detailed Site Layout Plan.

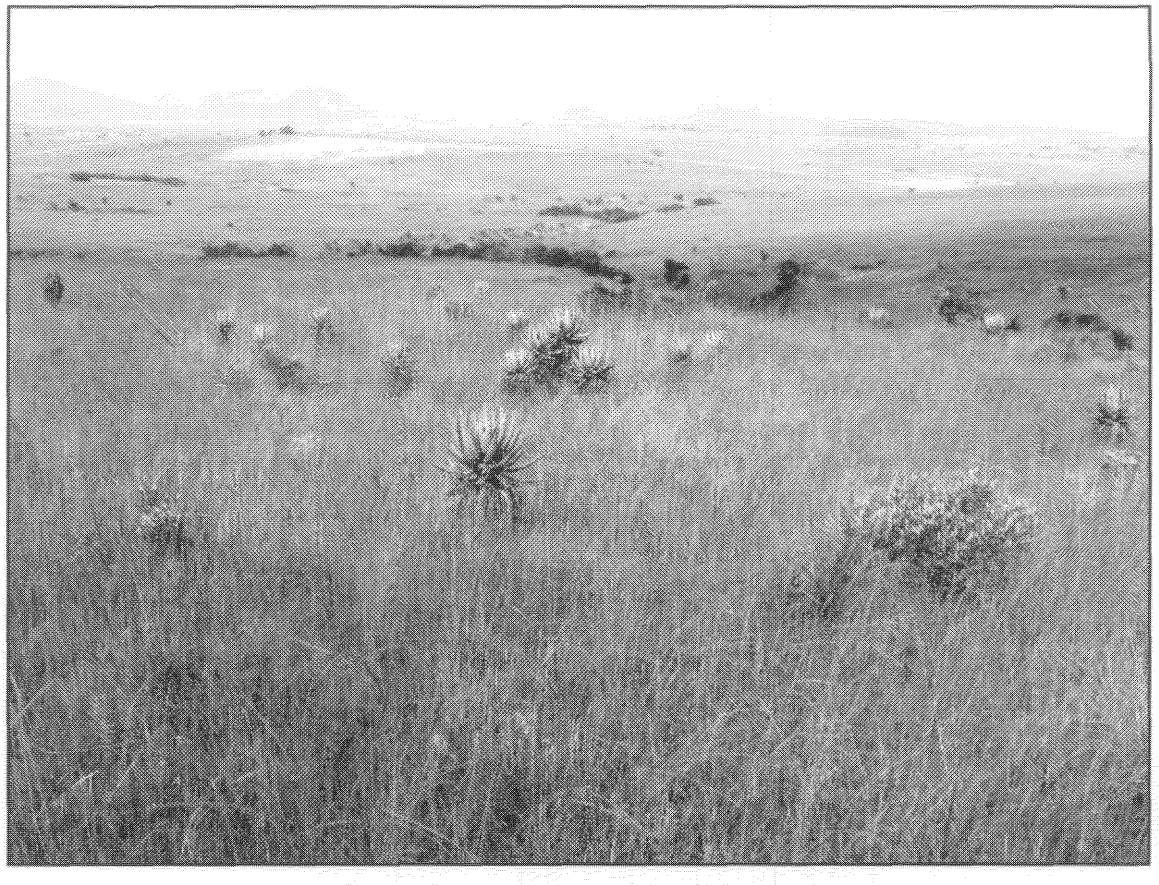
Plate 57 General view of **ONV-23**.

Documentation of settlement layout by surveying and drawing a detailed Site Layout Plan.

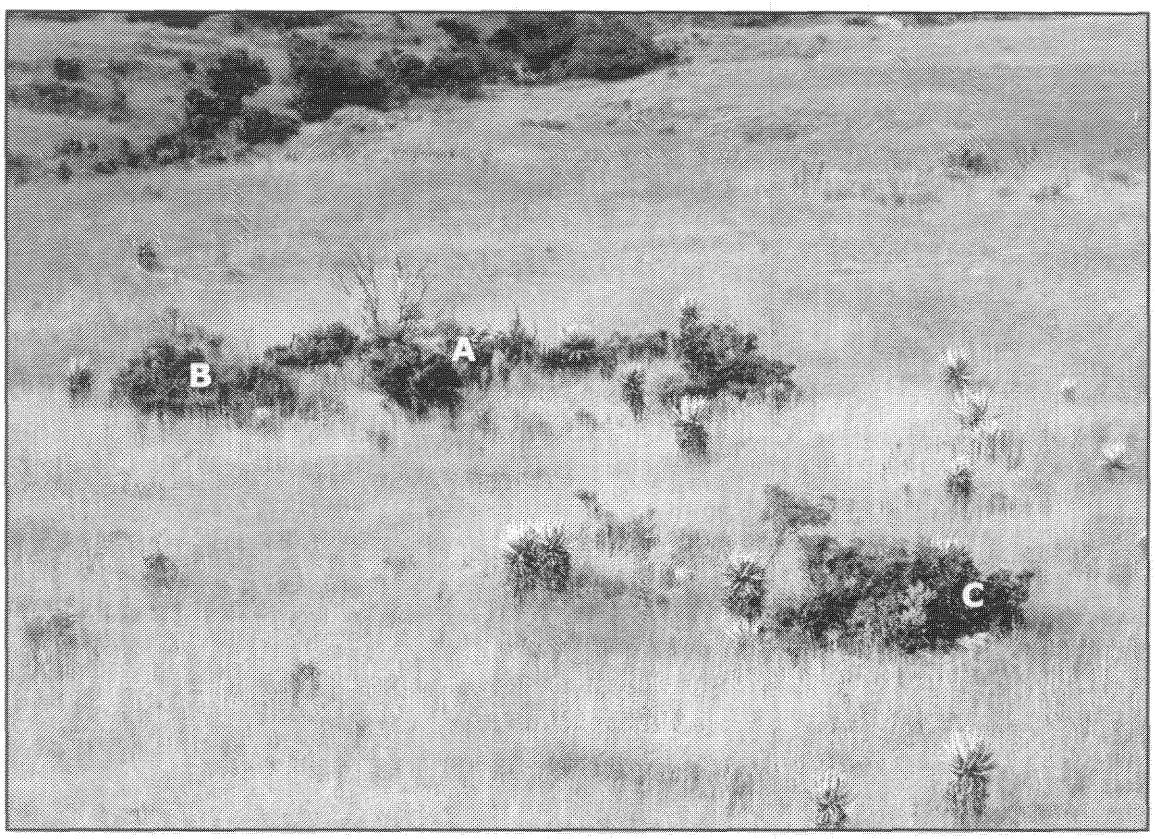
Plate 58 General view of a section of **ONV-24**. The cattle enclosure (A), calf enclosure (B) and one circular structure can be seen.

Plate 59 A section of the cattle enclosure (A) can be seen in the foreground with **ONV-23** (B) visible in the background.

Documentation of settlement layout by surveying and drawing a detailed Site Layout Plan.

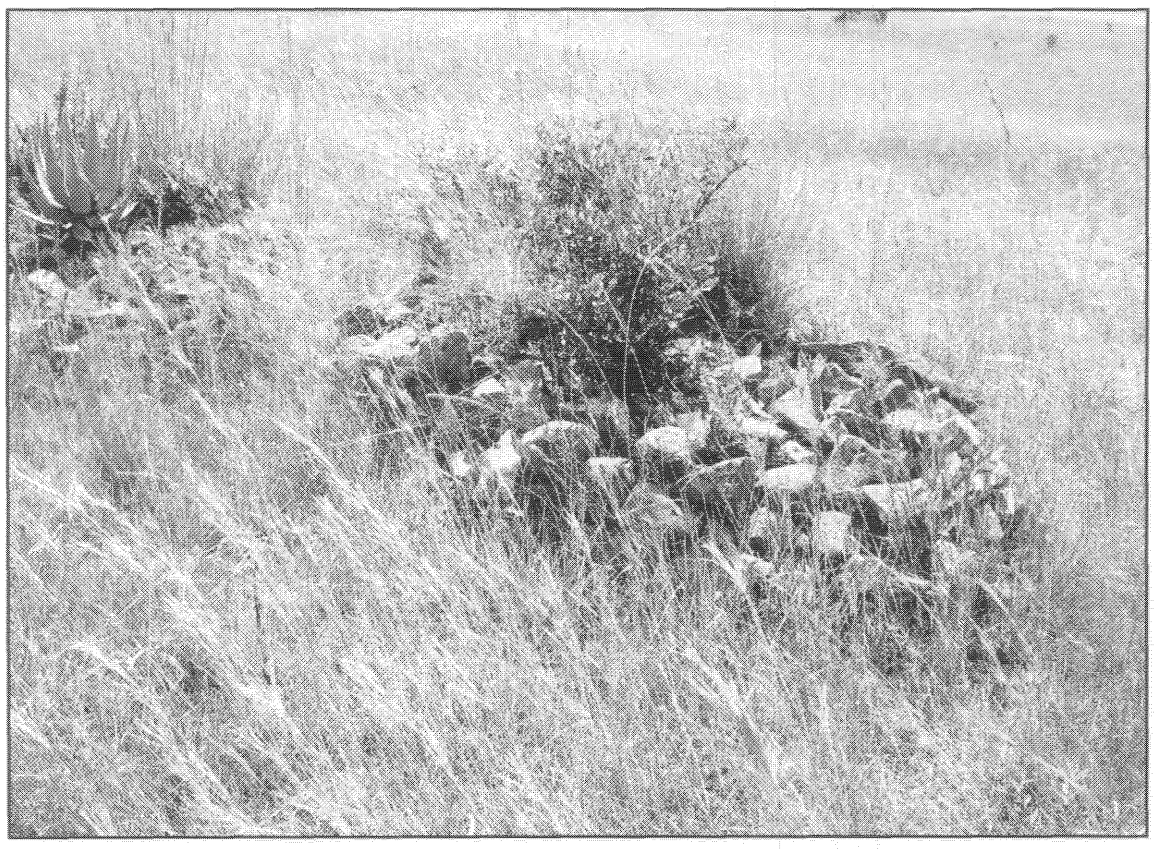
Plate 61 One of the adult graves from **ONV-28.**

As the site is situated inside the development footprint for the proposed Nkomati Mine Tailings Dam, it would be impossible to conserve the cemetery *in situ*. As such full grave relocation is recommended. Such a process must always be undertaken in full cognisance of the relevant legislation, and must include a detailed social consultation process to try and identify the family of the deceased. The Nkambule family was consulted with regards to the proposed relocation of their graves and they have provided permission for the graves to be relocated.

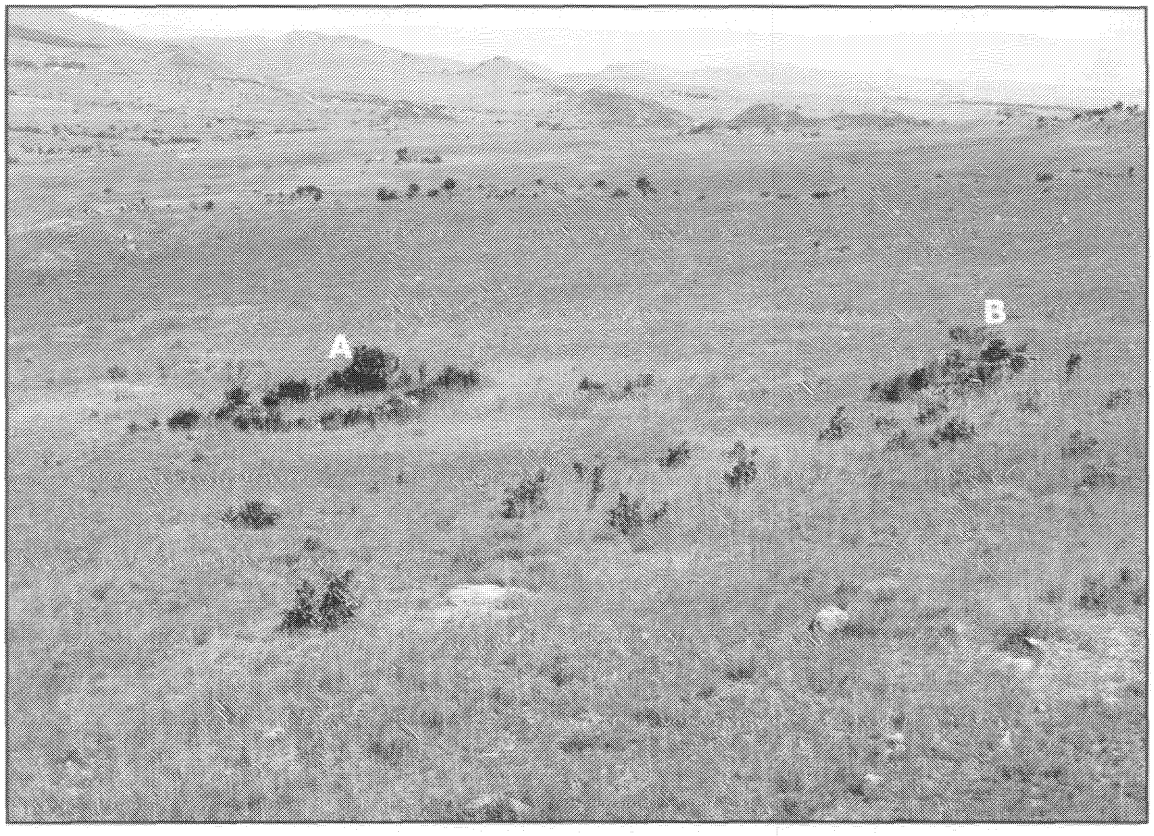
Plate 62 General view of the southernmost component of **ONV-29**. Photograph taken in a south-eastern direction. The cattle enclosure is on the left (A), with the dwelling structures on the right (B).

The mitigation measure recommended for the historic structures is the documentation of the entire site layout by surveying and drawing of a detailed Site Layout Plan. As the cemetery is situated inside the development footprint for the proposed Nkomati Mine Tailings Dam, it would be impossible to conserve the cemetery *in situ*. As such full grave relocation is recommended. Such a process must always be undertaken in full cognisance of the relevant legislation, and must include a detailed social consultation process to try and identify the family of the deceased. The Maseko family was consulted with regards to the proposed relocation of their graves and they have provided permission for this to take place.

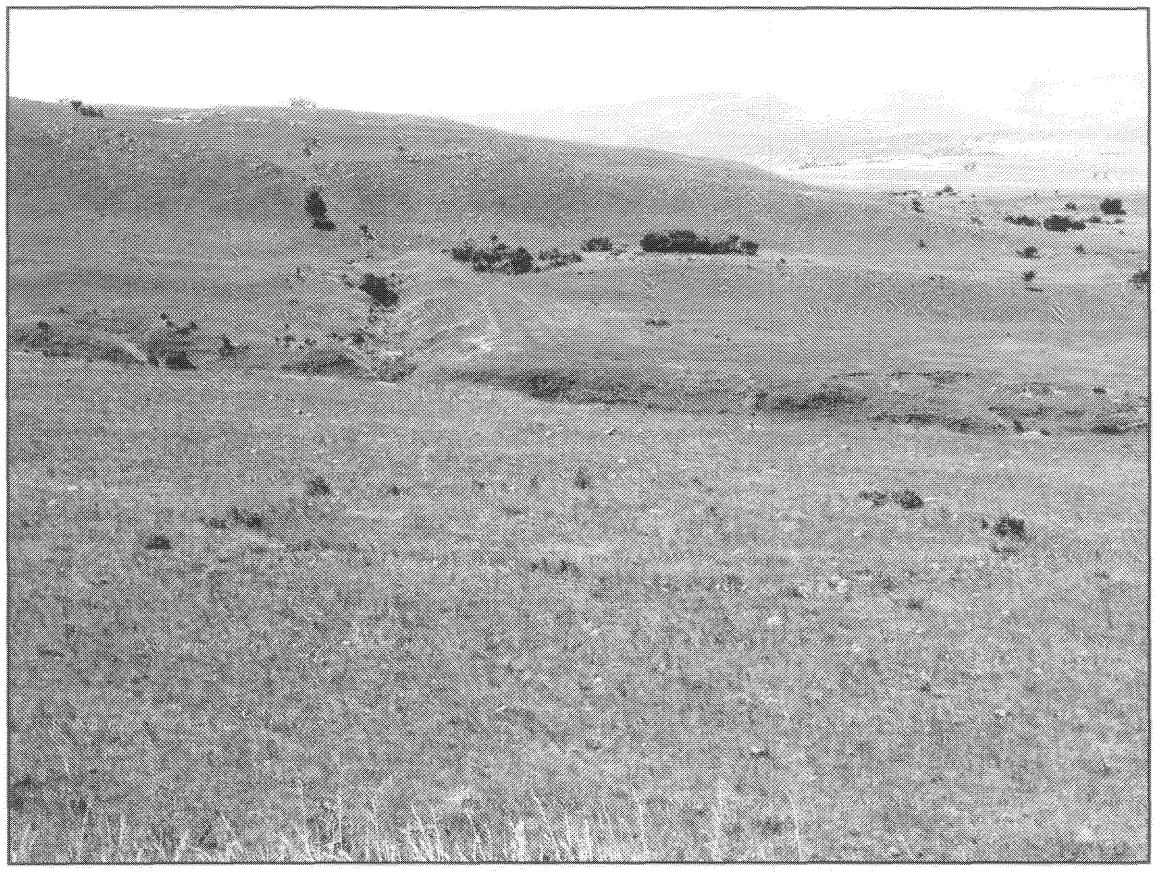
Plate 67 General view of **ONV-30**. Photograph taken in a north-eastern direction.

Even though the site is located outside of the proposed development footprint, it is recommended that its settlement layout be documented by surveying and drawing of a detailed Site Layout Plan.

Although the site will not be impacted upon by the proposed development, its future management and conservation must be ensured. It is therefore also recommended that a Heritage Site Management Plan be compiled.

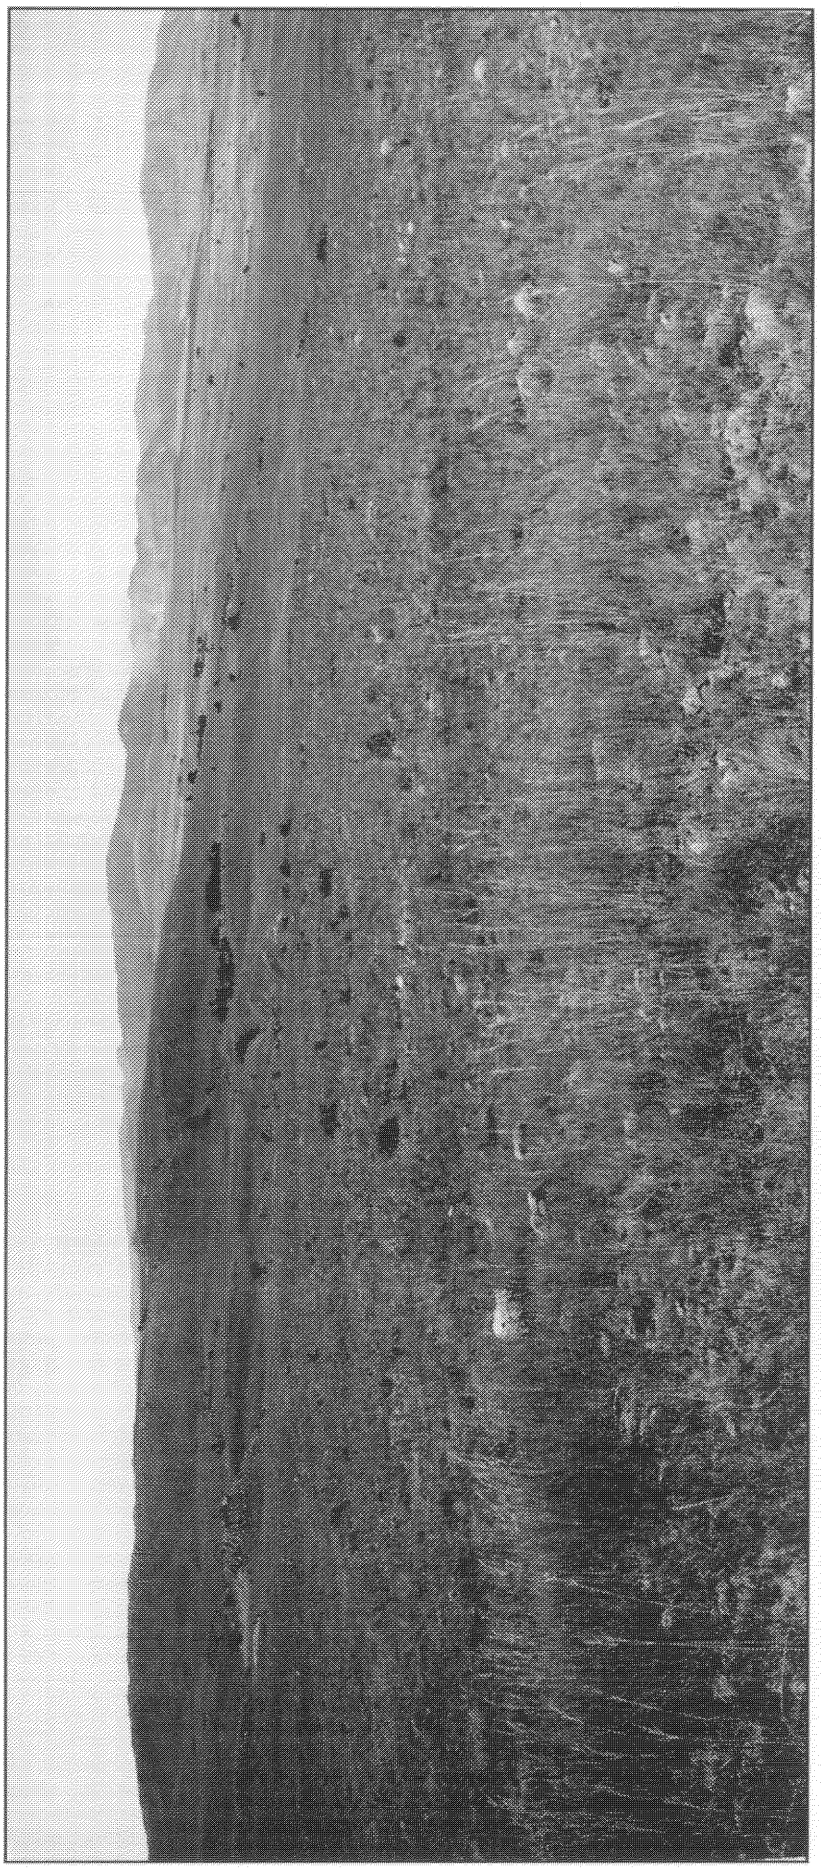
Plate 68 General view of the area in which site **ONV-31** is located.

Even though the site is located outside of the proposed development footprint, it is recommended that its settlement layout be documented by surveying and drawing of a detailed Site Layout Plan.

Although the site will not be impacted upon by the proposed development, its future management and conservation must be ensured. It is therefore also recommended that a Heritage Site Management Plan be compiled.

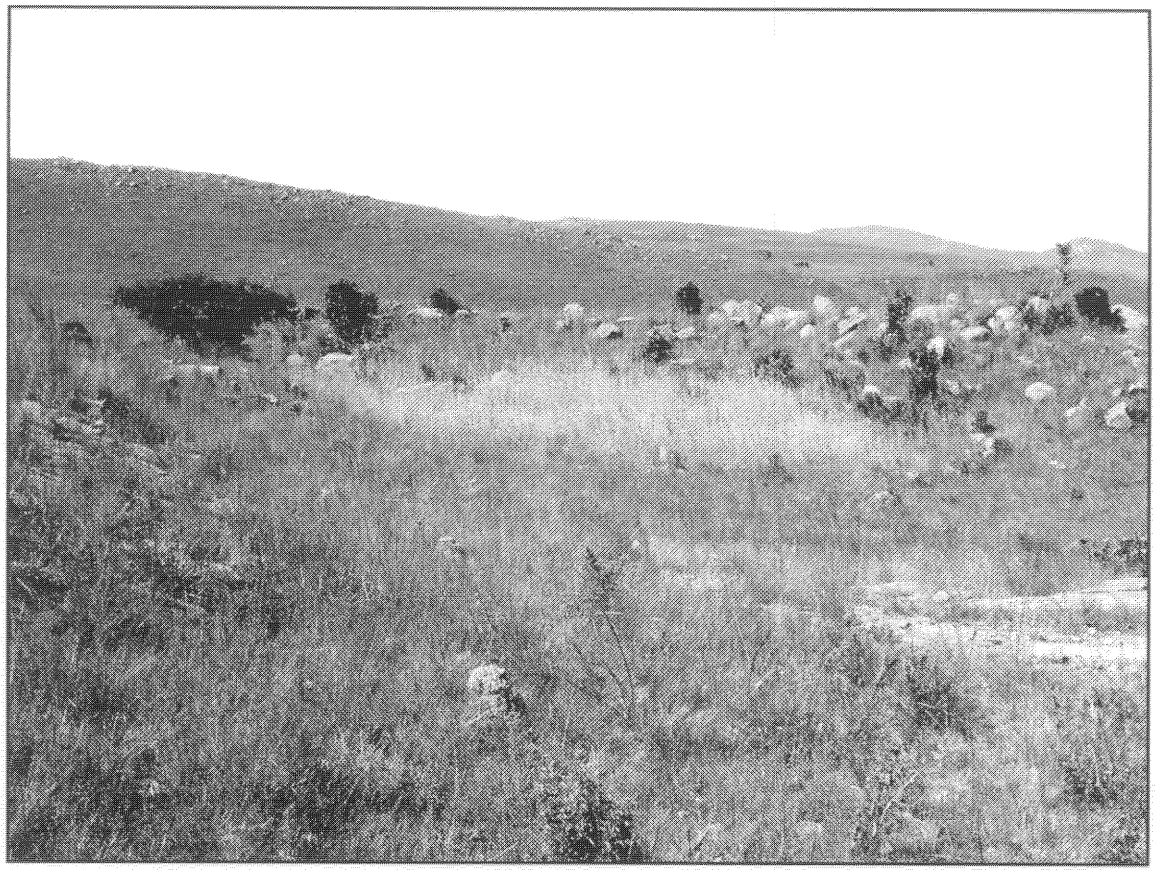
Plate 69 General view of **ONV-33**. Photograph taken in a north-eastern direction.

Even though the site is located outside of the proposed development footprint, it is recommended that its settlement layout be documented by surveying and drawing of a detailed Site Layout Plan.

Although the site will not be impacted upon by the proposed development, its future management and conservation must be ensured. It is therefore also recommended that a Heritage Site Management Plan be compiled.
