HERITAGE STATEMENT OLD ANGLICAN PARSONAGE/ RECTORY NUMBER 40 CHURCH STREET; ROBBEN ISLAND

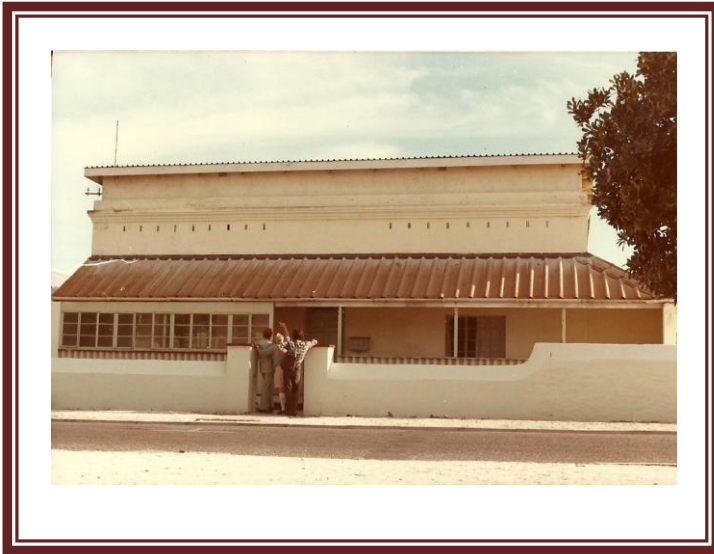
Fig.6.3. Front face ca 1983.

The balustrades and verandah supports were made from wood. The original beams still appear to be intact although the supports were replaced by metal poles, presumably sometime during the prison period. The original corrugated iron was replaced with asbestos sheeting. The verandah was also partly glazed in ca 1983.

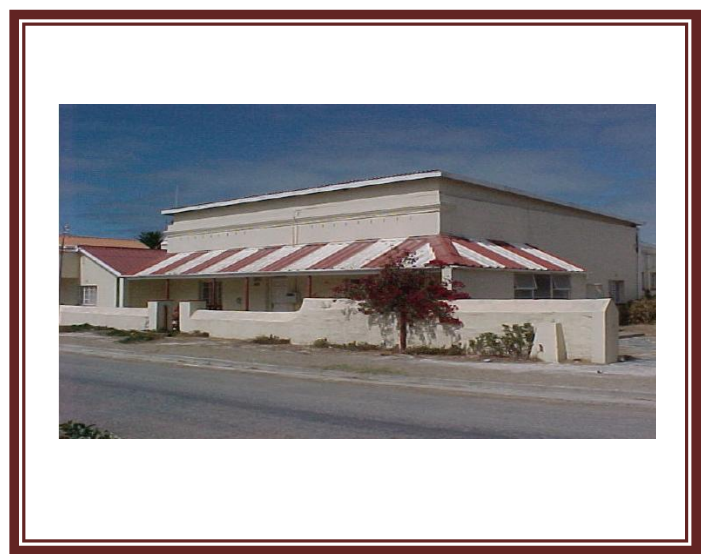
Fig.6.4. NE face ca 2001.

By 1890 the building exterior had been Victorianised with a typical concave corrugated iron verandah added on the eastern face, portion on the SE corner and a portion on the NE corner. The NE corner was removed ca 1963 when permission was granted for its removal by the Historical Monuments Commission. The paint scheme appears to have been candy striped with alternating red and white sheets. By 1983 the asbestos cladding was coloured a uniform brown. During the late 1990s the candy stripes were reintroduced.

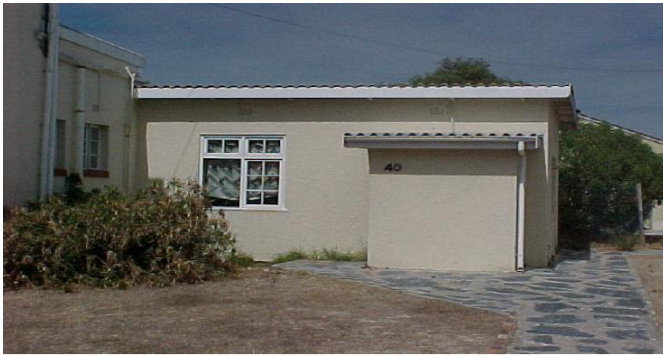
Fig.6.7. Annexe ca 2001

The annexe at the back on the NW corner appears to have been built partly from the original outbuildings and the yard wall shown on the 1841 floor plan. More research is required. The annexe was built after ca 1972 but more research is required for confirmation.

Reasonable although modern additions are cracking away from the original structure. The front door was poorly renovated using masonry filler and matt acrylic paint, which is flaking. The boundary wall needs repair in certain places. The water tank plinth bricks need attention. One metal window frame is badly rusted and needs to be replaced. The tin roof is in good condition. The verandah and annexe asbestos roofing requires attention.

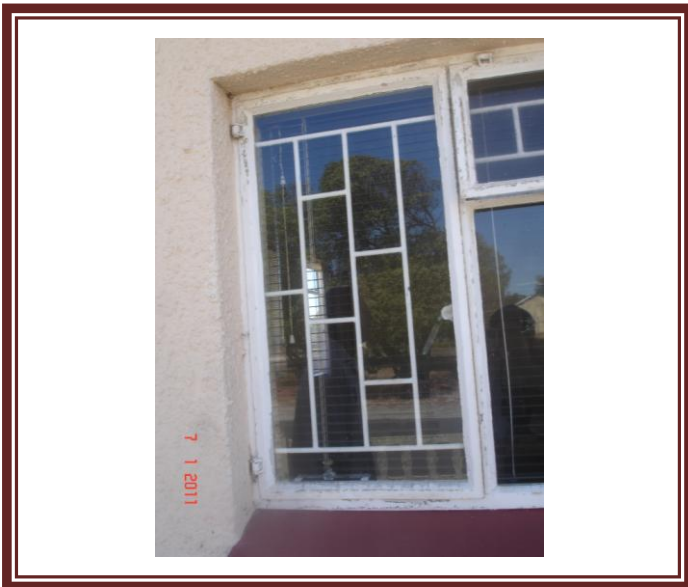
Fig.6.11. Window

The window frames were replaced with steel during the prison period.

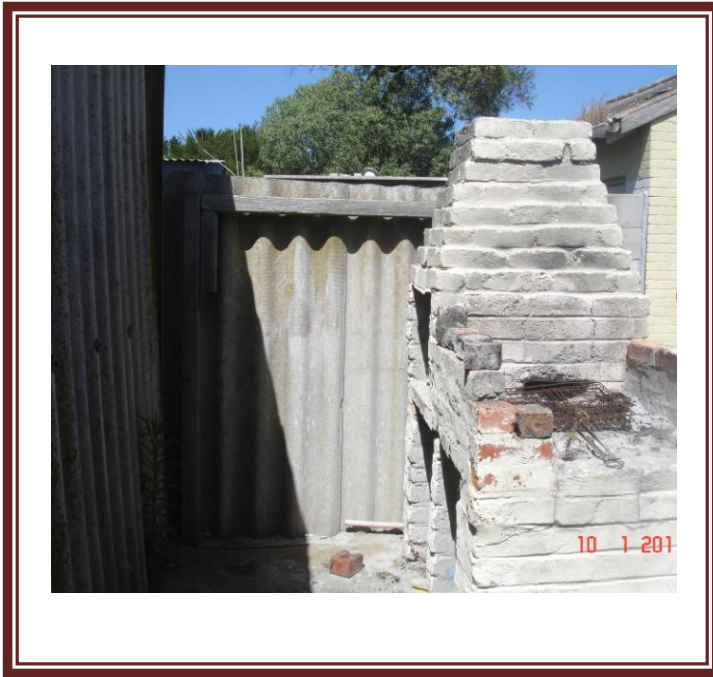
Fig.6.15. Brick braai.

A braai was also built during the 1980's. An asbestos water tank stands on a clay brick plinth, with some of the bricks in a bad state of decay.
