HERITAGE STATEMENT HOUSES NUMBERED 35, 36 AND 37 CHURCH STREET ROBBEN ISLAND

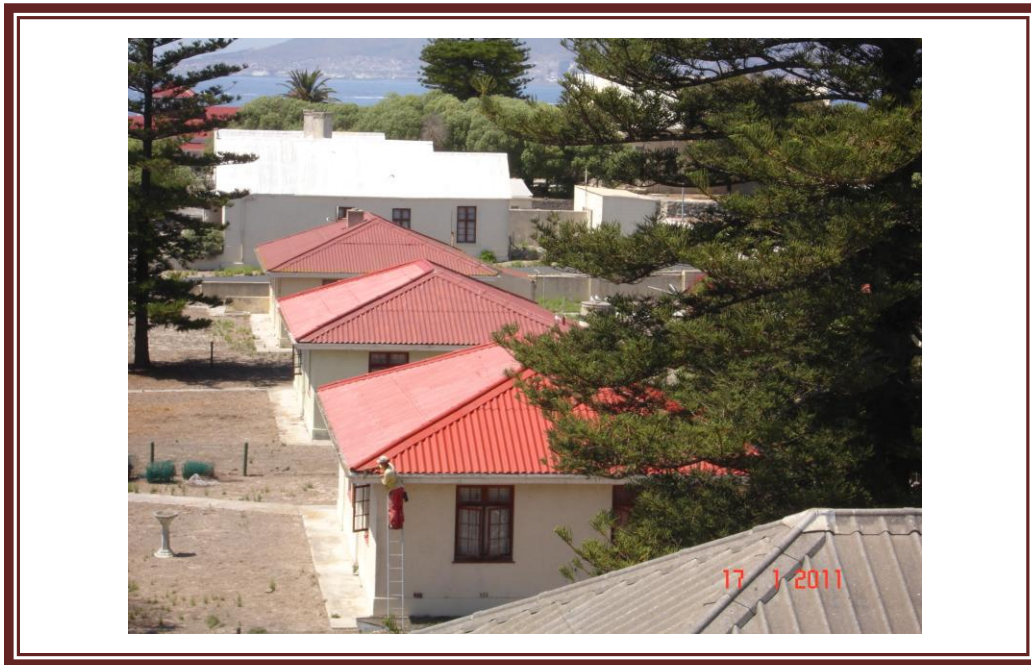
Three simple squares, asbestos roofing, gutters, water tanks and down pipes. Only no 35 retains its original chimney, the other two having been removed. All three still have there faux granite fireplaces. Wooden window frames, except for enclosed verandahs which are later steel. The masonry square above each front door that was used for the military ‘T’ numbering system is on the inside of the enclosed verandah. Each has a boundary wall added later and each wall has a different decorative finish. Each also has separate servant’s quarters. Two large pine trees, at house 35 and at house 38 are also present.

Fig.5.1. View from Church tower facing south.
