ROBBEN ISLAND MUSEUM OLD POWER STATION

PRELIMINARY REPORT No. 1: ARCHITECTURAL DESCRIPTION AND STATE OF CONSERVATION.

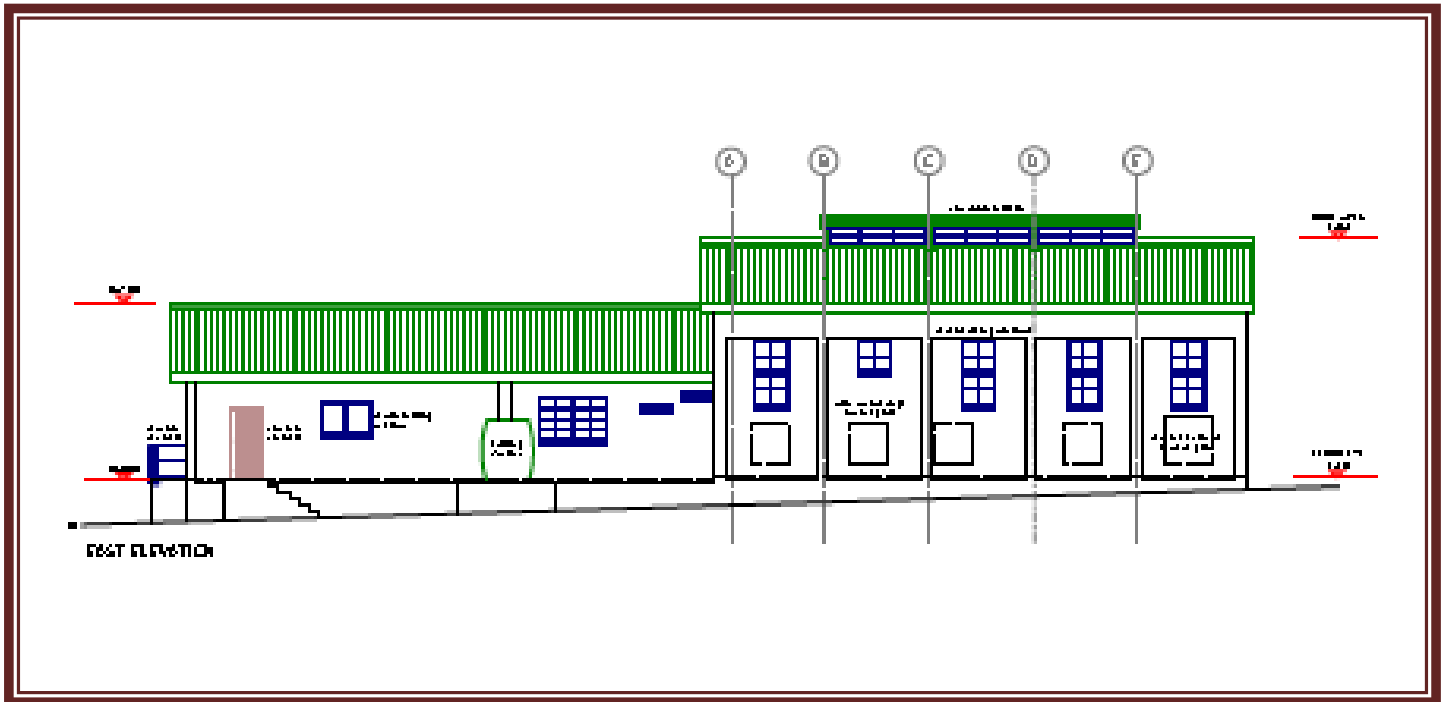
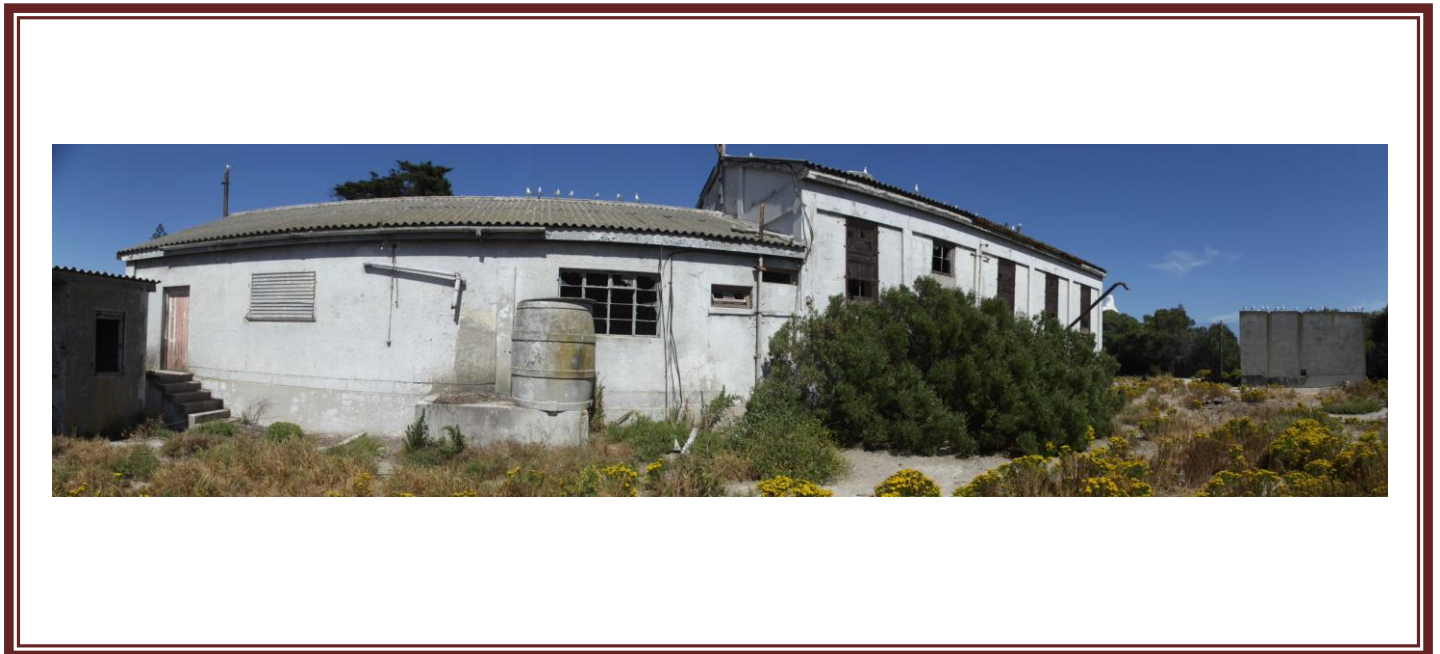
No visible holes in corrugated asbestos sheeting on both main building and extension. Asbestos airflow to south of main building in good condition. A mounting for a siren erected in ca 1967 is situated on the gable end of the southern wall of the main building.

A very rusted outside light fitting and conduit is still visible and not worth saving as is.

Oregon pine wood fascia on main building in poor condition. Extension has asbestos fascia in reasonable condition.

Six cast concrete pillars, one on the NE corner, one on the SE corner and 4 more between each corner support a concrete beam. Appears to have yellowish soft clay brick infill between pillars. Splatter plaster is peeling in some places, mostly where later alterations were made. Two holes approximately 25 centimetres in diameter can be seen in sections C and D. These are later alterations to allow for similar stainless steel exhaust pipes as can be seen coming out of window in section B.

Two cast concrete pillars, one on SE corner and one approximately two thirds of the way from corner to SE corner of main building. SE corner spalling badly. Section A appears to be an earlier extension to the main building than section B and consists of Robben Island type Breeze blocks between the pillars. These blocks are made from sand, seashells with some Portland cement added. Splatter plaster in relatively good condition apart from the edges with the pillars and the plinth where a definite crack separates the infill from the pillars.

Originally had 4 rectangular windows withbetween each pillar centrally placed. Frames made of wood [meranti] and appear to be in a salvagable condition. One was cut in half with later alterations and the half was bricked up. One was altered to allow a stainless steel exhaust pipe [approximate diameter 25 centimetres] to the outside for machinery that was installed later. What appears to be original steel mesh covers 3 of the windows. These have shielded the frames and some of the glass panes to some extent. Lower openings cut into original walls below windows to allow for cooling ducts for Rolls Royce twinset generators in ca 1972. Grills originally over these openings are no longer extant.

Built from Robben Island breeze blocks. Splatter plaster. Peeling in various places, especially where plinth meets walls

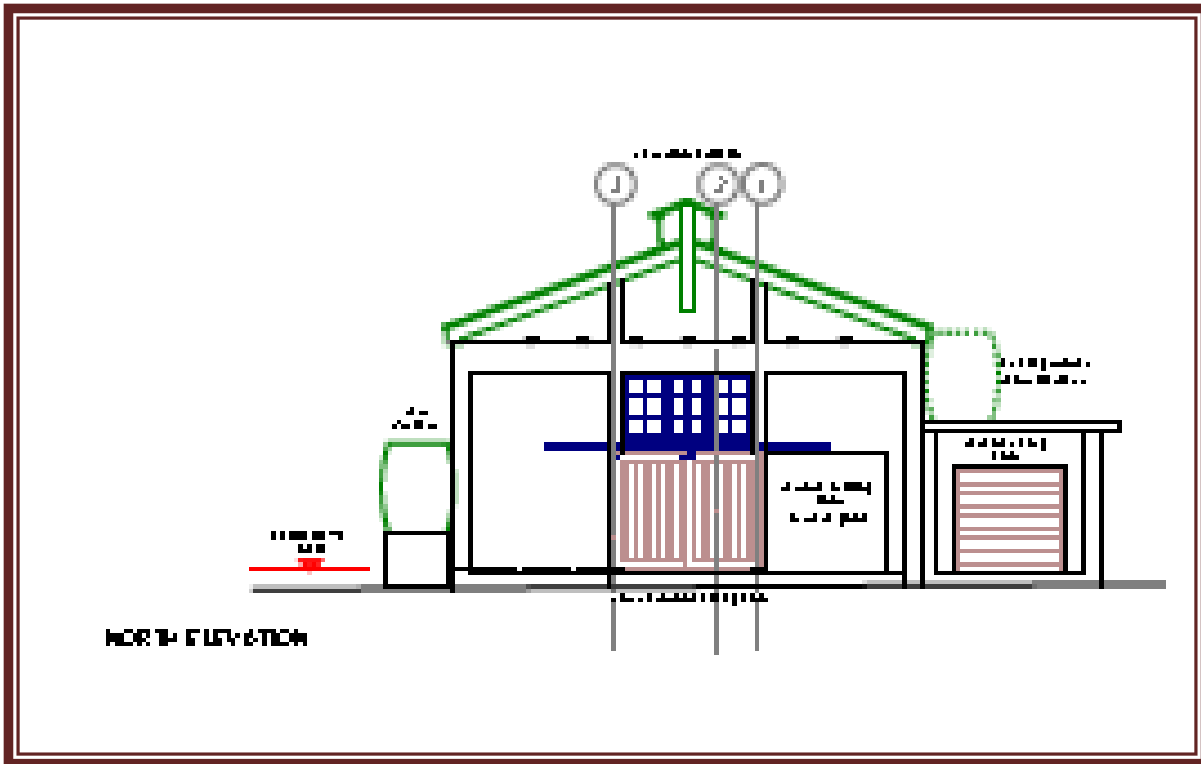
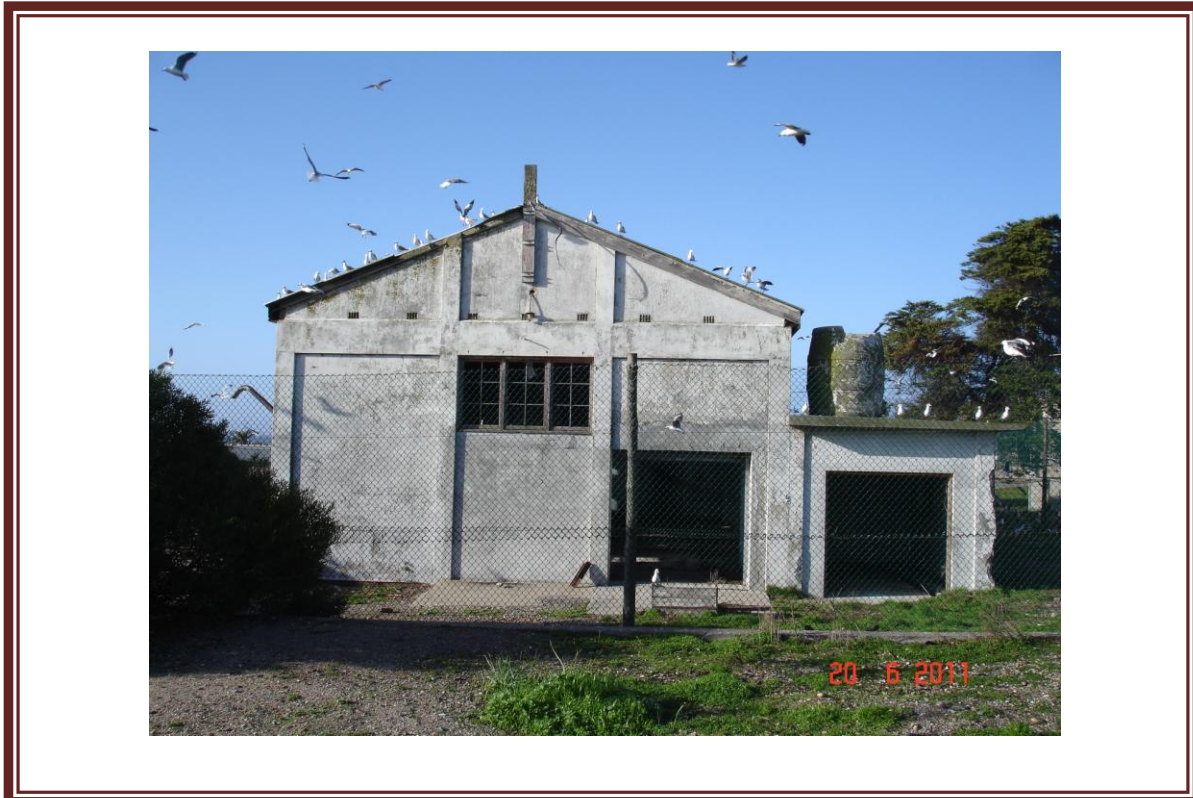
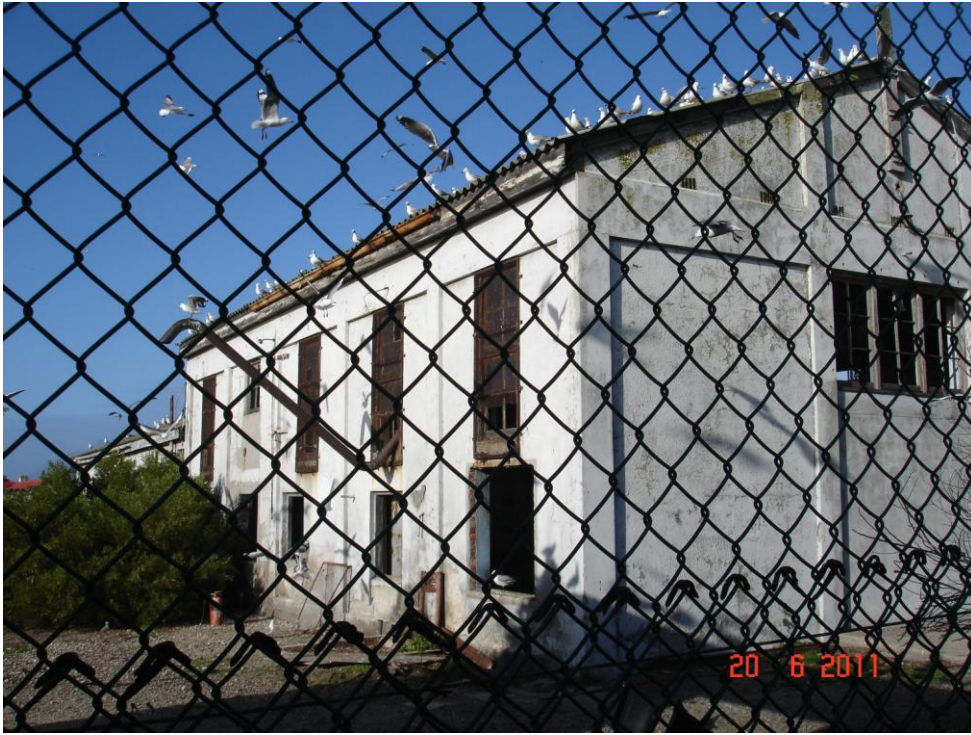
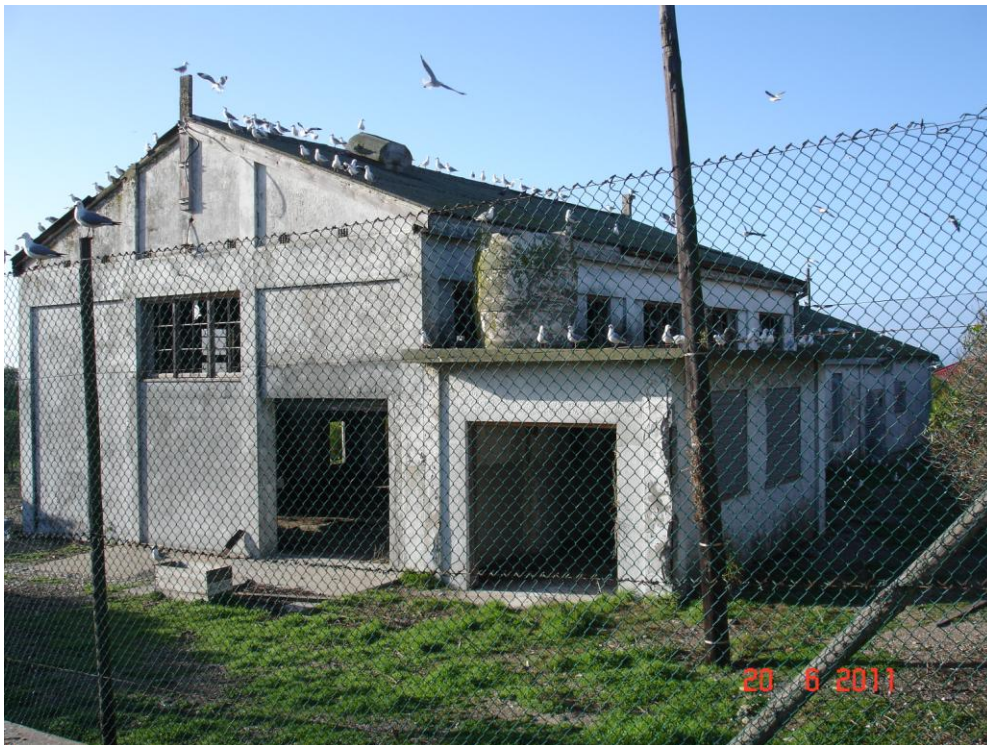
The north elevation was the original entrance to the main building. The door was placed centrally below the window. The current door opening on the NW corner was made in the 1970's. The smaller extension and door opening on the NW corner was also erected in the 1970's to house the new transformer when the Rolls Royce generator sets replaced older machinery.

The fascia on the eastern half is no longer extant. The fascia on the western half is in poor condition and may need to be replaced. The transformer room has a cast concrete roof in reasonable condition on the north elevation. A wooden upright completes the gable. The upright may have been the original start to the overhead power line system. This appears to be in good condition.

Plaster is in reasonable condition. Cast concrete pillars of the main building are in a reasonable condition. The pillars of the transformer room are spalling badly on the NW corner. The air bricks are evenly spaced and in good condition.

Window frames are Meranti. The wood on the exterior is in a very poor condition and the whole frame may need to be replaced. No glass panes extant.

The old main door ramp is still visible. A ramp is also at the later door of the main building and the entrance to the transformer room. A very rusted exterior light fitting is still visible. An asbestos water tank is on top of the transformer room roof and in poor condition.

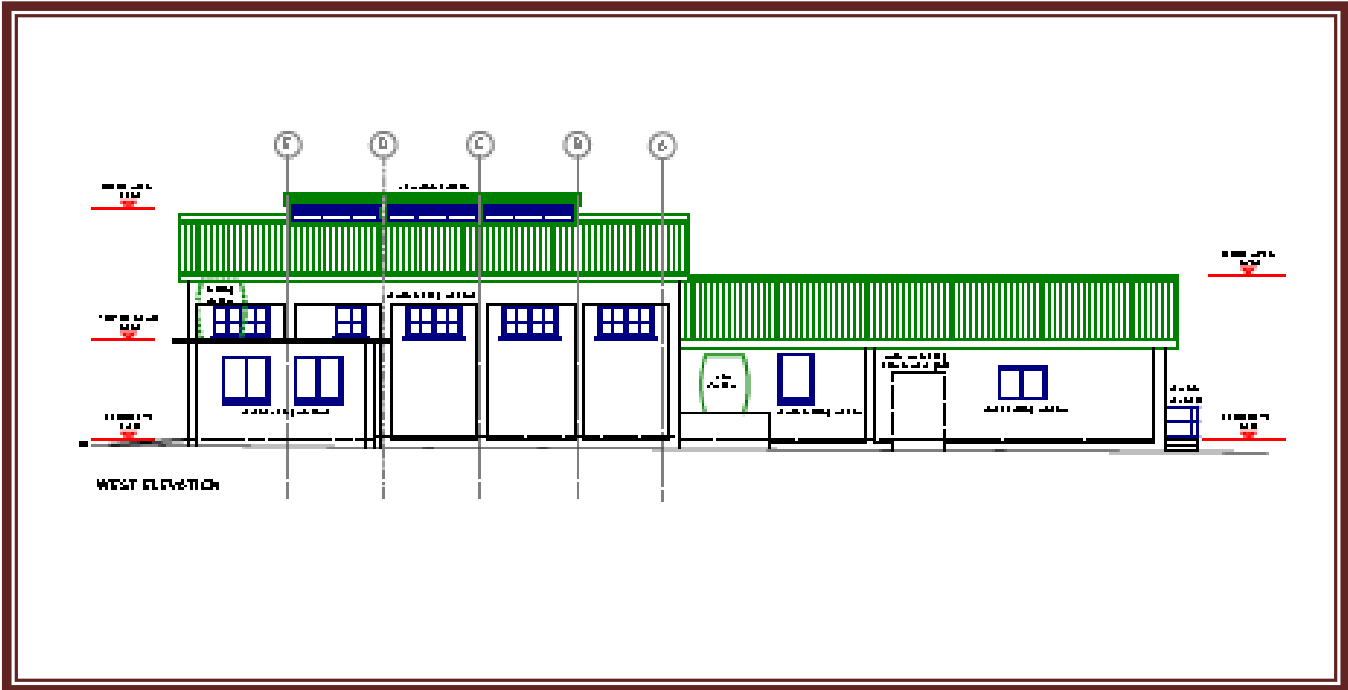
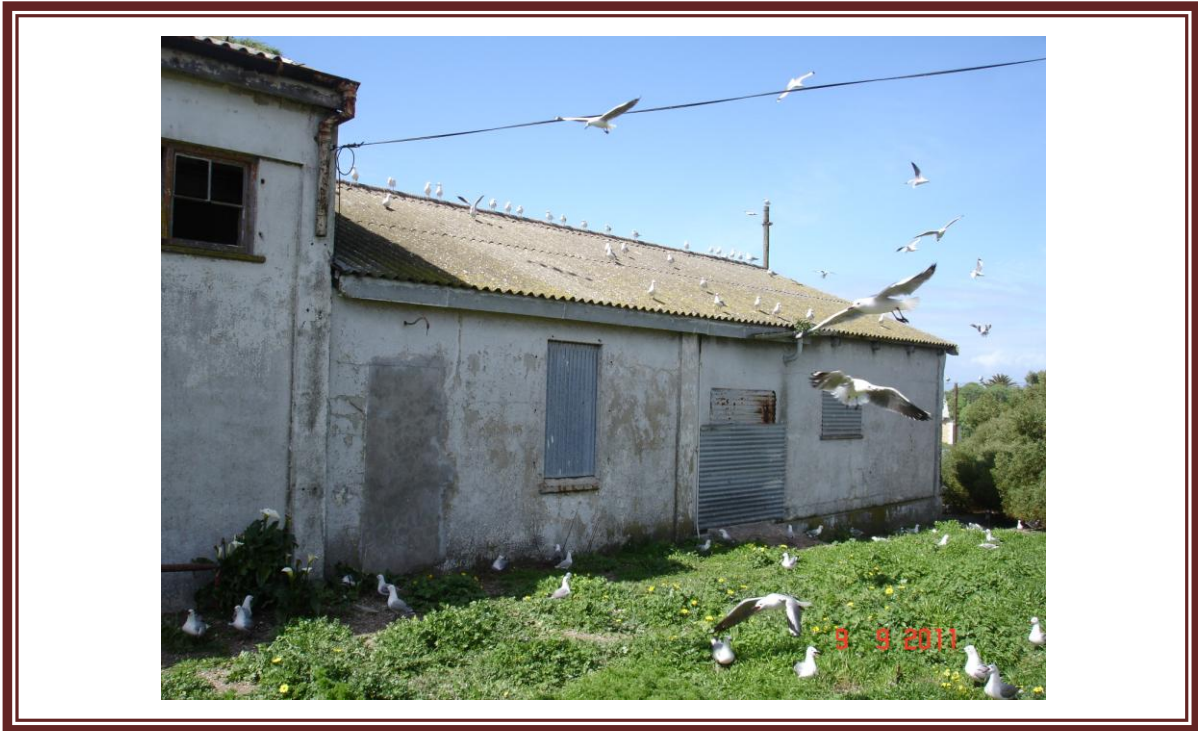
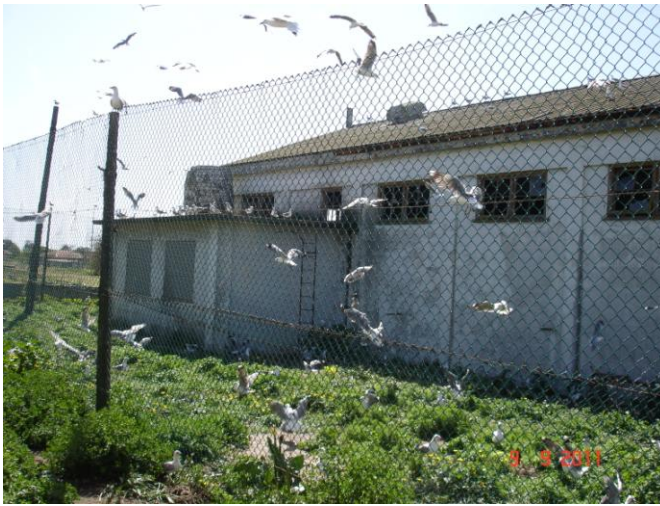
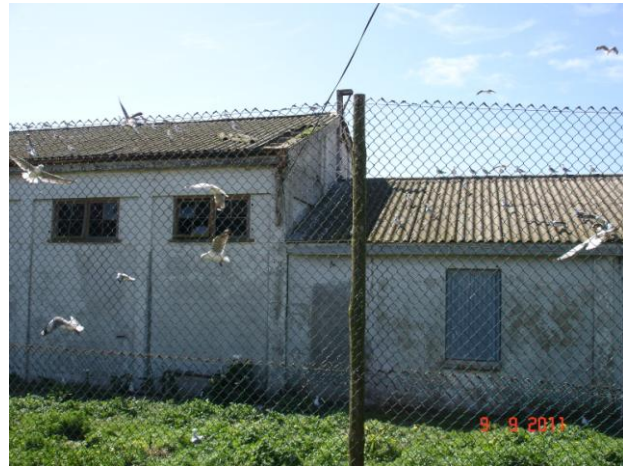
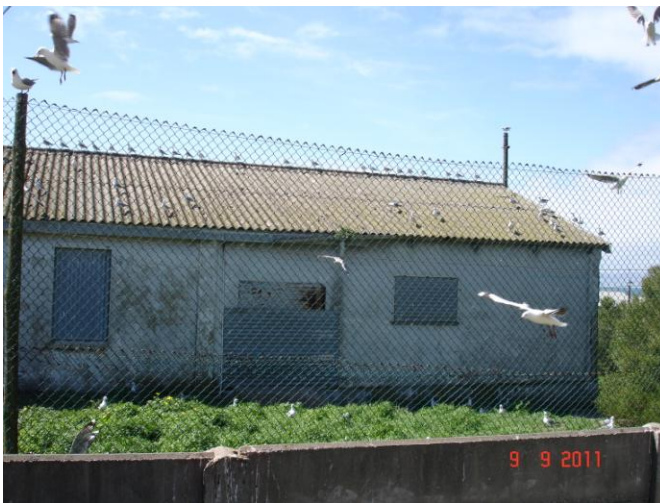
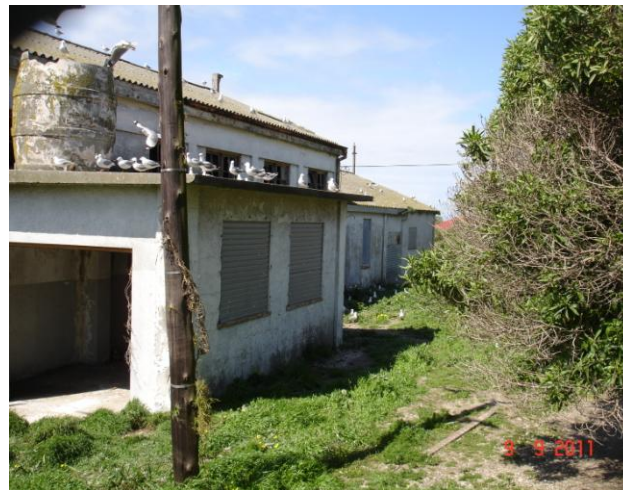
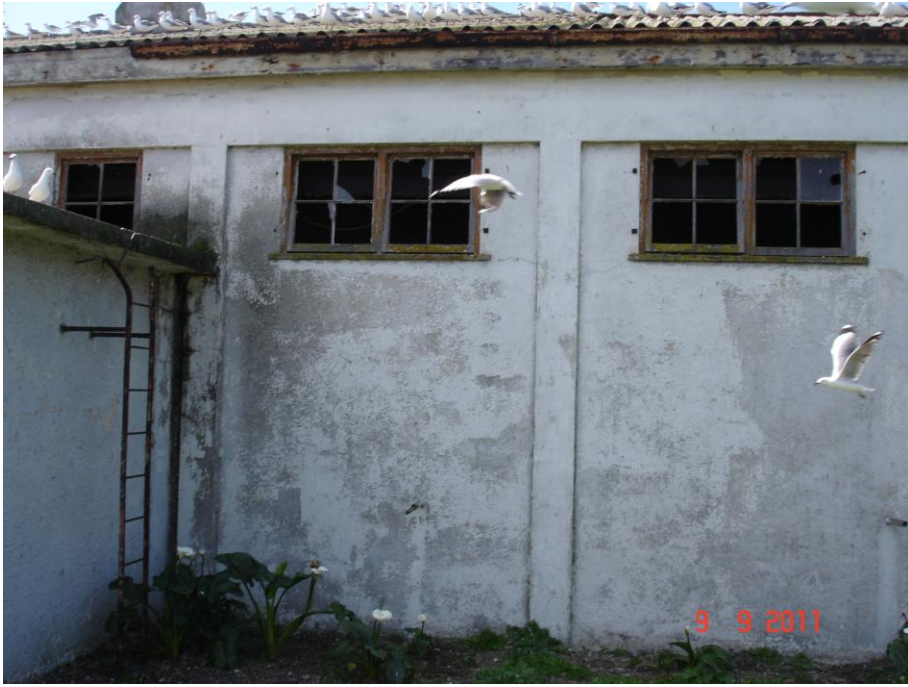
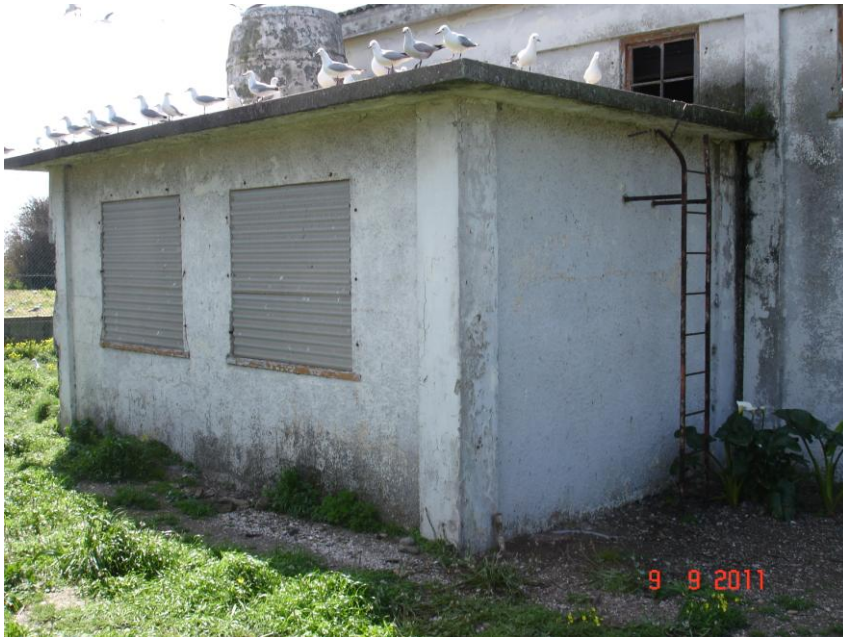
Cast concrete roof and plinth in good condition.

Plaster and cast concrete pillars in reasonable condition. SW corner pillar starting to show cracking. Iron ladder to roof rusted and in very poor condition.

Boarded up but no glass panes. Wood combination meranti on window sill and Oregon pine in frames. Some slats of panes missing.

Consists of corrugated asbestos sheeting in reasonable condition. SW corner sheet broken. Asbestos roof vents appear to be in reasonable condition.

A section of the original cast iron guttering rusted but still extant from sections A to D. No or very small pieces of downpipes visible.

Splatter plaster appears to be in good condition. Paint work in poor condition .

The original position planned for the row of windows was on the lower level below the gallery floor level. This appears to have been changed to above the gallery floor level in the tracing of 1963. Window frames meranti appear to be in good condition. SW corner [section A] window frame lower strut missing. Two or three glass panes extant.

Steel pipe fire bucket holder situated outside at section A on SW corner rusted and deteriorated beyond salvage.

Corrugated asbestos sheeting appears to be in reasonable condition.

Plaster part splatter part smooth in reasonable condition although there is some cracking. Paint in poor condition. Cast concrete column separating section A and B appears to be in good condition

Plinth and foundations only partially visible on SW corner appear to be in reasonable condition.
