ROBBEN ISLAND MUSEUM: OLD POWER STATION

REPORT No.4: REINSTATEMENT, RETENTION, REMOVAL, REPLACEMENT AND MODIFICATION OF HISTORIC FABRIC

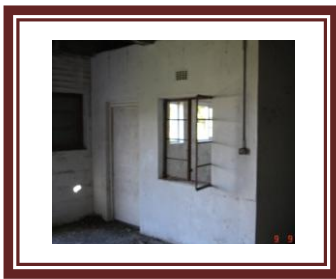
Fig.41. Office

A number of internal walls inside the extension to the main building will be removed. The walls represent two distinct periods, *circa* 1980's and *circa* 1950's. Where appropriate their positions should be interpreted on the floor, walls and ceiling. Samples from the removed bricks must be labeled with source and handed to RIM. Removed doors with frames and windows to be offered to RIM and only disposed of by the contractor if RIM declines them.

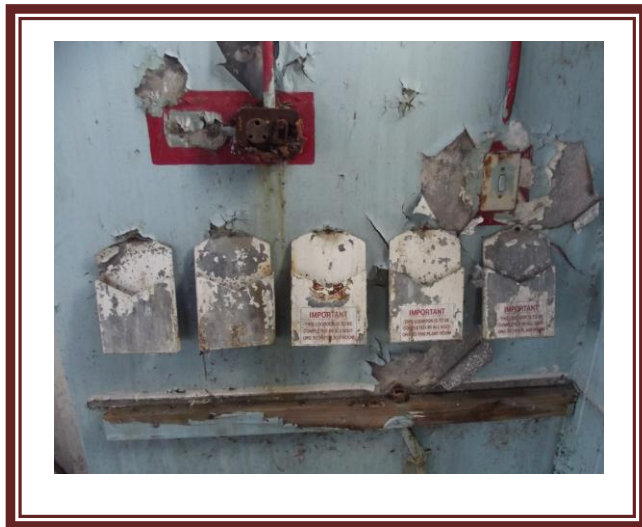
Fig.51. Log book holders

These have already been removed by RIM.
