ROBBEN ISLAND MAXIMUM SECURITY PRISON 'A' SECTION: URGENT REQUIREMENT FOR REMEDIAL ACTION TO CONSERVE THE TANGIBLE FABRIC

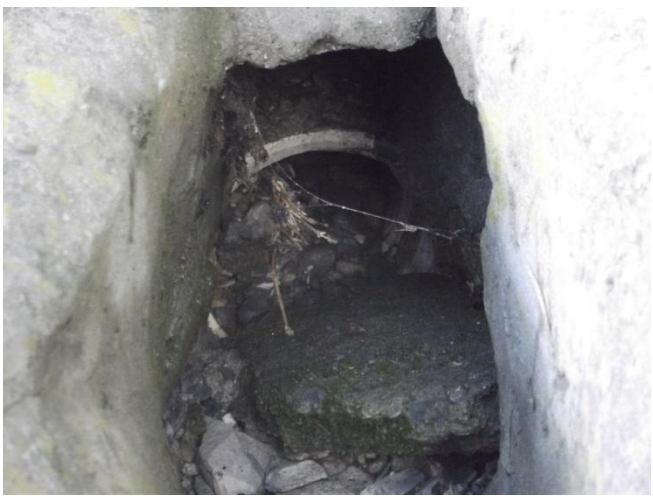
6555

Down pipes on the western and southern side sides have no runoff and water seeps straight into the soils adjacent to the walls. This may be one of the causes of the damp outside and inside the walls. Longer term remedial action requires the installation of water channels. While this may affect the authenticity of the elements the longer term conservation of the fabric must be considered. [see images 6553, 6554, 6555]

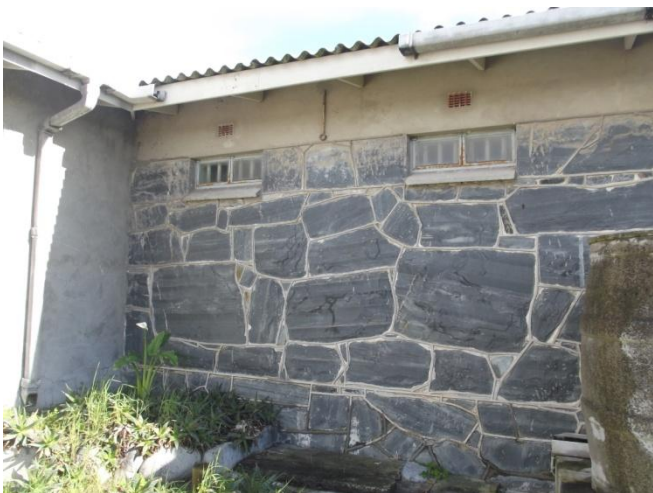
A number of windows have rusted and seized in place in the open position. See images 5932 for the recreation area, 6568 and 6569 for cell windows.
