YOUR REF.: WCS: 045965
OUR REF.: 2023-Architectural Report-
Newcastle Justice Complex

4 August, 2023

WCS: 045965: NEWCASTLE JUSTICE: HERITAGE BUILDINGS: ARCHITECTURAL REPORT

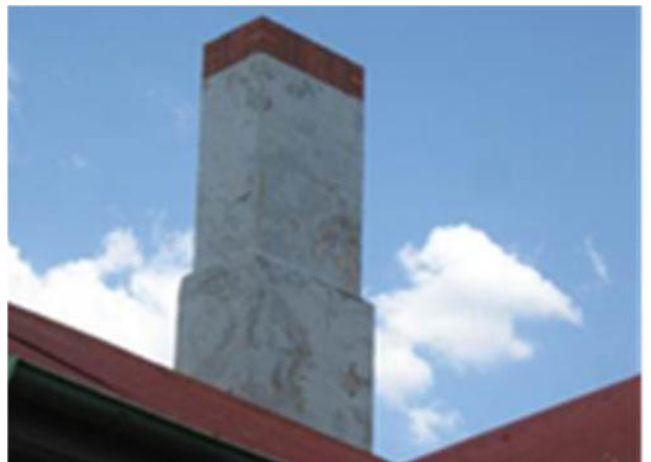
The chimneys are structurally sound and will only need a good service, sand down and new coat of paint.

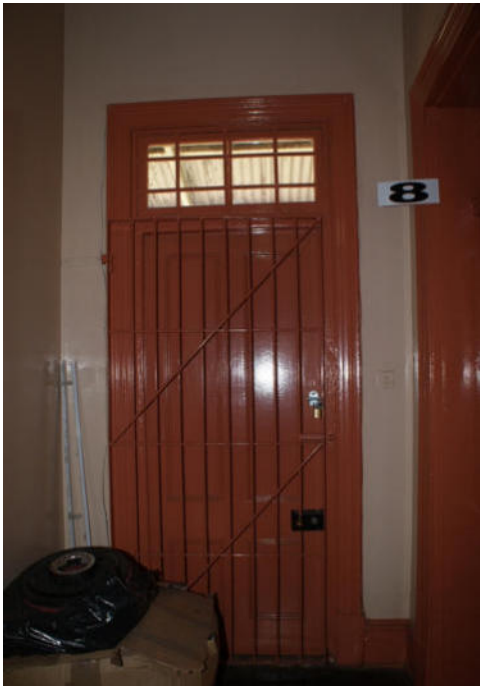
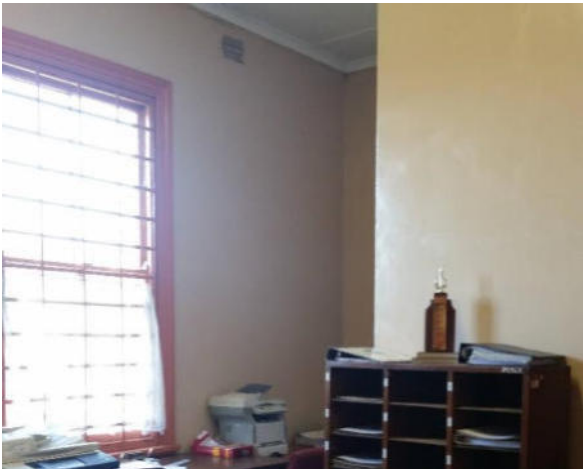
The position for the proposed toilet for the Magistrates Office is in the passage with new access directly from the Magistrates Office to the left of the photo.

The front door will be removed and replaced with a new window, to match existing.

The door to the right of the photo will be removed and the opening closed up.
