ROOM NO.4 - FIRST FLOOR (NORTH WING)		ROOM NAME - ROOM 4

PROJECT:
 Proposed alterations & refurbishment of the old Natal Command headquarters at 191 Snell Parade, Durban. battery beach , PTN 2 of 12696 durban

DRAWING TITLE:
 ROOM AND OFFICE DATA SHEETS

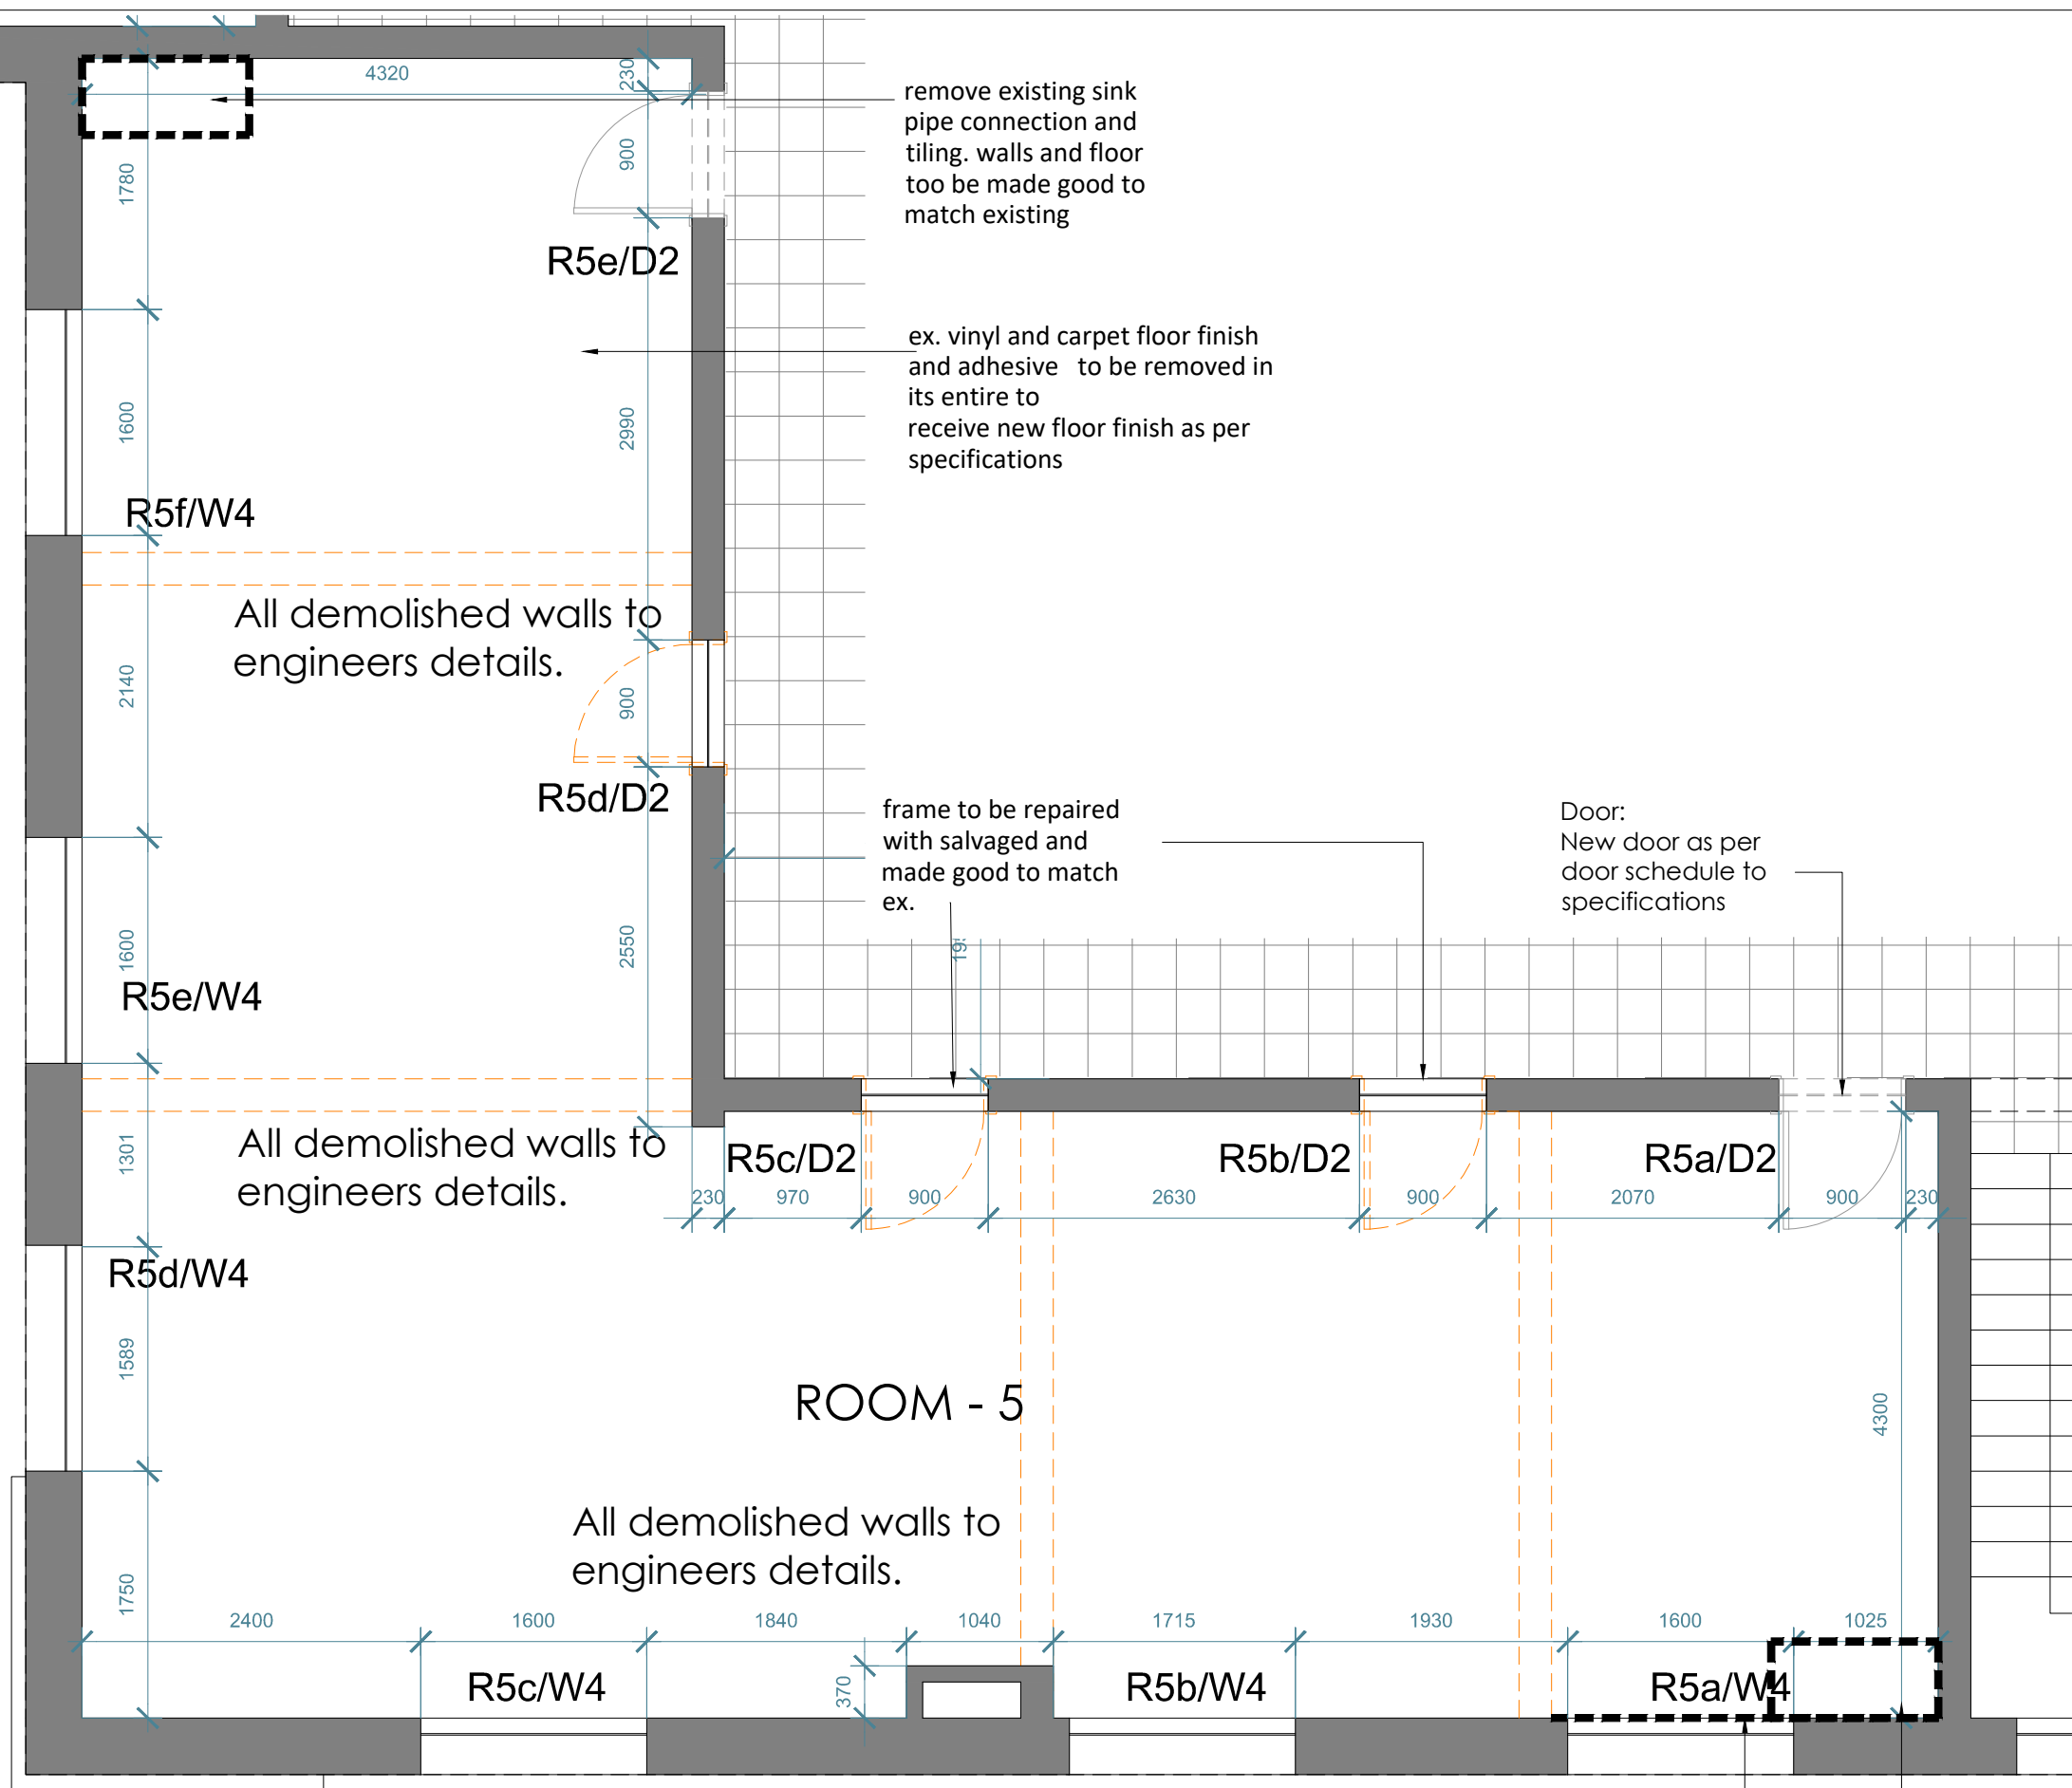
FLOOR FINISH	• ex. concrete floor, floor to be repaired and filled were required to receive new finish as per architects spec. - 14.54sqm
SKIRTING	• Skirting: Ex. skirting to be inspected for wood rot & water damage. Replace damaged skirting with salvaged. Sand, repair & seal as per specification
WALL FINISH	• Existing plaster & paint: - Walls to be scraped, treated, fill all imperfections. - Walls to receive new finish as per specifications
DADO RAILS	• Dado rail: Ex. dado rail to be inspected for wood rot & water damage. Replace damaged dado rails with salvaged. Sand, repair & seal as per specification.
CEILING	• 12mm plasterboard ceiling. sand down & apply plascon 2 coats high quality acrylic paint-colour as per specifications 75mm gypsum coved cornice - finish as per ceiling
WINDOW	• Existing Timber Window Frames: - Timber window frames to be inspected for wood rot and water damage. - Affected mullions to be removed and replaces to match. - All damage and broken glass to be replaced with 6mm toughened safety glass as per sans 10400 Part N or equally approved my specialist - Window hinges to be replaced with brass type hinge and secured with brass screws as per schedule Window handles: Window handles to be replaced with brass type handles to match existing and fixed with brass screws as per schedule Windowsill : - Windowsill to be inspected for damage ,and replaced were required - Affected sills to be removed and replaces to match.

DOOR	• Timber door frames to be inspected for wood rot and water damage. door frames to be repaired with salvaged and made good to match ex. Doors: Refer to door detail
