December 2009

**MATLA COAL LIMITED**

# **Matla Colliery Mine 2: Development of Rehabilitation Measures for Panels 6, 7 and 8**

**Report Number:** 11978-9326-1

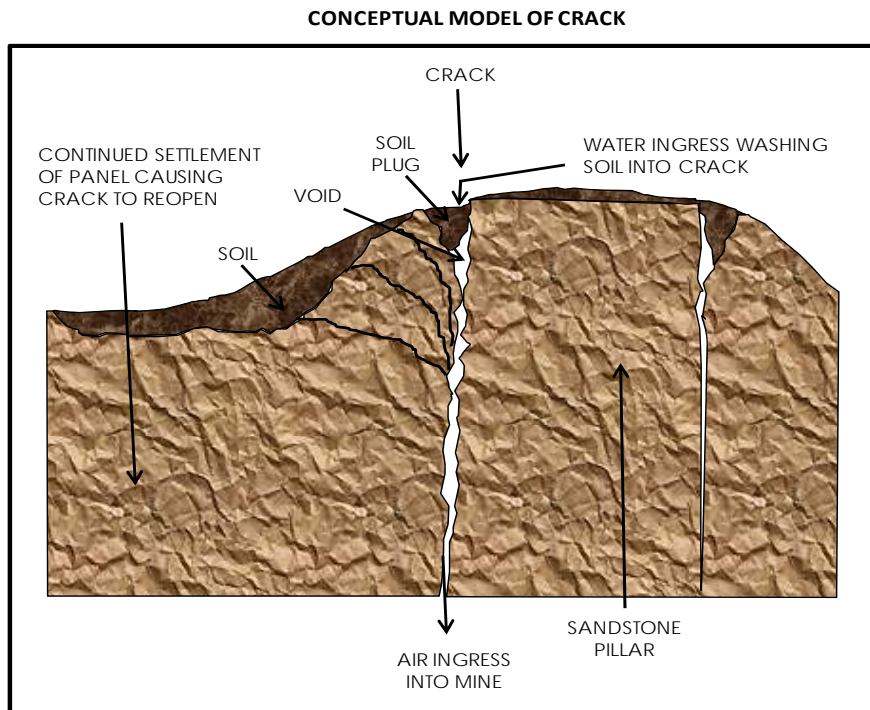
Figure 1: Conceptual model presenting drivers for continued crack formation

- Continued settlement of the goaf area causing further cracking;
- Occurrence of voids below backfill material pushed into cracks. Backfill material collapses or is washed into voids as backfill material settles and further cracking occurs; and
- Runoff from pillar portions collect in slight depressions caused by the crack resulting in the soil to becoming less consistent and then being washed into cracks.

These drivers are presented in a conceptual model in Figure 1. Figure 2 presents a photograph of a crack where fill material has fallen into the void as a result of continued settling and lack of support below the fill material. Figure 3 presents a photograph of where the crack has opened as a result of water ingress into the crack. Figure 4 shows the pooling of water in the slight depression of the crack which in time will wash the fill material down the crack and opening it. Figure 5 shows an aerial view of cracks that have been washed open. Lateral cracks in the geological material also occur but these have been successfully covered through the movement of soil.
