Structural Assessment: 24 Parry Road

Client: Homii

28 April 2022

Project number	220403			
Report number	220403-A-RPT-001			
Internal report No.	220403-A-RPT-001

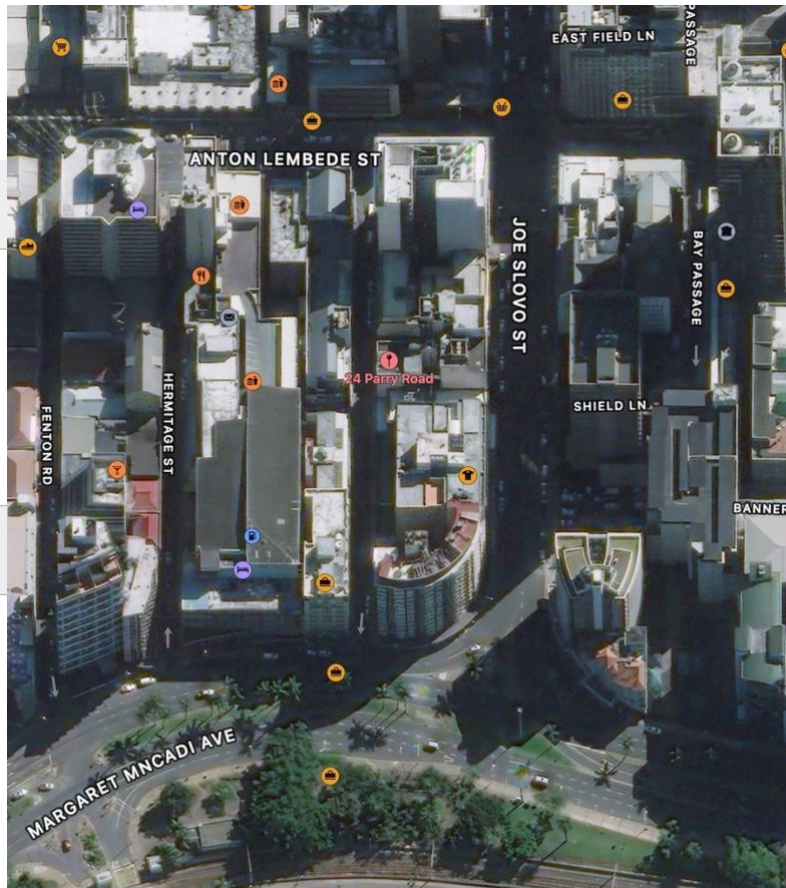
Figure 2: Building location

The building is located on Parry Road which is a narrow street located off Anton Lembede Street in the Durban CBD. The structure is flanked on either side by multi-story buildings with a direct entrance to the road level. The building is listed as a heritage building and has been left derelict for a considerable amount of time.
