# BRAMIN

13 July 2022  
Our Ref: 22631

**DESCRIPTION OF WORK** : **STRUCTURAL REPORT TO EXISTING BUILDING**  
**ADDRESS** : **ERF 6325 DURBAN,  
26 CLARK ROAD,  
BULWER.**

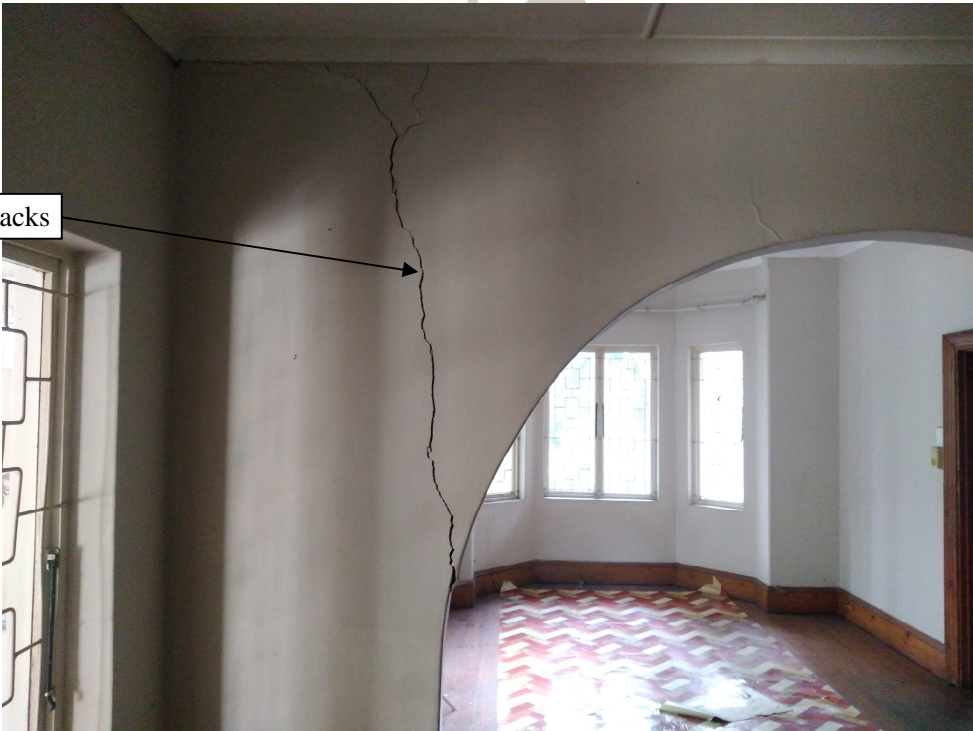
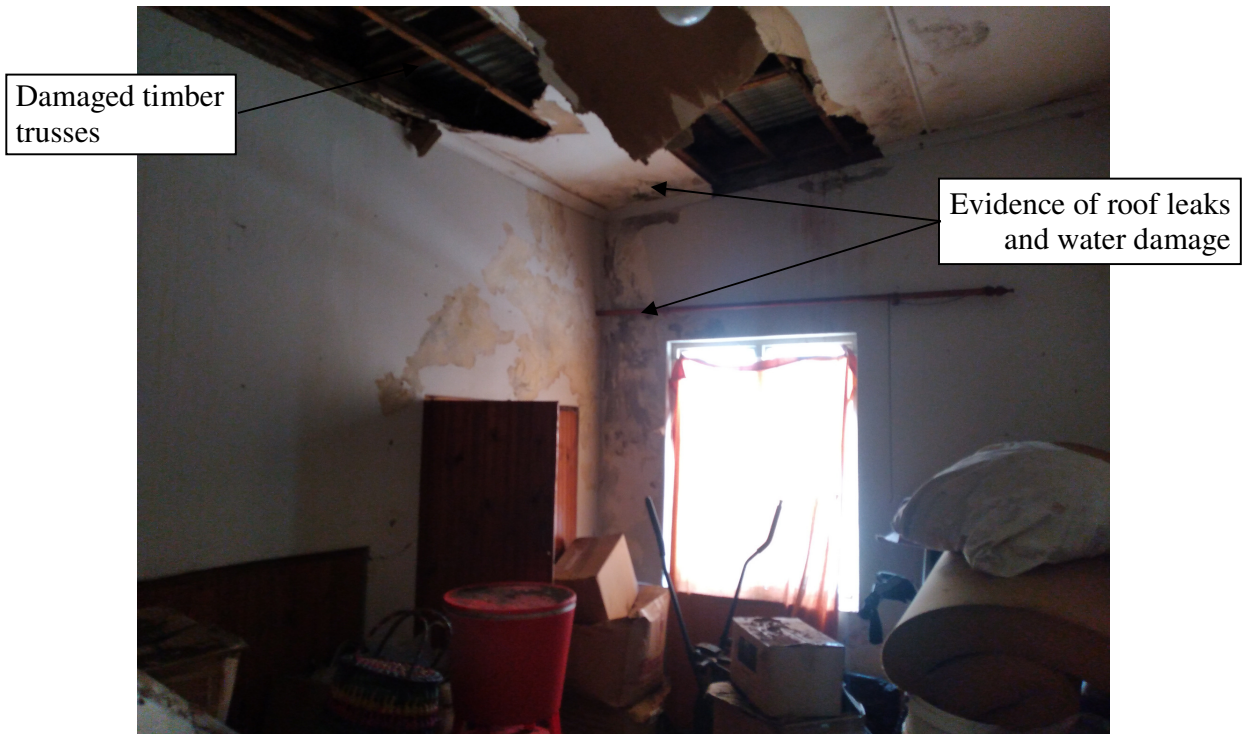
- The building is a double storey structure which stands unoccupied.
- The building is constructed with clay brick masonry units and timber truss with concrete roof tiles.
- The internal ground storey is supported by stilts and beams, the first floor is supported by a timber deck.
- Settlement is occurring to both external and internal walls as visible cracking had been noted.
- The flooring to the building is a timber structure, voided below. Signs of woodborer were noted as well as signs of rotting timber due to be wet/damp.
- The timber used to support the roof structure does not comply with our current regulations. Areas of concern were noted with regards to woodborer.
- There seems to be an ingress of water via the damaged roof structure.
- Gutters and downpipes are damaged, showing no stormwater control.

- The building does not comply with current regulation.
- Roof structure is required to be removed and replaced.
- Flooring is required to be removed and replaced.
- Foundation is to be underpinned, preferable removed and replaced.
- Stormwater management is to be put into place.
- The above clearly highlights the need for the structure to be demolished for a new development.

**THIS BUILDING IS STRUCTURALLY UNSTABLE AND SHOULD BE DEMOLISHED**
