230 CURRIE RD DARD REPAIRS & RENOVATIONS DURBAN

DESIGN, PROJECT MANAGEMENT & CONSTRUCTION OF DEPARTMENT OF AGRICULTURE & RURAL DEVELOPMENT RESTORATION PROJECT

SITE INSPECTION REPORT

CIVIL AND STRUCTURAL WORKS

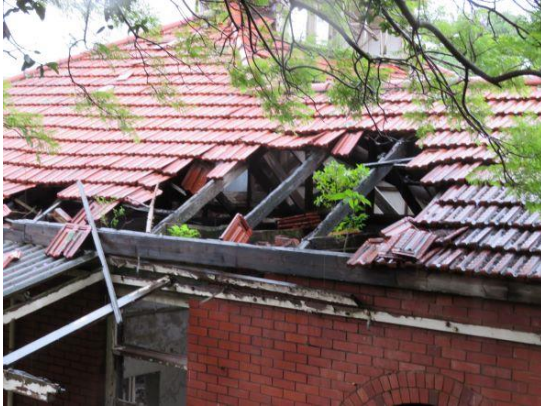
The timber roof structures and coverings for the building have largely collapsed due to decay and rotting of the structure. See photos 1 to 4.

Photo 1: Collapsing Roof Structure

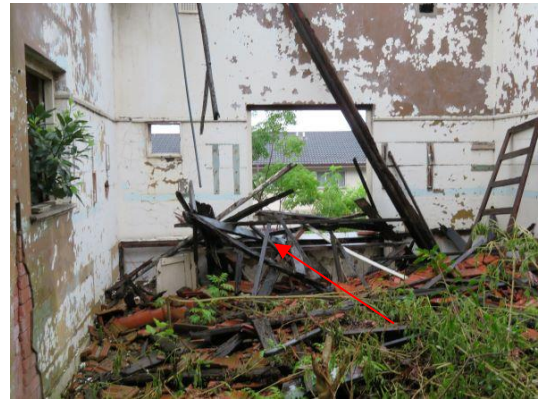
Photo 4: Collapsed Roof Structure Debris

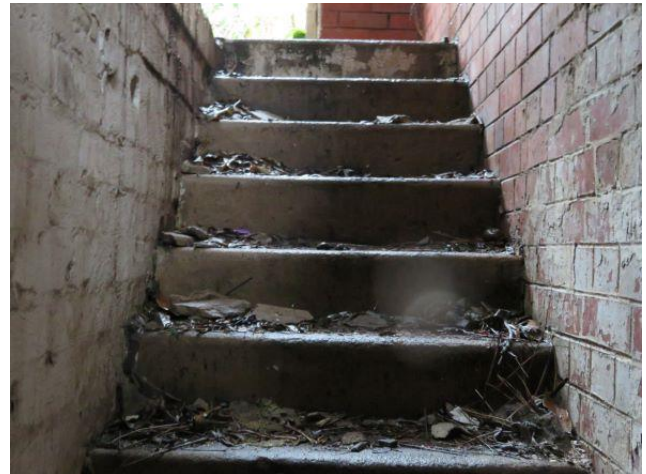
Photo 22: Stairs to Basement

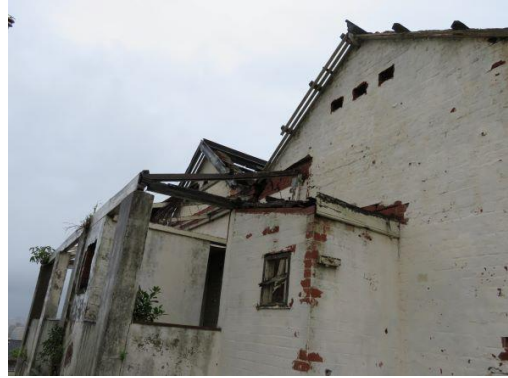
The roof coverings for the building are non-existent leaving the entire structure exposed to inclement weather for extended period of time. Timber roof structures are collapsing due to decay and rotting of the timber. See photos 25 to 28.

Photo 26: Collapsing Roof Structure

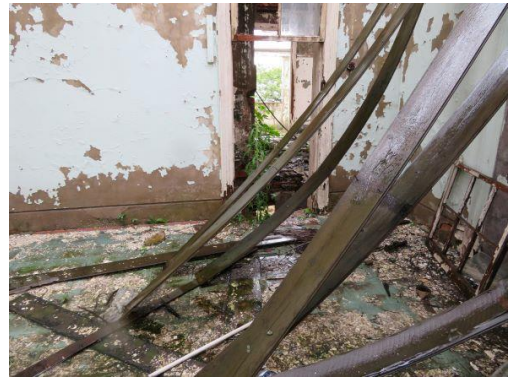
Photo 28: Collapsing Roof Structure Debris

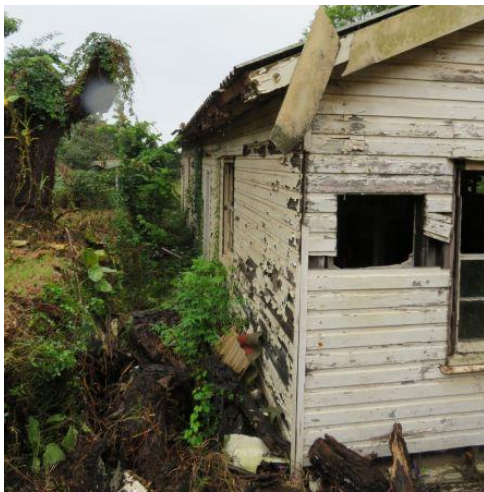
This is a temporary timber structure that is also in a very poor condition. See photos 55 to 60. The defects mainly relate to decay and rotting of the timber. The roof covering is of asbestos material hence a health hazard.

Photo 57: Front View of Building (Note no retaining wall provided)

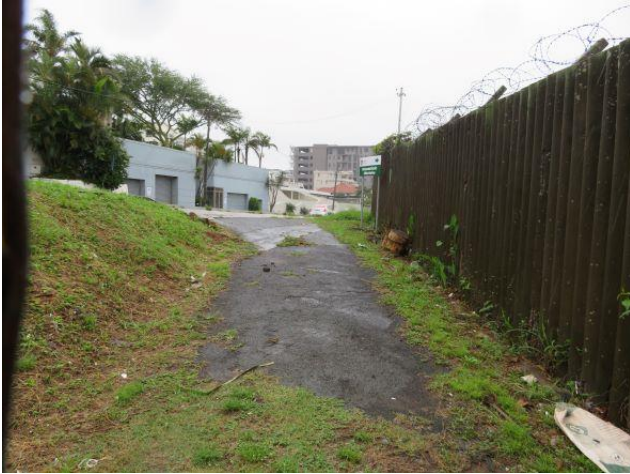
The tarred driveway that links both access gates is showing signs of surface failure with numerous crocodile cracks. There is vegetation growth on the road due to lack of maintenance of the road. See photos 61 to 64.

Photo 61: View of Driveway from the Main Gate

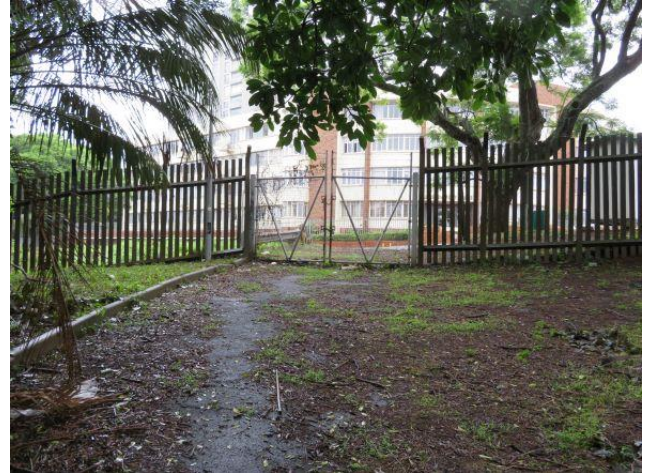
Photo 62: View of Driveway from Gate 2

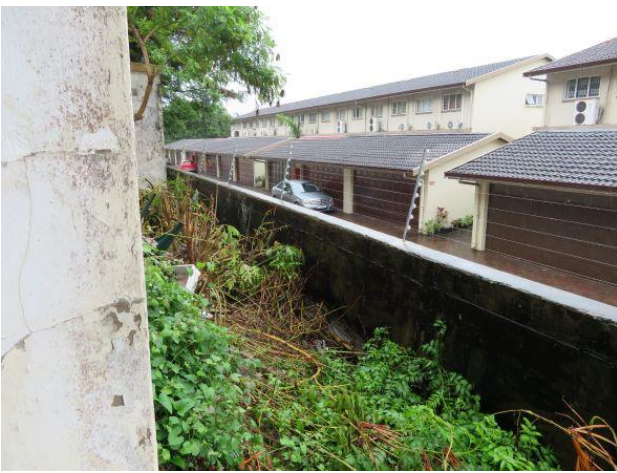
Photo 69: Retaining wall at the lower boundary of the site
