1. INTRODUCTION

**Jagersfontein Developments
Underground Recce No1 and 2 M.R.S.
Shaft
Final Report**

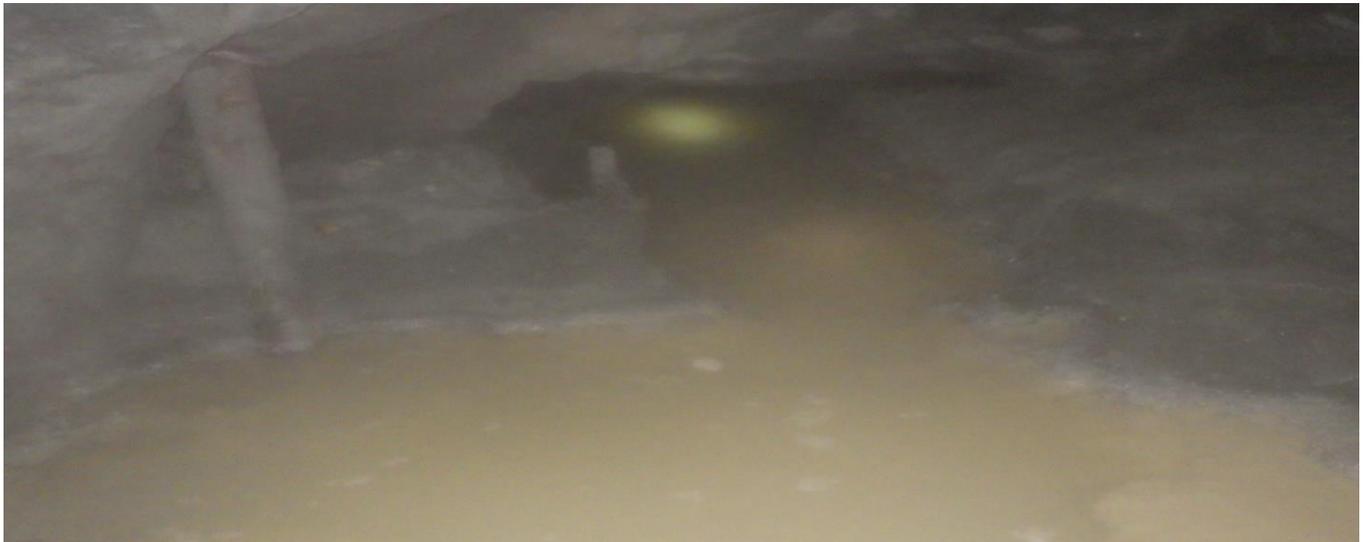
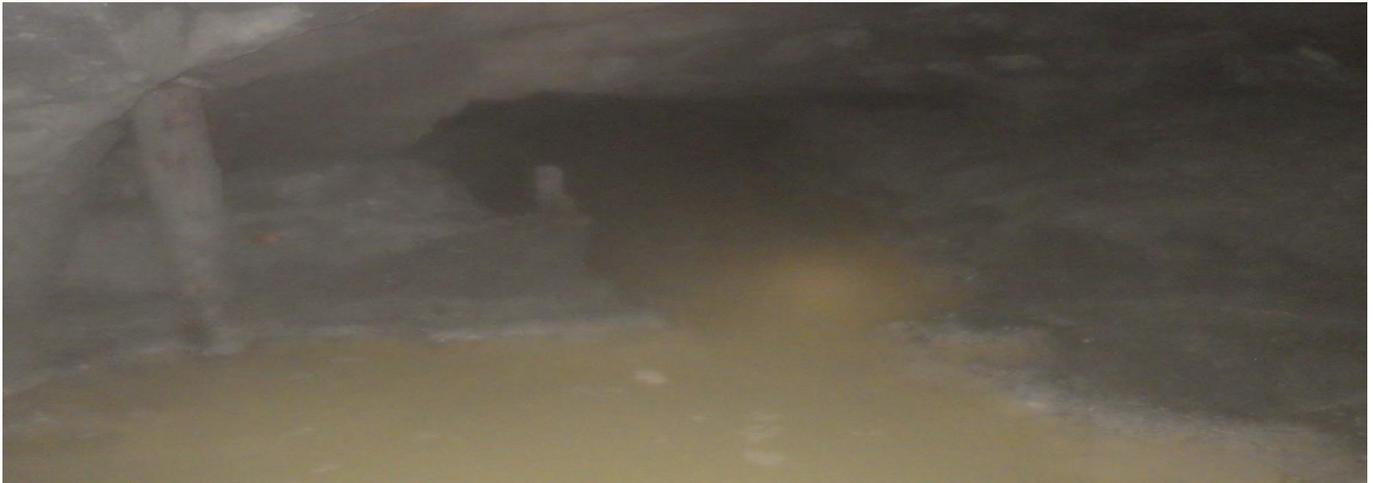
This picture is of 154 Level over run at the 34 degree incline towards the pit. Hand lashing must be conducted at this position to be able to get to the access point.

Water was intersected and a spindle pump was used to remove the water . We managed to dig a trench for access as indicated above.

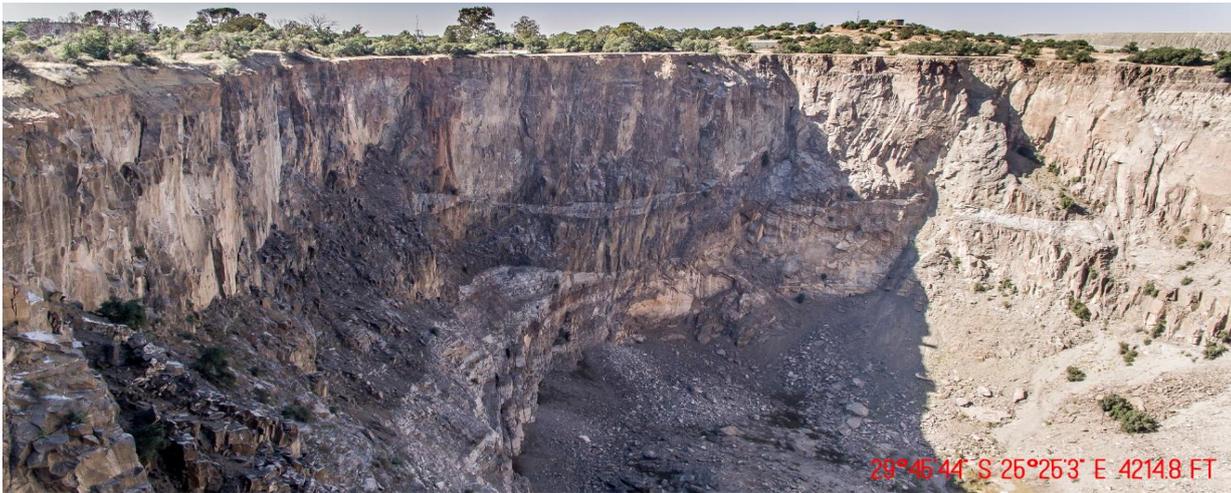
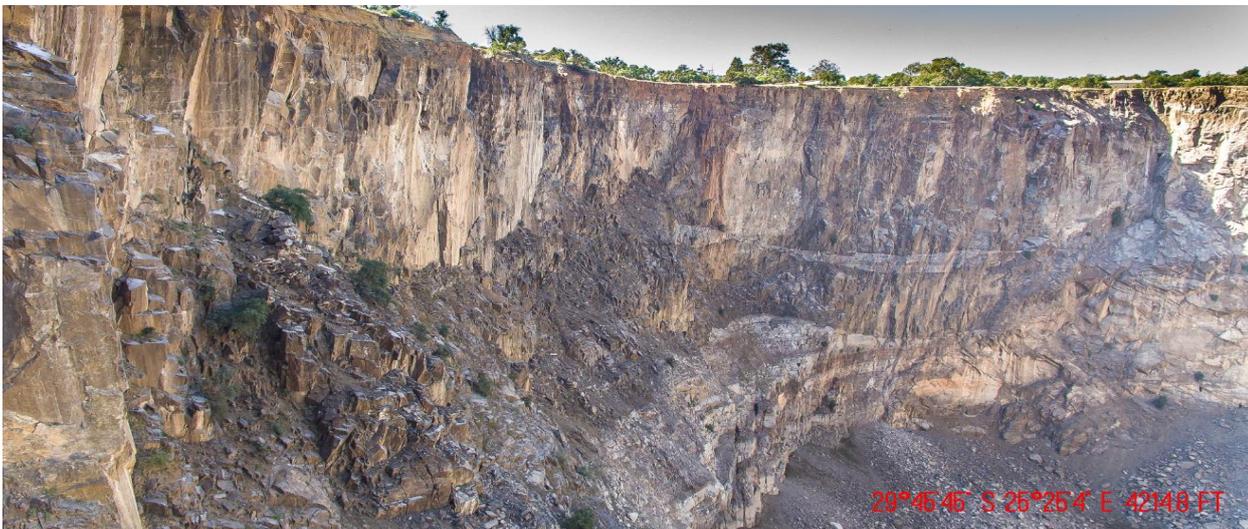
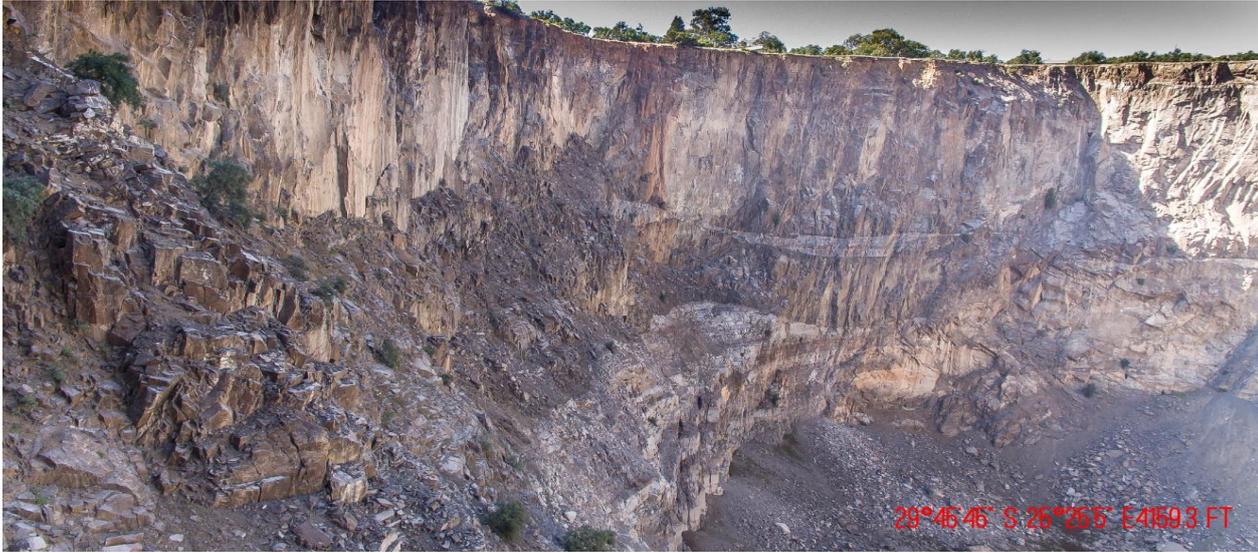
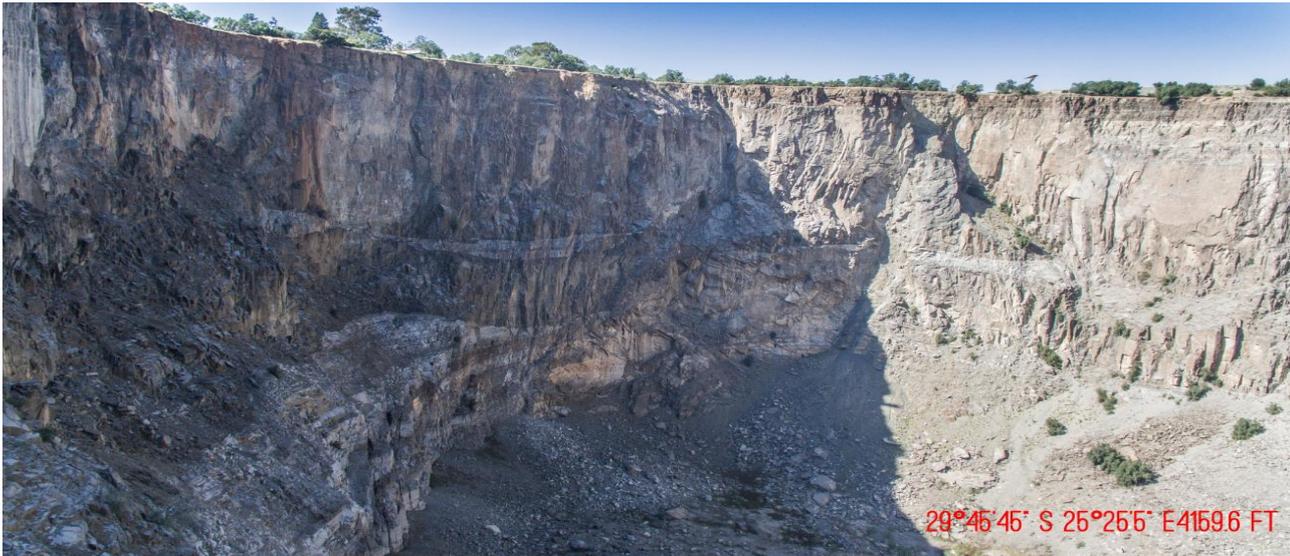
We took several photos with a drone and also made a video. It is clear that there is no opening or plug visible in the pit. The side walls caved in thru the years and that made it impossible for us to see the plugs or the condition of the plugs.

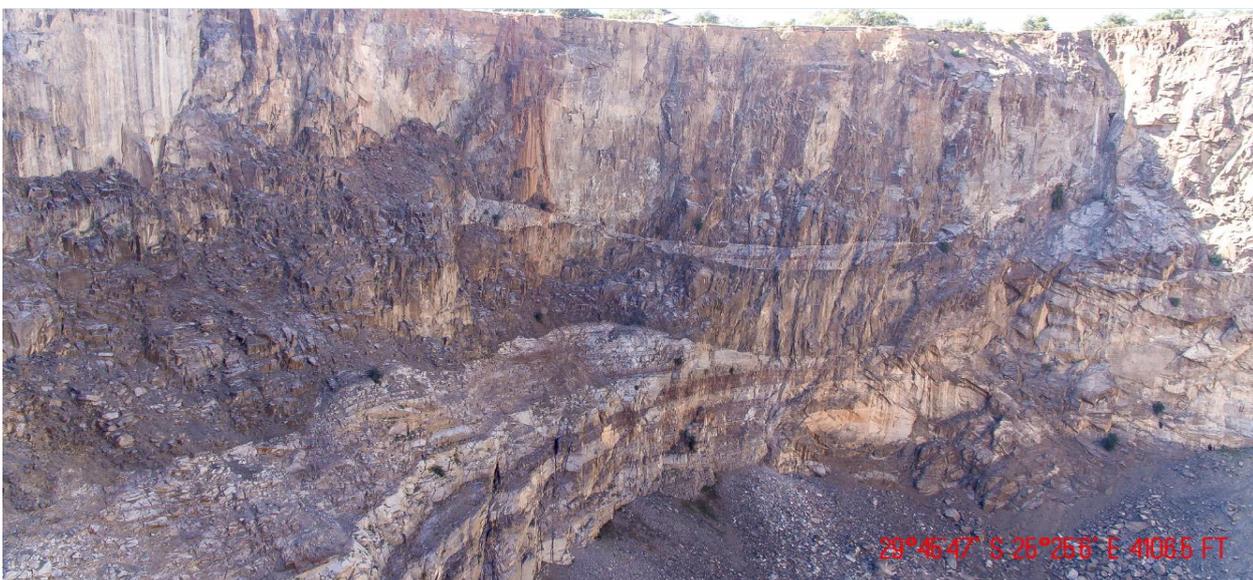
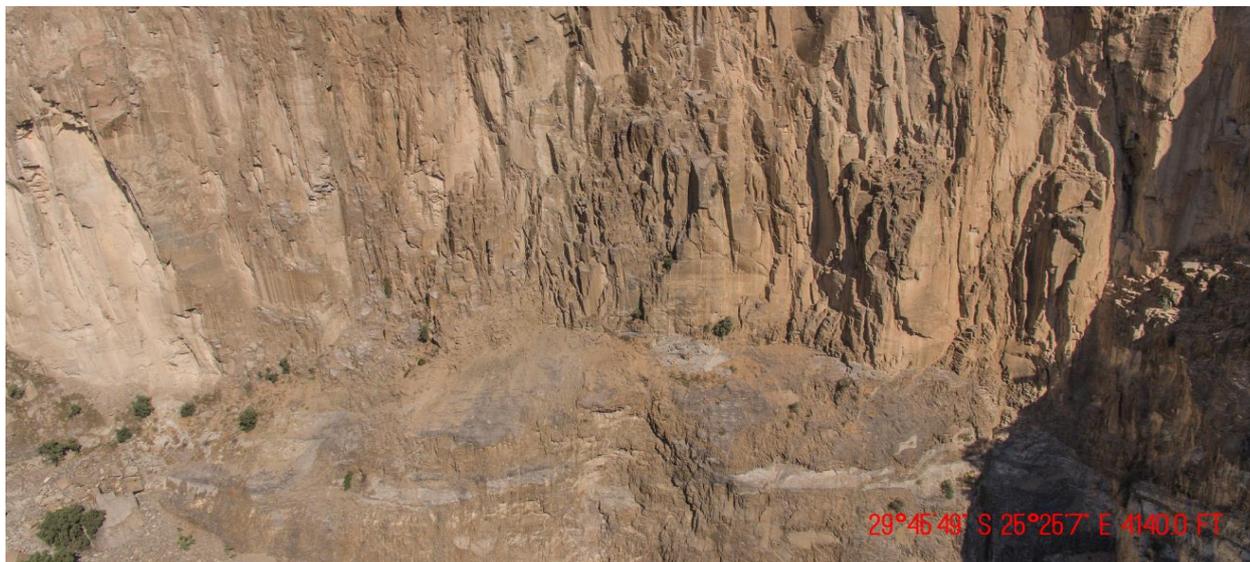
Excessive stof in the pit.
