PARLIAMENTARY PRECINCT: STALPLEIN: STRUCTURAL REPAIRS TO GRANITE STRUCTURES

32076-REP-001 REV 1

PRELIM STRUCTURAL REPORT

NOVEMBER 2015

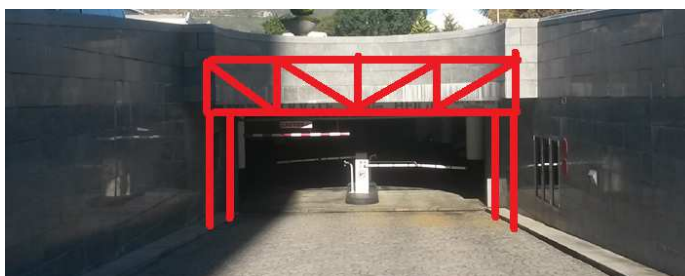
This area poses the biggest threat to the safety to pedestrians as well as occupants of vehicles entering the basement parking area, from falling granite elements.

It is recommended that a Scaffold bridge be constructed to protect people from any possible falling granite elements. This bridge can then be used during the restoration process to work safely, without obstructing the access for people and vehicles. See elevation below indicating conceptually where the bridge will be positioned.
