**PARLIAMENTARY PRECINCT: STALPLEIN:STRUCTURAL
REPAIRS TO GRANITE STRUCTURES**

WCS 050967S

C2640 / 32076-REP-001 REV 2

JULY 2017

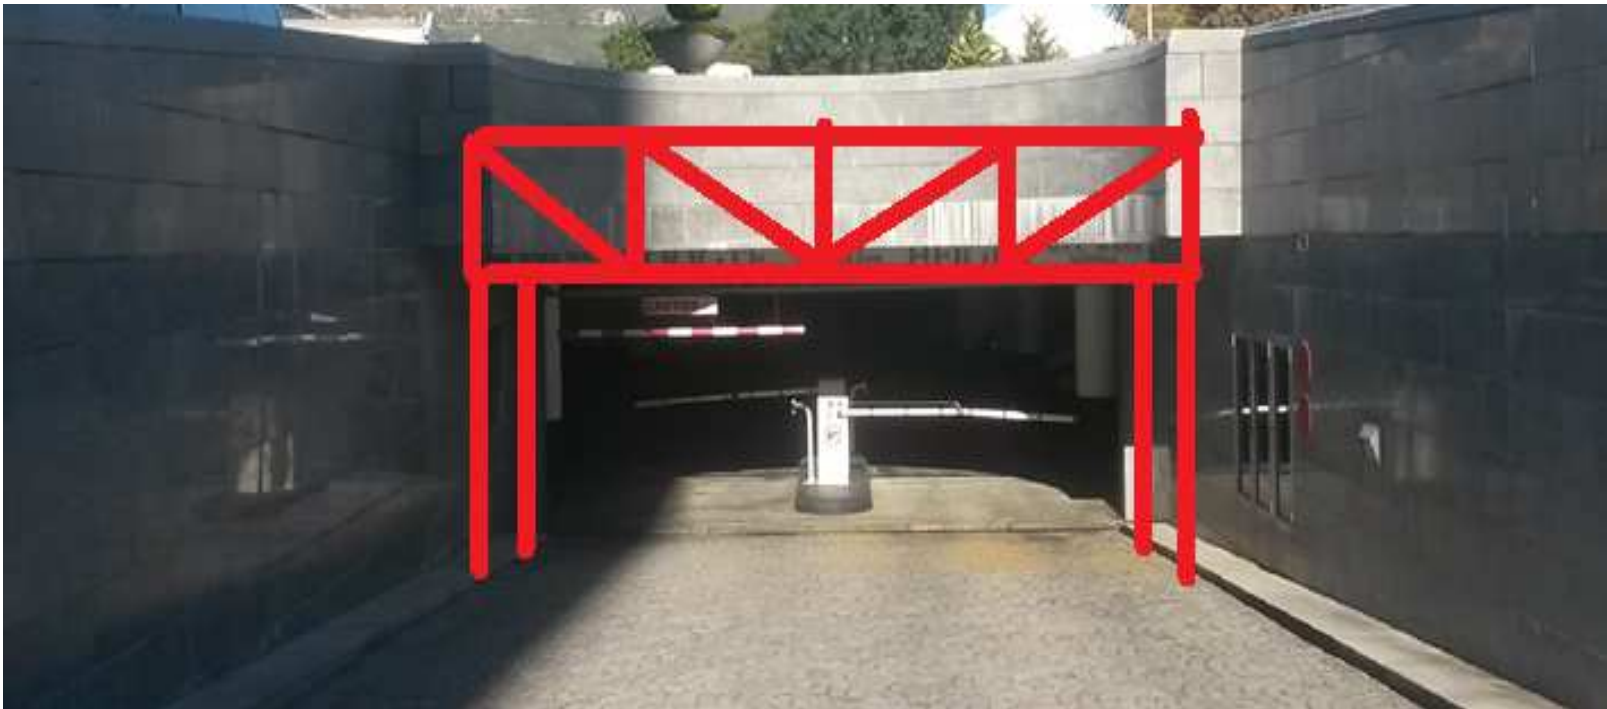
REMEDIAL OPTIONS FOR REPAIRING
GRANITE ELEMENTS – TEMPORARY
SCAFFOLD STRUCTURE TO ALLOW
ACCESS TO BASEMENT WHILE WORKS
OVERHEAD IS DONE

| SCOPE OF WORKS | RECOMMENDATION |
|--|---|
| <p>1. BASEMENT PARKING ENTRANCE: HONED PAARL GREY GRANITE</p> | <p>Overhead hanging granite elements:</p> <ul style="list-style-type: none"> •Replace missing granite element with new fixing lugs with stainless steel dome heads. •Expose fixing lug heads of vertically hanging granite slabs and treat with an anti-corrosive treatment and reseal soffit with a stainless steel dome heads. <p>Vertically hanging granite elements that are loose:</p> <ul style="list-style-type: none"> •Refix all loose panels - refer to report for method statement <p>Efflorescence staining on vertical elements:</p> <ul style="list-style-type: none"> •Investigate water route and create water proof barrier behind granite, including a storm water channel if need be to drain the water away. |
