RE: STRUCTURAL INVESTIGATION OF FIRST FLOOR BRICKWORK @ 336 CHE GUEVARA ROAD, BERA, DURBAN

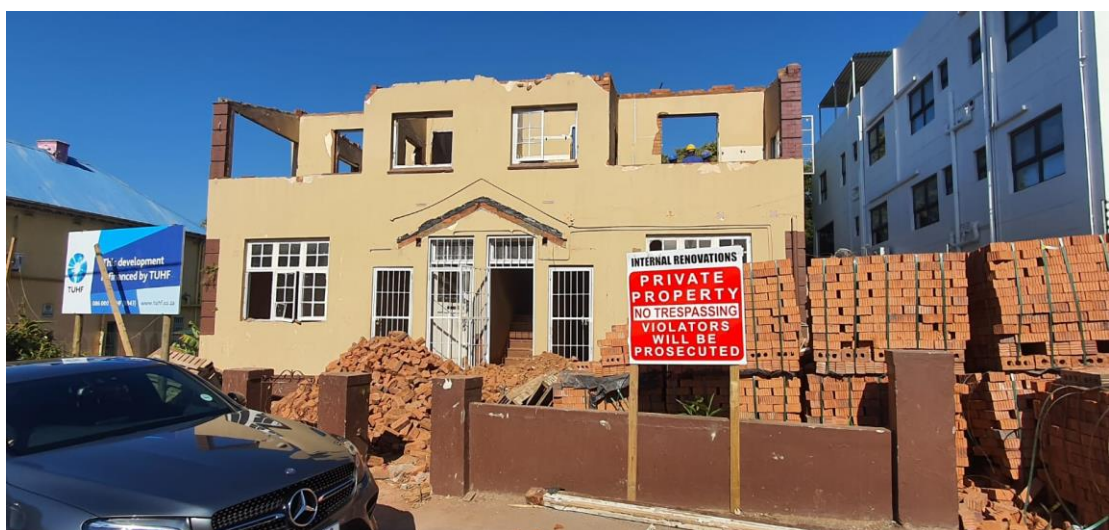
The existing building is a double story building with brick and mortar walls and a concrete slabs.

From our inspection the first floor brickwork that remains has shown severe signs of structural instability. There are large sections of brickwork along the external envelope that has cracked diagonally and vertically as well as it has released from the first floor slab as per the images below.

It is recommended that the external walls on the first floor be carefully demolished and rebuilt using new load bearing bricks. This being the most cost effective and quickest method.

Another recommendation would be to put in reinforced concrete columns and beams and infill with non-load bearing brickwork, however this will result in a higher cost and take more time to construct.
