UMSUNDUZI MUSEUM

REPORT - ASSESSMENT OF EXISTING ROOF AND RAINWATER GOODS AT MAIN BUILDING

APRIL 2023

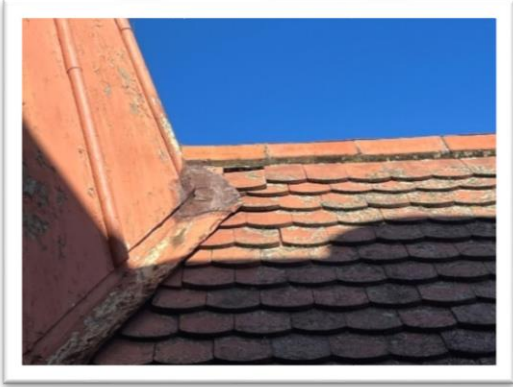
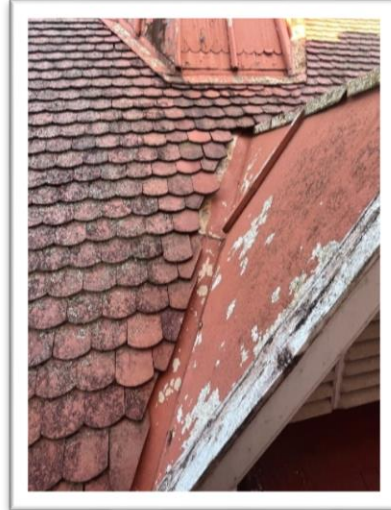
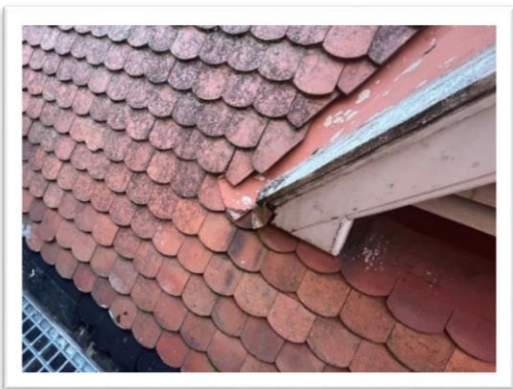
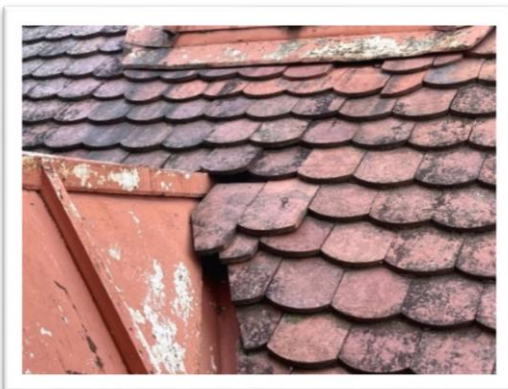
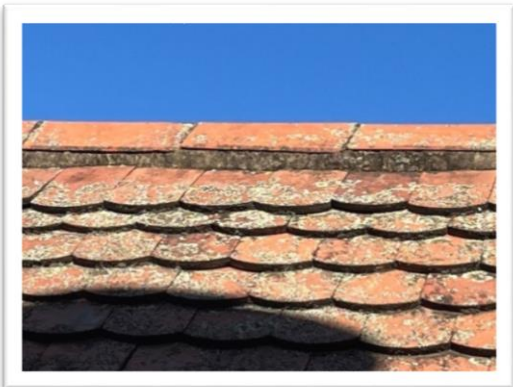
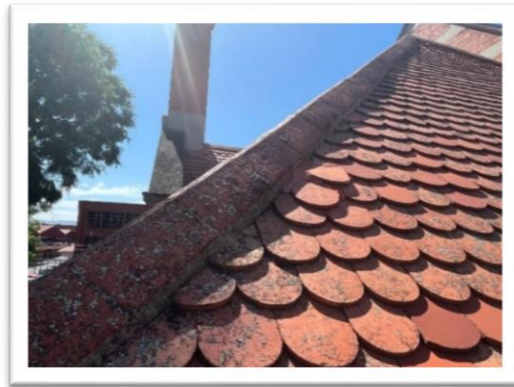
The roof tiles are in overall good condition, with the Museum having some clay tiles in stock to facilitate localised replacement of broken tiles. Where tiles or ridge caps are broken or dislodged, it however allows water to ingress onto the support battens and eventual rotting and weakening of the timber battens. Localised bitumen sealing has been attempted in various areas as a preventative measure.

- Damaged and broken localised roof tiles to be removed and replaced with full whole units, as per stock currently on site.
Special import tiles to match existing would need to be procured if site stock is not sufficient for these repairs.

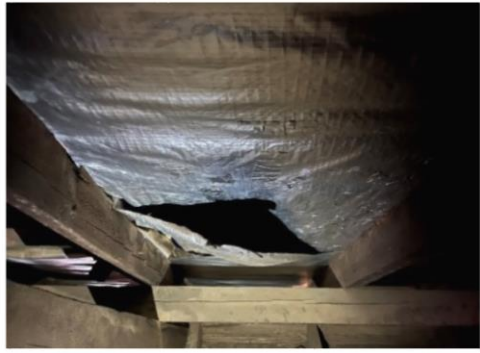
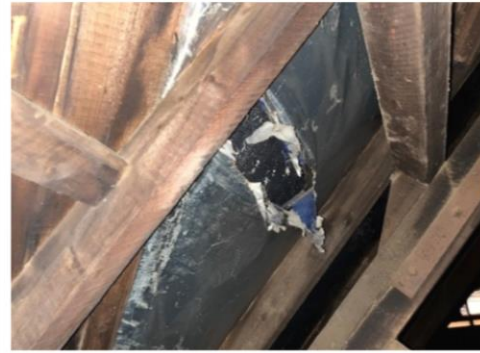
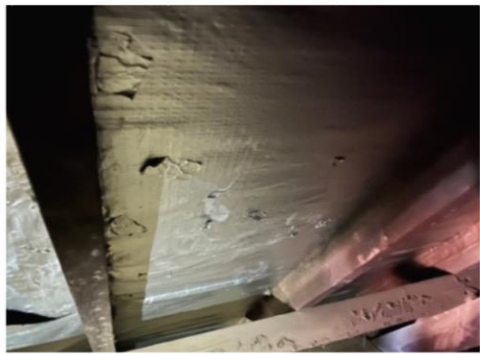
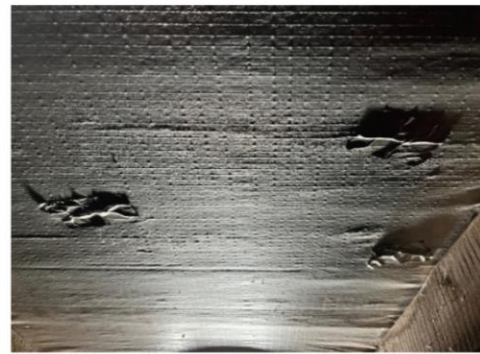
Water ingress onto ceilings and down walls are also results of dislodged and broken tiles. It was noted that the underlay, which acts as a waterproof barrier under the tiles, was also damaged in several places across the footprint of the building, which would allow water to penetrate onto ceilings and the timber trusses.

- Minor damaged roof underlayment to be repaired with DPM Jointing Tape, this only applies to smaller tears and holes.
- Where underlayment is severely damaged and missing, this would need to have new underlayment installed.
These sections of roof would need to be uplifted to replace damaged underlayment and any rotten battens. Only sections that can be done in a single day to be worked on.

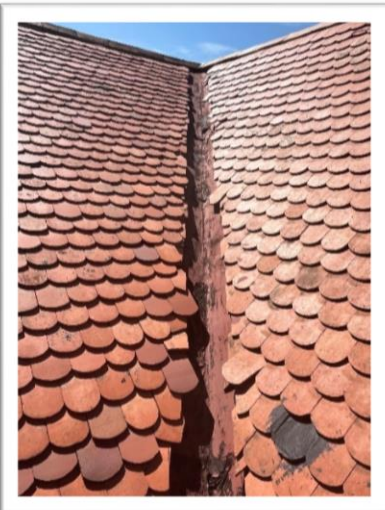
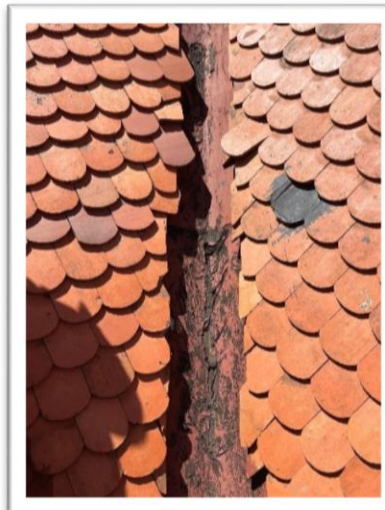
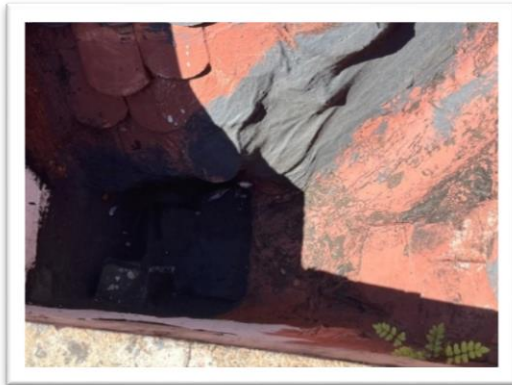
In roof valleys, it was evident that in several areas, the overlap joint between the metal valley and tile-edge was compromised, due to movement of the tiles. In several instances, the resulting leaks were poorly waterproofed with a waterproof membrane and bitumen paint, which is considered a temporary solution.

- Damaged and temporary repaired valleys to be properly replaced with new sheet metal lined timber valleys.
Existing valley tiles to be removed and existing sheet metal valley lining to be removed, timber valleys to be inspected and replaced with new when required. This to be done a single valley at a time (or only a number that can be fully repaired in a single day).

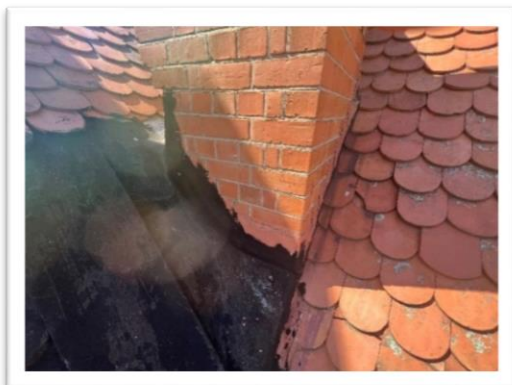
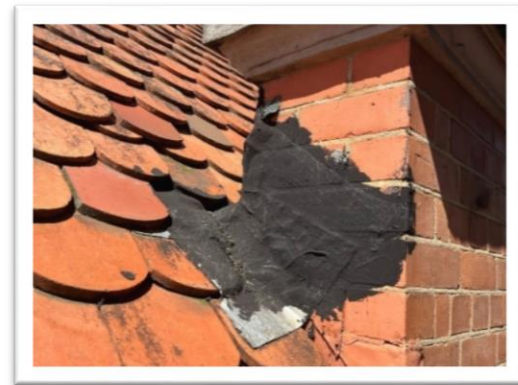
Flashing and counter flash waterproofing, where the tiles meet brickwork, is in most cases either missing, not correctly installed or poorly installed.

Roof tiles to be removed (including all remedial applied waterproofing). Tiles to be removed to expose any metal flashing. Where flashing is damaged, this is to be removed, if not damaged then this may be reused.

Stepped sidewall flashing and straight headwall flashing to be fitted to wall, with sufficient 'soaker' setback. Roof tiles to be refitted into place (with missing and broken tiles being fitted with new). Stepped sidewall counter flashing and straight headwall counter flashing to be fitted to wall (cut into brickwork) and over top of roof tiles (notched at each tile).

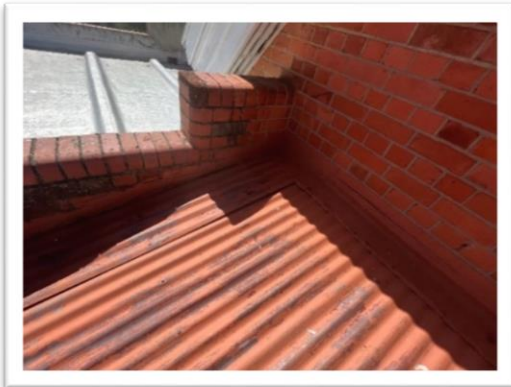
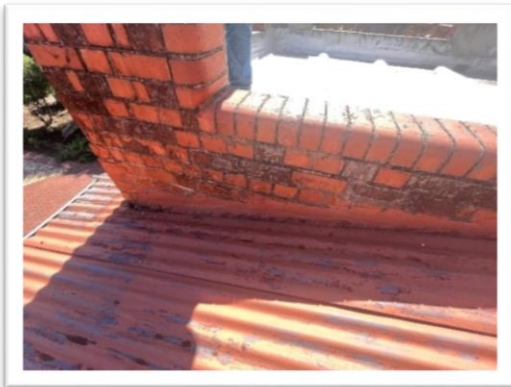
The corrugated iron roofs of the buildings are generally in good condition, considering the age of the building. The sheets show signs of paint deterioration, with rust becoming evident in areas.

- Existing sheets to be removed and cleaned of all paint. Once inspected and considered adequate for reuse, they should be cleaned and prepared for reinstallation using new roofing screws and washers. Once fitted, roofs to be painted to match existing colour. All purlins to be checked for integrity, replace with new where required.
- Roofs with low pitches (once repaired as per above) should be coated with a monolithic water proof coating instead of paint, to match existing colour where possible.
- Damaged and temporary repaired valleys to be properly replaced with new sheet metal lined timber valleys.

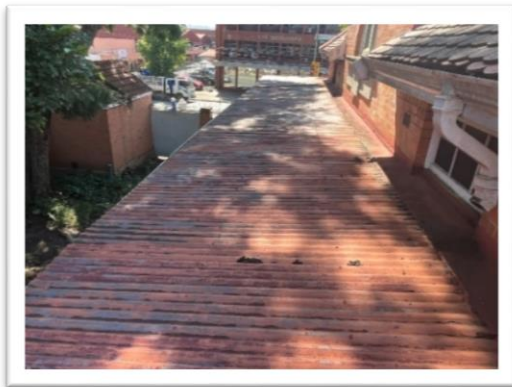
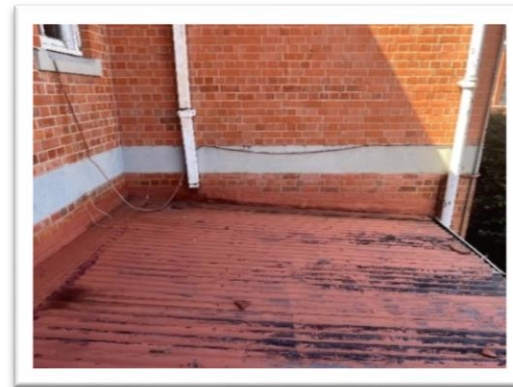
Some roofs are laid at a 2° slope, which is too shallow an angle to provide sufficient run-off during bouts of rain.

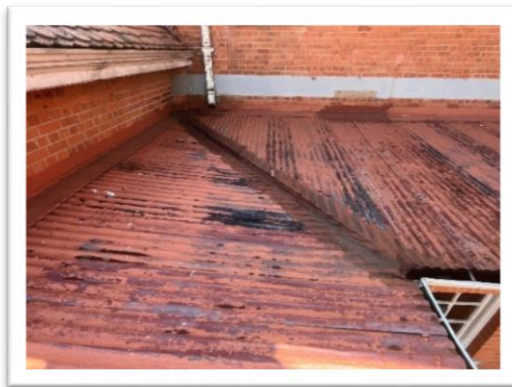
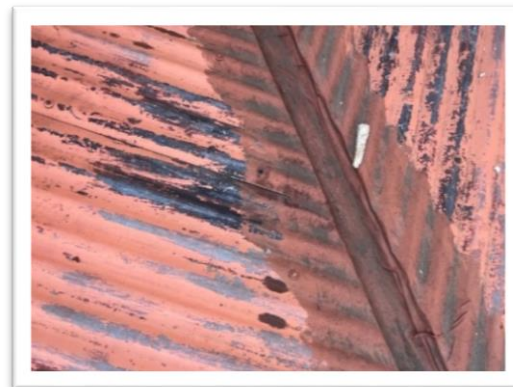
The valleys on some of these sheet metal roofs were incorrectly waterproofed, in a possible attempt to counter the leaks. These roofs will leak because of the shallow slope, allowing water ingress to the areas below.

Existing sheets to be removed and existing sheet metal valley lining to be removed, timber valleys to be inspected and replaced with new when required. This to be done a single valley at a time (or only a number that can be fully repaired in a single day).

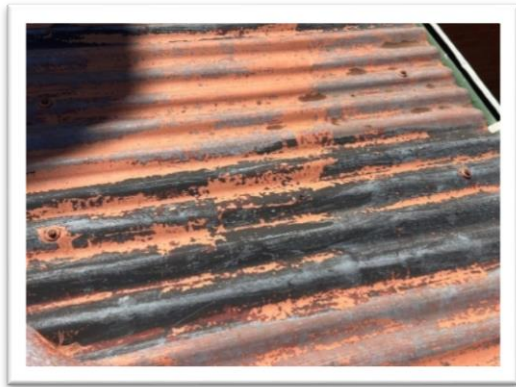
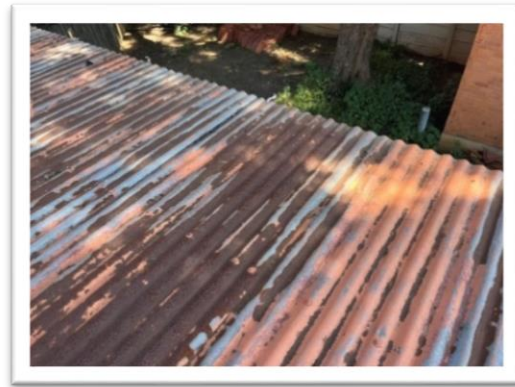
Loose fixing of some roofs was also noted, which may also indicate failure of the timber battens below because of old age and/ or rot.

- All loose and degraded roof sheet fixings to be replaced with new, once cleaned and replaced roof sheets are installed.
- Ridge caps, sidewall flashing and headwall flashing to be removed. Once repaired/ replaced roof sheets are fitted, new purpose bent sheet metal ridge caps and flashing to be installed. Correct counter flashing to be fitted, stepped on sidewall and straight on headwall.

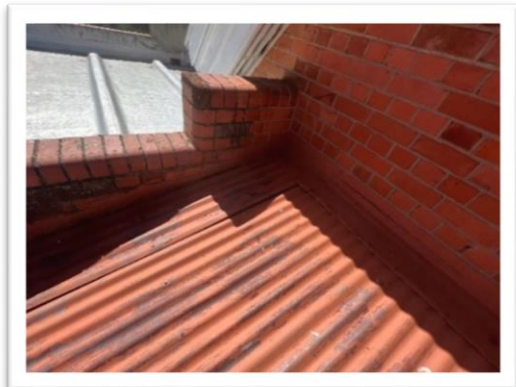
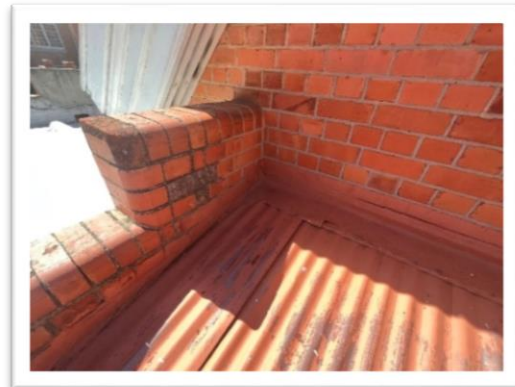
Ridge caps, flashings and counter flashing are showing signs of failure and detaching from the wall and roof sheets, which would result in leaks during wind-driven rainfall.

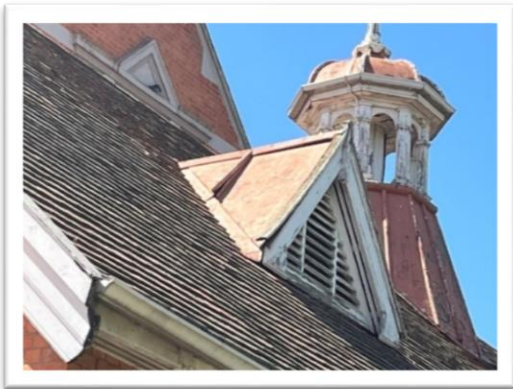
The flat-formed lead sheets used to cover the dormers and turrets are showing signs of age and are unclipping in many instances.

- All roof tiles around dormer and turret lead roof sheeting to be removed. Existing lead sheet metal to be removed and repaired, refit lead sheets over repaired/ new soaker flashing and correctly bind seams of ridges. All by specialist installer. Existing soaker flashing to be inspected and repaired/ replaced where necessary. This is to be done with lead sheet metal and by a specialist installer. Tiles to be refitted over the repaired/ new soaker flashing, new tiles to be fitted where required so as to reduce gap between flashing and tiles.
- Removed ridge pieces to be repaired or replaced, and fitted to newly replaced roof sheeting. Proper notching and capping to be done around seamed ridge joints.

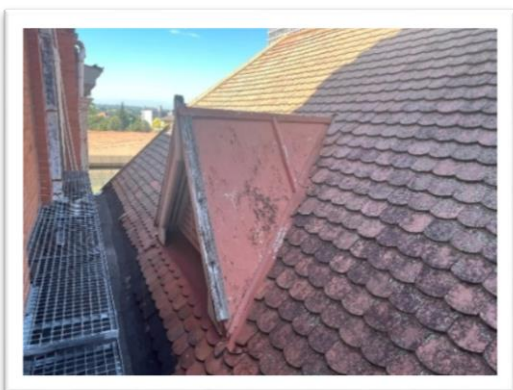
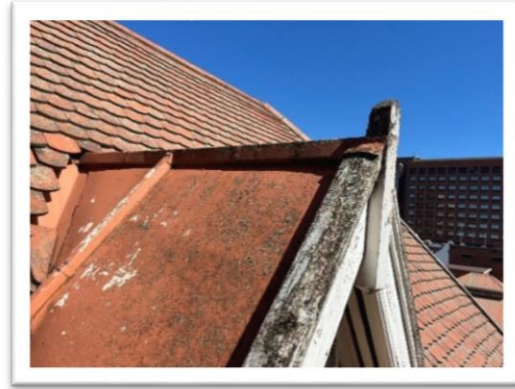
In general, these require all the flashing joints and ridges to be re-formed to seal and join together properly. Paint has weathered significantly and is peeling off these sheets and joints.

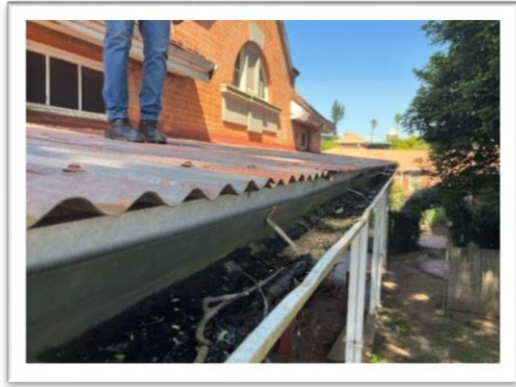
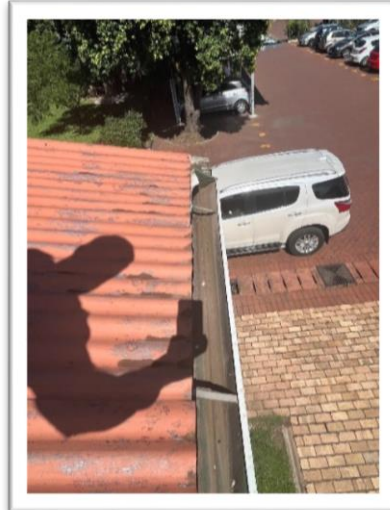
Eave gutters on the entire building generally require cleaning and in some instances would need to be replaced in full with correct falls. Several of the gutters were filled with leaves and other debris, which will impact negatively on their efficiency.

- Eave gutters require cleaning of all debris and silt build-up, this will unblock gutters and let the flow of water run freely.
- Gutters to be inspected for replacement. Damaged/ bent/ twisted gutters to be removed and replaced with new. Gutter to be sheet metal and profile to match that of existing.
- Damaged and rotten timber fascia boards to be removed and replaced with new, to match existing in size and profile. Must be fully painted before gutters are fitted.
- Roof finish overhang into gutters to be adequate in size, where short on tiled roof; new tiles to be fitted and cut back to correct overhang size. Tiles to match existing roof tiles.

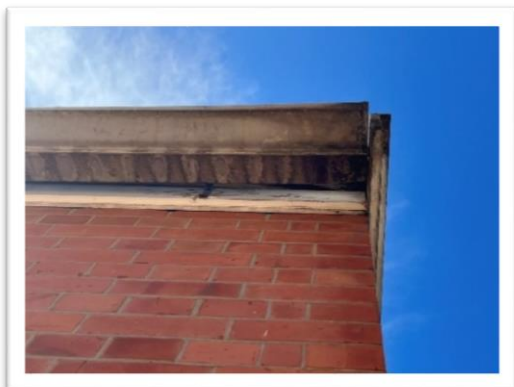
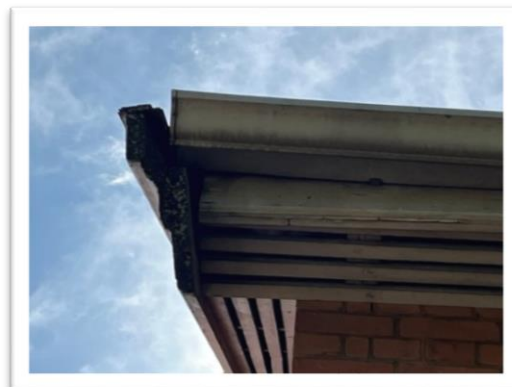
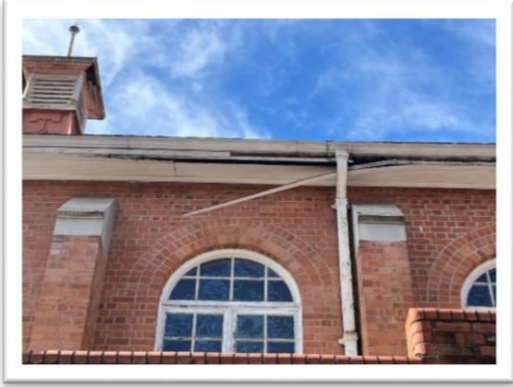
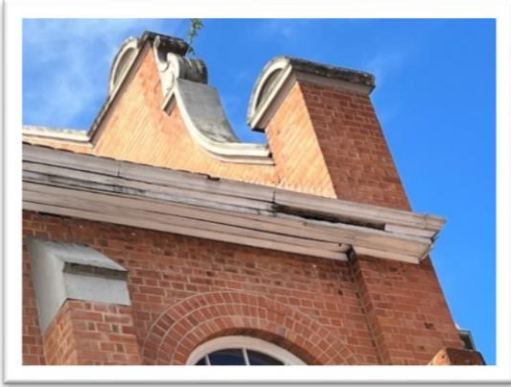
Structural failure of a number of these gutters can be attributed to the failure of the timber fascia they are fixed to, where the fascia have rotted or pulled away from their support structure.

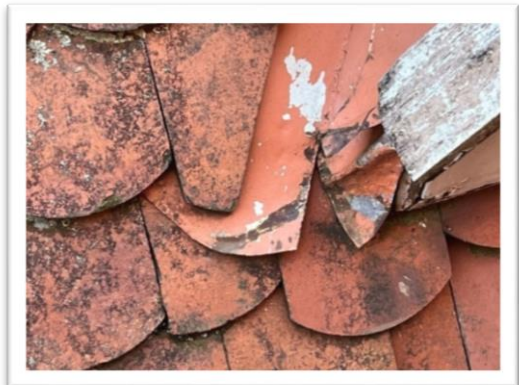
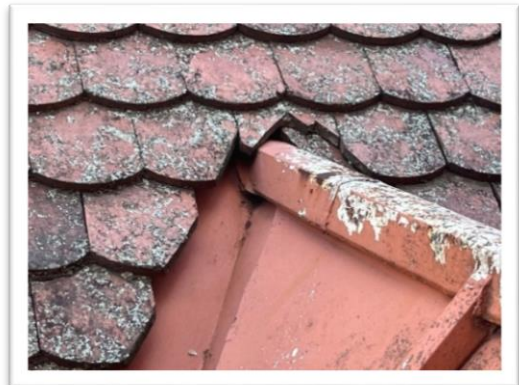
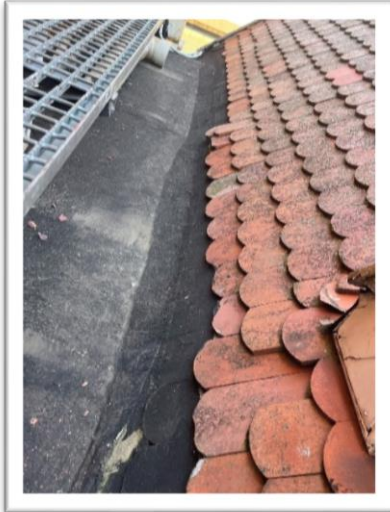
In other instances, the roof overhangs are not sufficient enough to discharge water into the gutter, which would result in water ingress into the building.

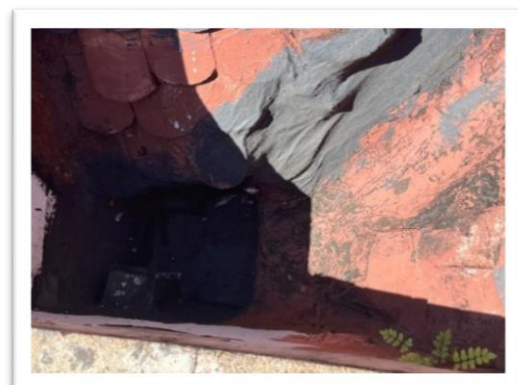
The box gutters fitted to the building appear to be the major source of water leaks to the inside of the building. The box gutters appear to be structurally in good condition, but in most instances, the waterproofing applied to the box gutters is failing at the joints with brickwork, roof edges and parapets, causing leaks. There is also evidence of leaves and debris collecting in some box gutters.

- Box gutters to be cleaned of all debris silt build-up, this will allow free flow of water to the outlets as well as eliminate pooling water issues.
 - Box gutter waterproof membrane to be removed, gutter structure to be inspected and fully repaired/ replaced where required. Roof riles/ roof sheets would need to be lifted in these areas to properly inspect and repair the gutter.
 - Box gutter to be fully waterproofed with new monolithic type sealant 3-4mm thick, to create new watertight gutter.
 - New bent soaker sheet to be fitted under roof finish and into box gutter, using sheet metal.
 - Roof finish to be reinstated, where necessary the roof finish must be replaced or added to so as to create an adequate overhang into the gutter.
-
- DOWNPIPES

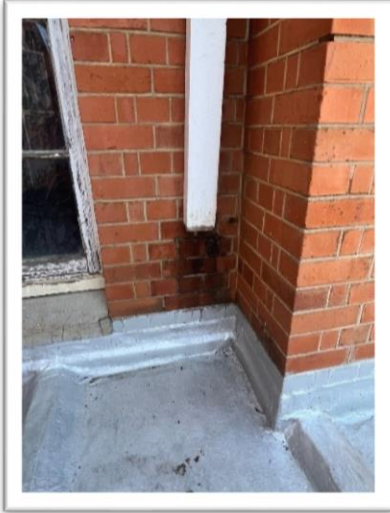
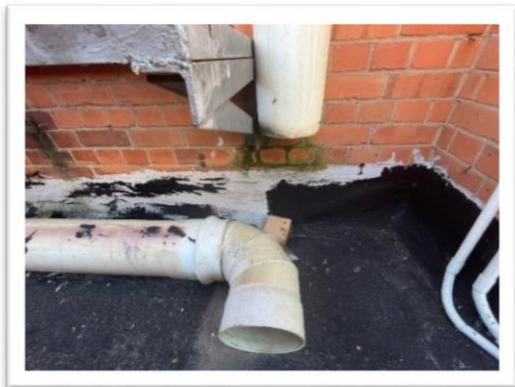
The building was originally fitted with cast-iron type downpipes, of which a large number have been replaced over the years with aluminium type downpipes of similar size. Almost all remaining downpipes are in a severe state and/ or coming loose at the joints and fixing brackets, resulting in water not being directed efficiently to the ground.

- All degraded downpipes to be repaired where possible, by weld/ brazing holes closed. Where holes are too big, then a closing plate cut to size is to be weld/ brazed into place.

- Downpipes to be fully cleaned and sanded down, prepared for new paint.
- Missing downpipe shoe to be fitted where missing, without the shoe the water is not directed away from the building.

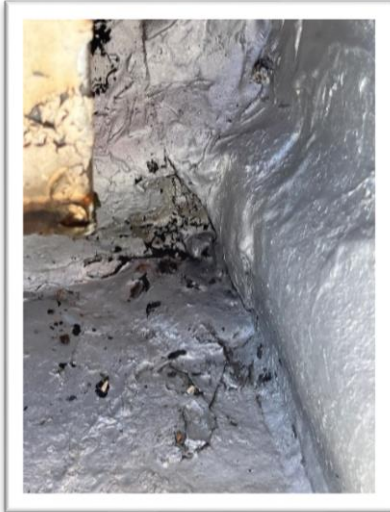
The condition of the bitumen waterproofing on the concrete and timber flat roofs is poor. It appears that the waterproofing was recently re-painted in an attempt to improve its performance, but the paint's function is to protect the waterproofing and not to improve its performance, hence the problem has not been addressed. The major source of leaks from the flat roofs is at the flashing & counterflashing intersections, overlap joints, and in corners to parapet walls, etc.

- Existing waterproofing to be removed in full from all flat roofs, including the flashing and counter flashing on the walls.
- Inspect all structure of flat roof, and repair when required. Roofs are either concrete or timber construction.
It is advised that any ridges or unnecessary protrusions be removed as they make waterproofing more difficult.
- All corners where flat roof meets wall are to have 45° chamfers added, either as screed (concrete) or timber pieces (timber).
- Full monolithic type waterproof coating 3-4mm thick. This should rise up the walls by at least 250mm (or above highest drainage outlet).
The wall rise should have a bent sheet metal counter flashing fitted of the join, this flashing to be cut into wall and sealed.

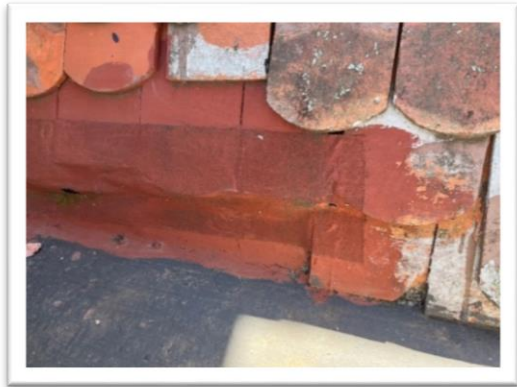
Almost all valleys and remedial waterproofing to same needs to be addressed. It appears that the metal valleys have been waterproofed numerous times over the years, with a majority of the applications not following the original correct method. This leads to waterproofing membrane being applied over the edge tiles into the valley, allowing water to ingress behind the roof tiles and not into the valley. In several instances damaged side wall and counter flashings were observed.

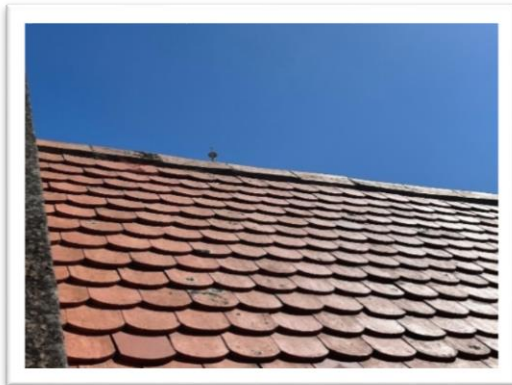
Hip and ridge tiles are generally in descent condition, with only a couple of loose capping tiles that require re-fixing. These loose capping's will allow water to ingress into the roof space and behind the roof tiles, causing damage to these internal spaces.

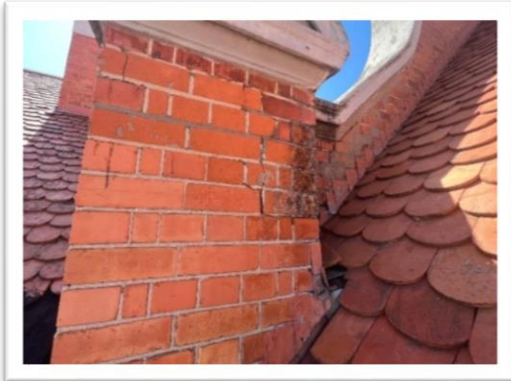
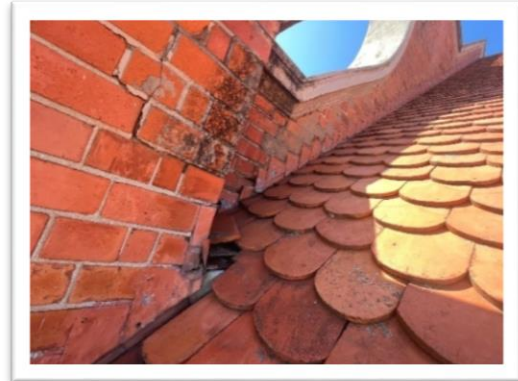
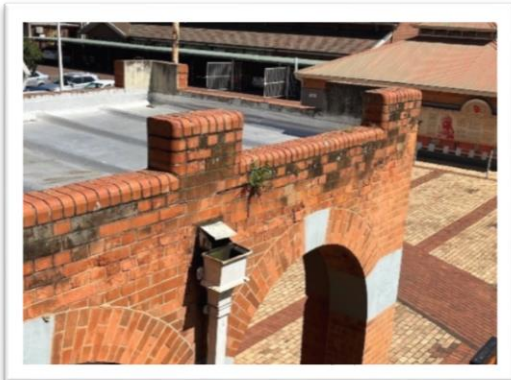
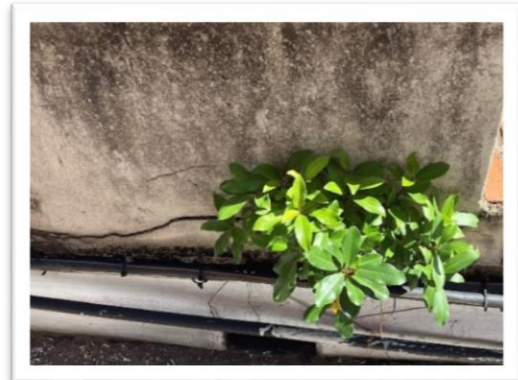
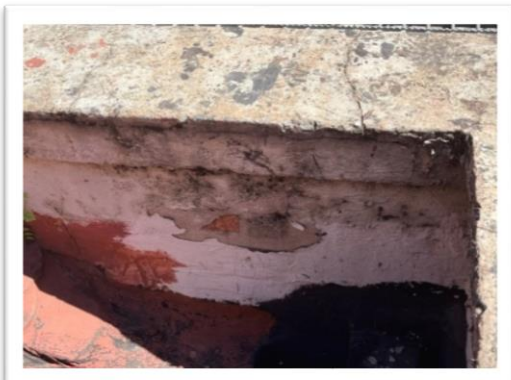
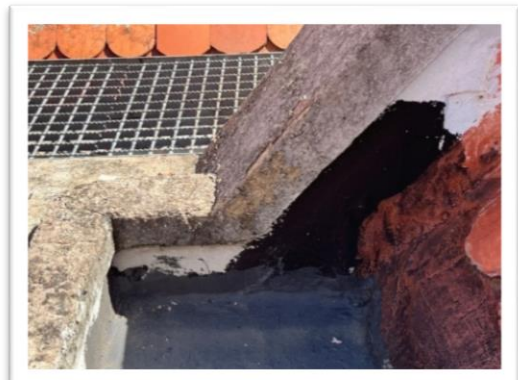
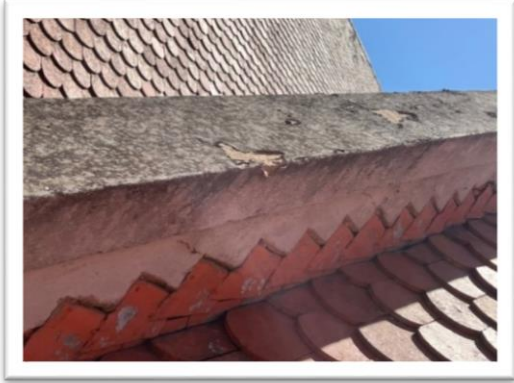
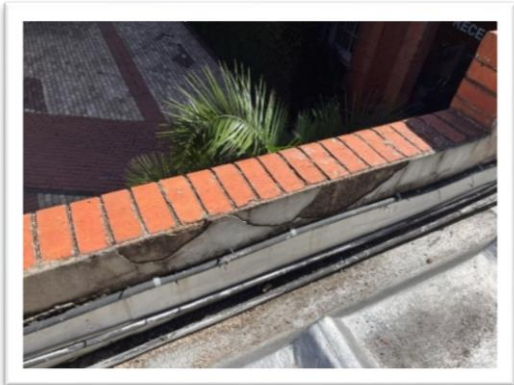
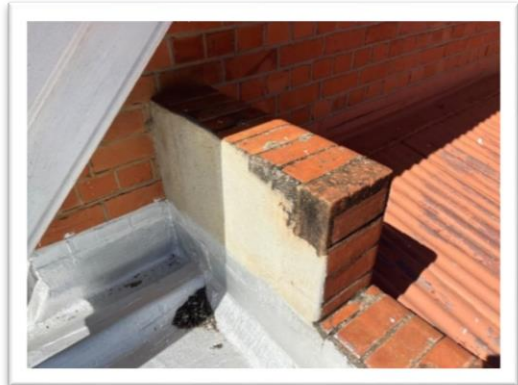
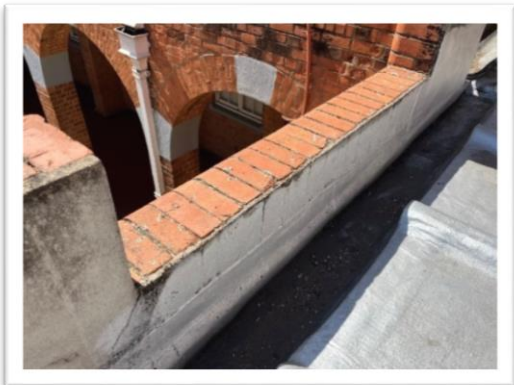
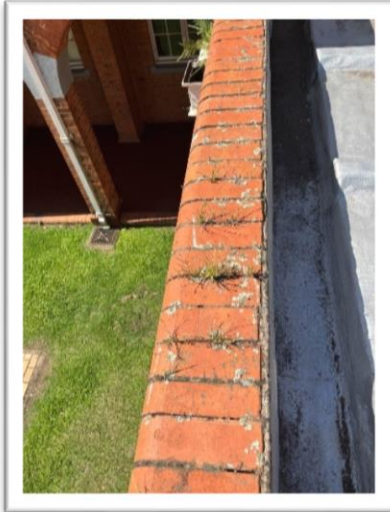
Copings on plastered and face brick parapet walls and gables require attention. In a number of instances, the plaster providing the waterproofing to the top and sides of the parapet walls is failing, allowing water seepage into the walls. This over time will exaggerate the peeling of the remainder plaster and result in water seeping into the wall itself, which will manifest as damp. There is also evidence of weeds growing out of the cracks in walls because of wall dampness. Damaged face brick and missing mortar joints are evident in areas, which also allows water seepage over time into the wall cavity.

- Copings on all parapet walls to have all cracks and chips repaired with non-shrink grout, copings to be fully prepared for new paint.
- Severely damaged/ cracked copings to be chopped out in sections, new copings to be cast into place (to match existing profile). Plaster to be non-shrink with waterproof additive and glass fibre reinforced mixture.
- Paint to be the mastic type waterproof paint, to match the existing cement grey colour.
- Damaged/ crumbling mortar joints to be raked out to point of being dry. These joints must be repaired by filling them with a non-shrink grouting, which has a waterproof admixture.
- Where possible, it is advised that the degraded/ cracked/ broken bricks be removed and replaced with new to match existing. Priority will be to find old stock bricks to use.

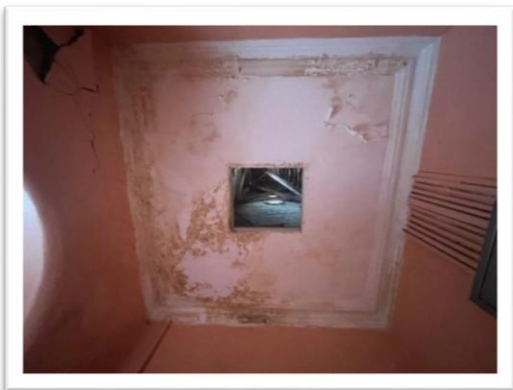
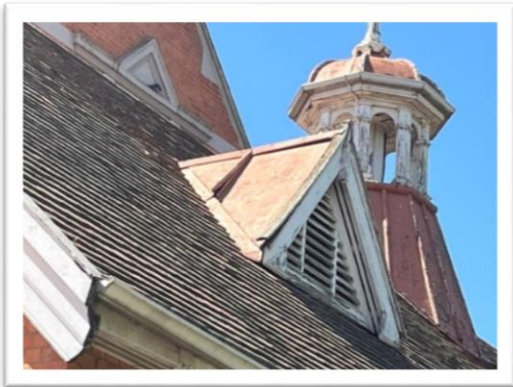
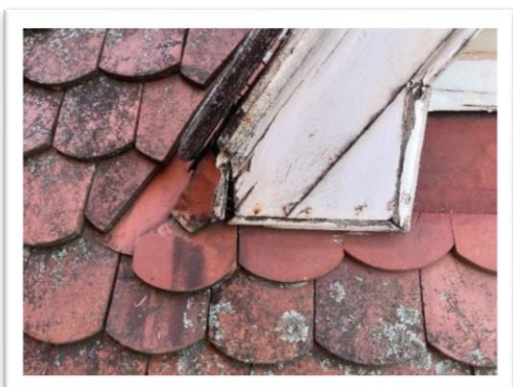
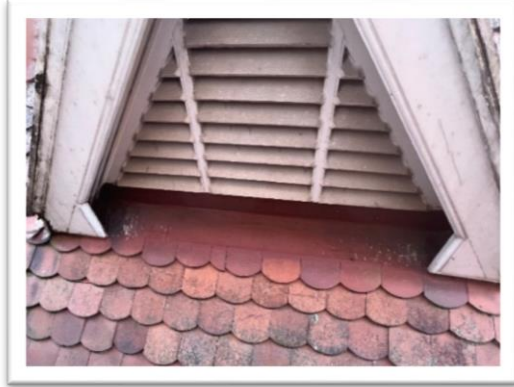
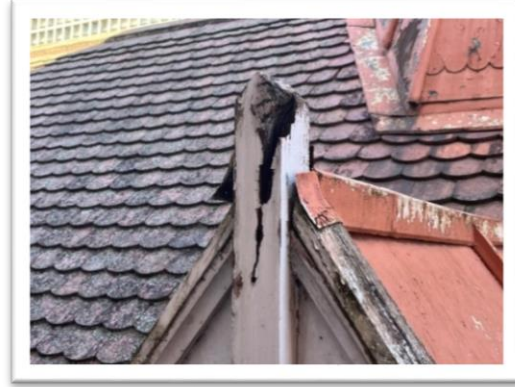
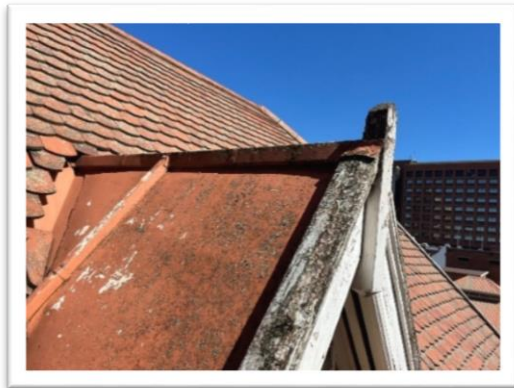
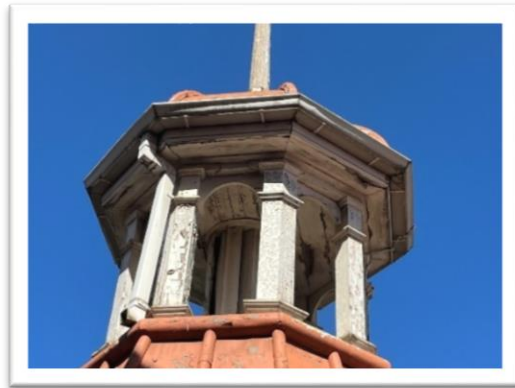
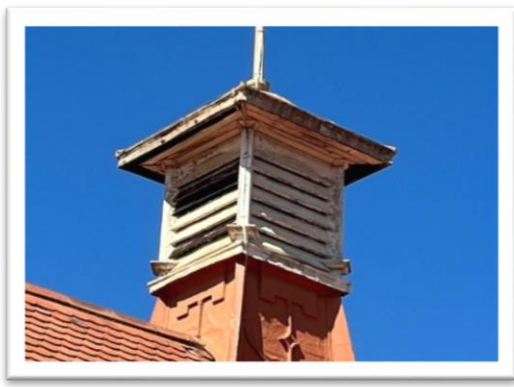
The timber turrets on the roof require extensive restoration, as the timber elements of these structures have failed. This too presents a risk of collapse. The dormer metal roof sheets require maintenance, as the sheets have started to separate from each other. The timber structures within the dormer face have deteriorated severely and require repair/ replacement. The timber louvres in these structures are broken in places, directly allowing rainwater to penetrate the roof space and ceilings below.

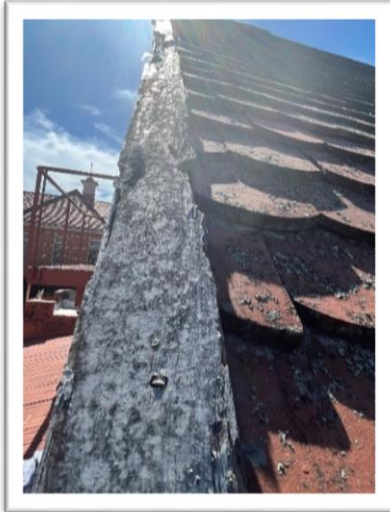
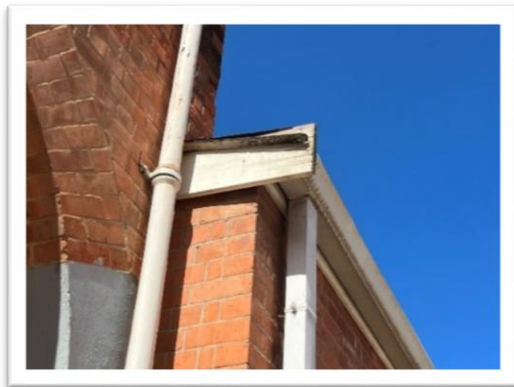
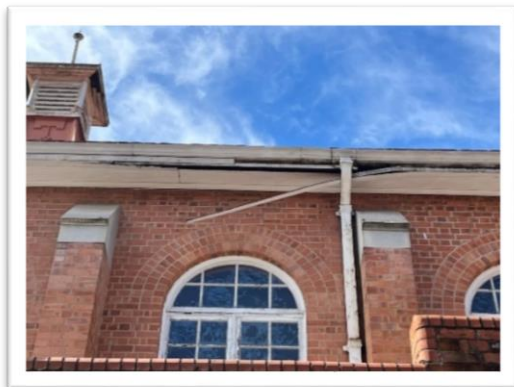
The timber barge boards and fascia's require repair/ replacement. In a number of instances, the fascia itself has rotted and is no longer considered to be structural. These fascia's are coming away from its support structures, which would indicate possible damage to the support structure as well.

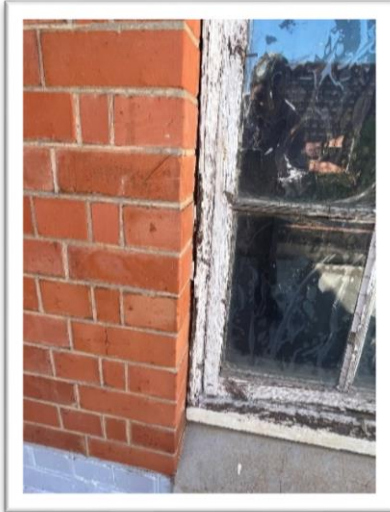
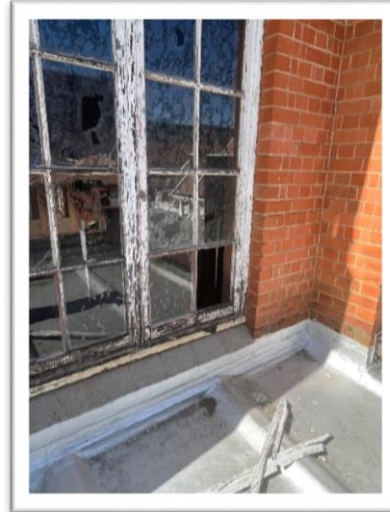
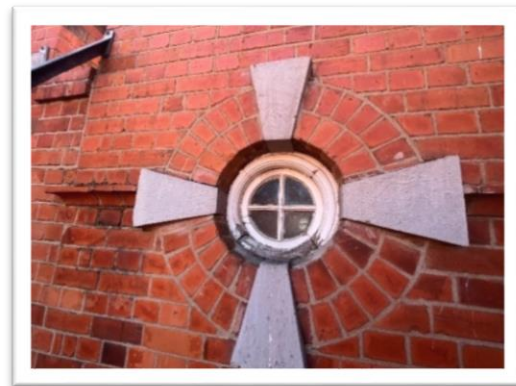
There are several timber windows that have deteriorated quite severely over time, possibly due to lack of maintenance and exposure to the elements. These windows are no longer waterproof and allow water to directly penetrate the wall cavity and interior of the building.

- Damaged and broken timber windows to be removed and repaired. All work to be carried out by approved carpenter.
New timber frames, transoms/ mullions and beading to be fabricated to match existing exactly where required, using approved hardwood (saligna/ meranti).
- Repaired timber windows to be fully prepared and painted, prior to being refitted into openings.
- Gaps between walls and window frames are to be fully sealed with an acrylic type watertight sealant, internally and externally.
- Missing and broken glass panes to be replaced with new.
Existing putty to be removed from windows and new putty to be applied for all windows.

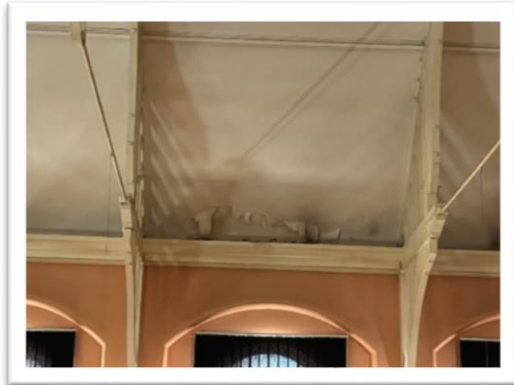
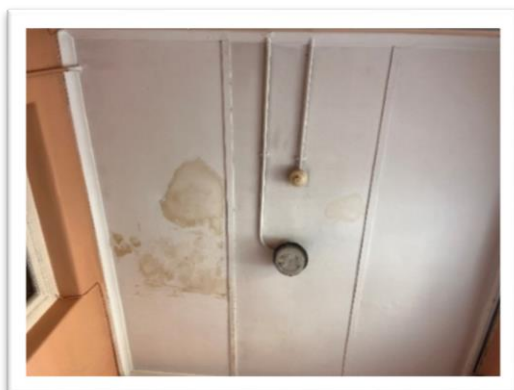
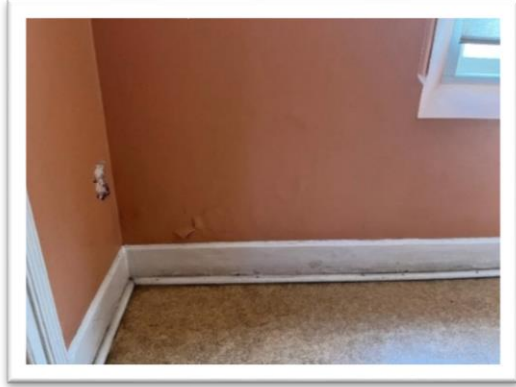
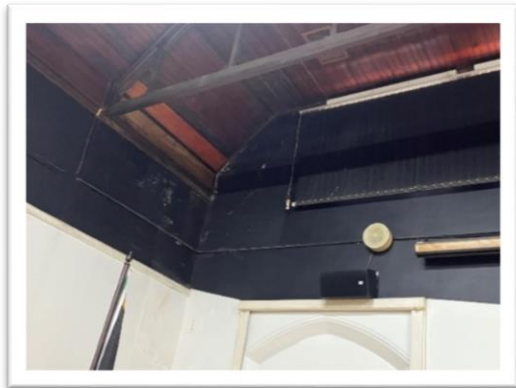
Due to the prolonged water ingress from the leaks identified, the ceiling and internal wall plaster of the building have been damaged in several areas. Damp is evident in the internal walls and signs of water damage on several ceilings throughout the building. Once the external leaks have been successfully addressed, the interior elements can be safely repaired/ replaced in accordance with AMAFA guidelines.

- All internal walls and ceilings that have been damaged due to water ingress must be fully prepared for new paint; scraping, sanding, filling and re-sanding.
- Where ceilings are damaged, they must be replaced in sections. The existing cornice must be removed and kept safe (if still usable).
New cornice and mouldings must be made, to match the existing exactly, when replacement is required.
- Surfaces to be painted once all is fully repaired.
