Gordon's Bay Fishing Harbour: Notification of Intent to Develop

Professional Consultancy Services for Coastal Engineering Infrastructure Activities – Proclaimed Fishing Harbours Western Cape

Project Descriptions

Gordons Bay Harbour

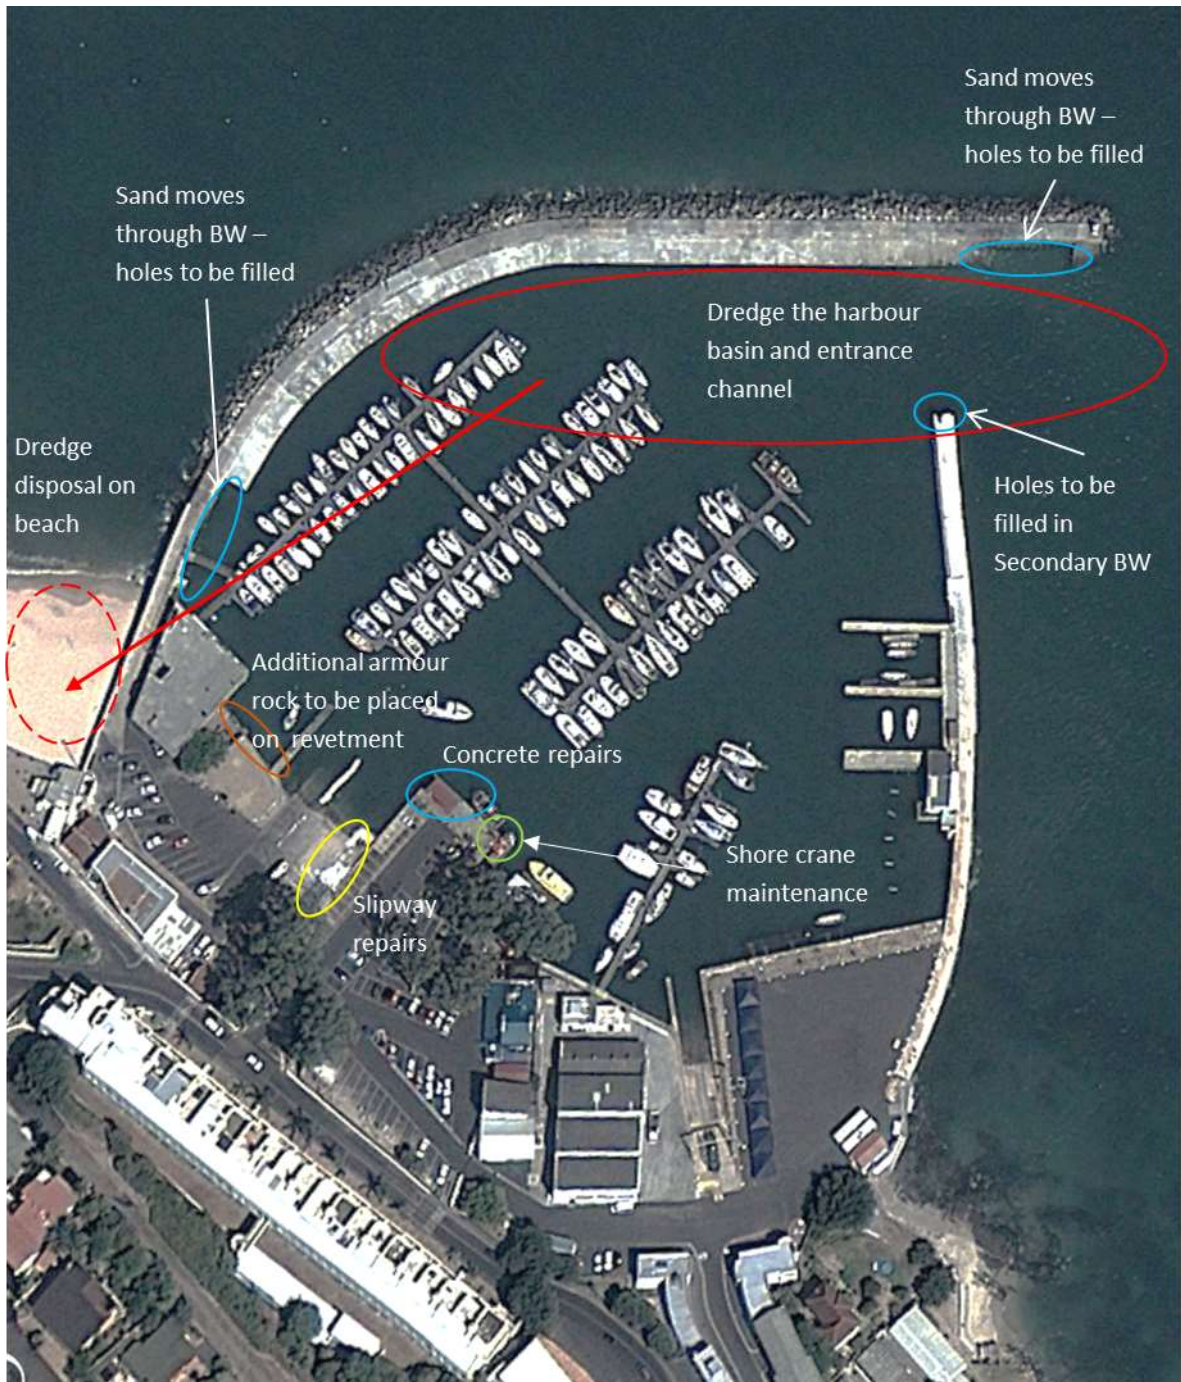
Figure 2-2: Work required in Gordons Bay Harbour

A summary of the repair and maintenance work required in Gordons Bay harbour is shown in Figure 2-2.

<p><u>Main Quay</u></p> <p>Fill hole in the gravity quay wall with plain concrete (below water level). This is to prevent undermining and potential failure of the structure. This will not increase the footprint of the Main Quay structure on the sea bed.</p>

<p><u>Naval quay</u></p> <p>Cast new concrete capping along the entire length of the retaining wall. The repair work includes nominal shrinkage steel and steel dowels to tie the new concrete into the existing structure and will not increase the footprint of this structure.</p>

<p><u>Boat ramp lead-in jetty</u></p> <p>The fender fixings along the lead-in jetty are all bent and need to be replaced. New tyre fenders are required to replace missing ones.</p>

<p><u>Naval Jetty</u></p> <p>Replace damaged timber fenders on the jetty corners.</p>

<p><u>Main Quay</u></p> <p>Bollards need to be cleaned and painted. Corroded bollard holding down bolts must be replaced.</p>

<p><u>Quay Crane</u></p> <p>Dismantle refurbish and replace the derrick quay crane. Alternatively, this crane will be replaced with a new one of similar capacity.</p>

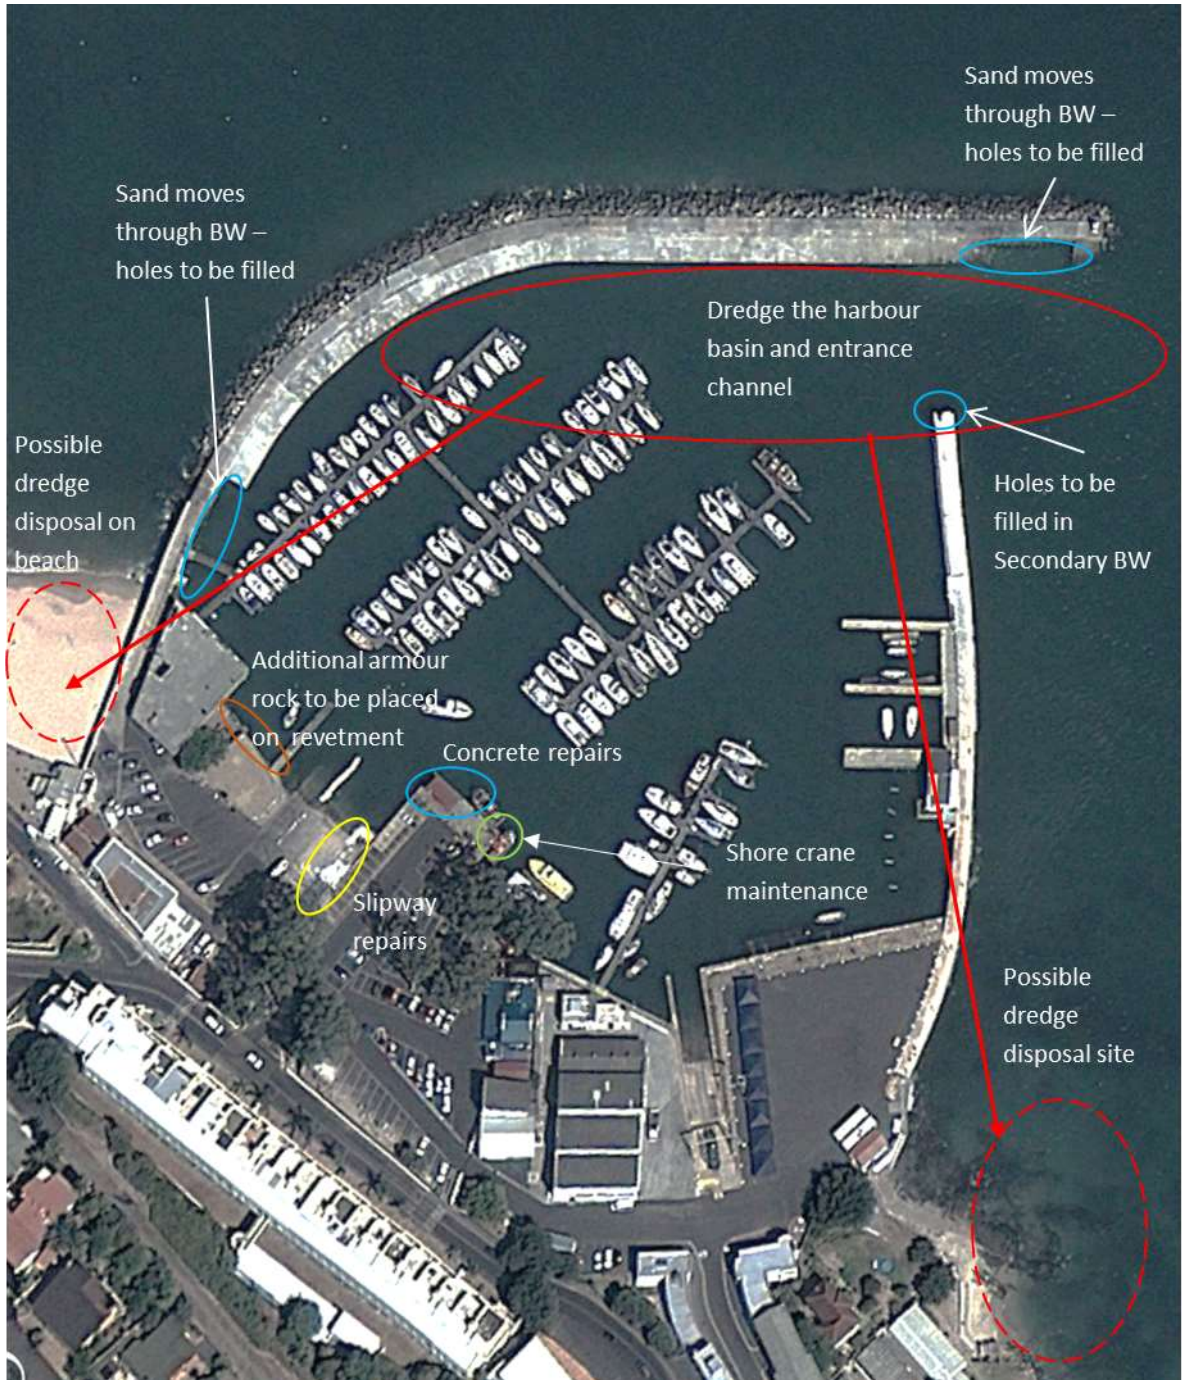
Figure 2-2: Work required in Gordons Bay Harbour

A summary of the repair and maintenance work required in Gordons Bay harbour is shown in Figure 2-2.

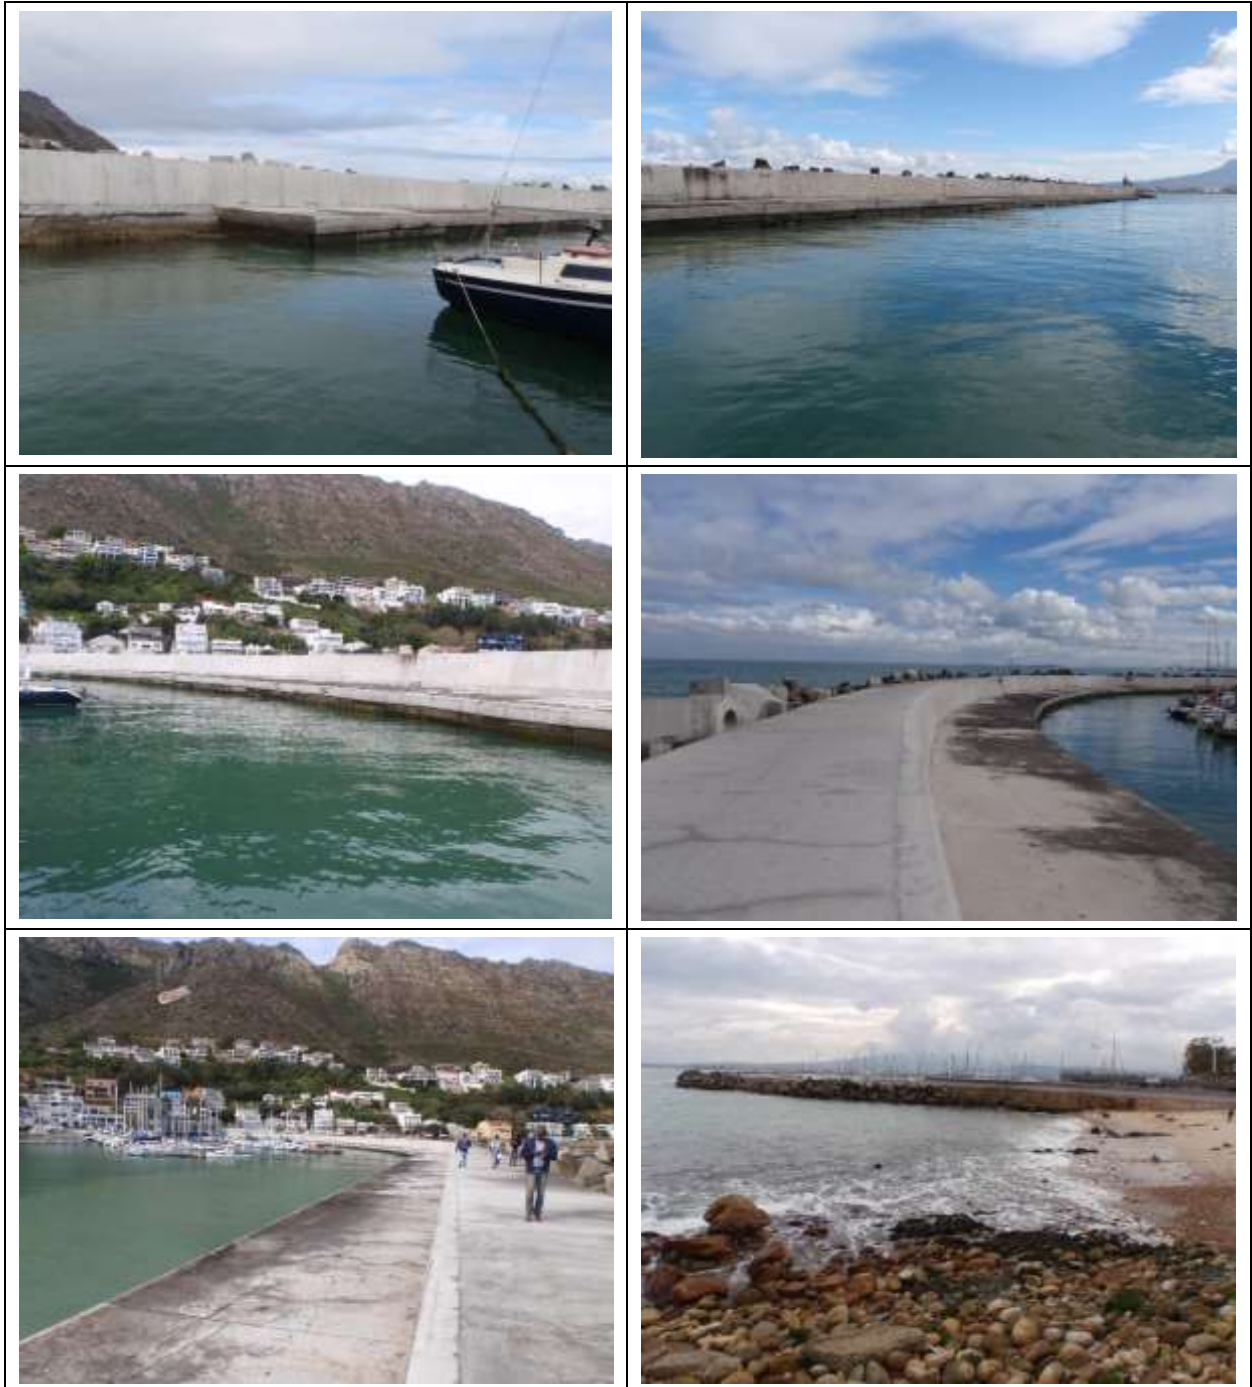
ANNEXURE A | MAIN BREAKWATER – ADDITIONAL FIGURES

The Gordons Bay breakwaters are generally in good condition, with some minor maintenance that is required. This includes the filling of holes in the lower section to prevent sand from migrating through the breakwater – Refer to Table 2-4.

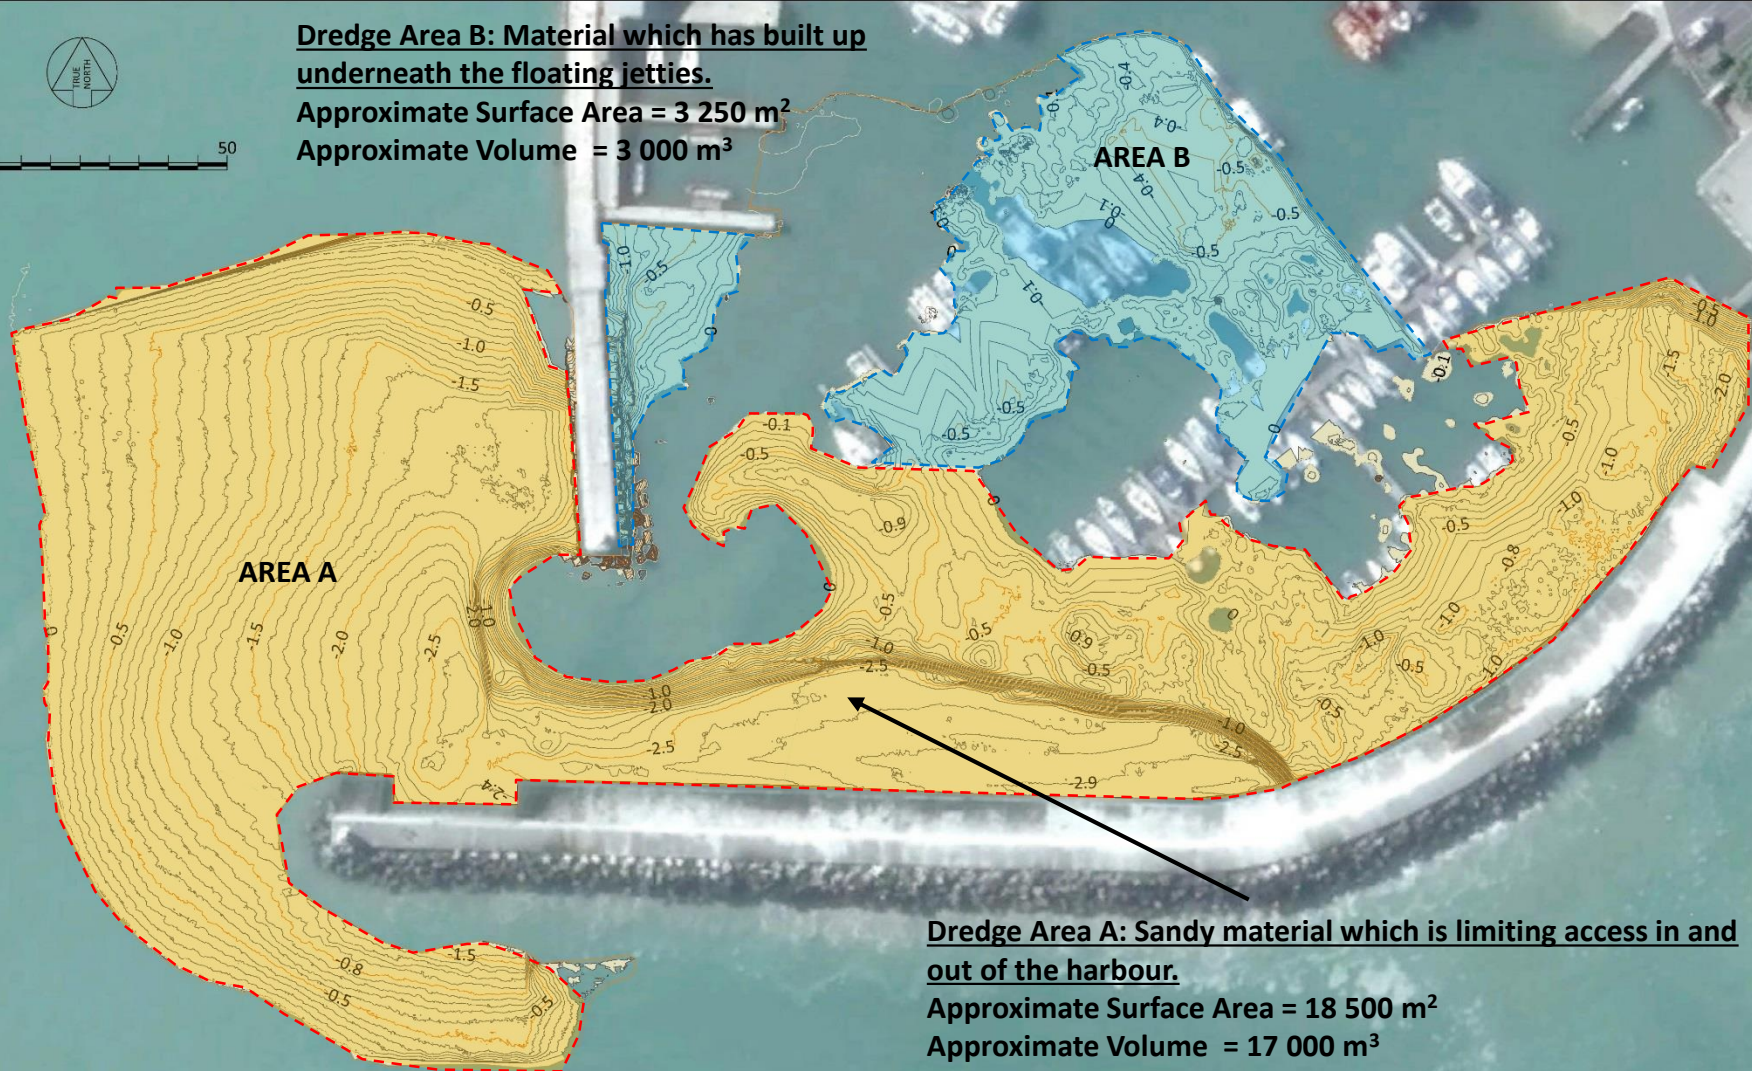
Dredge Area A: Sandy material which is limiting access in and out of the harbour.

Approximate Surface Area = 18 500 m²

Dredging is required to restore the required water depths in the entrance channel and harbour basin. Sand has built up in the harbour entrance to such an extent that larger vessels cannot use the harbour and smaller vessels can only enter and leave the harbour during high tide. This is a major concern for the safety of people and vessels using the entrance and for the operation of the NSRI who need to be able to operate under all conditions. The total dredge volume is approximately 20,000m³. A sediment study undertaken by Lwandle has indicated that the sediments to be dredged are not significantly contaminated (well within guideline levels). The dredge disposal site for Gordons Bay Harbour will be at the Bikini Beach:
