### Hermanus Fishing Harbour: Notification of Intent to Develop

## Professional Consultancy Services for Coastal Engineering Infrastructure Activities – Proclaimed Fishing Harbours Western Cape

### Project Descriptions

Hermanus Harbour

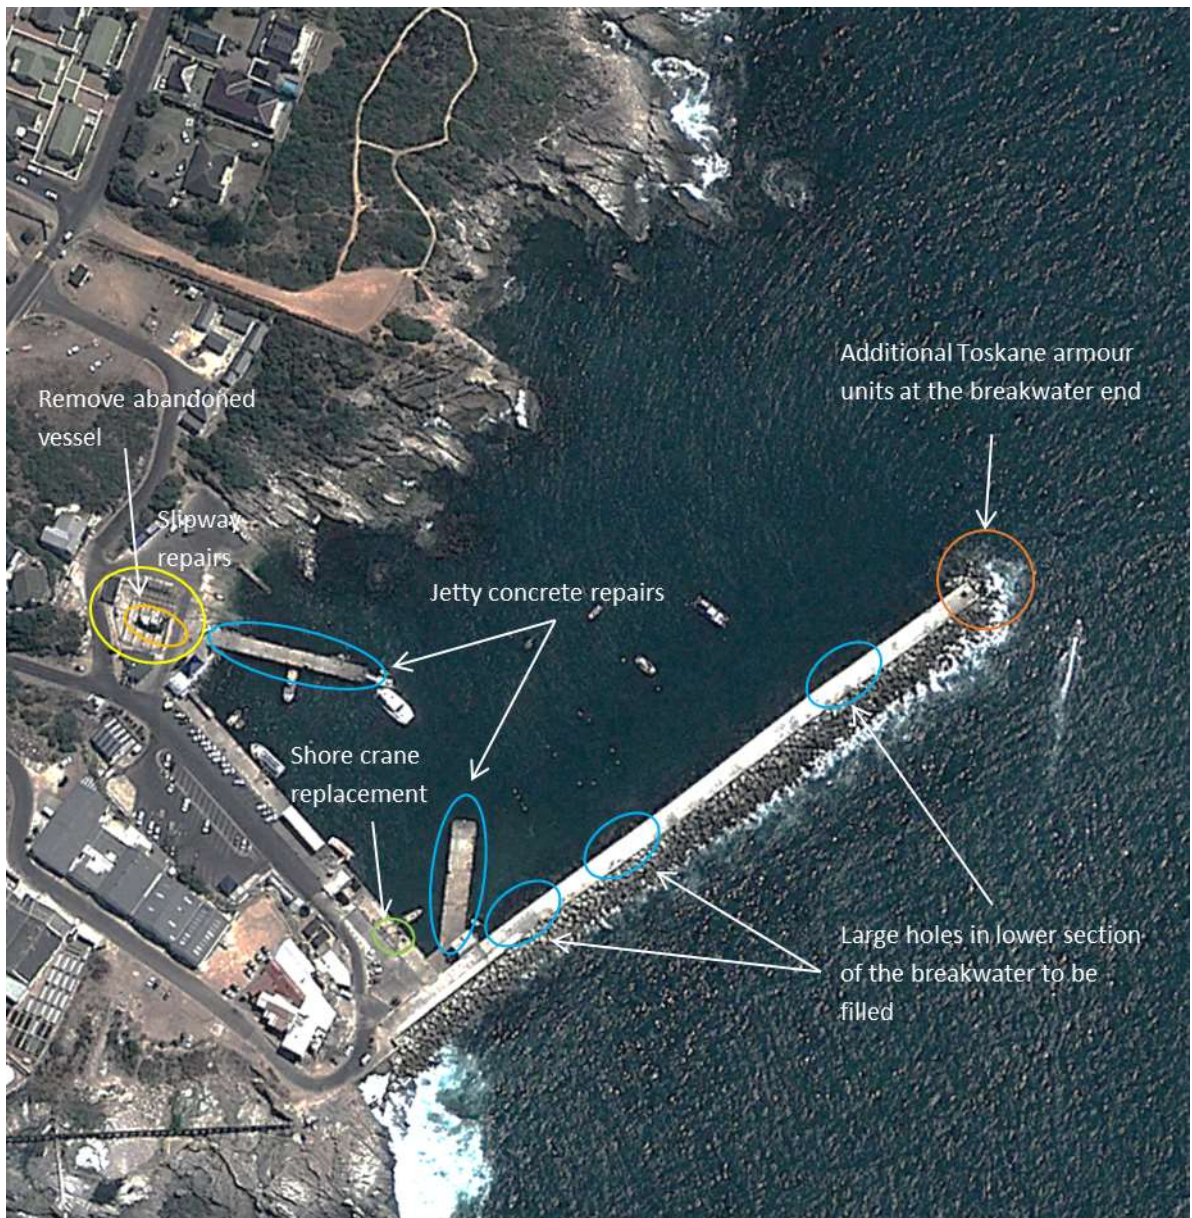
**Figure 2-2:** Work required in Hermanus Harbour

<p><u>Breakwater jetty</u> The two end raker piles of the breakwater jetty are cracked due to overloading and need to be repaired.</p>

<p><u>Lead-in jetty</u> Concrete repairs are required on the underside of jetties where the reinforcing steel is corroding and the concrete is spalling – typical of the breakwater and lead-in jetty.</p>

<p><u>Main quay</u> Fender fixings along the quay have corroded and need to be replacement. Damaged and missing tyres need to be replaced.</p>	 
<p><u>Breakwater jetty</u> As above</p>	 
<p><u>Lead-in jetty</u> Bollards need to be cleaned and painted. Corroded bollard holding down bolts must be replaced.</p>

<p><u>Bogie wheels</u> Some of the bogie wheels are worn and corroded and tend to jam during operation. All bogie wheels need to be removed, serviced and re-installed. Badly damaged bogie wheels will be replaced.</p>

<p><u>Slipway cradle</u> Dismantle, clean and apply corrosion protection to the cradle structural steel.</p>

<p><u>Slipway rails</u> Replace sacrificial anodes and damaged fixings.</p>

<p><u>Breakwater end</u> Additional Toskane concrete armour units are required at the end of the breakwater.</p>	 
<p><u>Navigational light</u> The door of the breakwater navigational light needs to be replaced.</p>	 
<p><u>Holes within breakwater</u> There is a significant flow of water through holes within the breakwater. These holes are to be grouted up with the use of underwater grout, grout bags and a dop pump. This repair work will not increase the footprint of the breakwater</p>

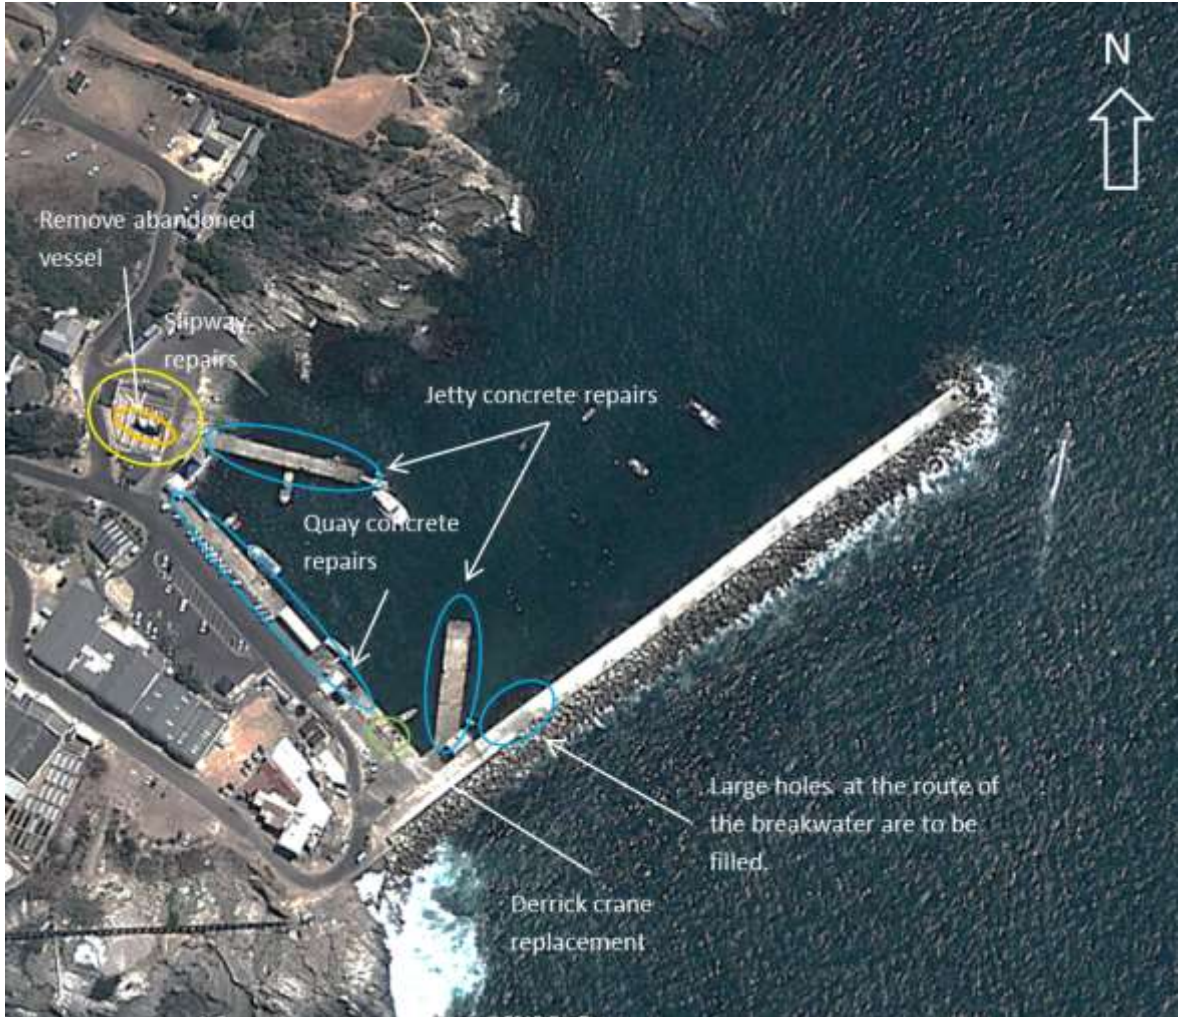
**Figure 2-2: Work required in the Hermanus Harbour**

A summary of the repair and maintenance work required in Hermanus is shown in **Error! Reference source not found.**

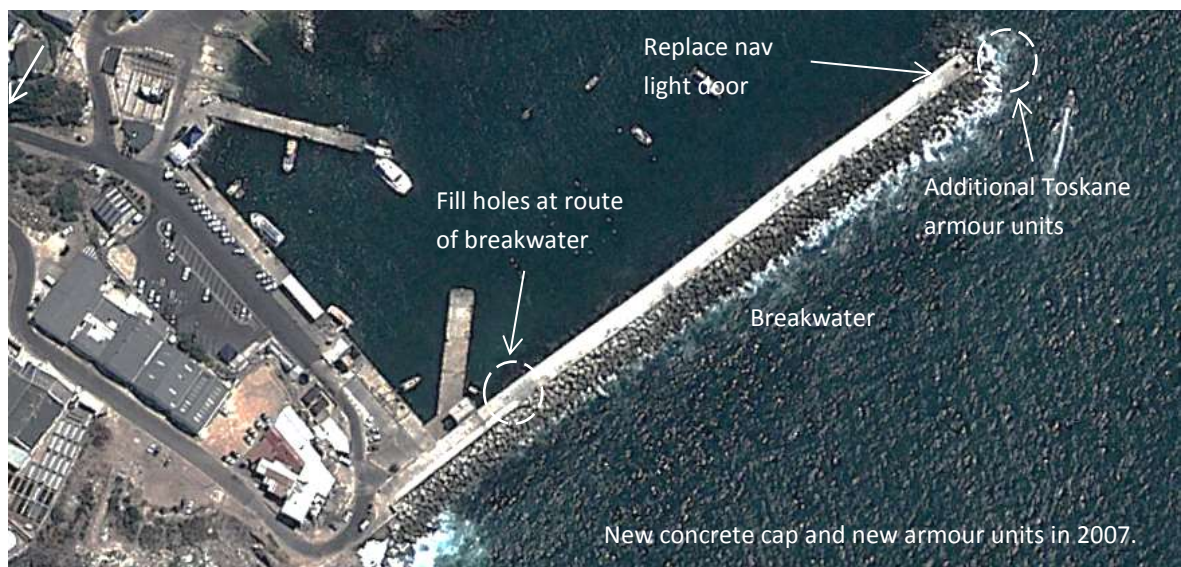
**Figure 2-3: Main Breakwater Structure**

The breakwater is 290 m long and has been constructed as a thick insitu concrete cap on top of randomly placed concrete blocks as shown below. Toskane concrete armour units were placed along the seaward face in 2006/2007 for extra protection. Although the breakwater is generally in good condition there is a significant flow of water through the breakwater. This is a result of the very porous randomly packed blocks. This porosity adds to the high wave energy that is experienced in the harbour and is problematic for vessels moored in the harbour. Figure 2-2 Shows the main breakwater structure in the Hermanus Harbour. The following repair work is required:

The Hermanus breakwater is generally in good condition, with minor repair work required. Refer to Table 2-2 for breakwater repairs.

<p><u>Breakwater end</u></p> <p>Additional Toskane concrete armour units are required at the end of the breakwater.</p>	 
<p><u>Navigational light</u></p> <p>The door of the breakwater navigational light needs to be replaced.</p>	 
<p><u>Holes within the route of the breakwater</u></p> <p>Grout holes along the route of the breakwater. This will involve the use of underwater grout, grout bags and a dop pump to pump the grout into the holes within the breakwater. The repair work will not increase the foot print of the breakwater.</p>

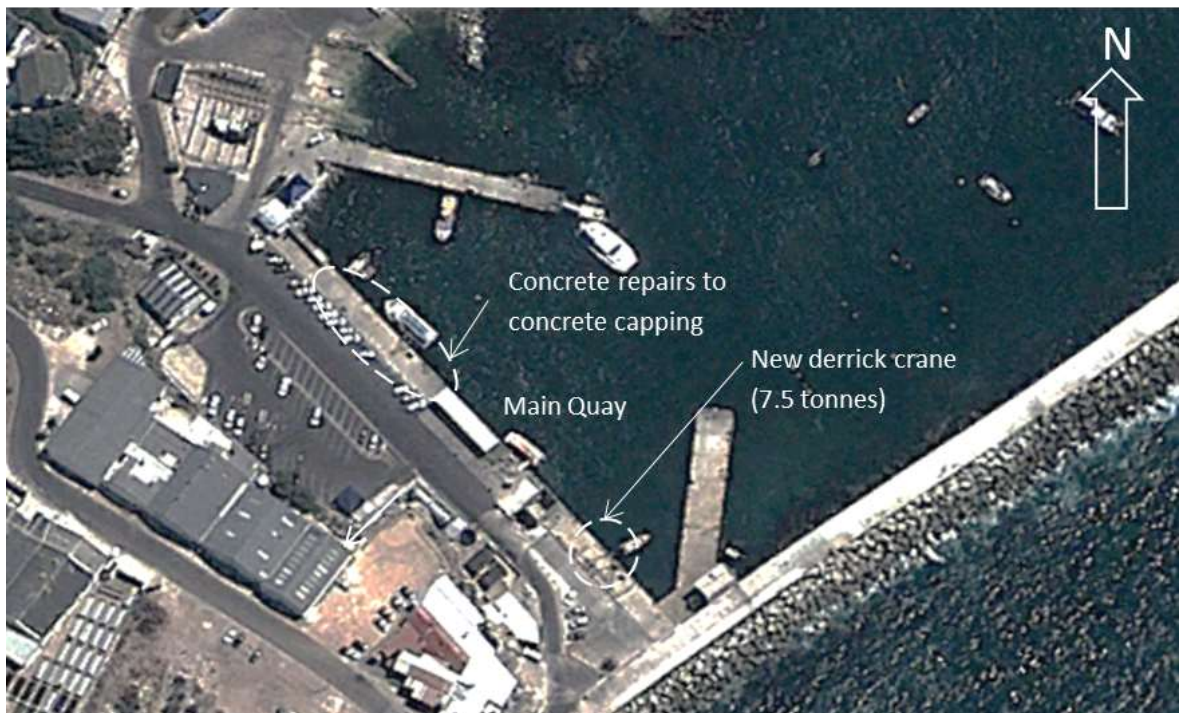
**Figure 2-4: Main Quay Structure**

The main quay is a 140 m long mass concrete blockwork gravity wall. The following repair work is required:

<p><u>Concrete Repair</u> Concrete repairs along the concrete capping of the main quay (excessive cracking).</p>

- Minor concrete repairs along the cope edge and capping;
- Replace badly corroded bollards;
- Replace corroded and missing fender fixings;
- Replace damaged and missing fenders; and
- Replace derrick quay crane.

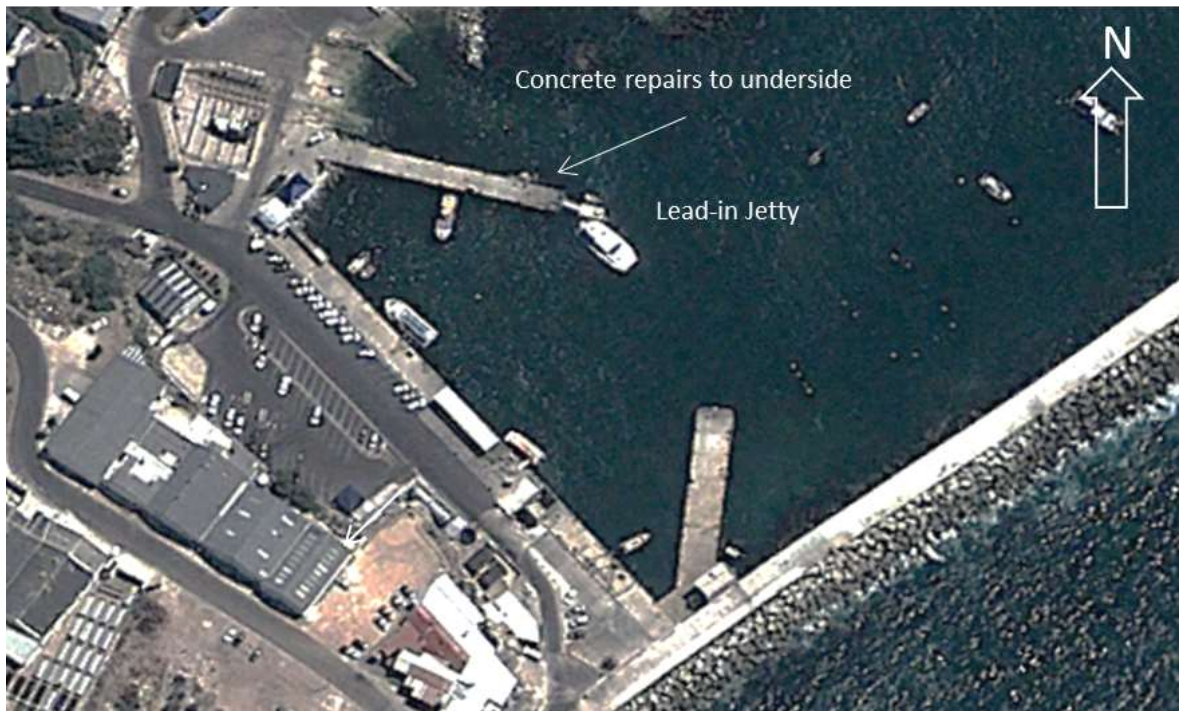
**Figure 2-5: Lead in Jetty Structure**

Figure 2-5 shows the lead in jetty structure in the Hermanus Harbour, whereas Table 2-4 shows the typical repair work required.

- Minor concrete repairs along the cope edge (end section);
- Concrete repairs on the underside of the jetty;
- Repair, clean and paint bollards;
- Replace corroded and missing fender fixings; and
- Replace damaged and missing fenders.
