### Kalk Bay Fishing Harbour: Notification of Intent to Develop

## Professional Consultancy Services for Coastal Engineering Infrastructure Activities – Proclaimed Fishing Harbours Western Cape

Kalk Bay Harbour

S2042-1-TN-EN-002

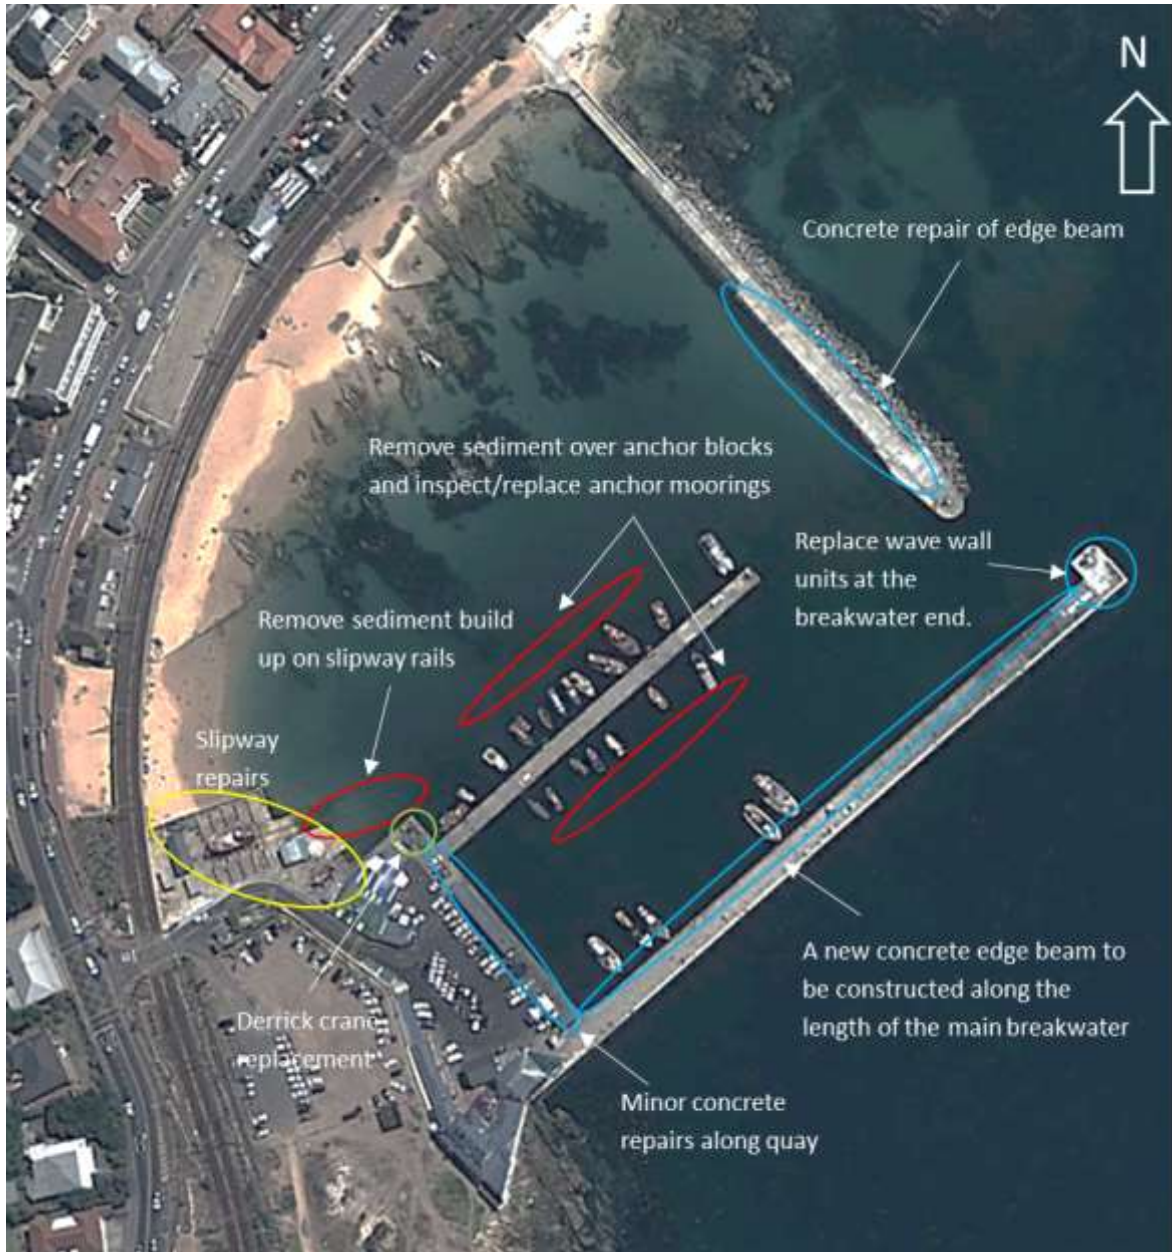
**Figure 2-2:** Work required in the Kalk Bay Harbour

A summary of the repair and maintenance work required in Kalk Bay is shown in Figure 2-2.

<p><u>Main Breakwater</u> Concrete repair of the capping at the route of the primary breakwater.</p>	 
<p><u>Fish Landing Quay</u> Concrete patch repairs along the cope edge of the fish landing quay. This will include careful breakout of the damaged concrete, cleaning of corroded steel reinforcement, steel passivation coating and the application of repair mortar.</p>	 
<p><u>Secondary Breakwater</u> Cast a reinforced concrete edge beam to seal off side of secondary breakwater cap to prevent loss of fine material.</p>

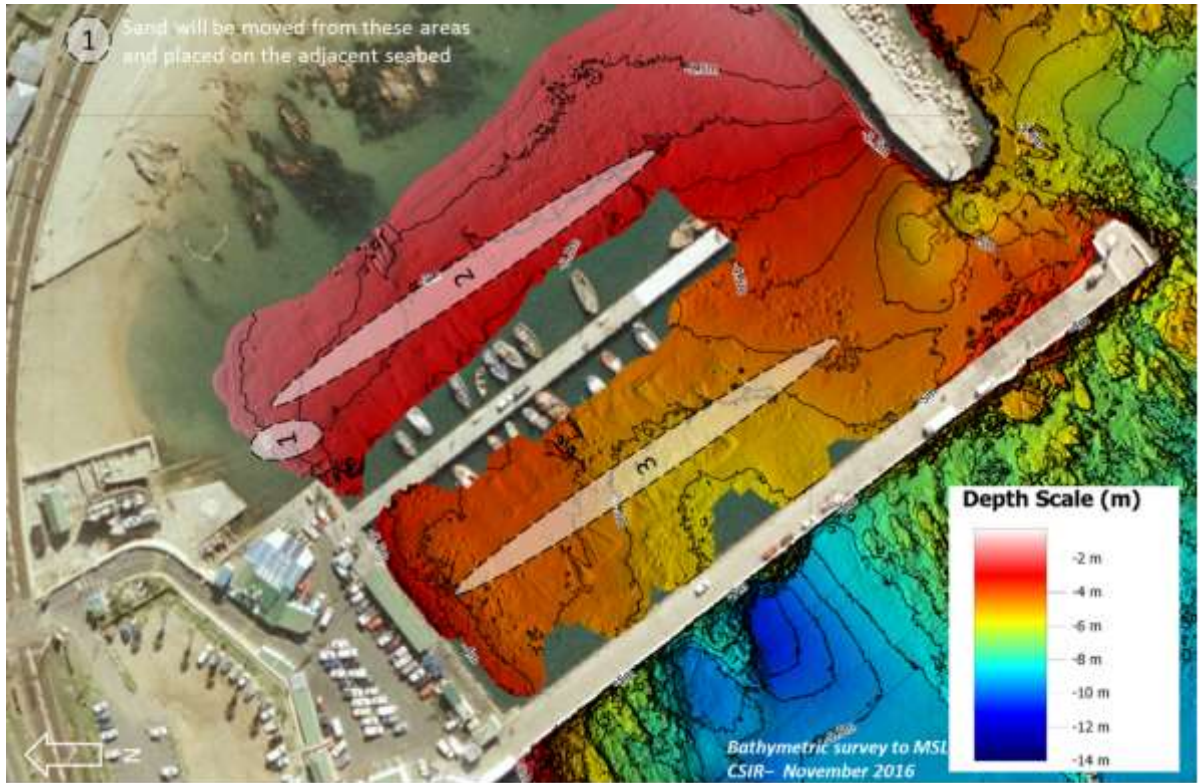
**Figure 2-5:** Dredge areas for Kalk Bay harbour

Based on the hydrographic survey for Kalk Bay harbour, there is sufficient depth for vessels to use all berthing facilities within the harbour, and thus no dredging is required to maintain harbour functionality. However; there are small amounts of material which are to be moved from the large slipway rails and the mooring anchor blocks and chains. Figure 2-5 shows the areas which require material to be moved within Kalk Bay Harbour. The total volume of material to be moved is approximately 335 m<sup>3</sup>.

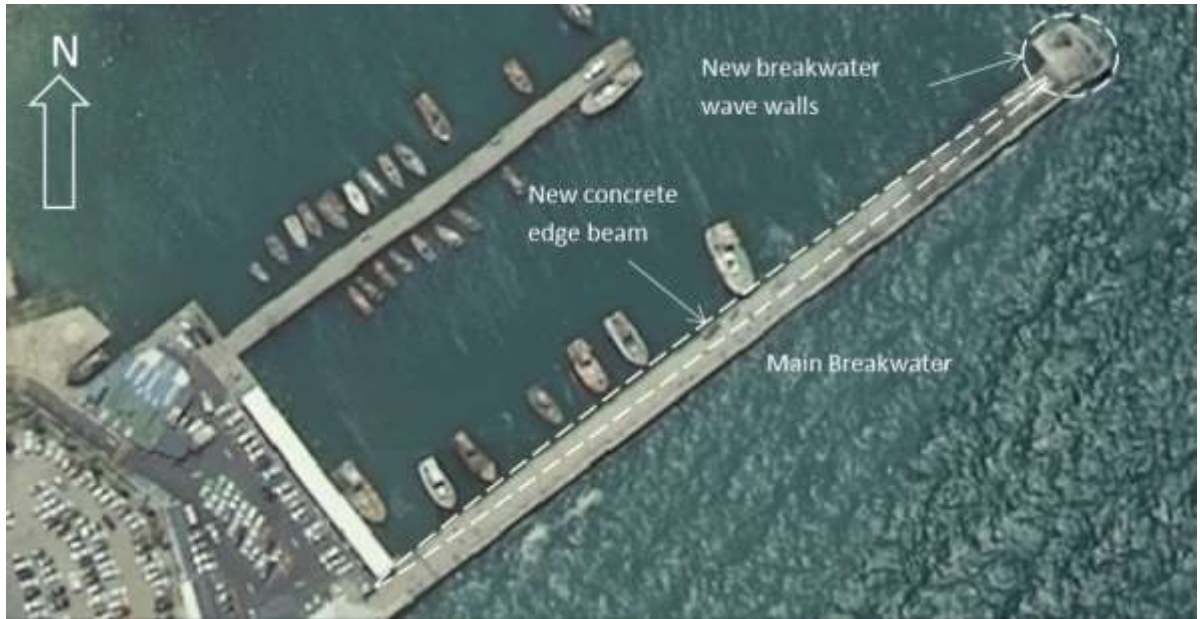
**Figure 2-3: Main Breakwater**

The main breakwater is a 240 m long and 9 m wide gravity structure constructed with packed mass concrete blocks, as shown in **Error! Reference source not found.** The breakwater also provides additional mooring along the leeward side. A proposal for the upgrade of the breakwater is shown in Figure 2-4. The required repair work is as follows:

The Kalk Bay main breakwater is generally in good condition, however some concrete repair, and maintenance of the quay furniture is required. Refer to Table 2-2 for the typical work along the Kalk Bay main breakwater.

- Construct a dividing wall at the beginning of the breakwater. This is to limit access to and from the fish landing quay and preventing seals for accessing the breakwater;
- Concrete repairs to the wave wall;
- Replacement of missing sections of wave wall at the end of the breakwater;
- Fill voids in the vertical breakwater wall above and below water level;
- Repair, clean and paint bollards;
- Supply and install new bollards;
- Replace corroded and missing fender fixings; and
- Replace damaged and missing fenders.

<p><u>Main Breakwater - Concrete Capping</u> Concrete repair of the capping at the route of the primary breakwater.</p>	
<p><u>Main Breakwater – Wave wall repairs</u> Concrete patch repair along the length of the wave wall.</p>

<p><u>Main Breakwater – Wave replacement</u> Replace missing wave wall units.</p>

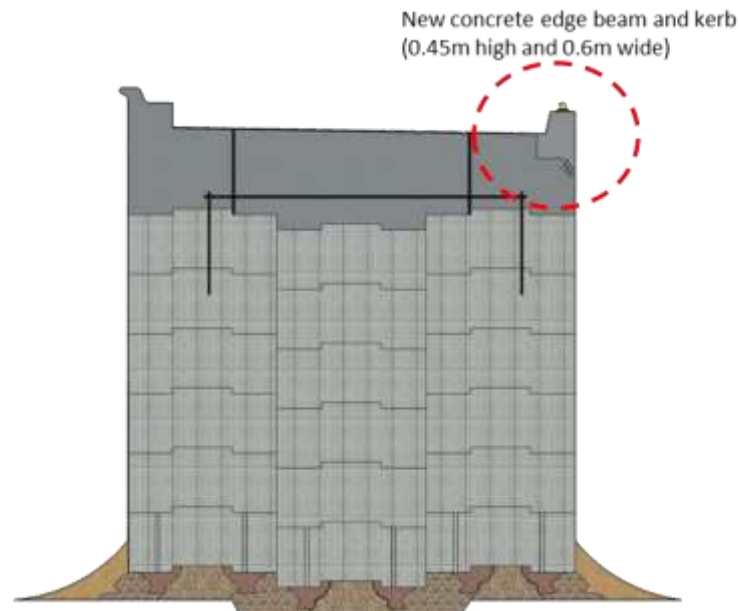
**Figure 2-5: Typical section of the main breakwater and edge beam upgrade**

The inside edge beam along the breakwater is in a poor condition. The limited bollards result in mooring lines being fixed to fender fixings. These fixings are not designed to take the loads and therefore have caused damage to the edge beam. Sections of the cope beam are also undermined due to eroded concrete. The damaged edge beam is illustrated in the photos in Figure 2-4 below.

A new concrete edge beam will be constructed on the leeward side of the breakwater and will accommodate a new layout of bollards and fender fixings. The edge beam will have a 0.45 m high raised kerb. The kerb will improve safety by acting as a barrier along the edge. Gaps will be provided between kerb units for overtopping drainage. Refer to Figure 2-5 for the proposed typical section of the breakwater upgrade.

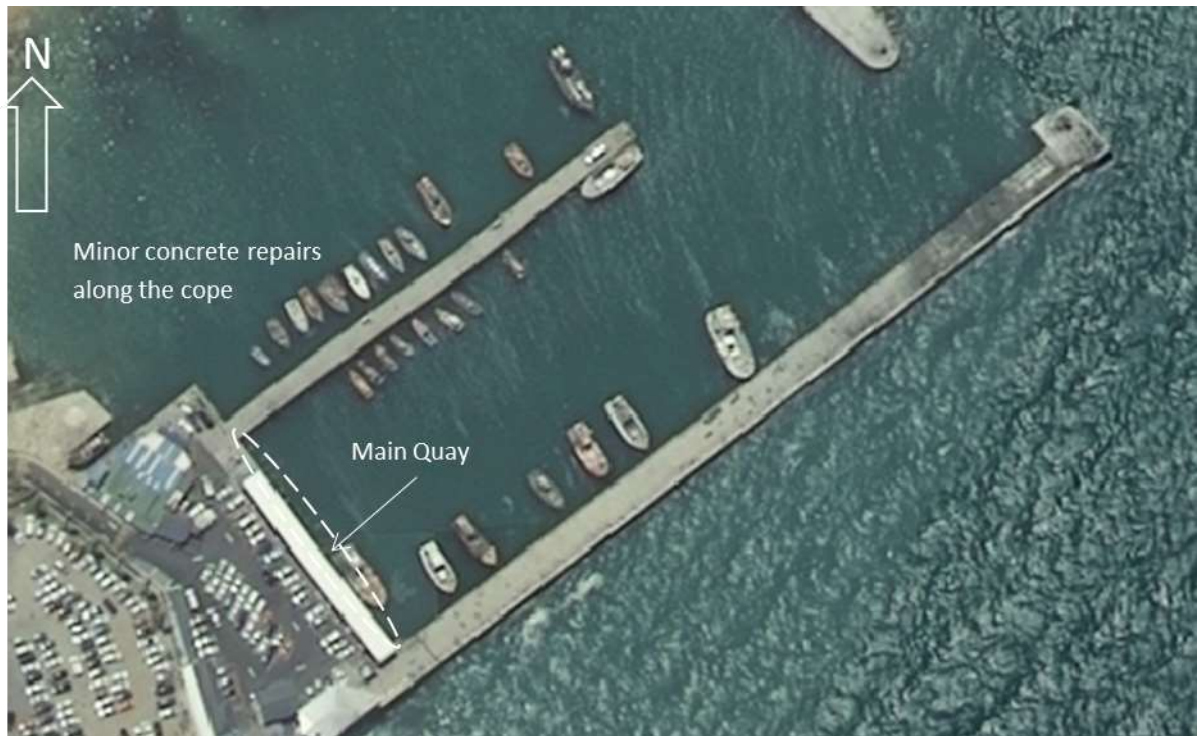
The fish landing quay is a 70 m long precast concrete block wall used for offloading fish and servicing of trawlers. The required repair work is as follows:

- Minor concrete repair along the cope edge of the fish landing quay;
- Repair, clean and paint bollards;
- Replace corroded and missing fender fixings;
- Replace damaged and missing fenders.

Table 2-3 shows the typical concrete repair works required on the fish landing quay, as well as the need for the supply and installation of a new bollard on its eastern edge.
