Timber Roof Construction, Nurses Home, KZN Children's Hospital, Durban.

Terms of Reference

Gavin Brown and Associates were appointed by KZN Children' Hospital Trust, to carry out an urgent investigation of the Timber roof construction over the Nurses Home at the KZN Children's Hospital in Durban.

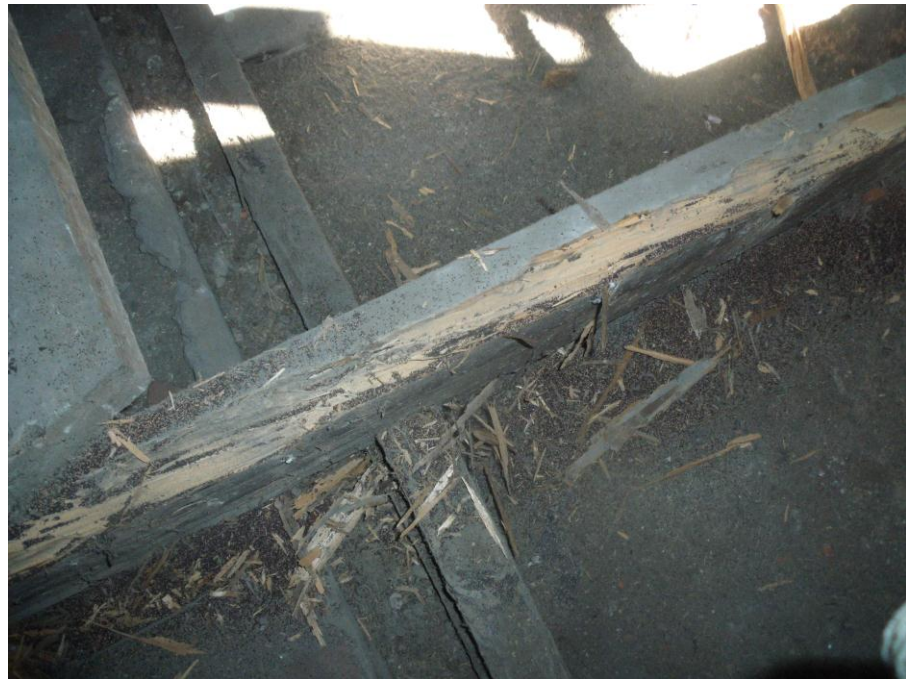
Large amounts of borer dropping were noticed on the ceilings boards. The timber was tested by tapping on its surface with a welders hammer. The surface of timber that appeared sound gave way when struck with the hammer, indicating severe damage from wood borer infestation. This was evident in both the truss timbers and the ceiling joists.

Figure 6- Wood borer damage on truss

We are of the opinion that the trusses over the Nurse's Home cannot be repaired, and recommend that they be replaced with nail plated engineered trusses.
