AMAFA PHOTOGRAPHIC REPORT FOR PROPOSED ADDITIONS AND ALTERATIONS TO 1236 SOUTH COAST ROAD, MOBENI, DURBAN

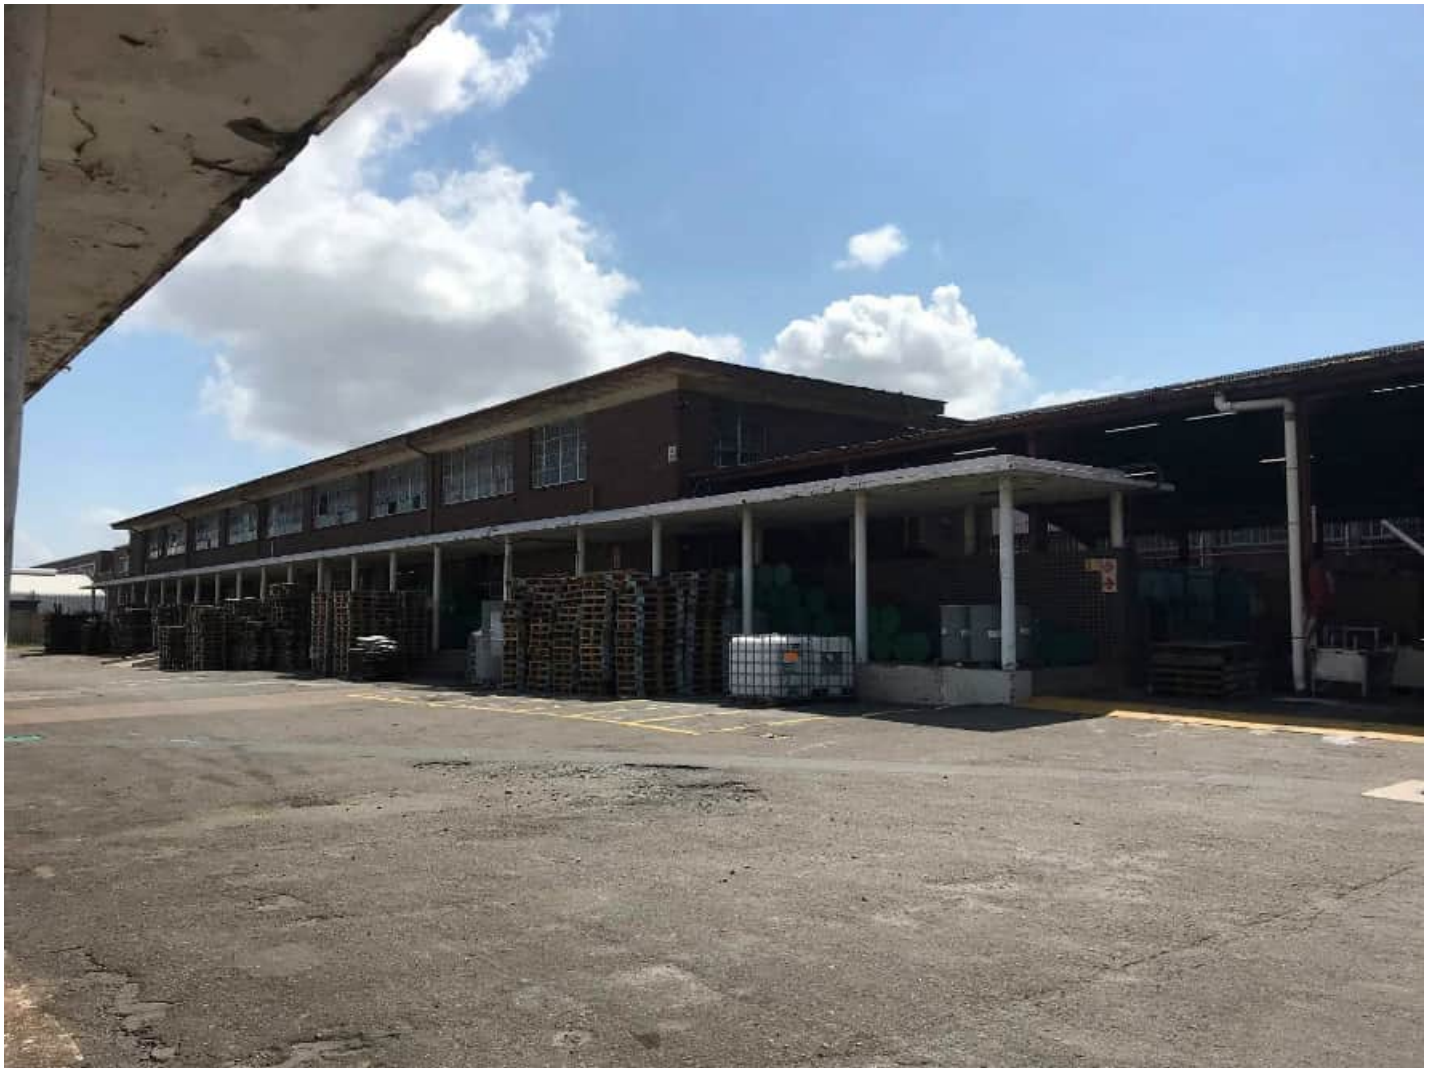
Figure 1). Image illustrates a South Eastern façade view of the existing Laboratory building in which the first-floor items are proposed for demolition.

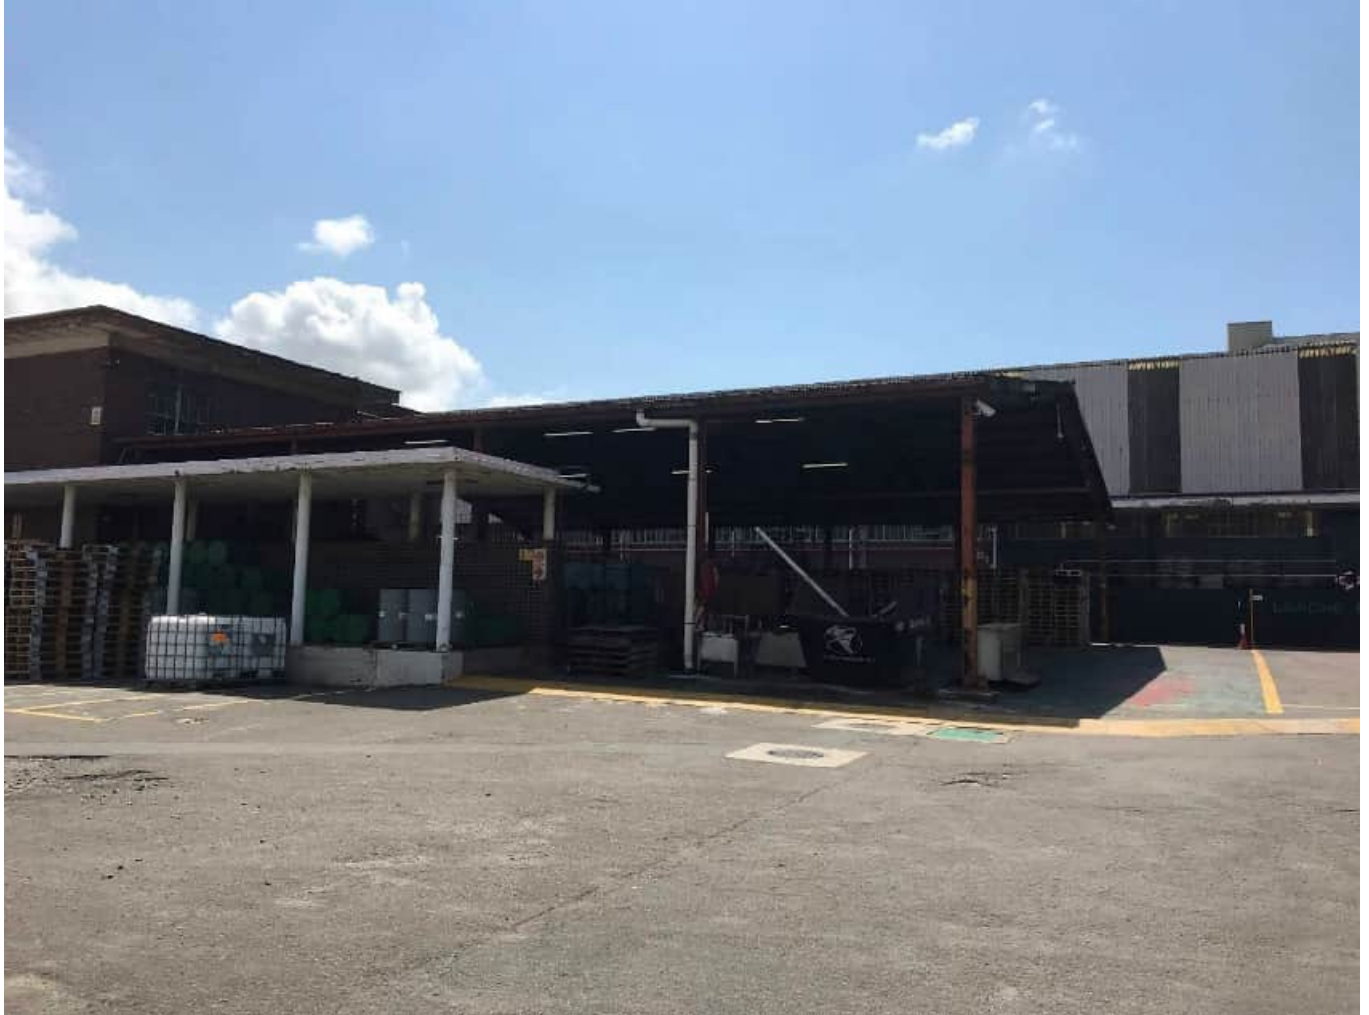
Figure 2.) Image illustrates a South Eastern façade view of the existing Laboratory building in which the part demolition of the canopy is proposed. Image also illustrates existing covered area adjacent to the laboratory, which shall remain in its current state.

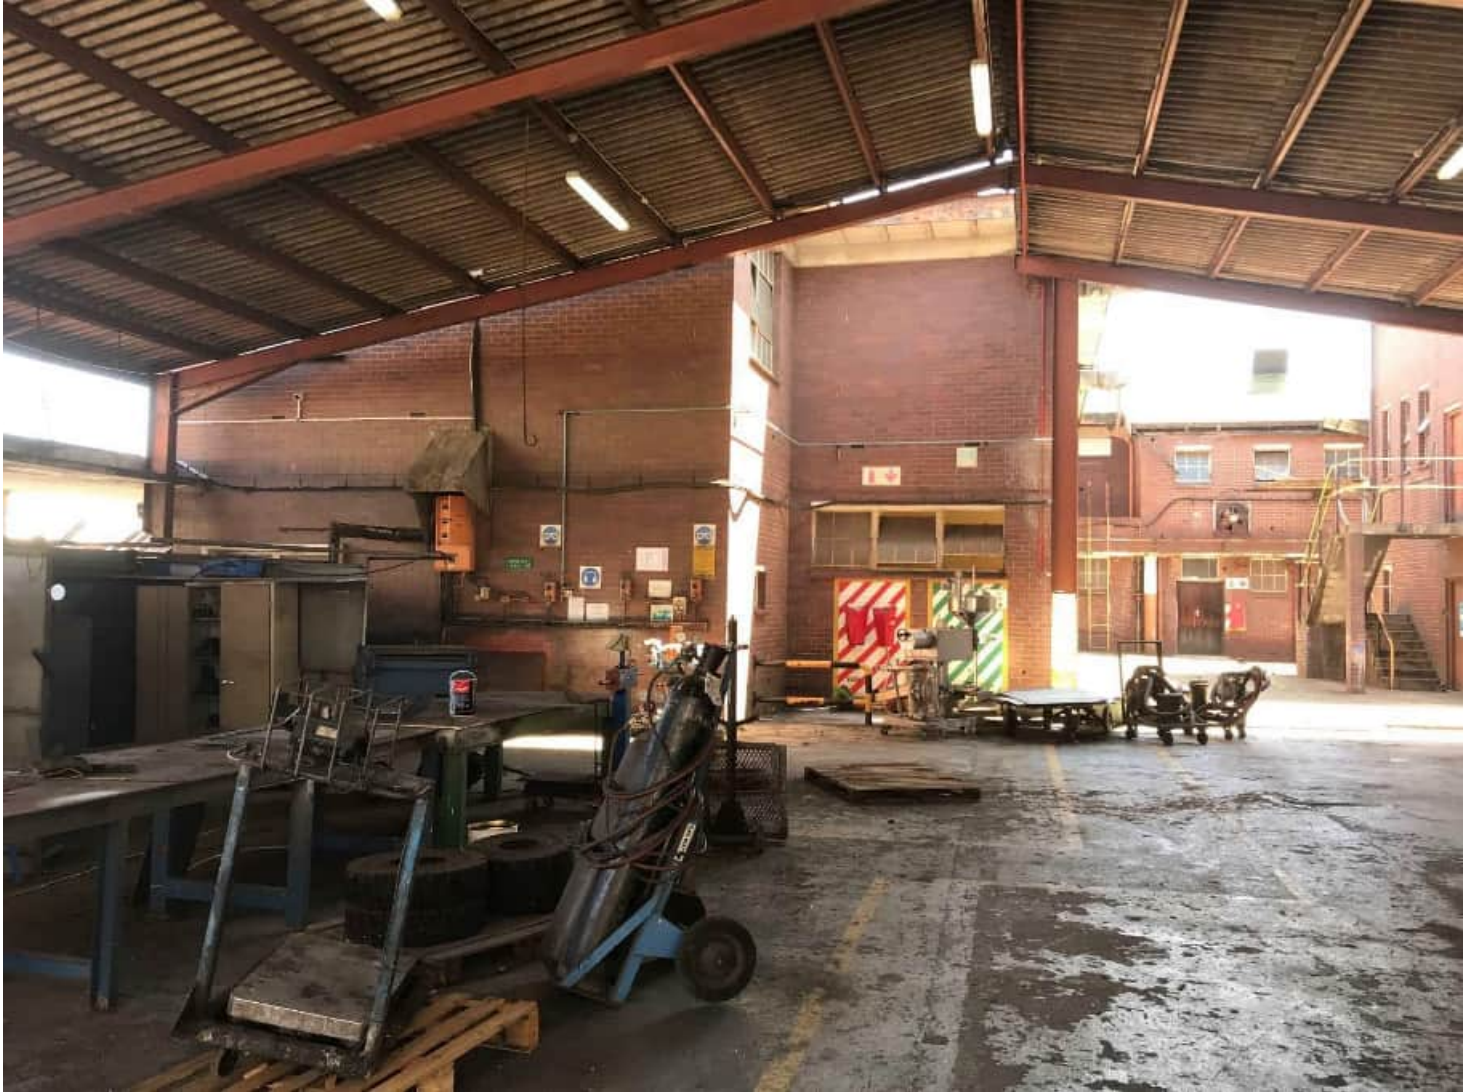
Figure 3.) Image illustrates a part Eastern façade view of the existing Laboratory building in which the demolition of the First floor is proposed. Image also illustrates existing covered area adjacent to the laboratory, which shall remain in its current state. To the far right of the image, the existing staff quarters can be seen in its context, which is also proposed for demolition.

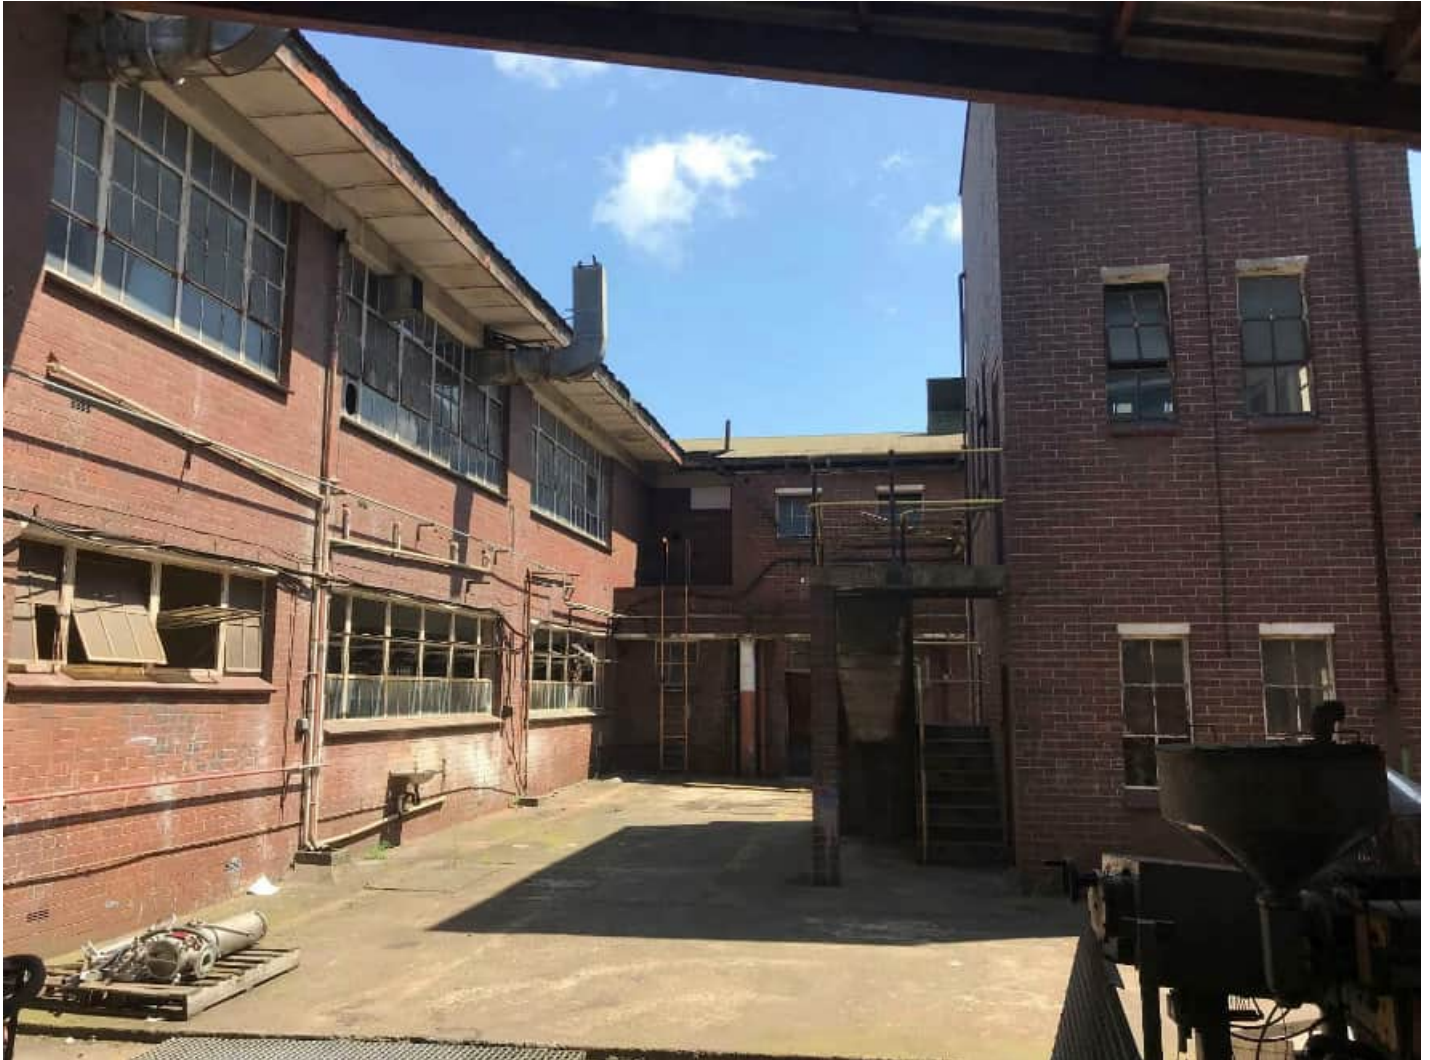
Figure 4.) Image illustrates Eastern façade view of the existing Laboratory building in which the demolition of the First floor is proposed. To the far right of the image, the existing staff quarters can be seen in its context, which is also proposed for demolition.

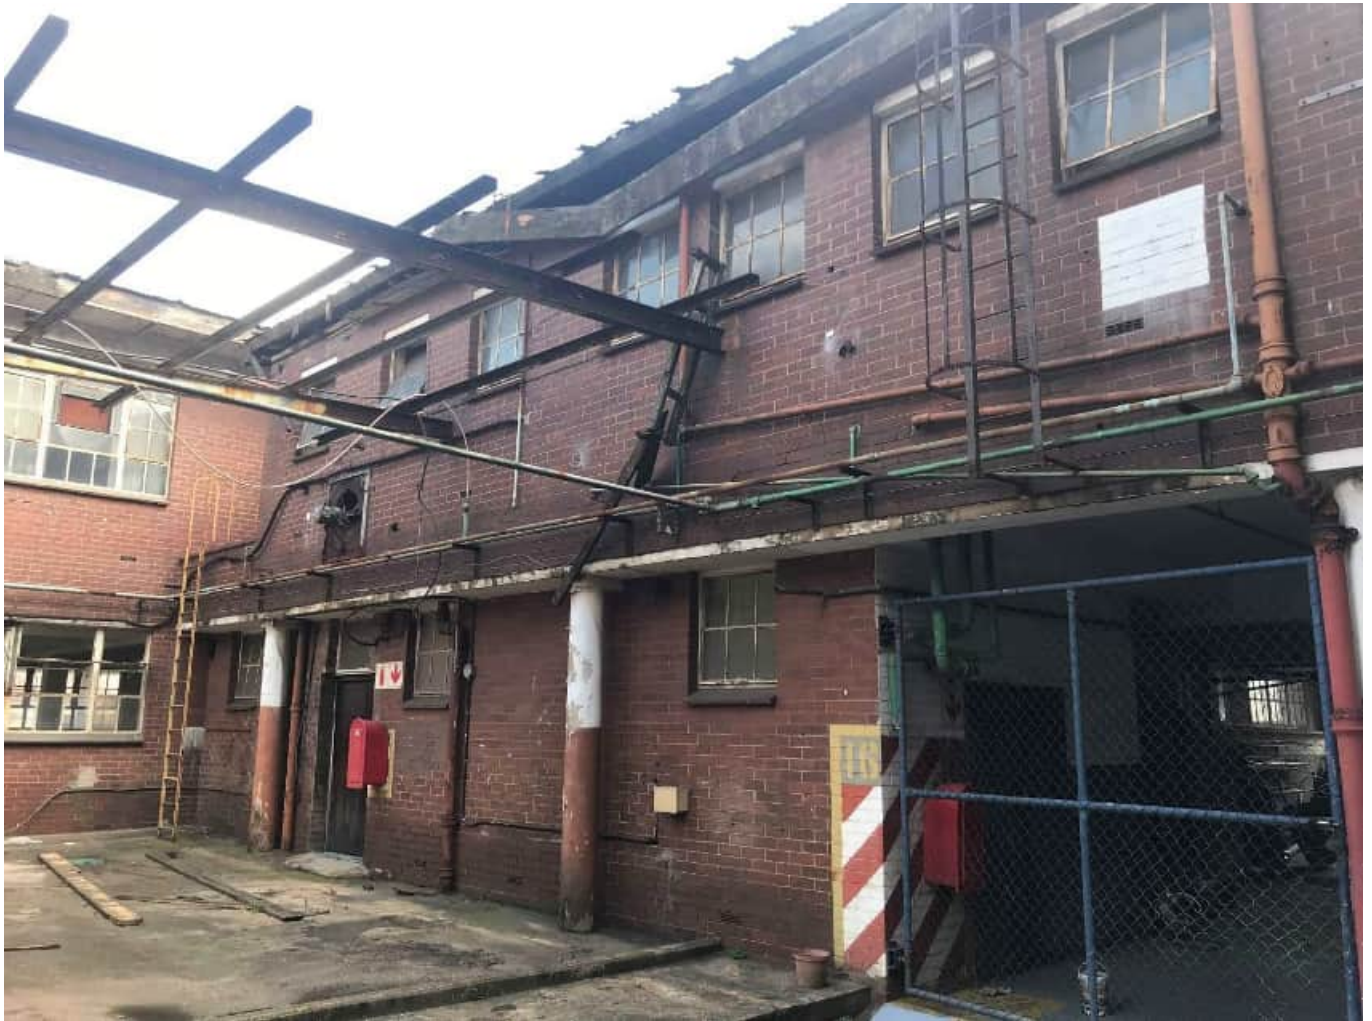
Figure 5.) Image illustrates Eastern façade view of the existing Laboratory building in which the demolition of the First floor is proposed.

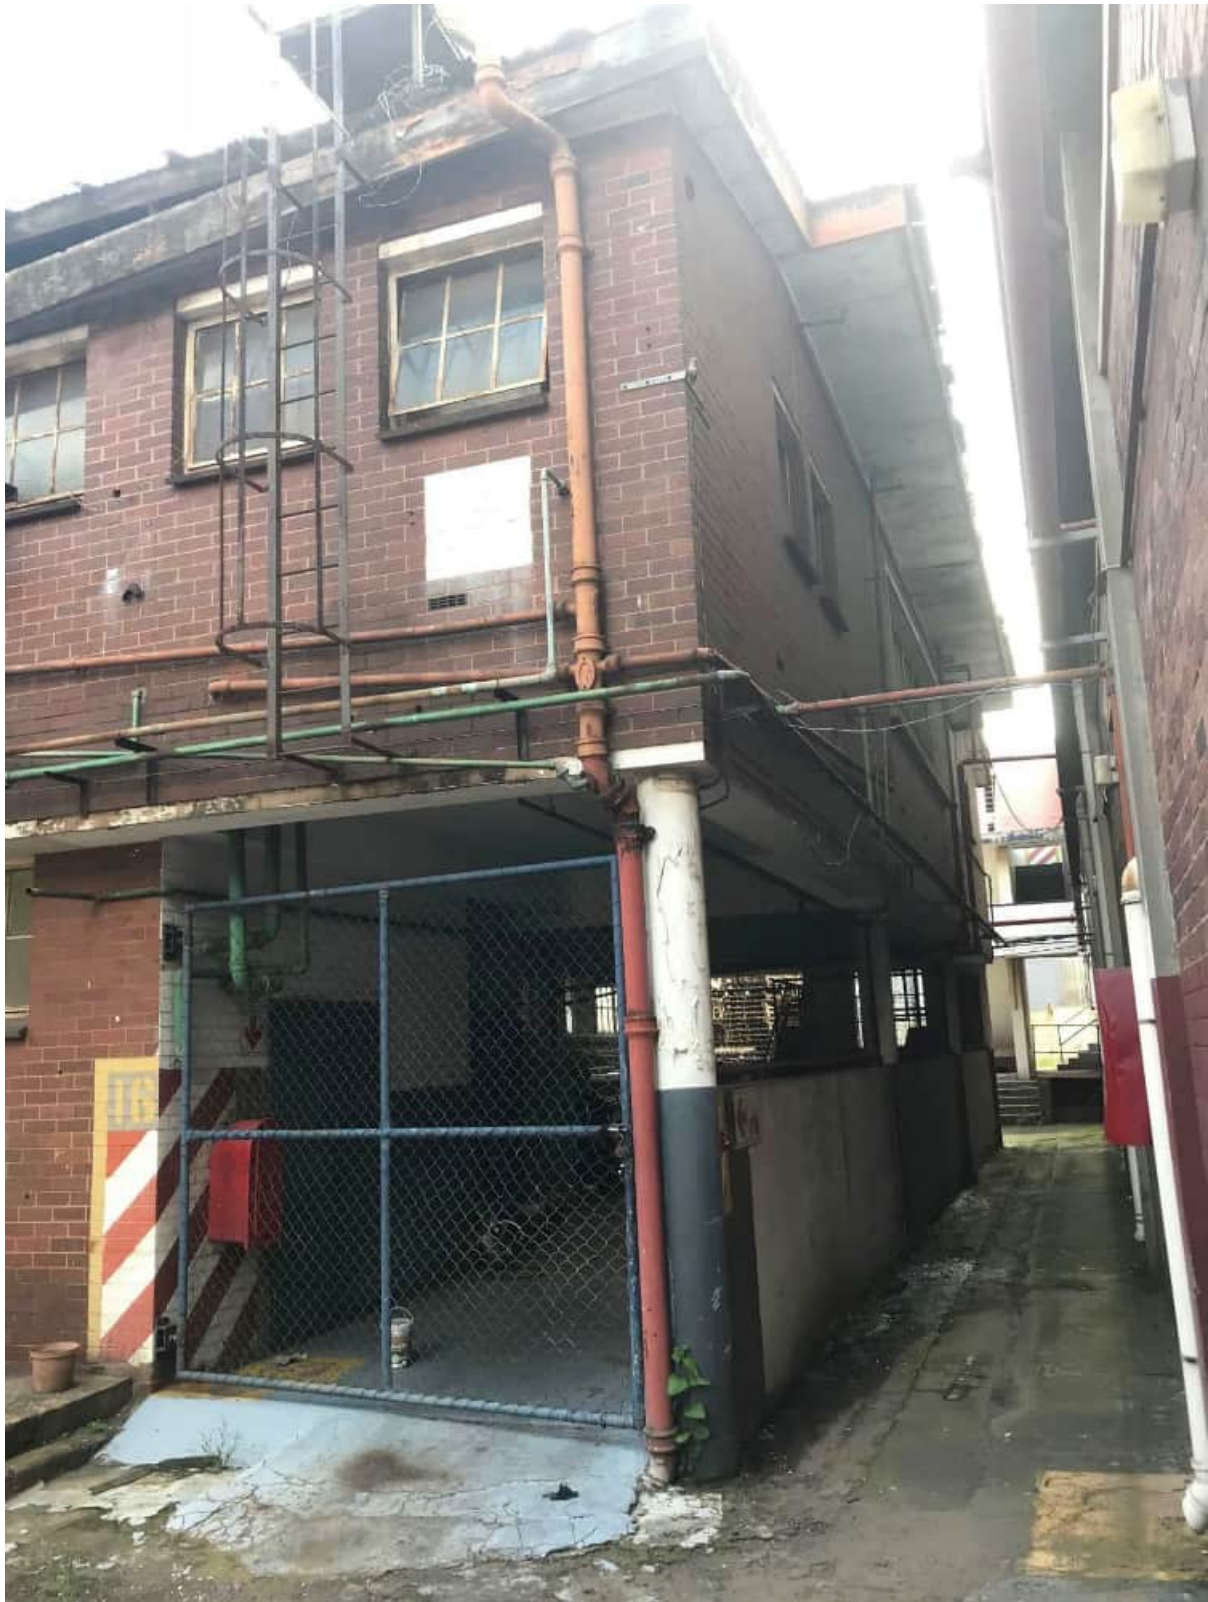
Figure 6.) Image illustrates North Eastern façade view of the existing Laboratory building in which the demolition of the First floor is proposed.

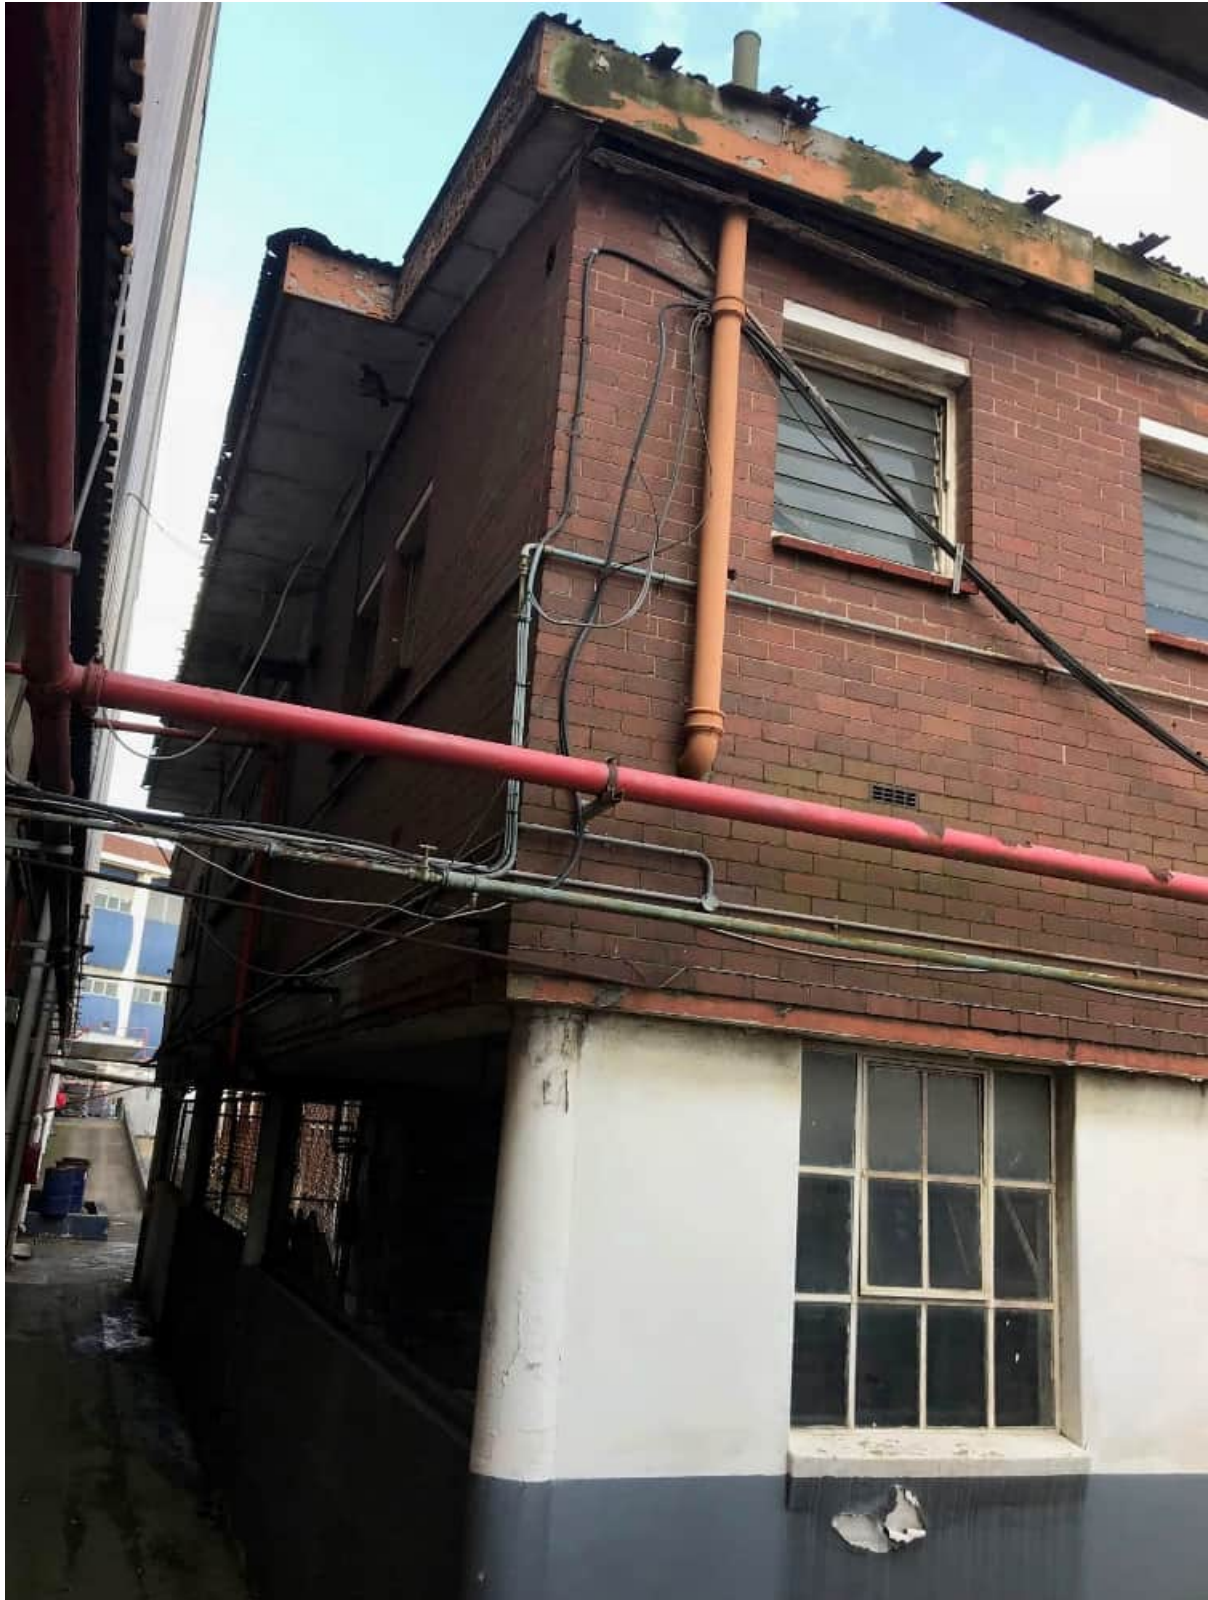
Figure 7.) Image illustrates Northern façade view of the existing Laboratory building in which the demolition of the First floor is proposed.

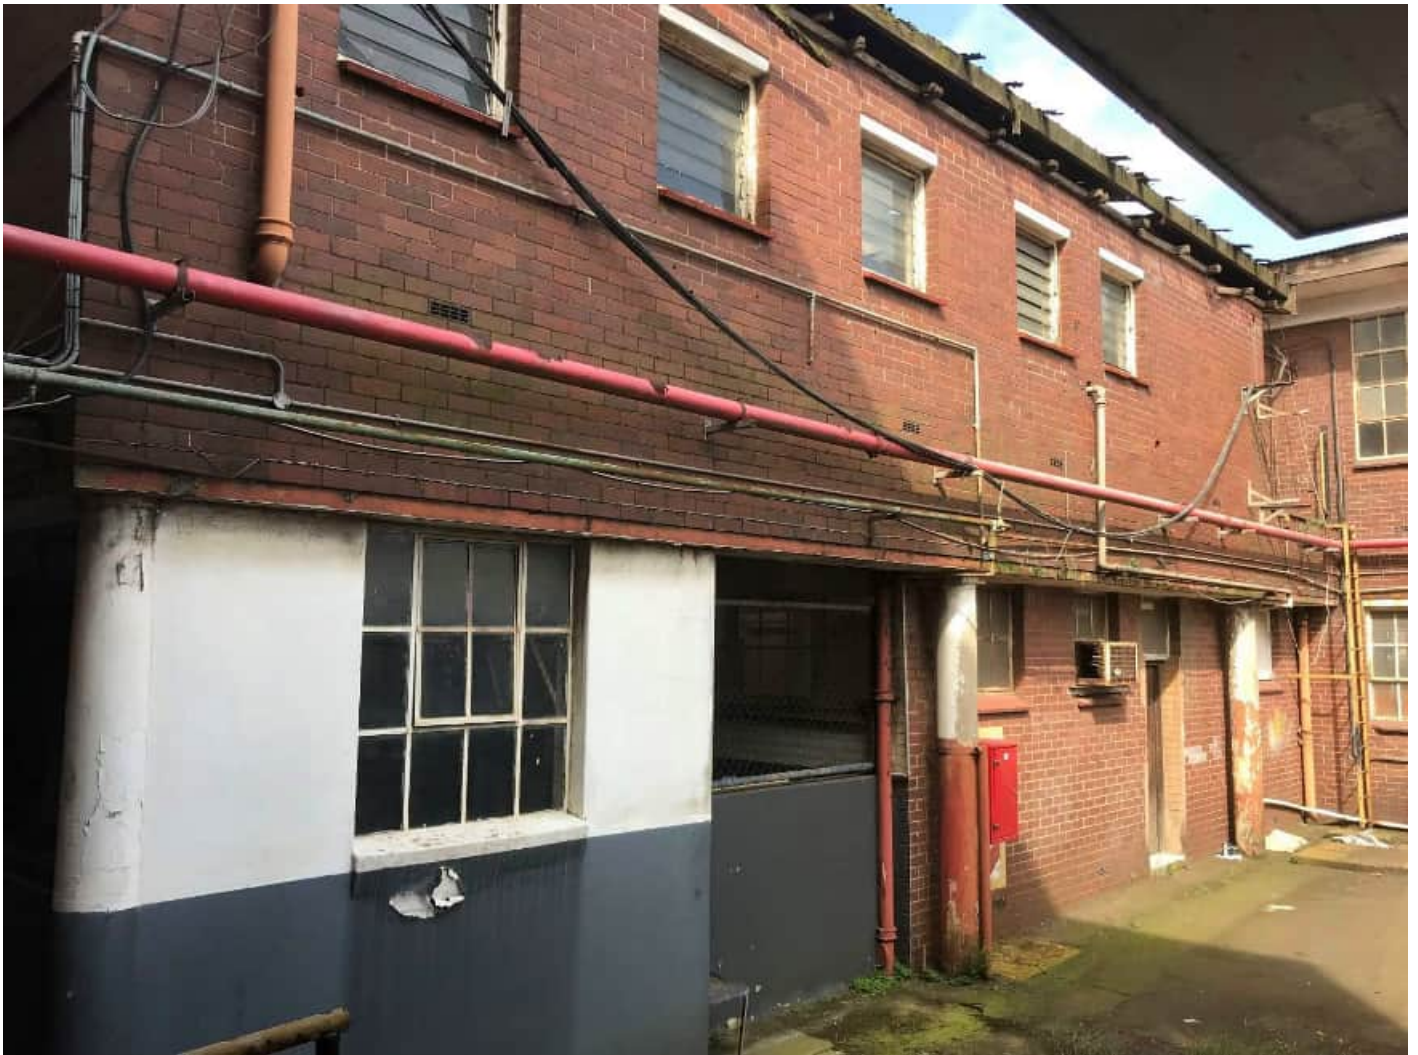
Figure 8.) Image illustrates part North west/Western façade view of the existing Laboratory building in which the demolition of the First floor is proposed.

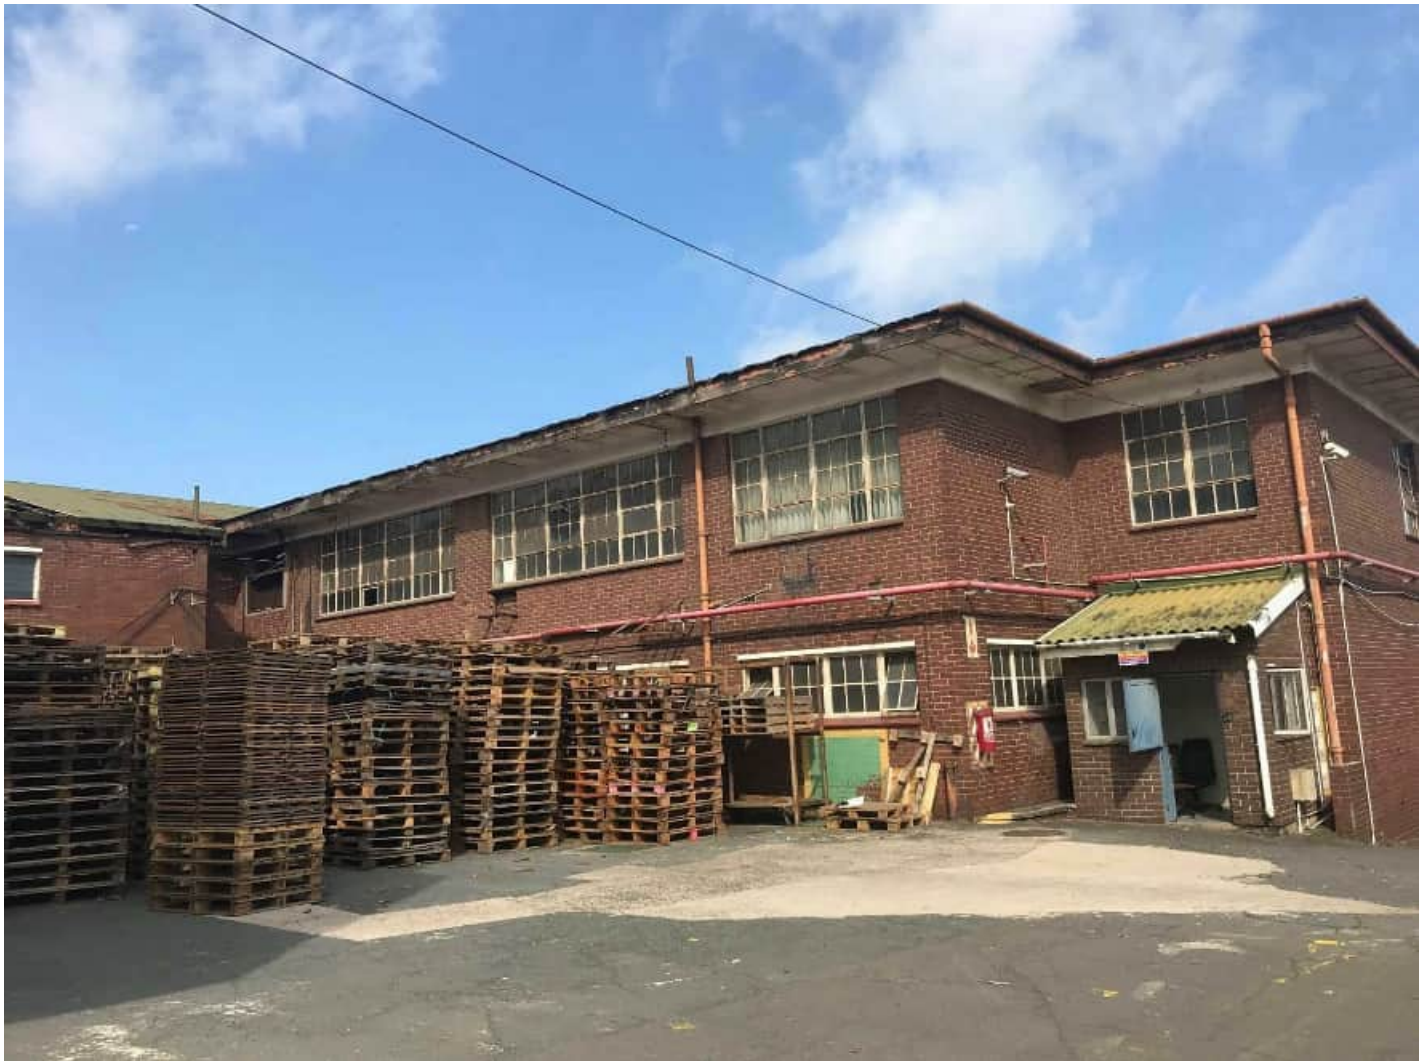
Figure 9.) Image illustrates Western façade view of the existing Laboratory building in which the demolition of the First floor is proposed.

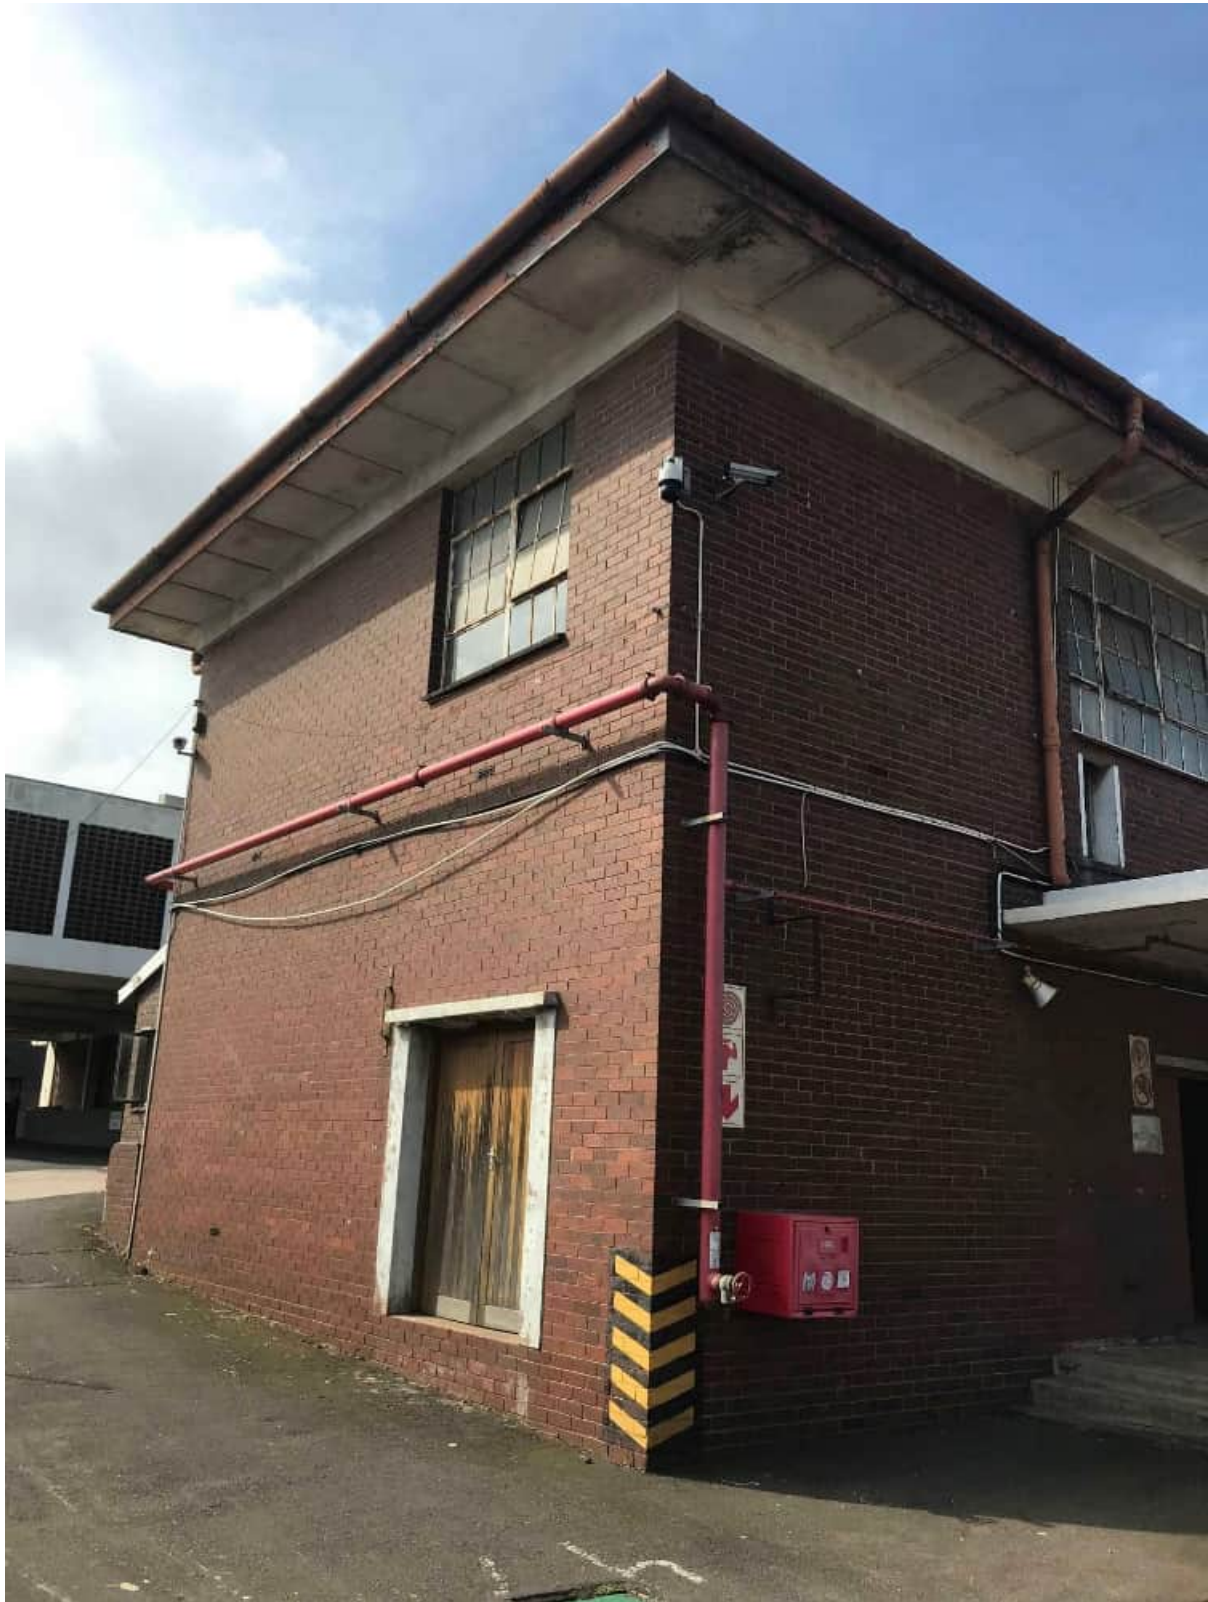
Figure 10.) Image illustrates South Western façade view of the existing Laboratory building in which the demolition of the First floor is proposed.

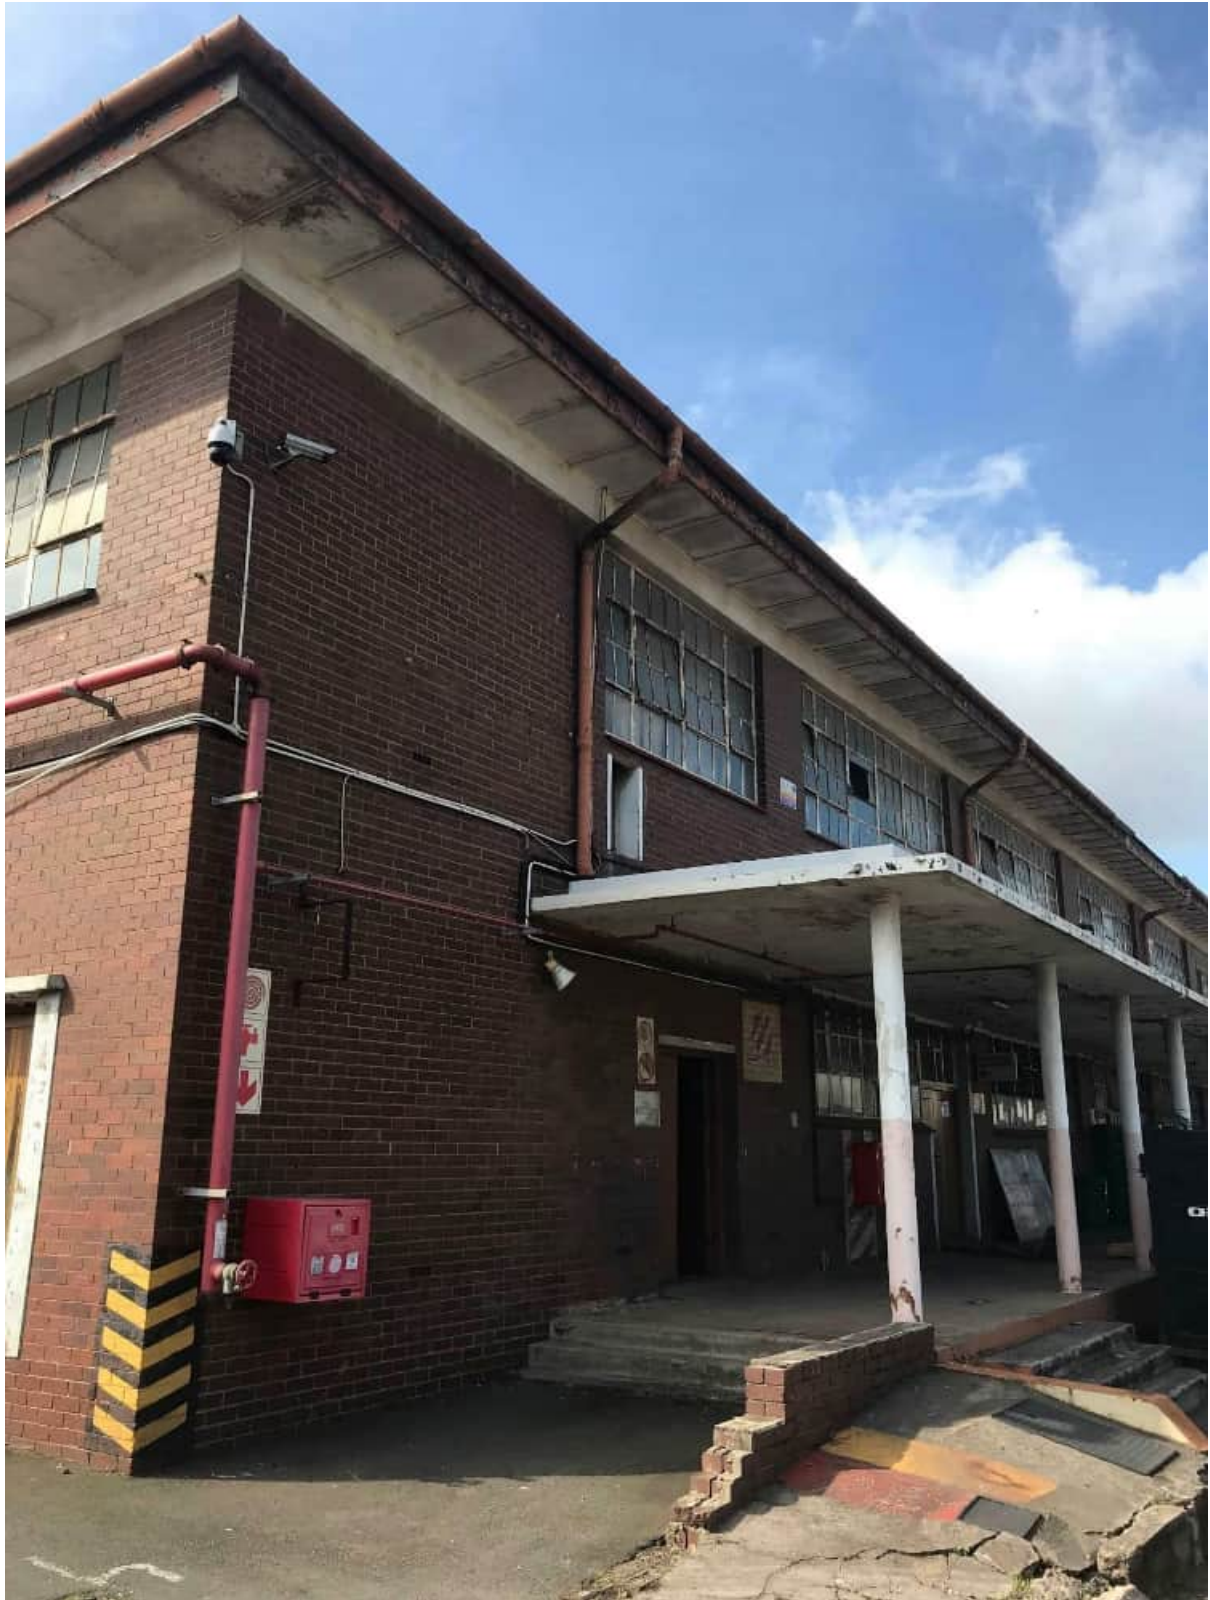
Figure 11.) Image illustrates South Western/South façade view of the existing Laboratory building in which the demolition of the First floor is proposed.

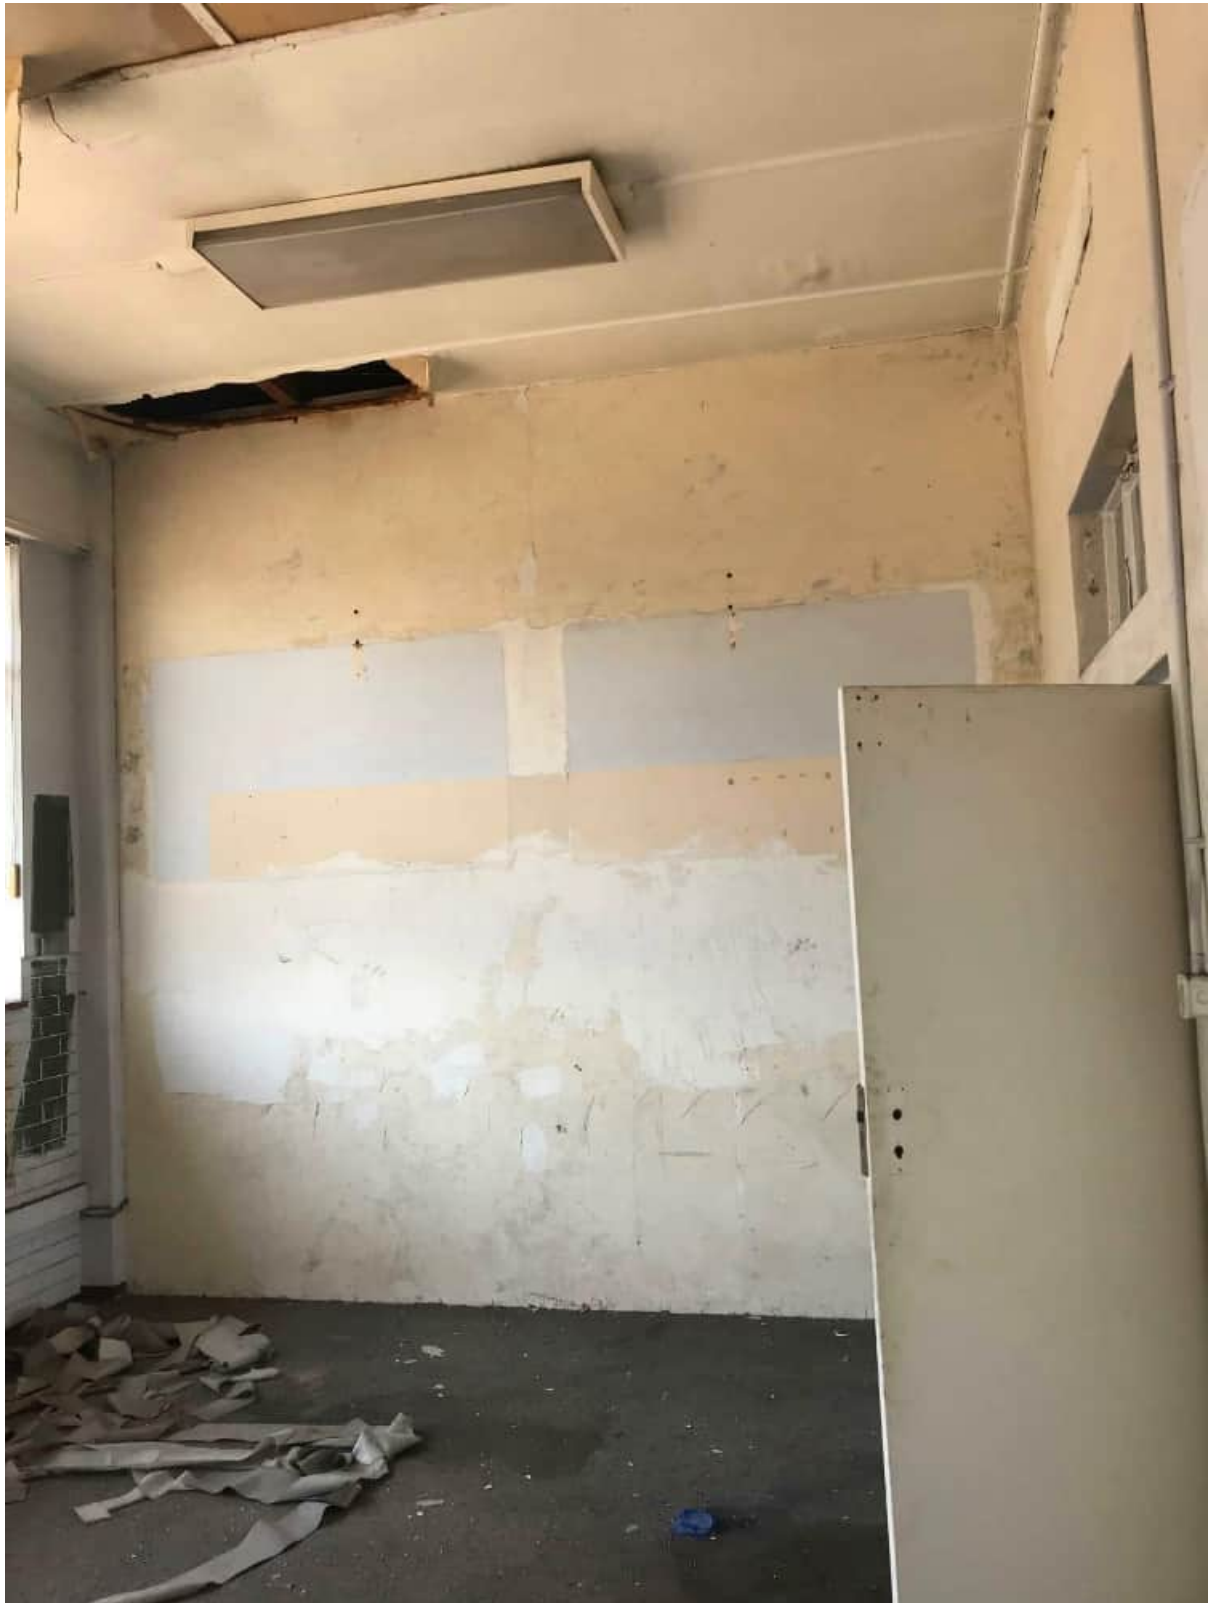
Figure 12.) Image illustrates first floor internals. The proposed includes demolition of all first-floor items.

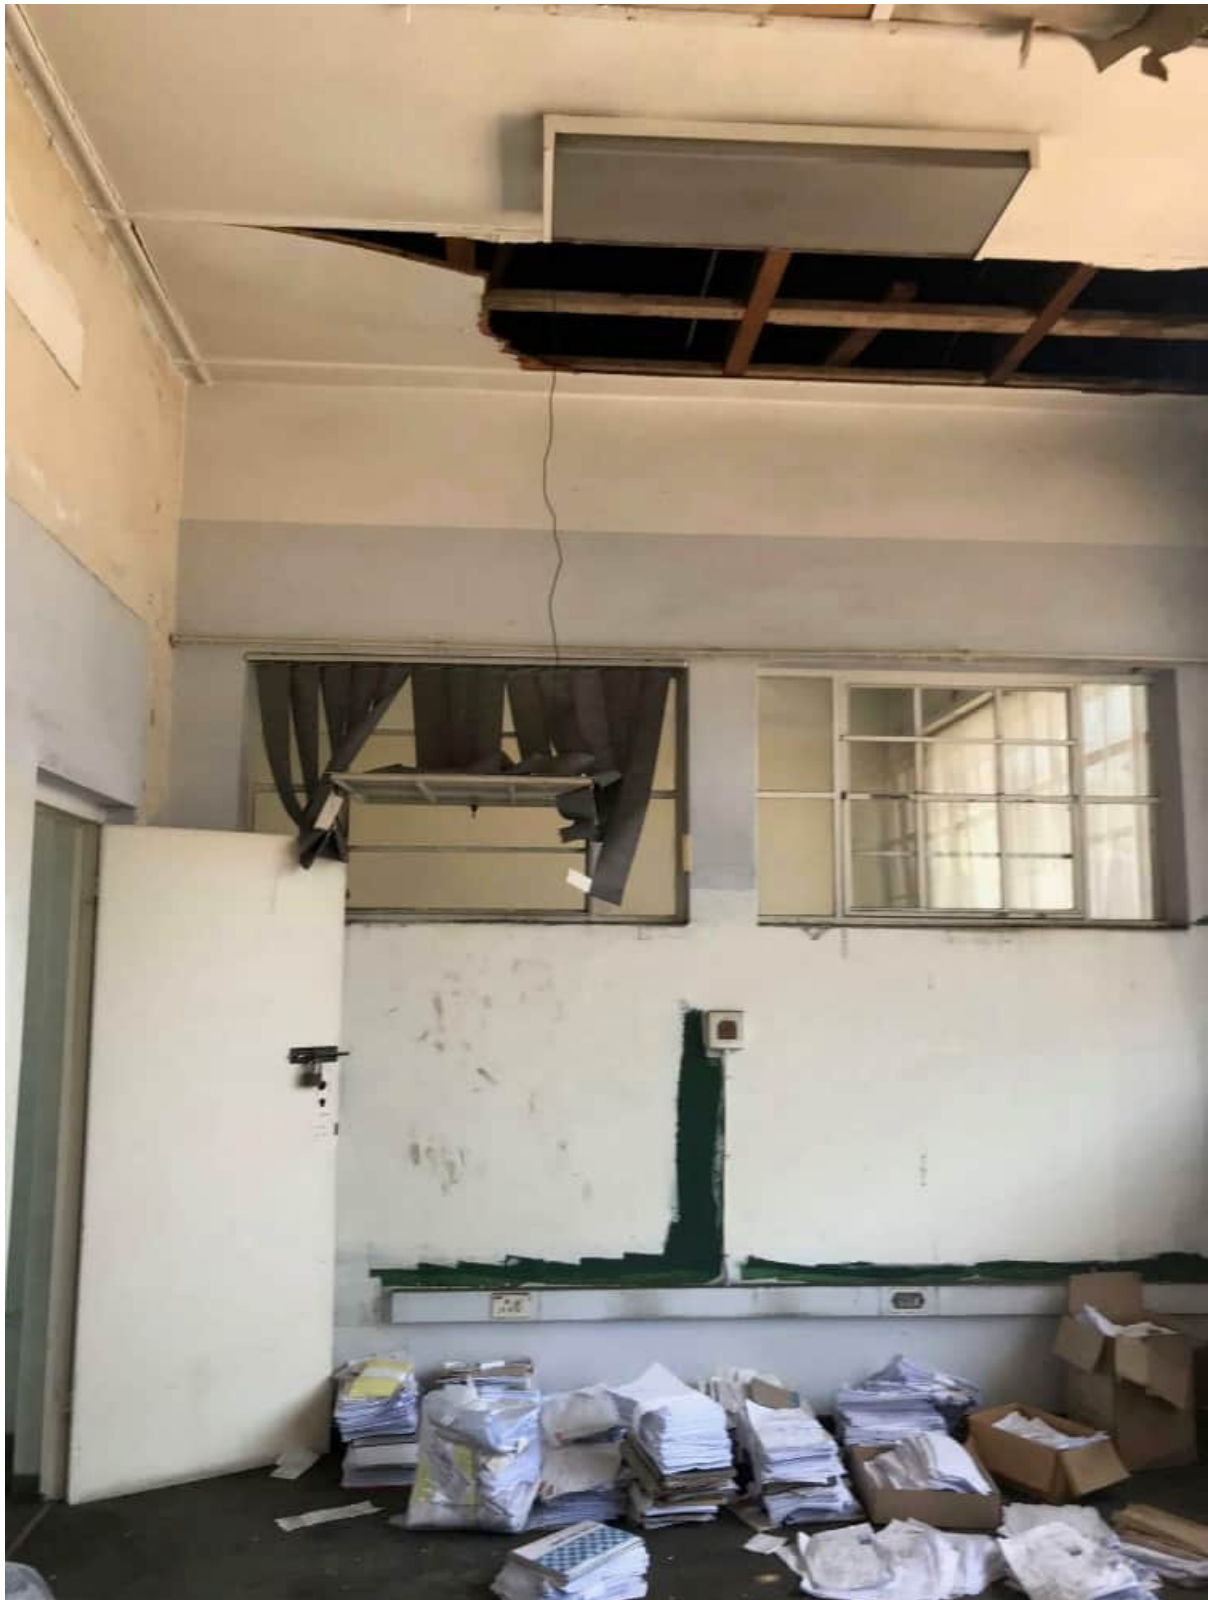
Figure 13.) Image illustrates first floor internals. The proposed includes demolition of all first-floor items.
