AMAFA PHOTOGRAPHIC REPORT FOR PROPOSED ADDITIONS AND ALTERATIONS TO 1236 SOUTH COAST ROAD, MOBENI, DURBAN

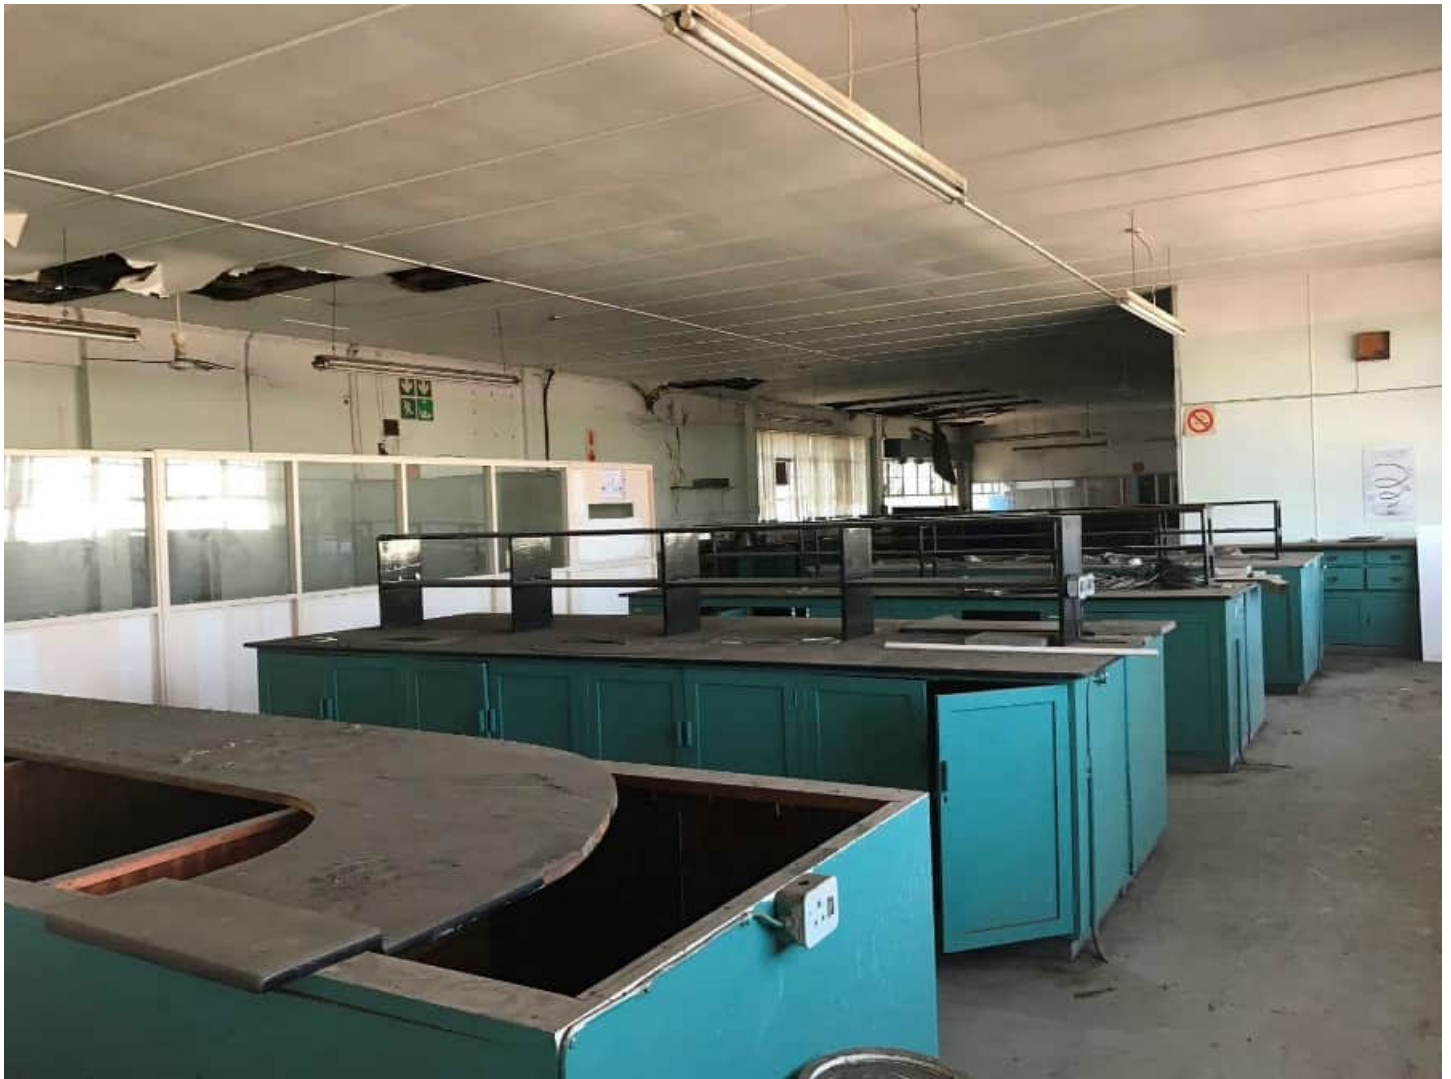
Figure 14.) Image illustrates first floor internals. The proposed includes demolition of all first-floor items.

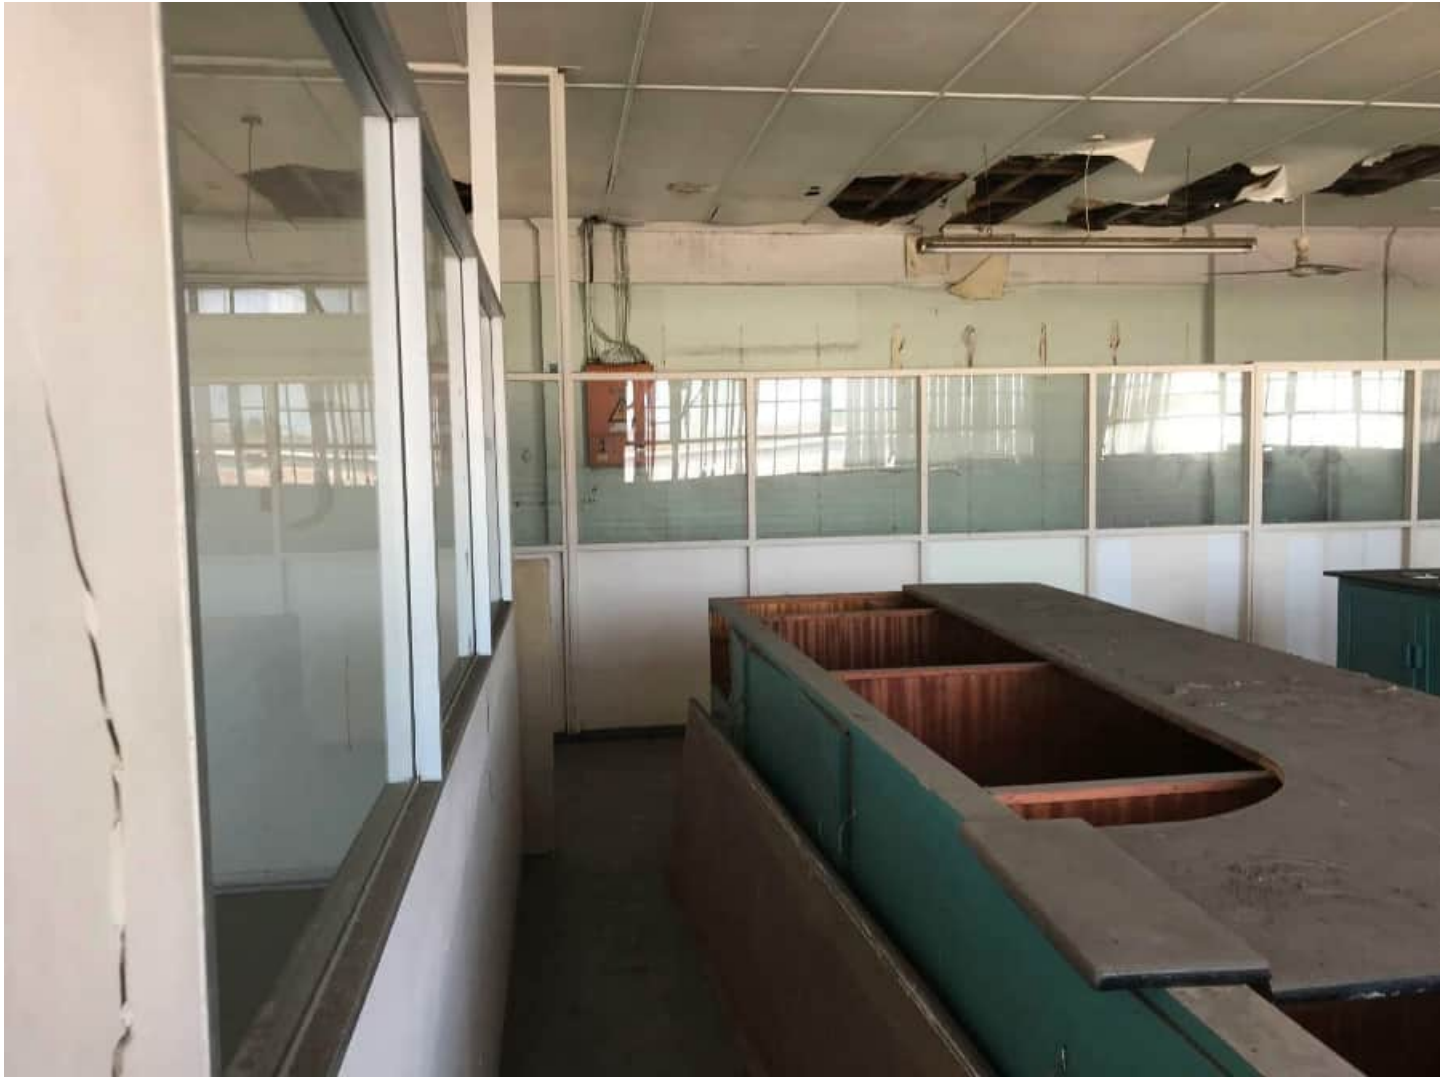
Figure 15.) Image illustrates first floor internals. The proposed includes demolition of all first-floor items.

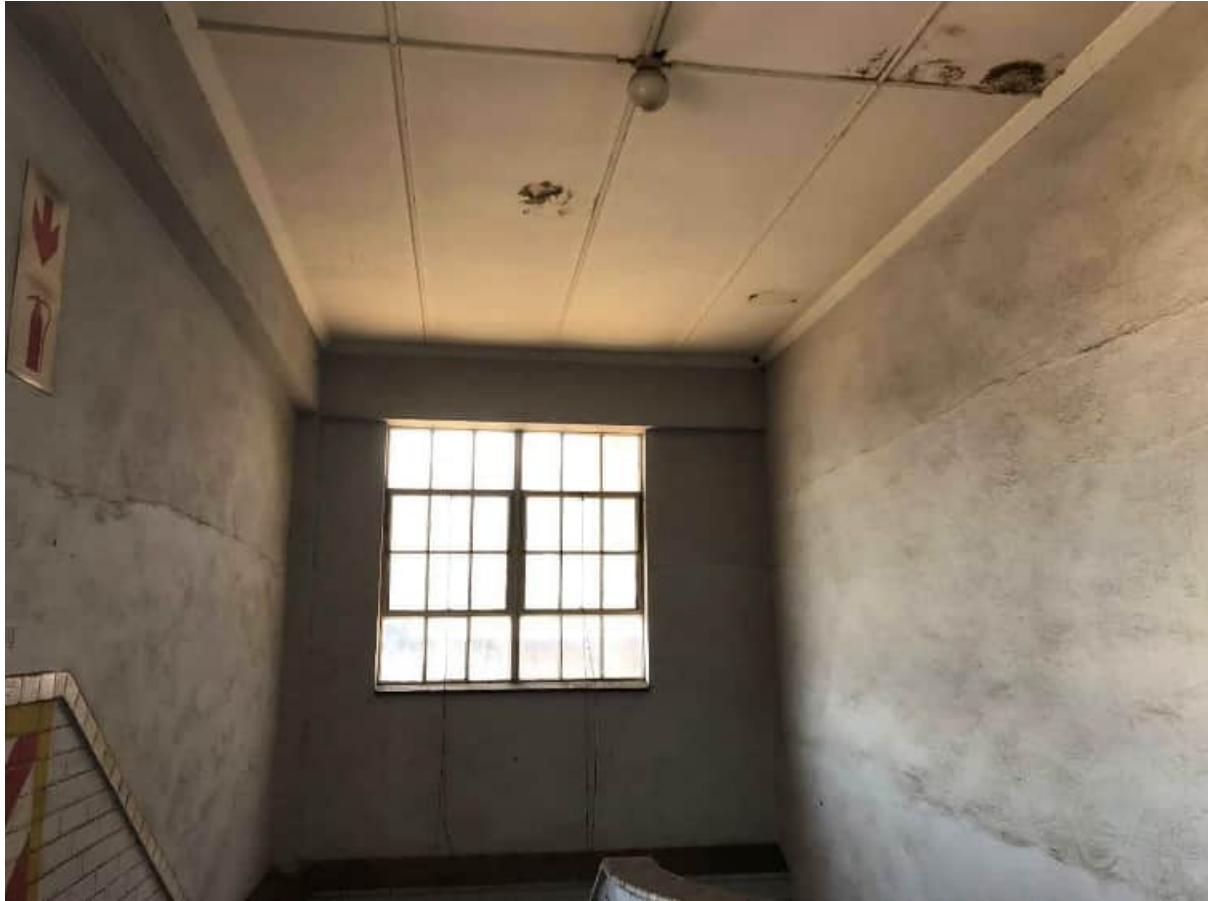
Figure 16.) Image illustrates first floor internals. The proposed includes demolition of all first-floor items.

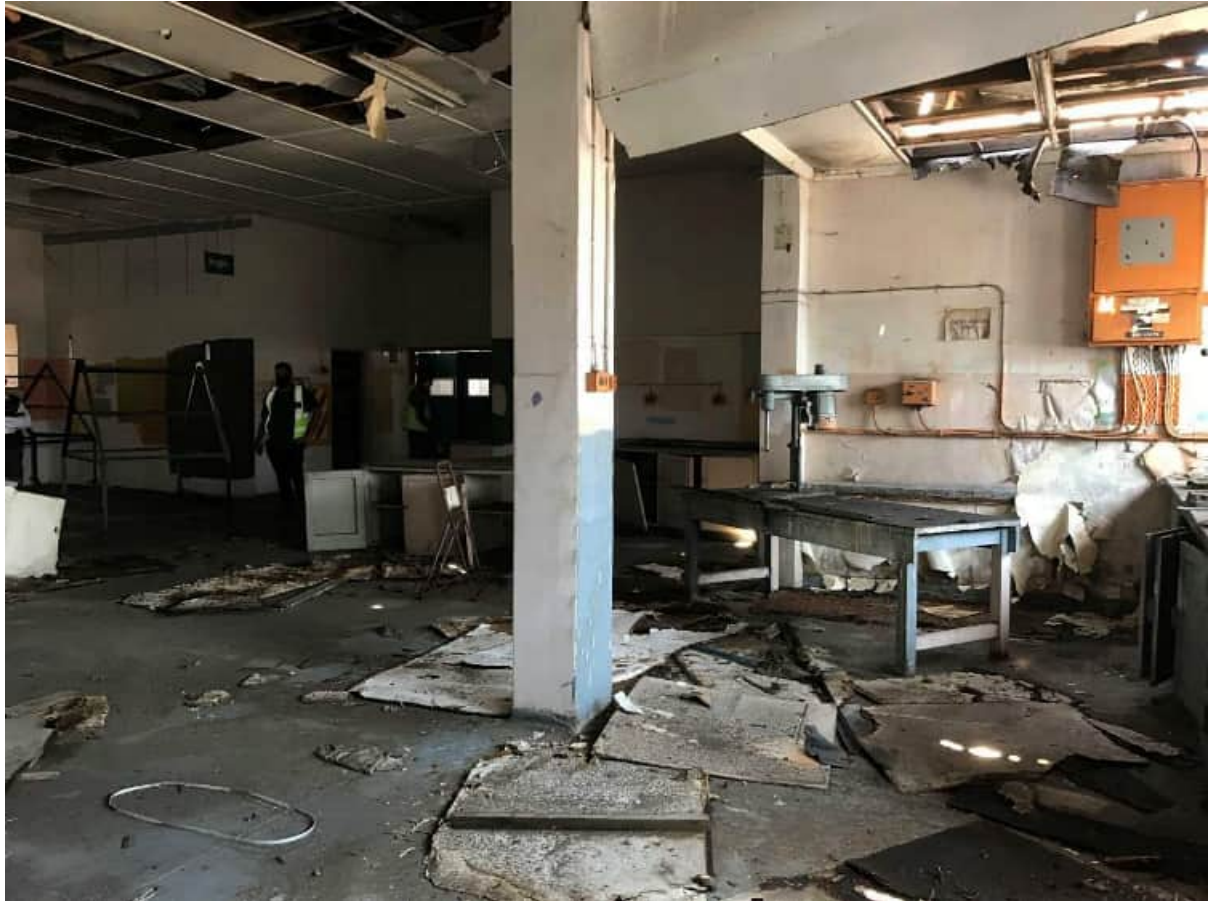
Figure 17.) Image illustrates first floor internals. The proposed includes demolition of all first-floor items.

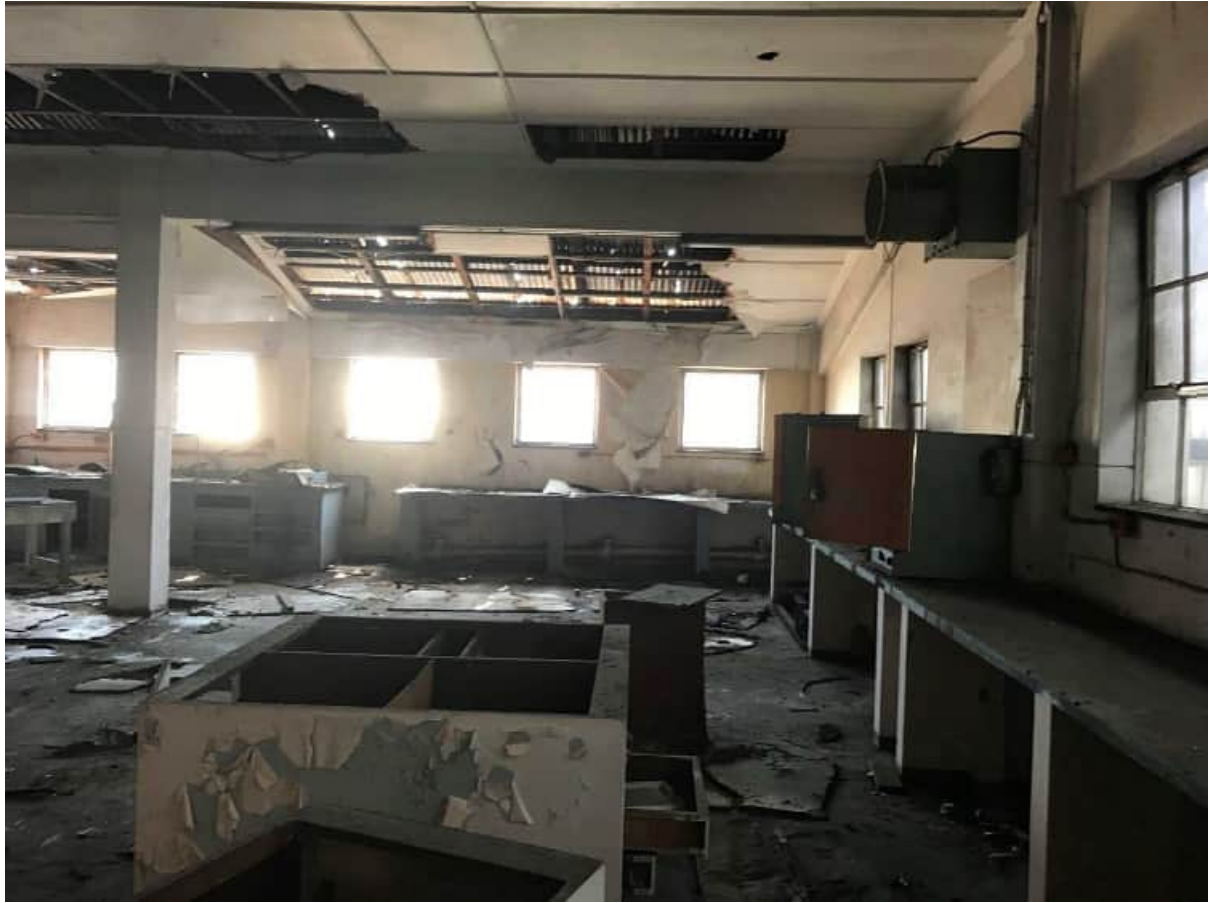
Figure 17.) Image illustrates first floor internals. The proposed includes demolition of all first-floor items.

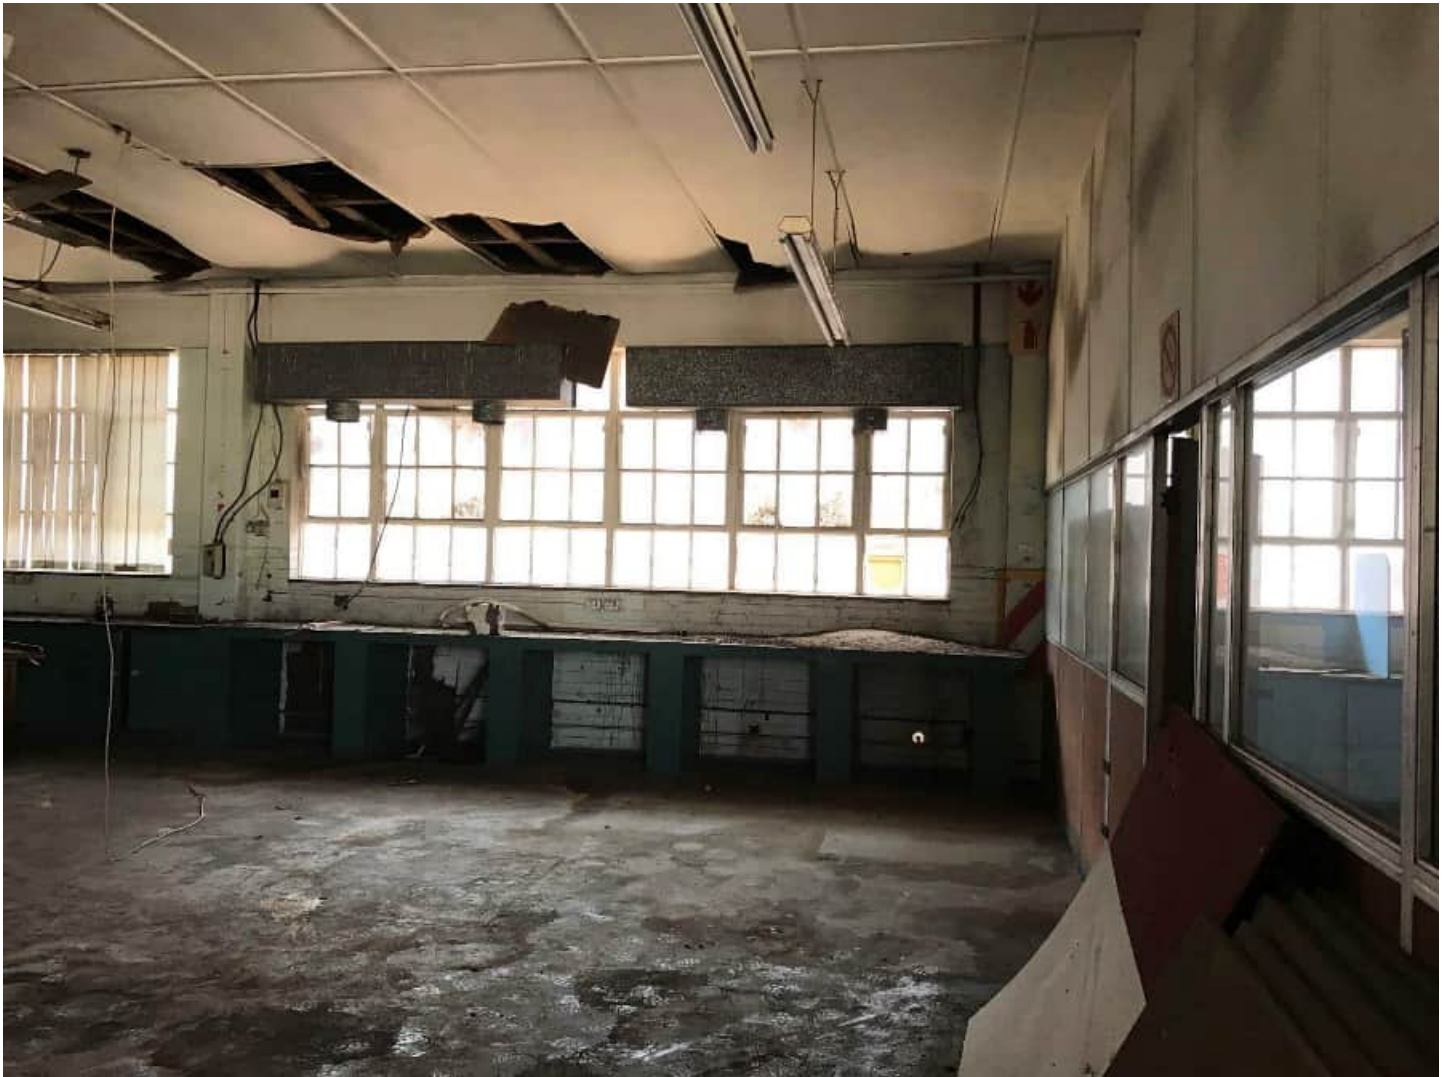
Figure 18.) Image illustrates first floor internals. The proposed includes demolition of all first-floor items.

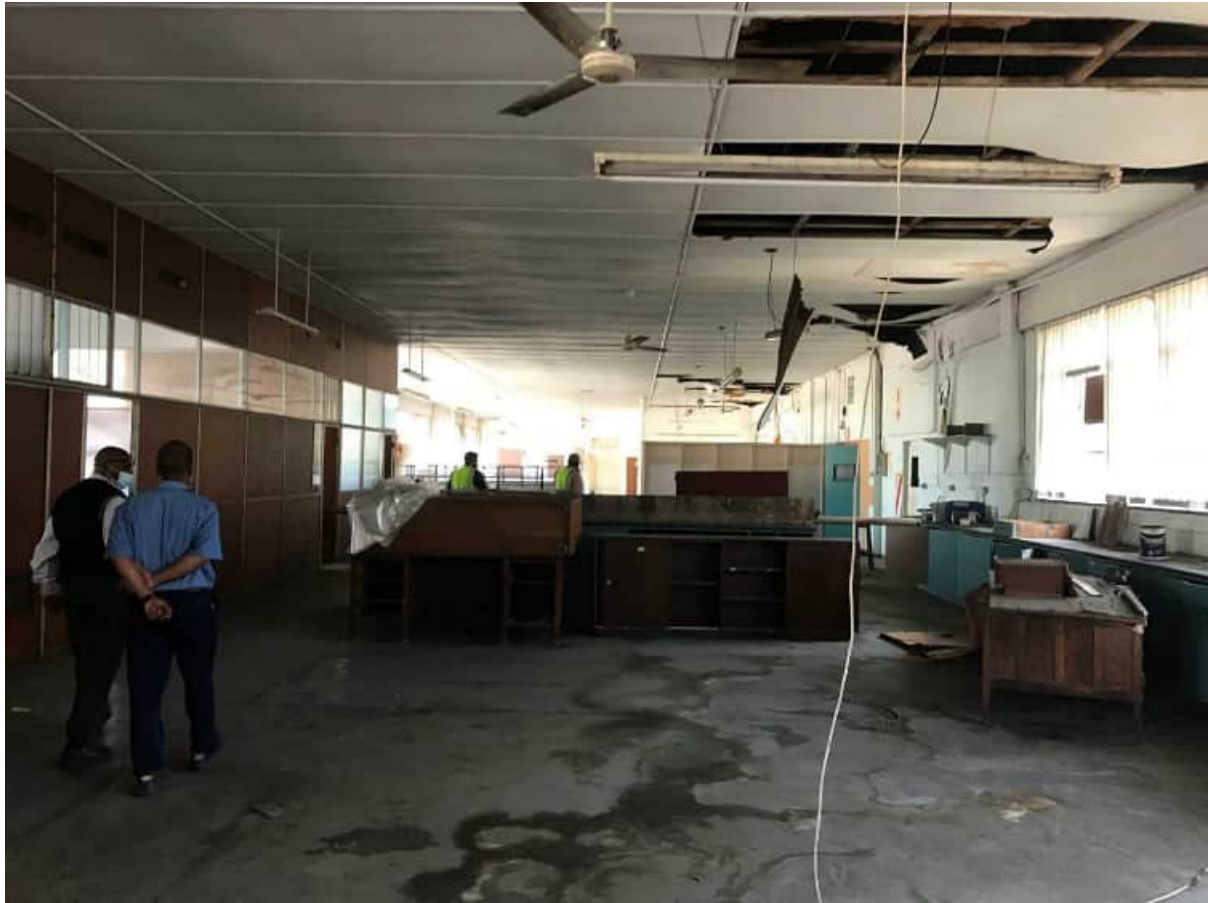
Figure 19.) Image illustrates first floor internals. The proposed includes demolition of all first-floor items.

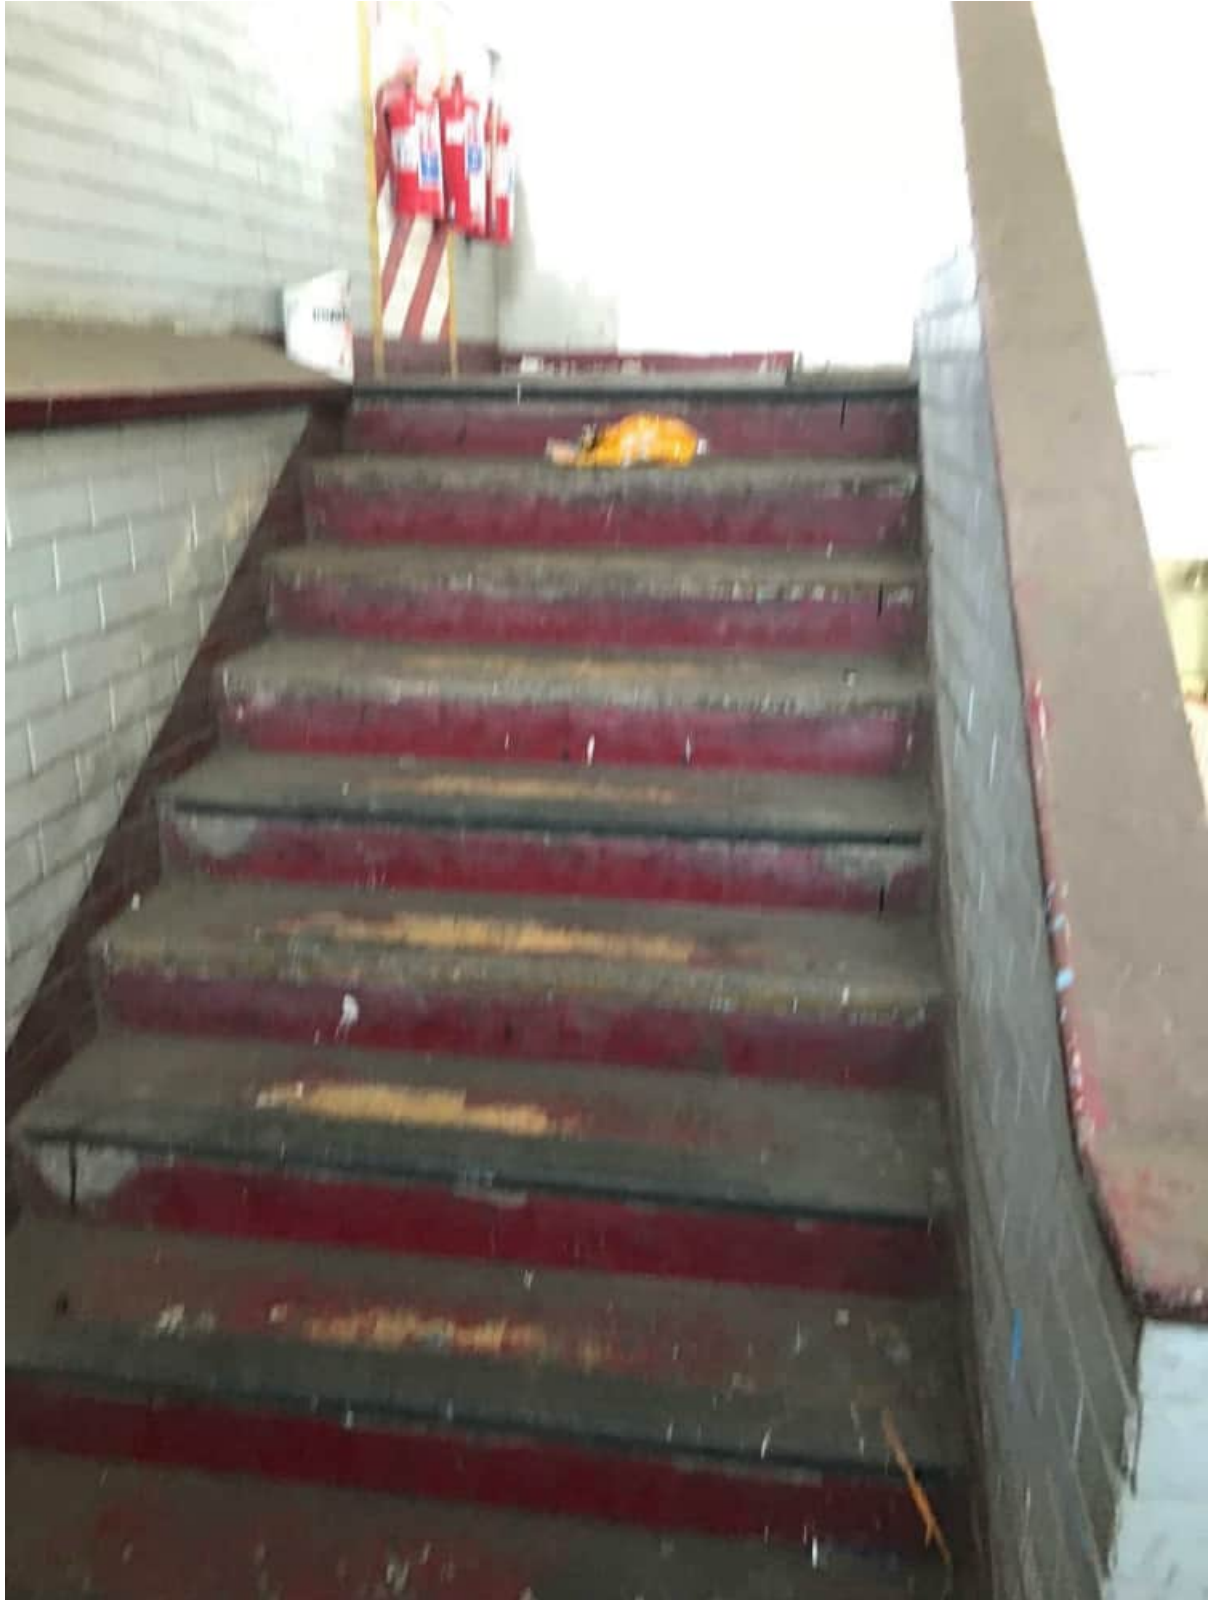
Figure 20.) Image illustrates first floor internals. The proposed includes demolition of all first-floor items.

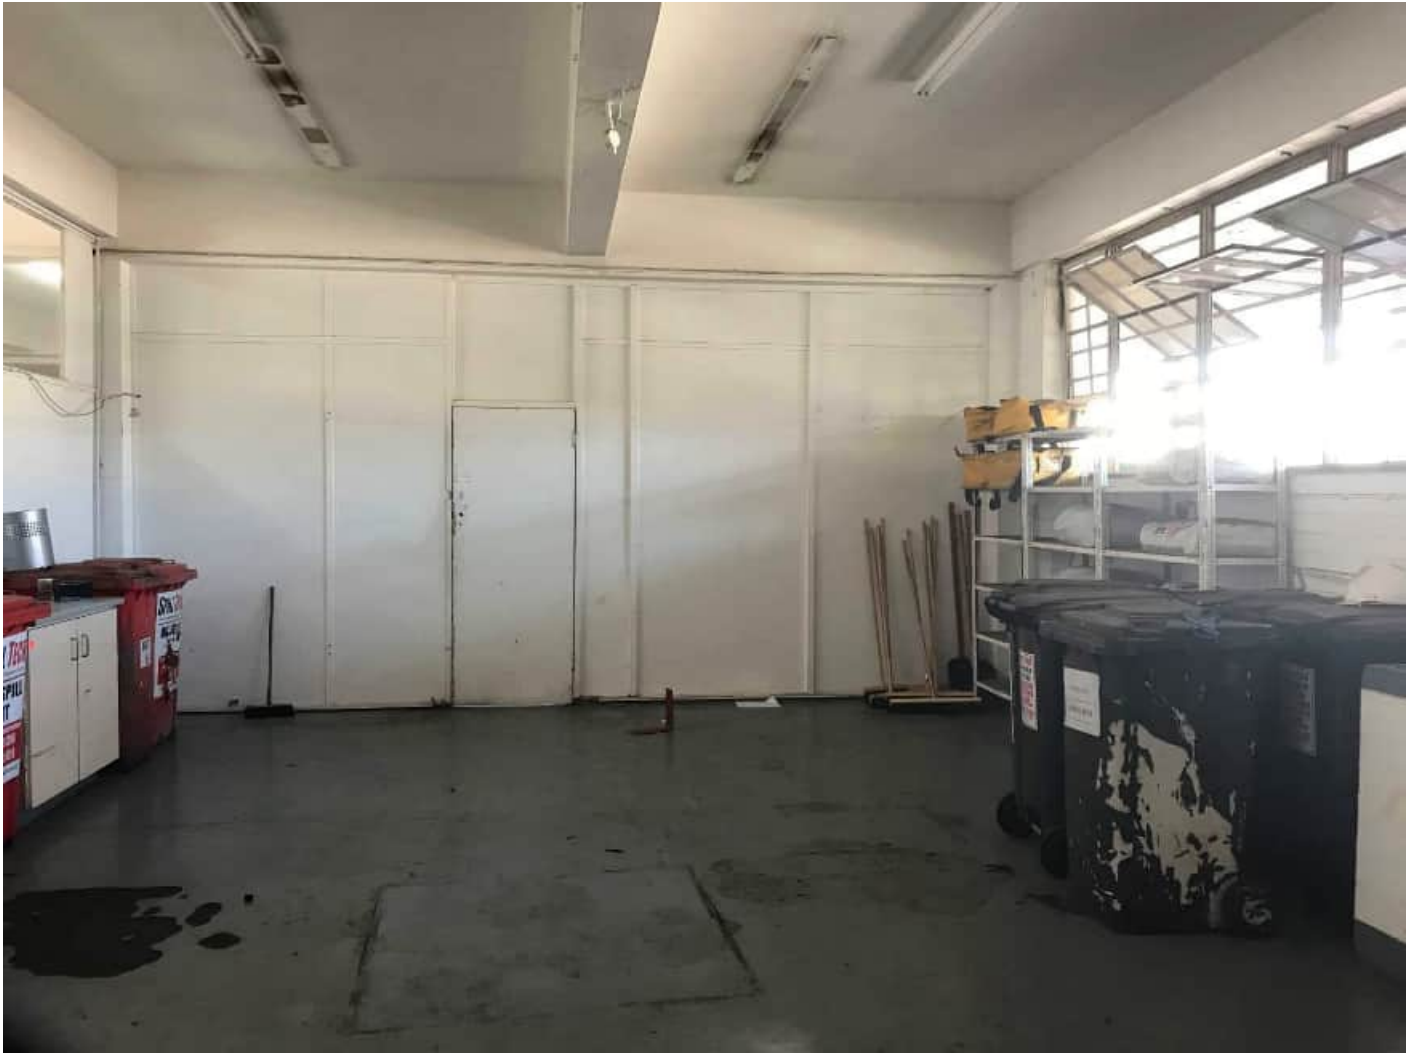
Figure 21.) Image illustrates Ground floor internals (laboratory) .. Refer to plans for items that are removed, refurbished or demolition.

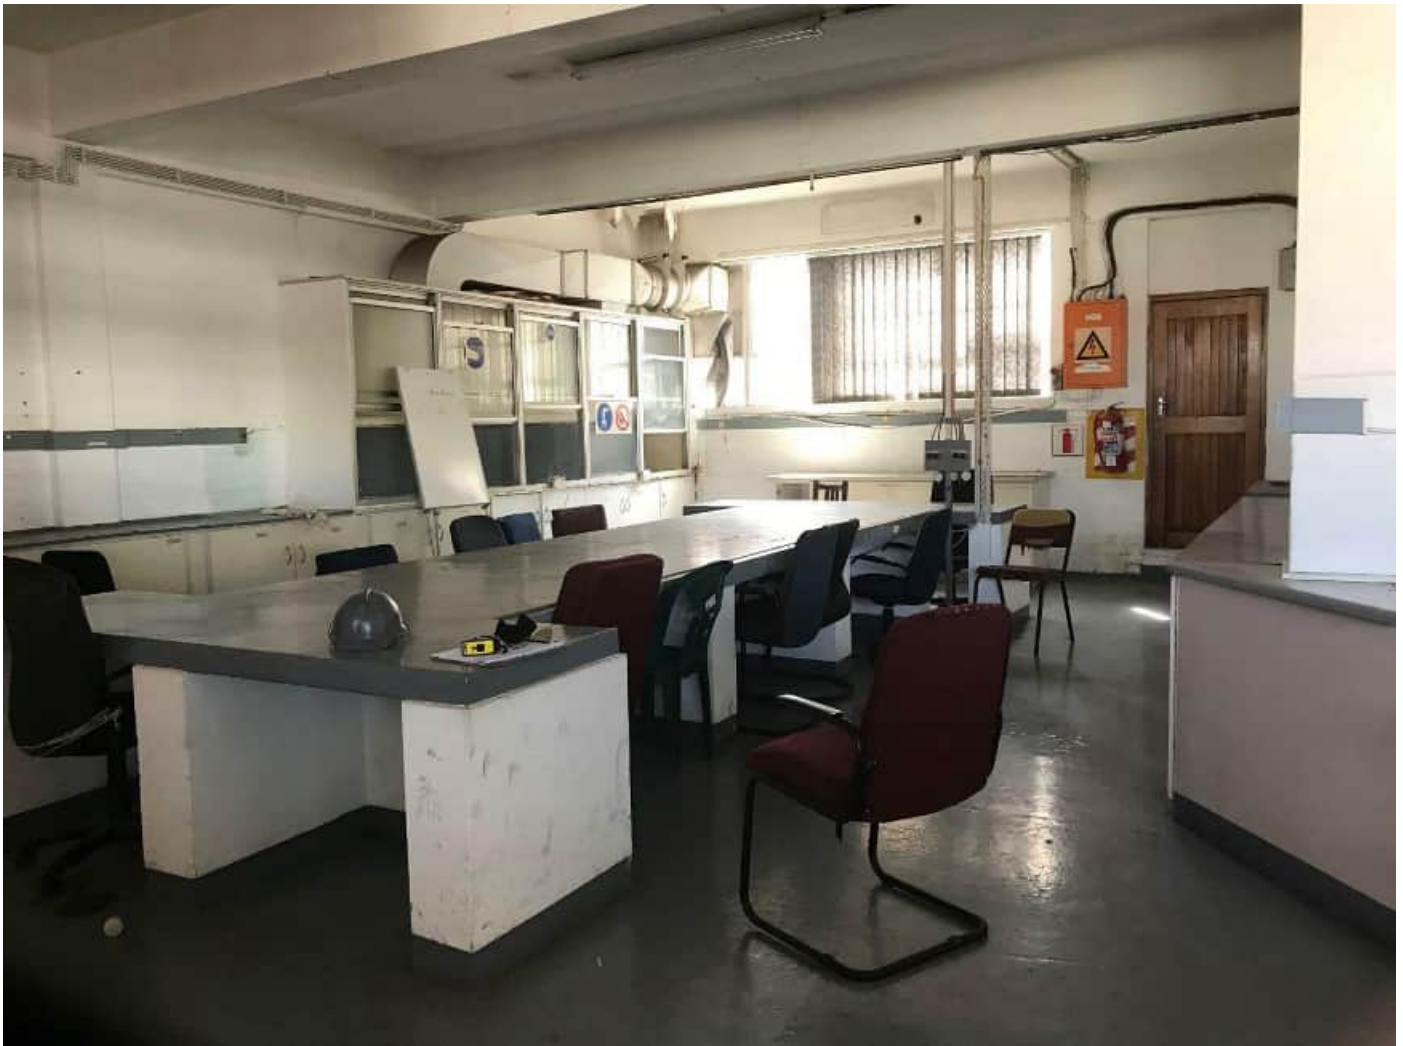
Figure 22.) Image illustrates Ground floor internals (laboratory) .. Refer to plans for items that are removed, refurbished or demolition.

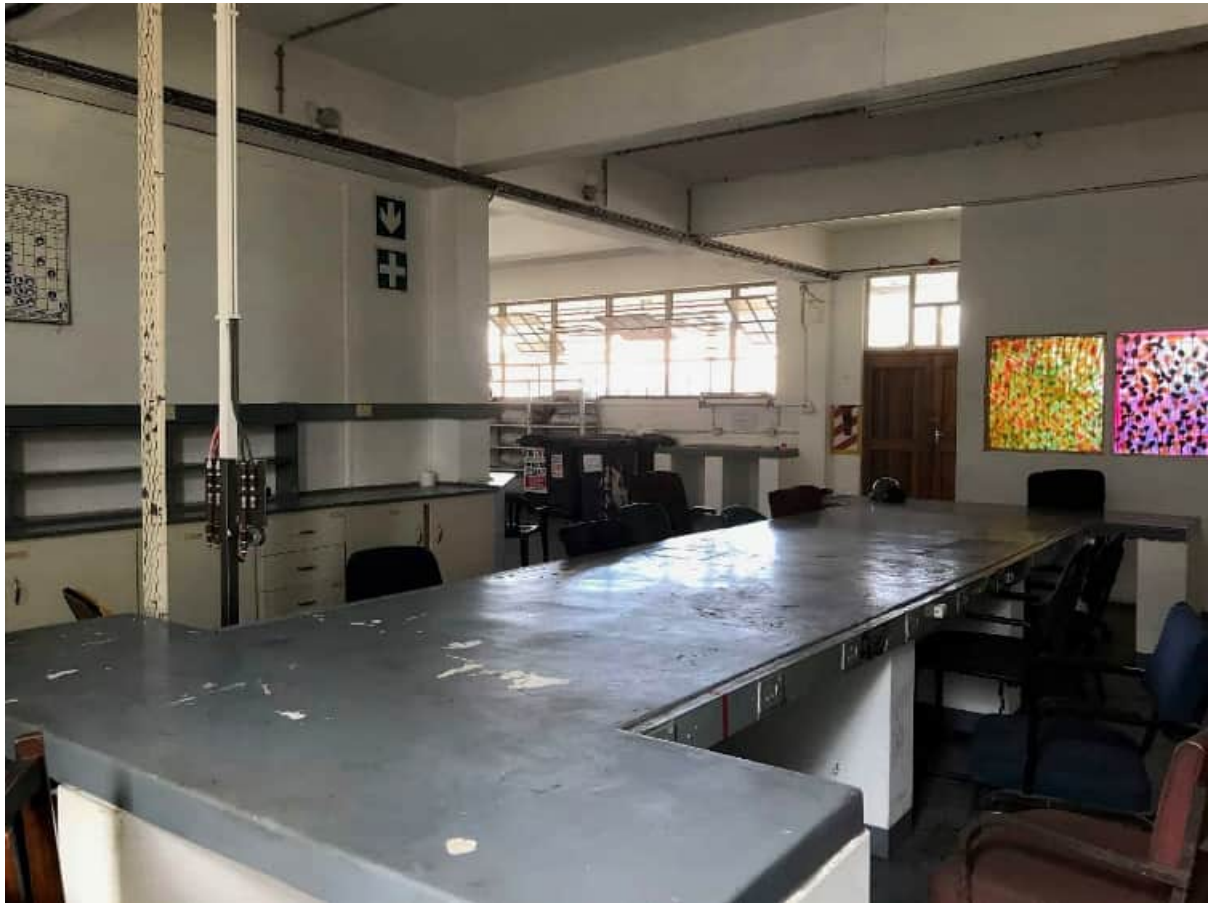
Figure 23.) Image illustrates Ground floor internals (laboratory) .. Refer to plans for items that are removed, refurbished or demolition.

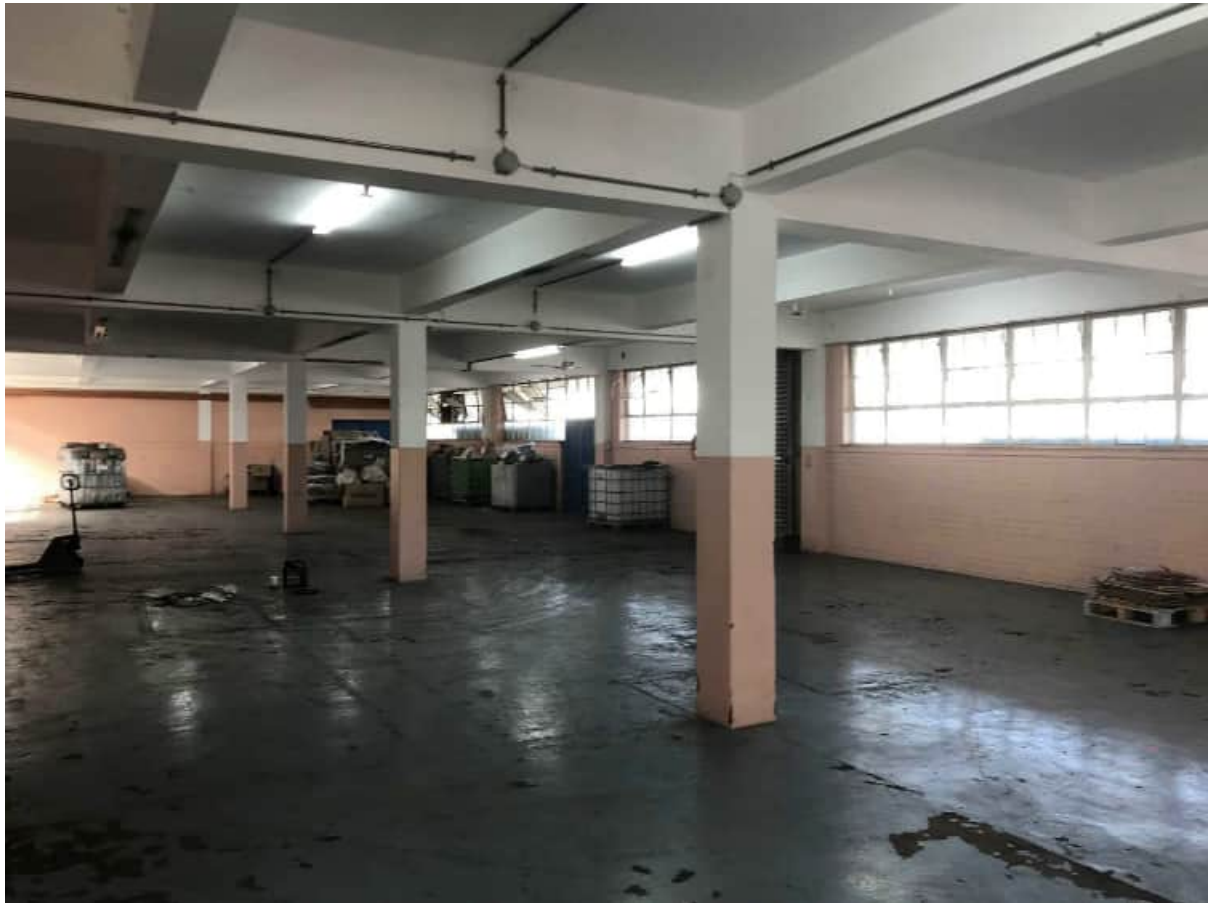
Figure 24.) Image illustrates Ground floor internals (laboratory) .. Refer to plans for items that are removed, refurbished or demolition.

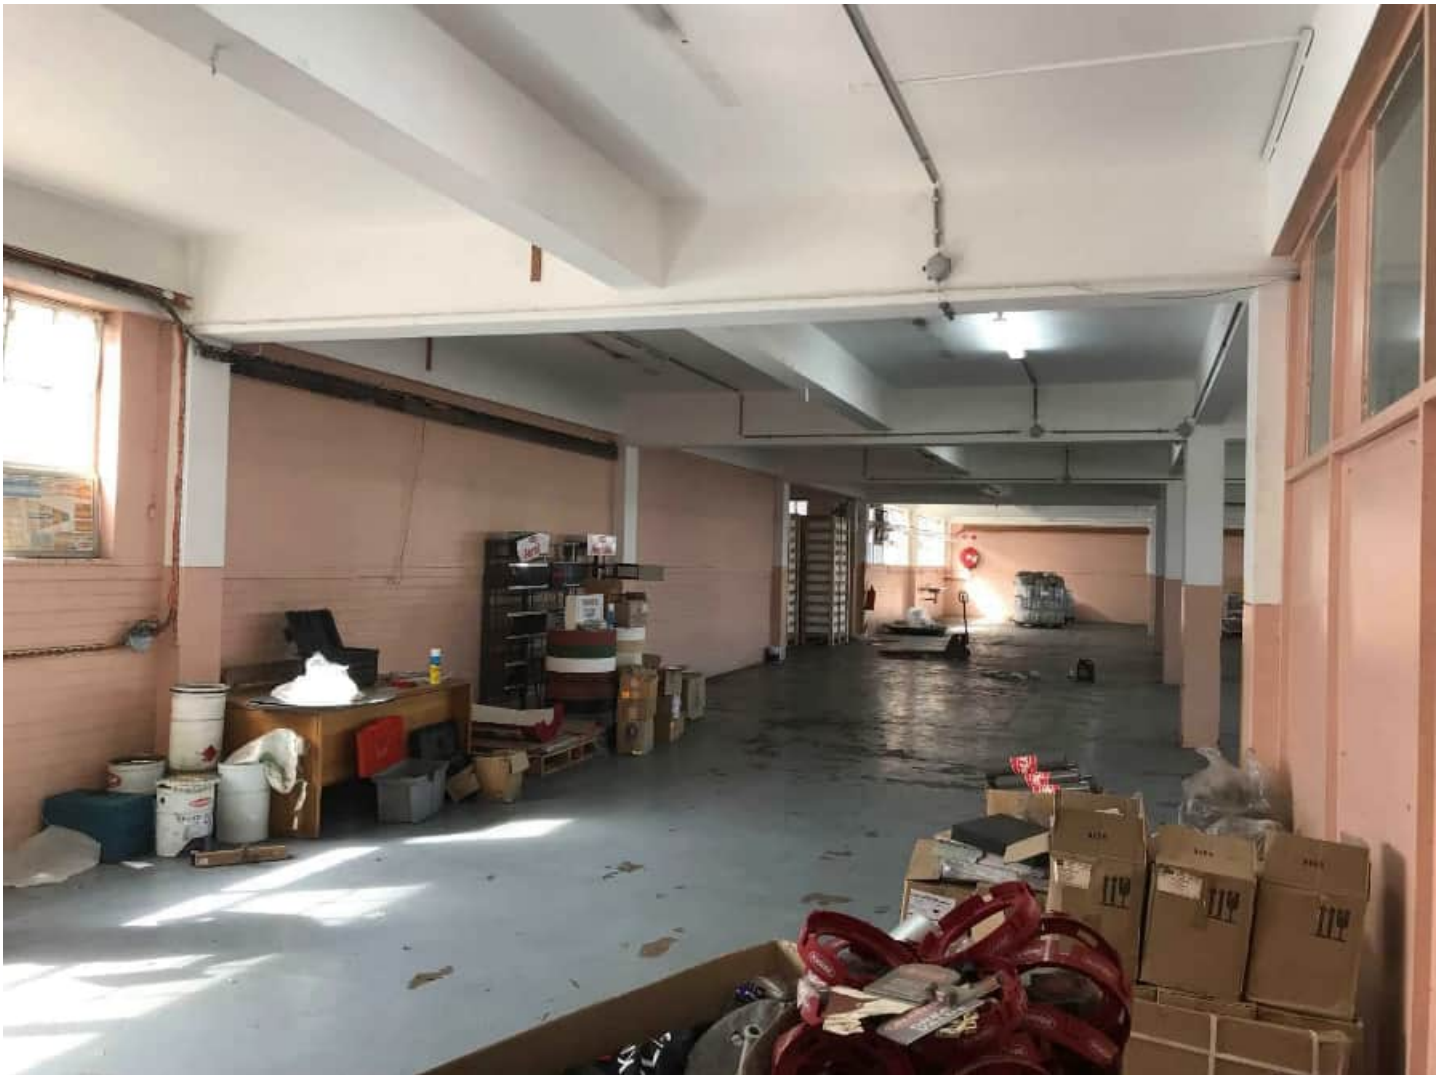
Figure 25.) Image illustrates Ground floor internals(laboratory) . Refer to plans for items that are removed, refurbished or demolition.

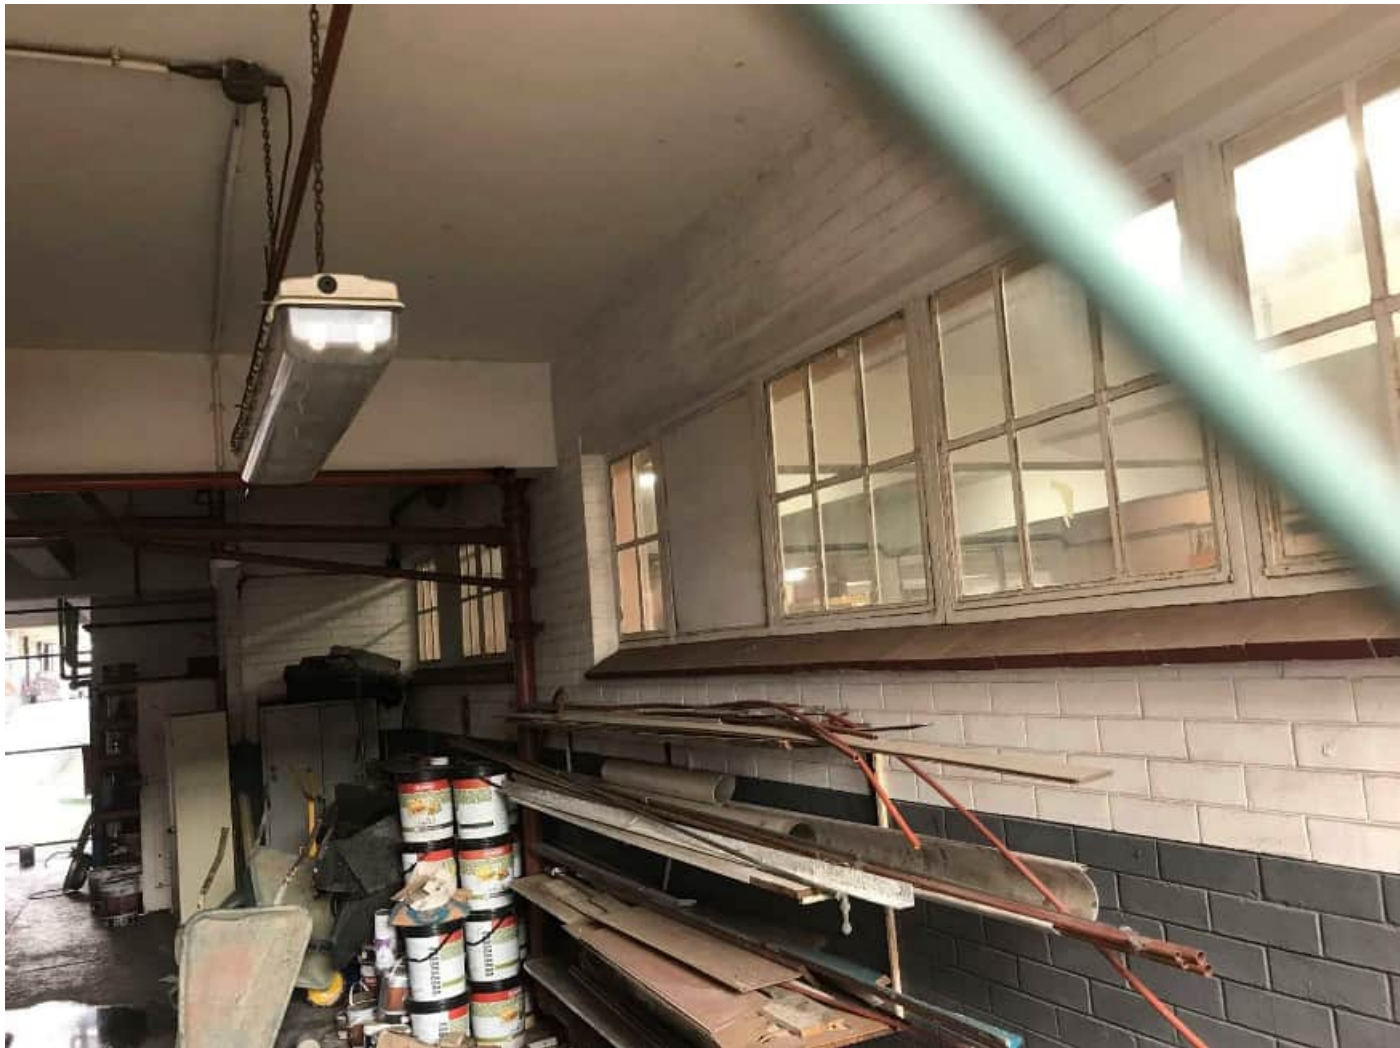
Figure 25.) Image illustrates Ground floor internals (north façade). Refer to plans for items that are removed, refurbished or demolition.

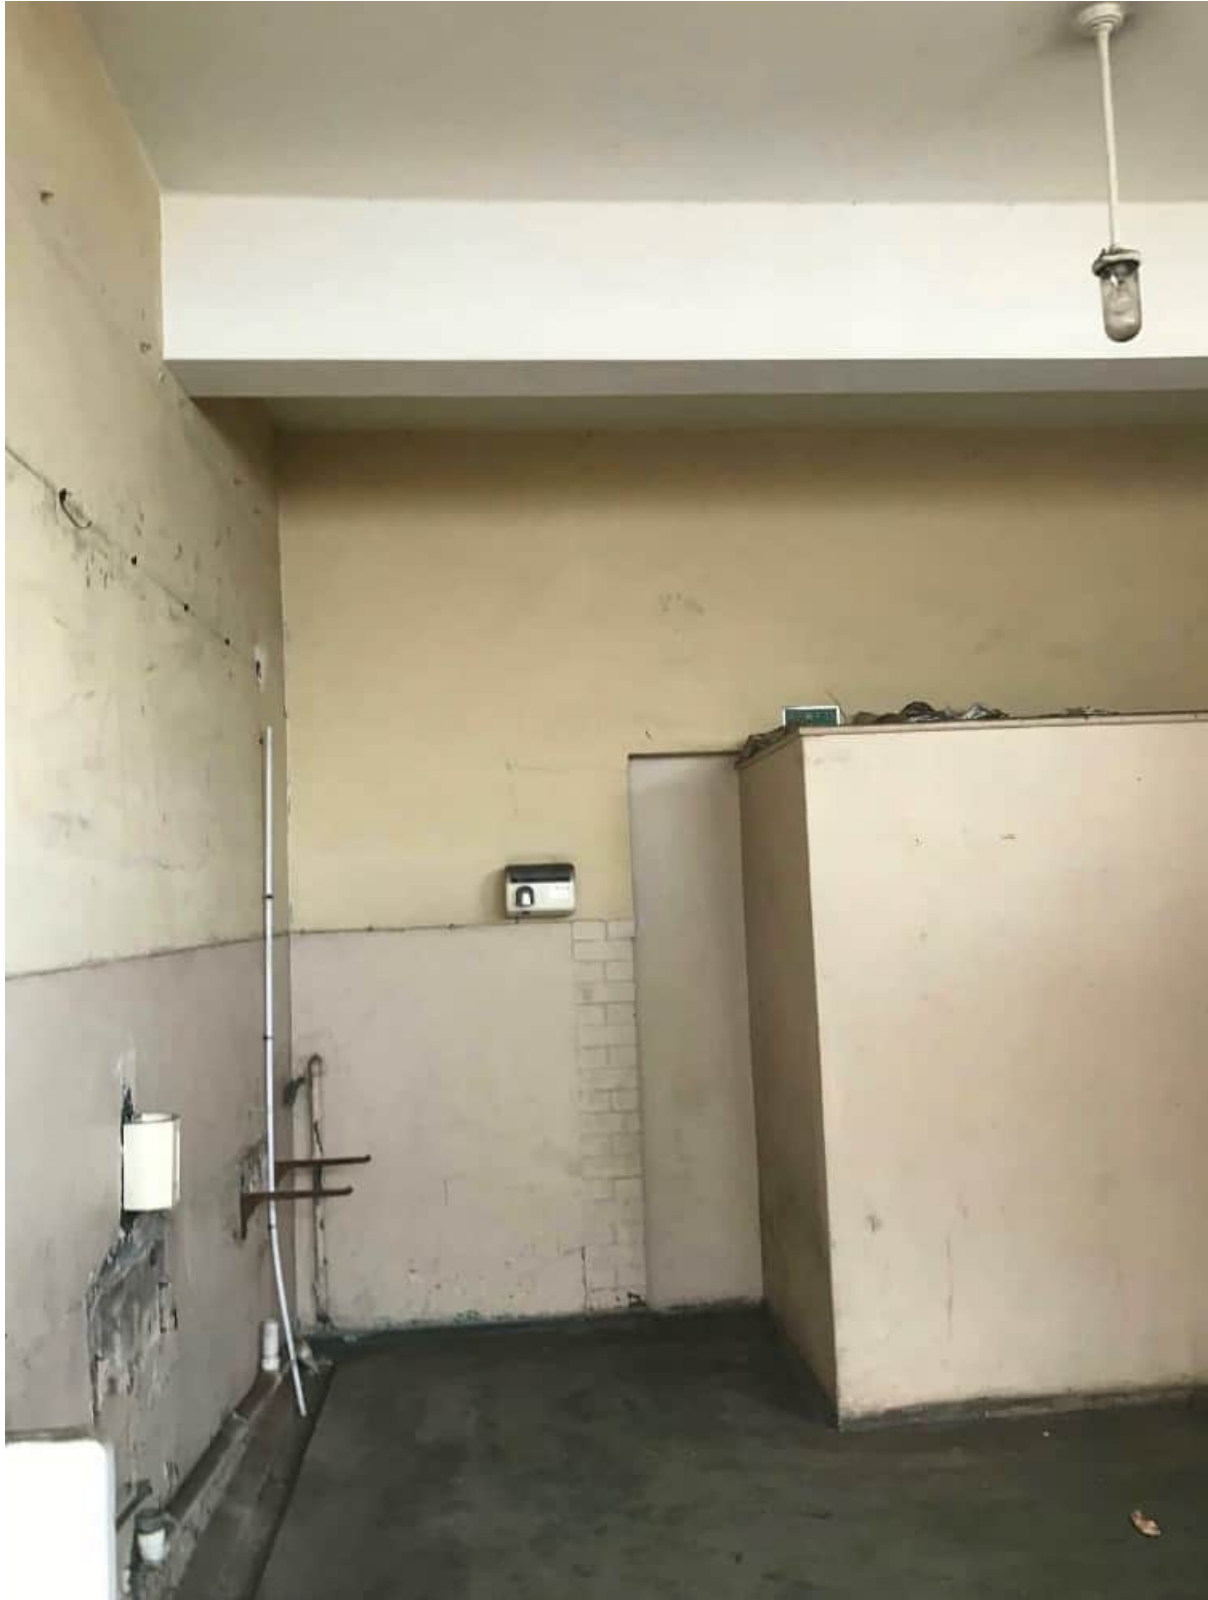
Figure 26.) Image illustrates Ground floor internals (ablutions). Refer to plans for items that are removed, refurbished or demolition.
