AMAFA PHOTOGRAPHIC REPORT FOR PROPOSED ADDITIONS AND ALTERATIONS TO 1236 SOUTH COAST ROAD, MOBENI, DURBAN

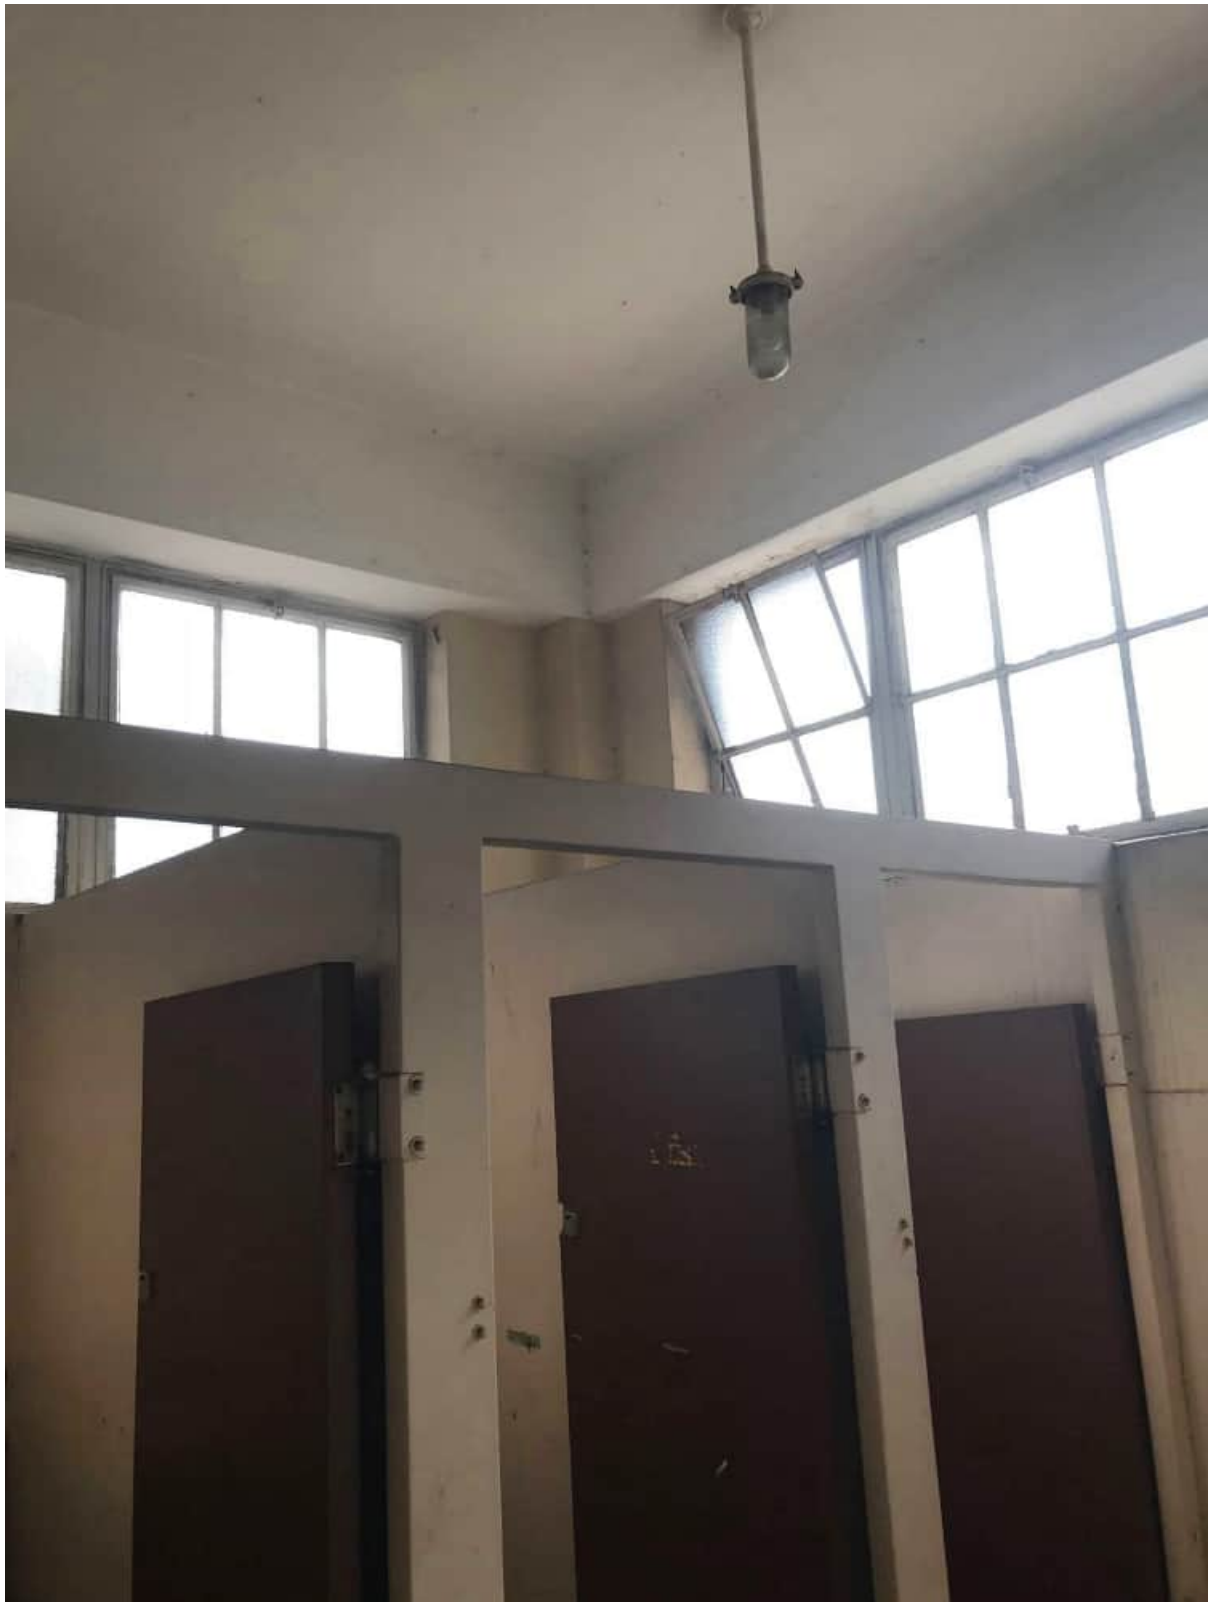
Figure 27.) Image illustrates Ground floor internals (ablutions). Refer to plans for items that are removed, refurbished or demolition.

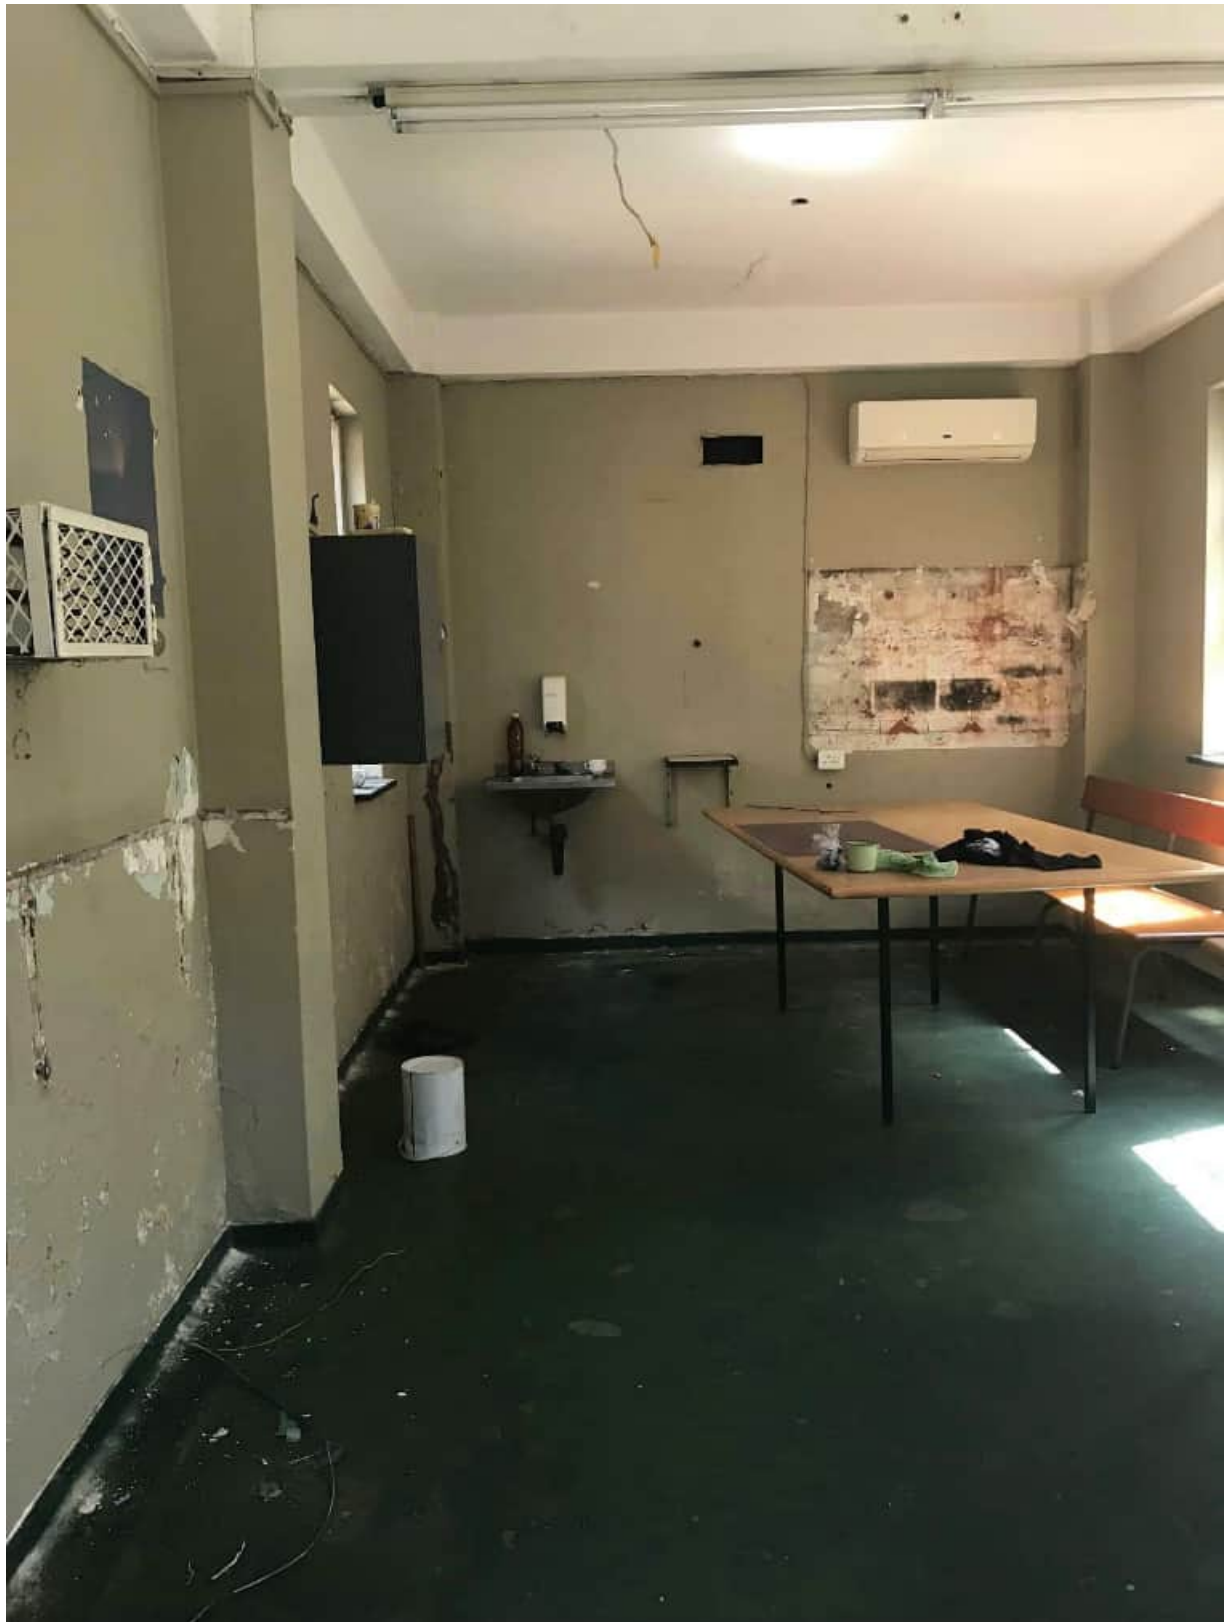
Figure 32.) Internal view of staff quarters.

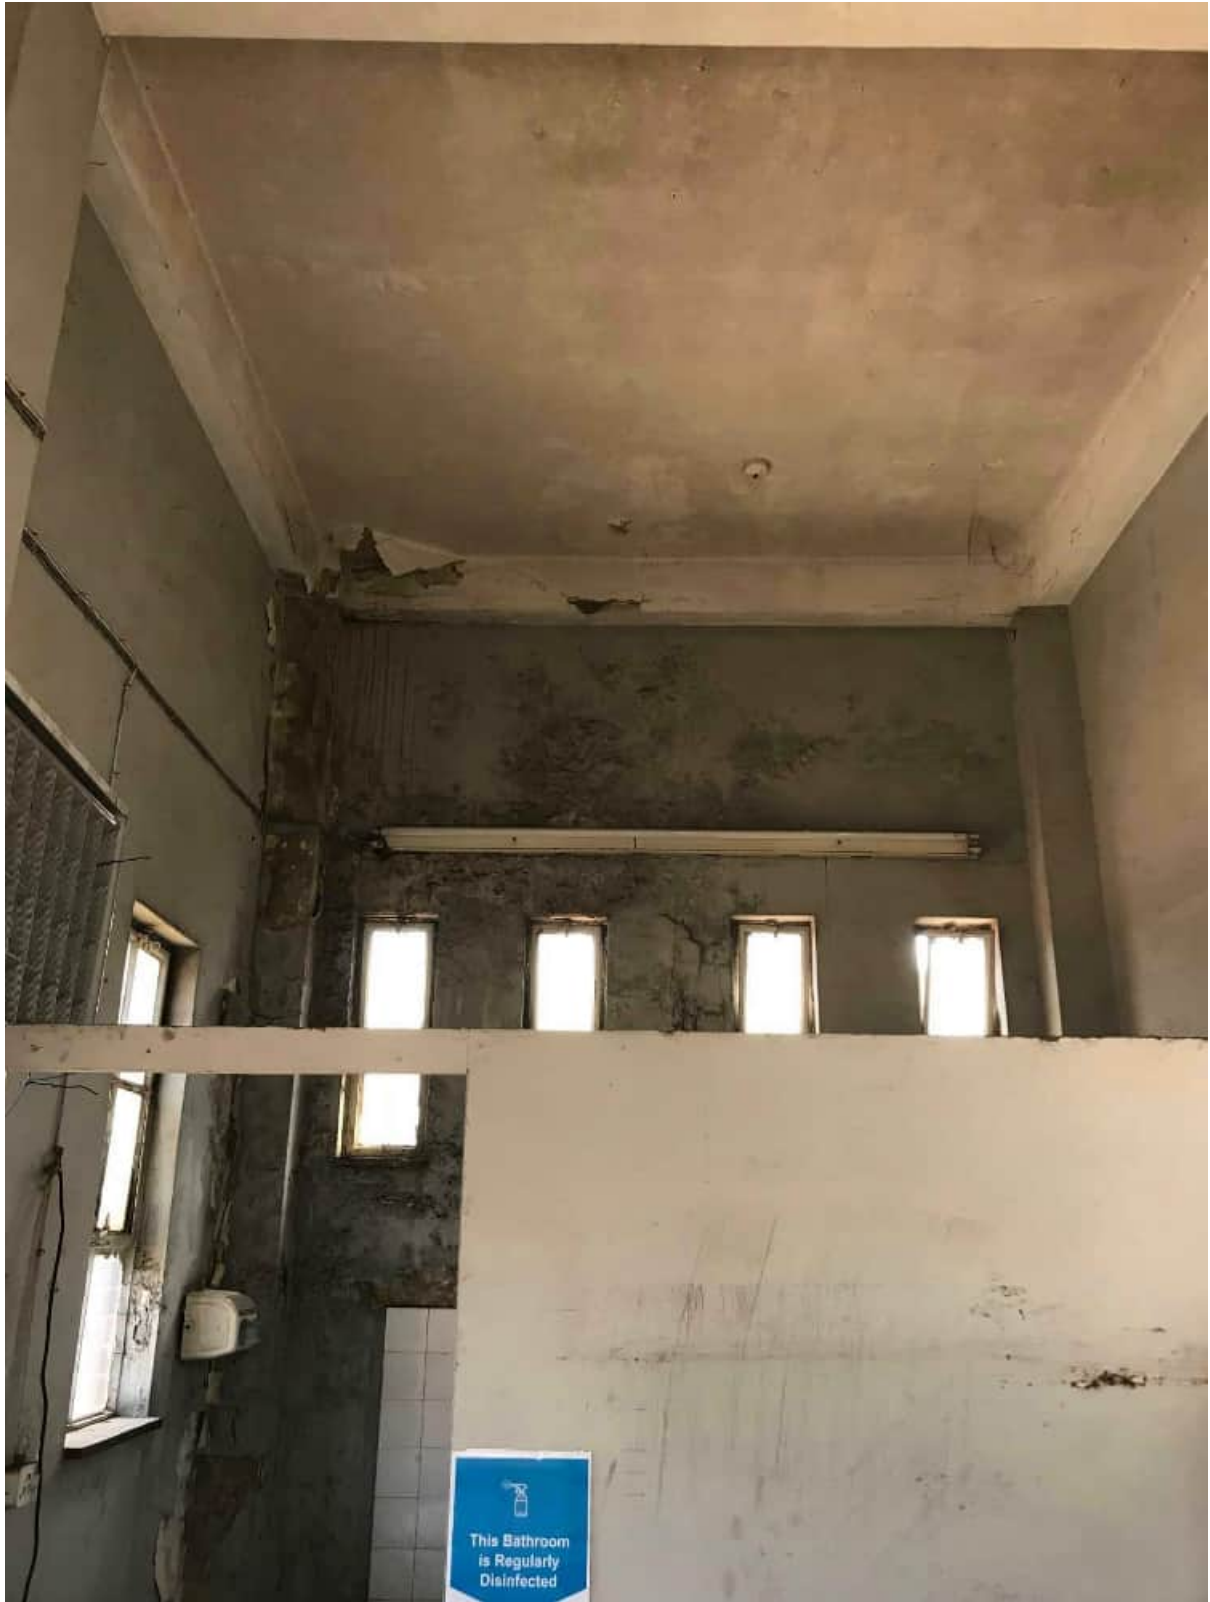
Figure 33.) Internal view of staff quarters ablutions.

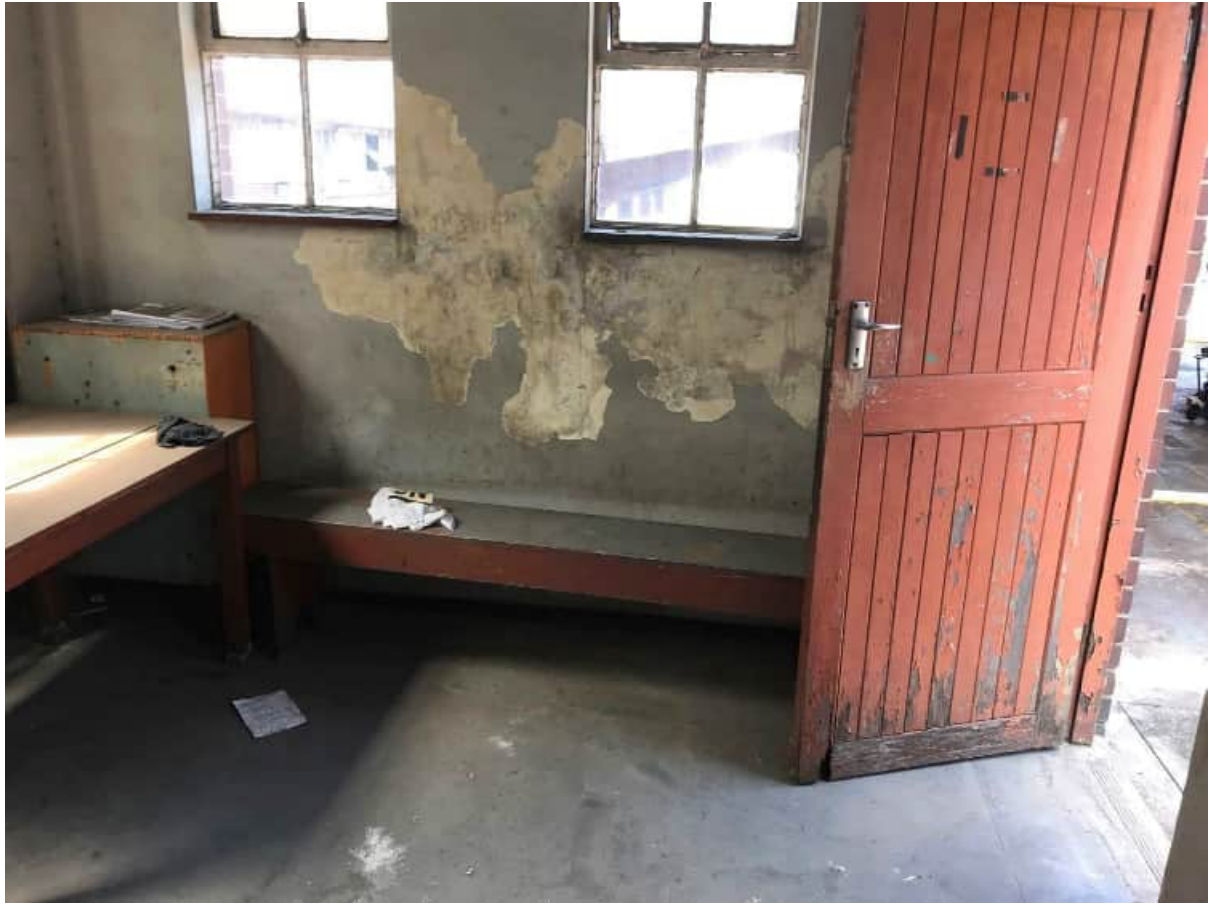
Figure 34.) Internal view of staff quarters first floor.

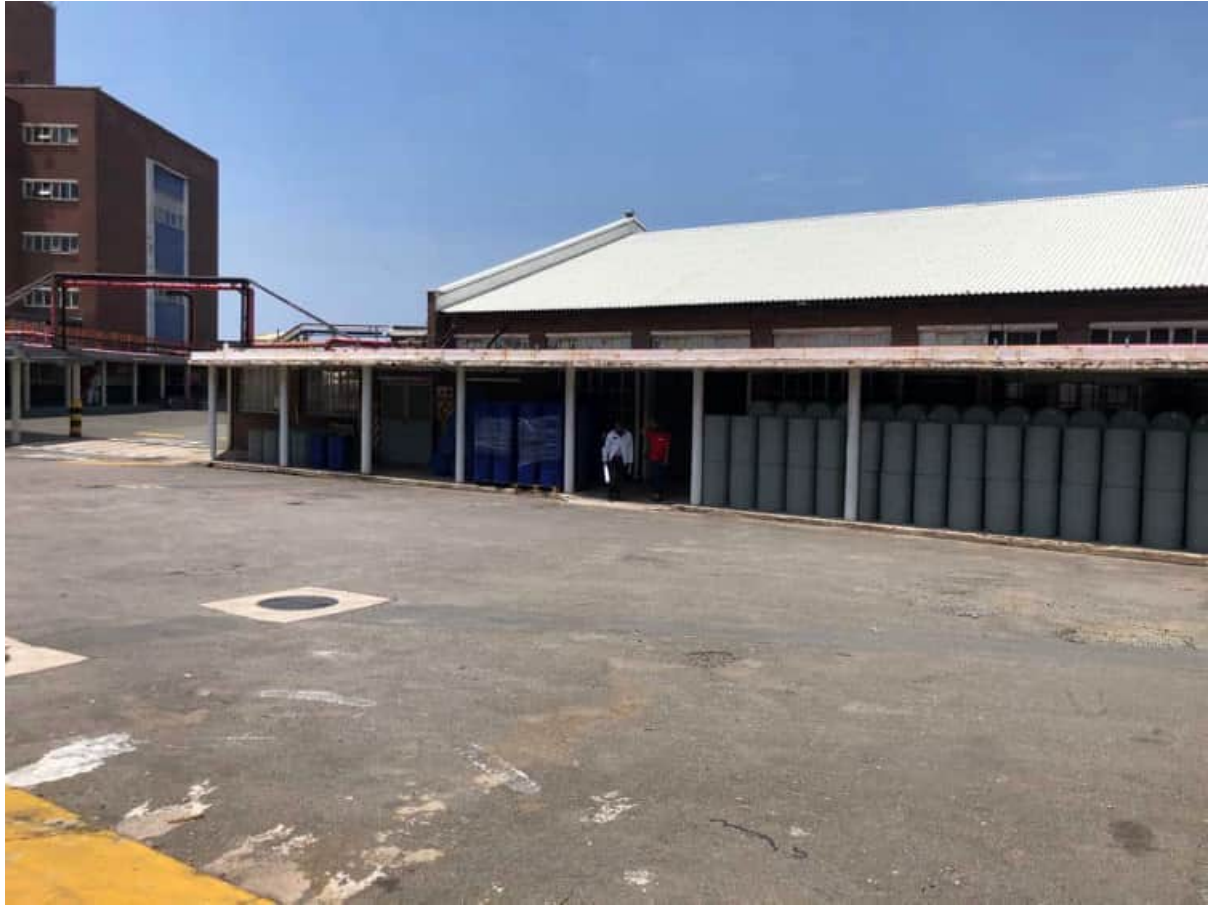
Figure 36.) View illustrating North western façade of office building & storage unit. Refer to plans for list of proposed works.

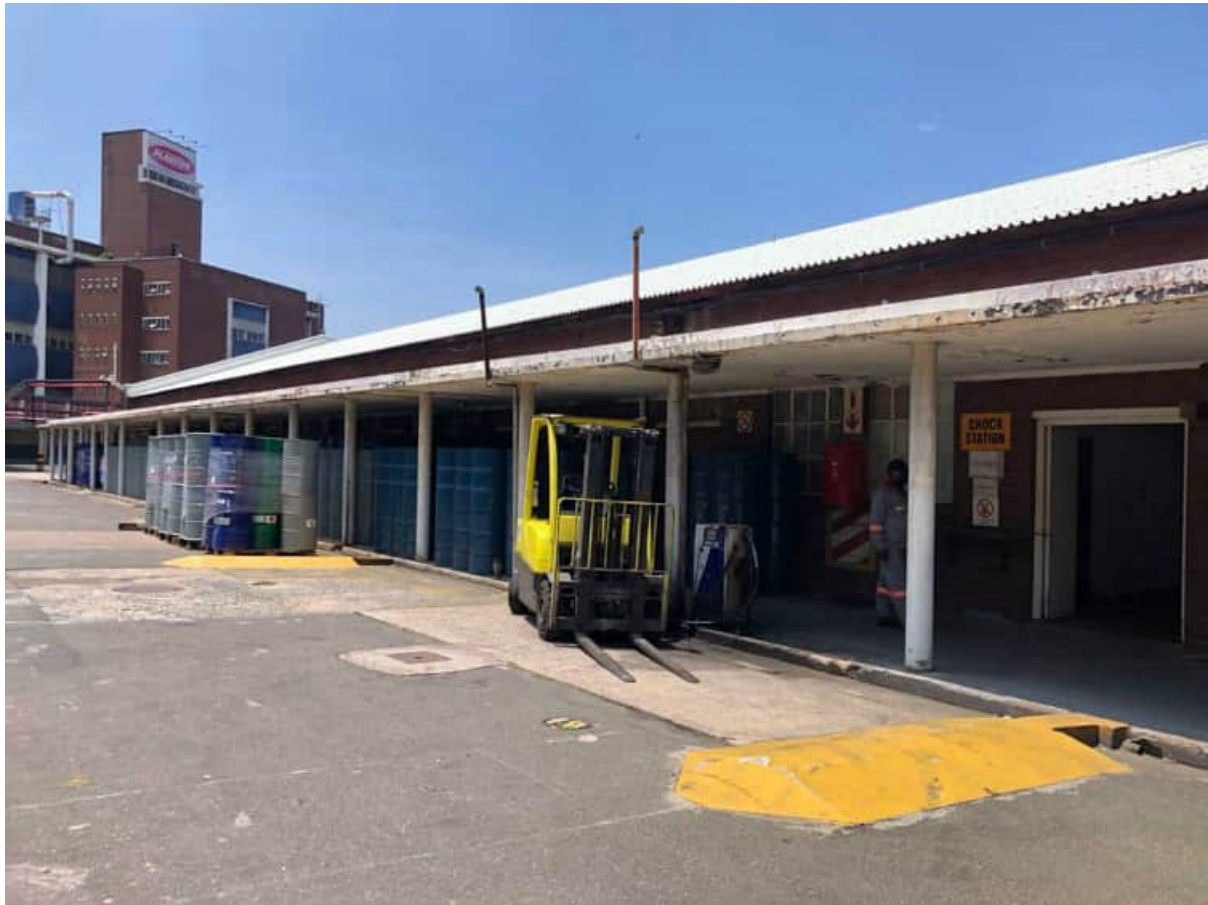
Figure 37.) View illustrating North western façade of office building & storage unit. Refer to plans for list of proposed works.

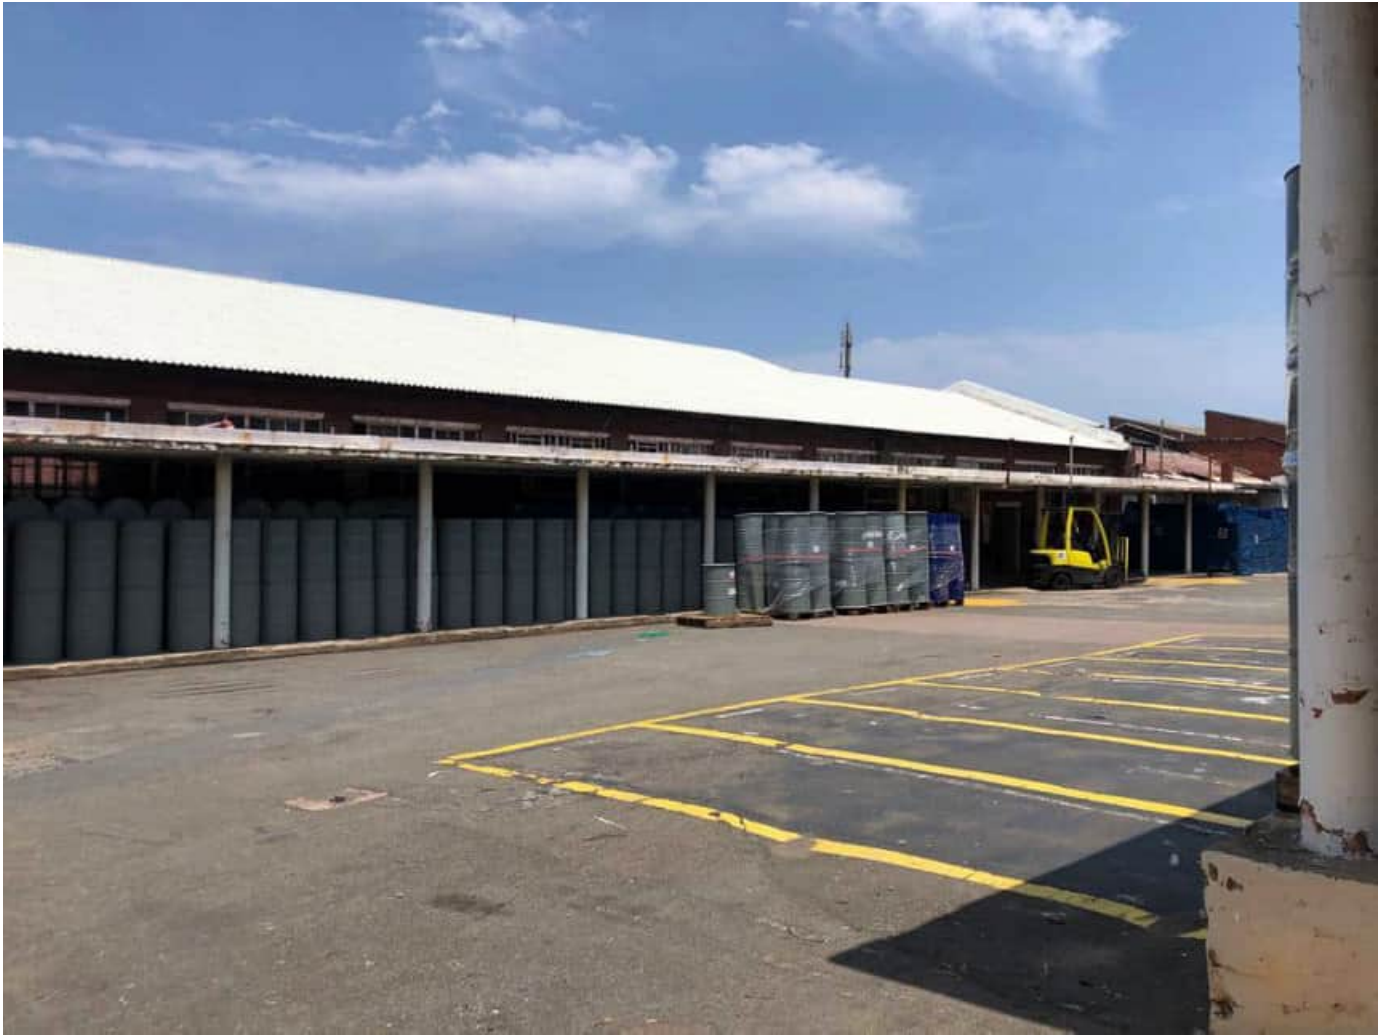
Figure 37.) View illustrating north western façade of office building & storage unit. Refer to plans for list of proposed works.

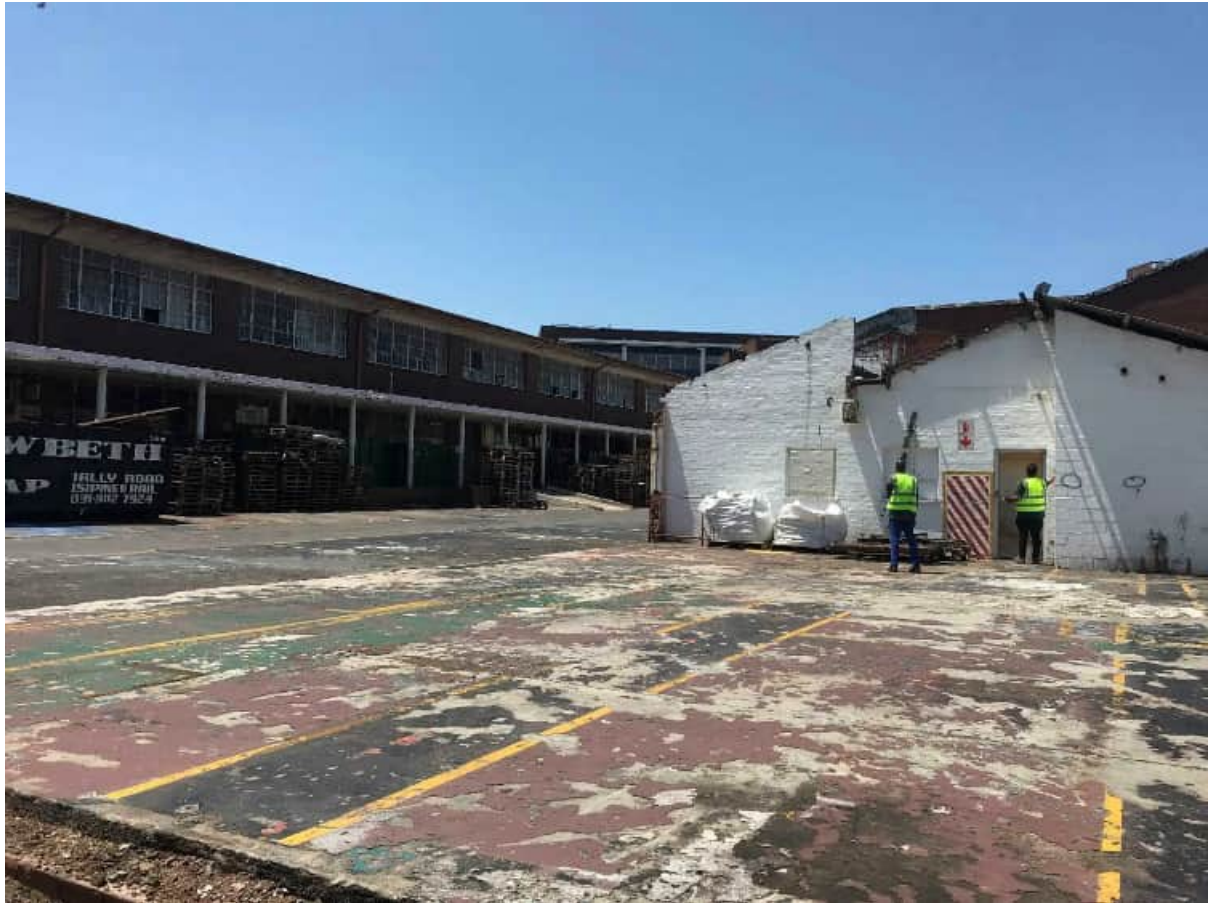
Figure 38.) View illustrating the area in which the side view of the garage/workshop

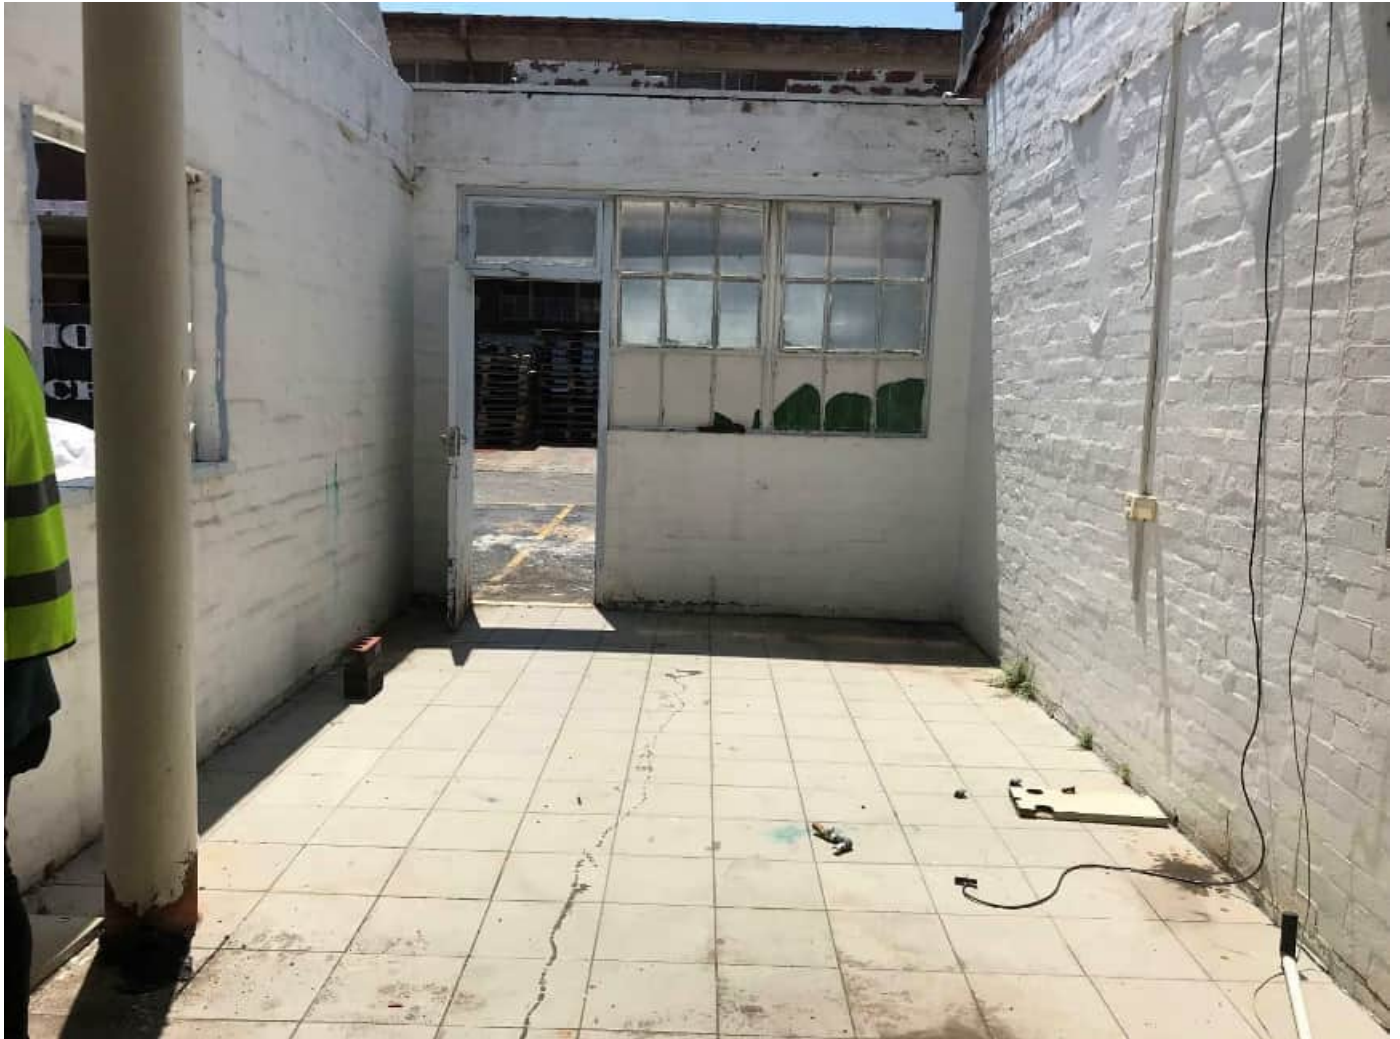
Figure 41.) View illustrating the internals of the garage Store. Refer to plans for list of additions, alterations & proposed demolition

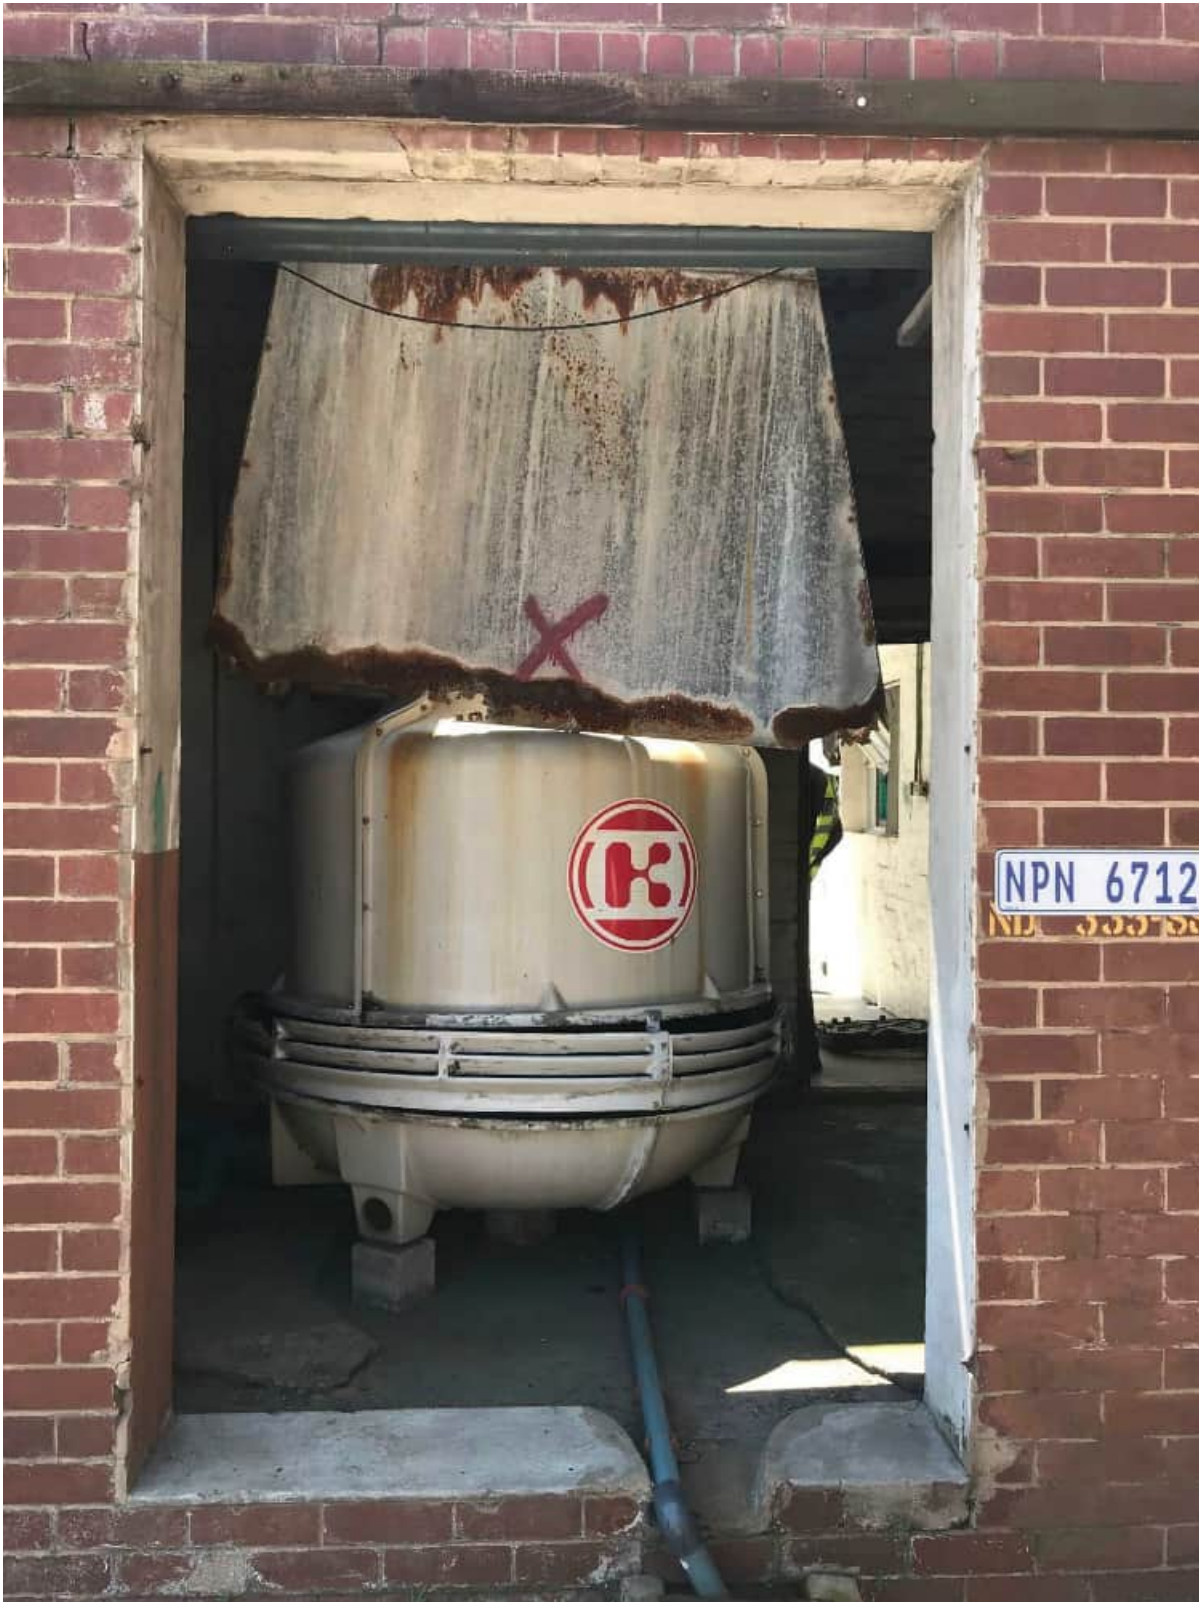
Figure 42.) View illustrating the internals of the garage Store and plant room. Refer to plans for list of additions, alterations & proposed demolition

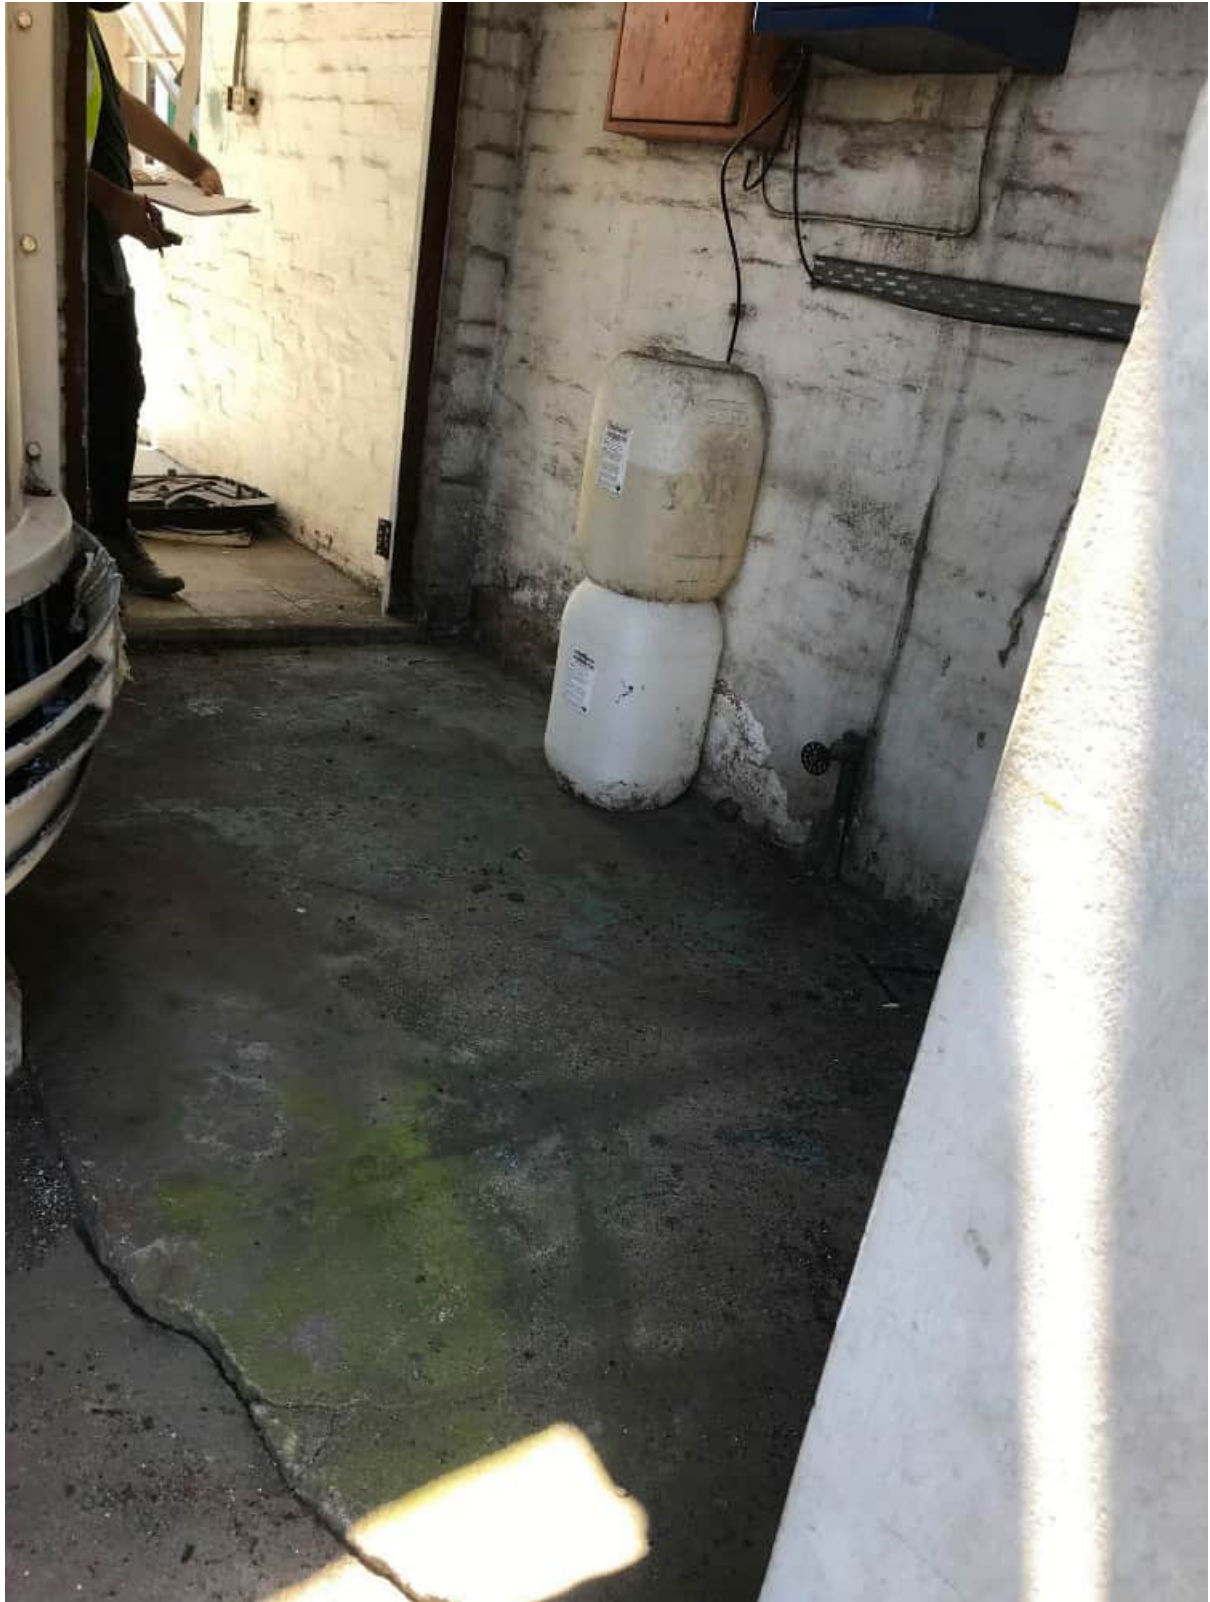
Figure 43.) View illustrating the internals of the garage Store and plant room. Refer to plans for list of additions, alterations & proposed demolition.

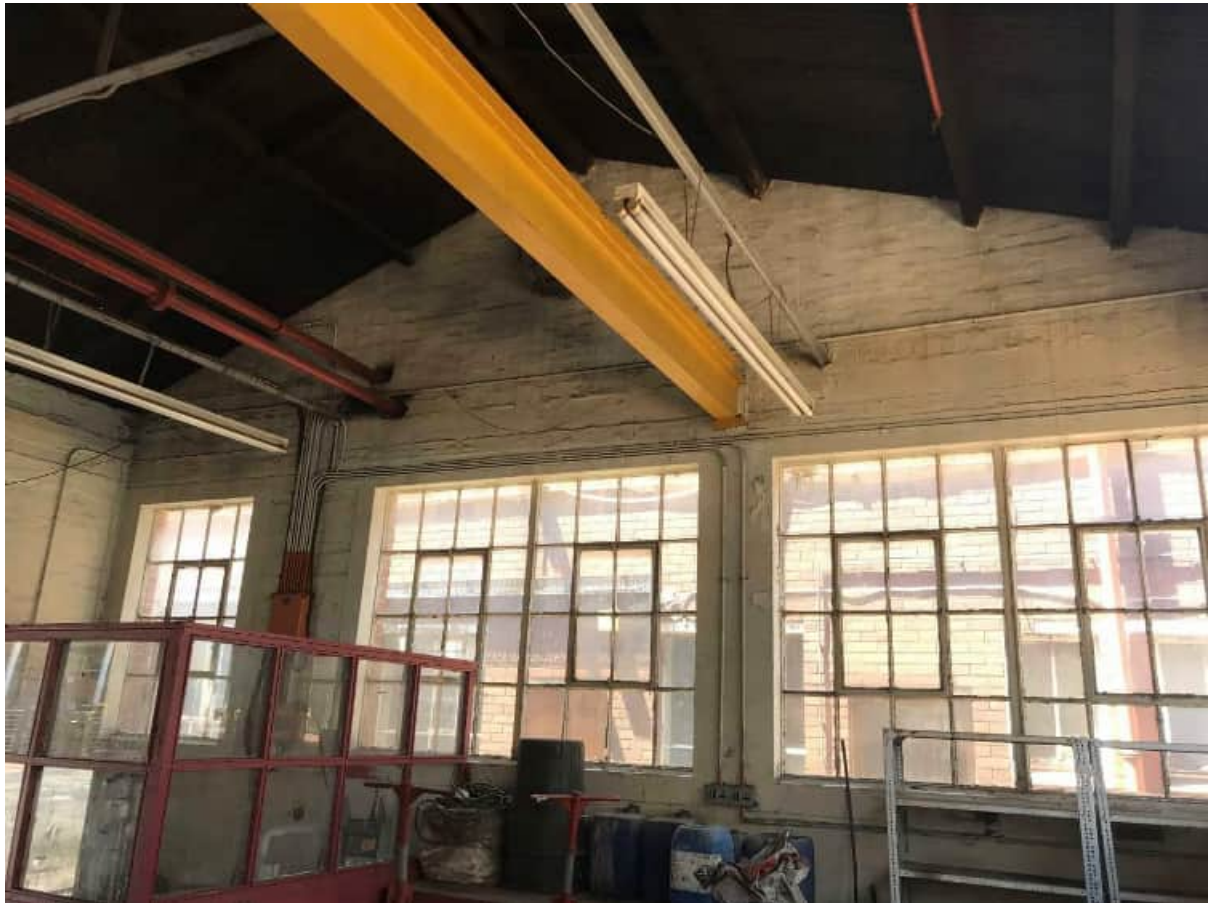
Figure 44.) View illustrating the internals of the garage bays. Refer to plans for list of additions, alterations & proposed demolition.

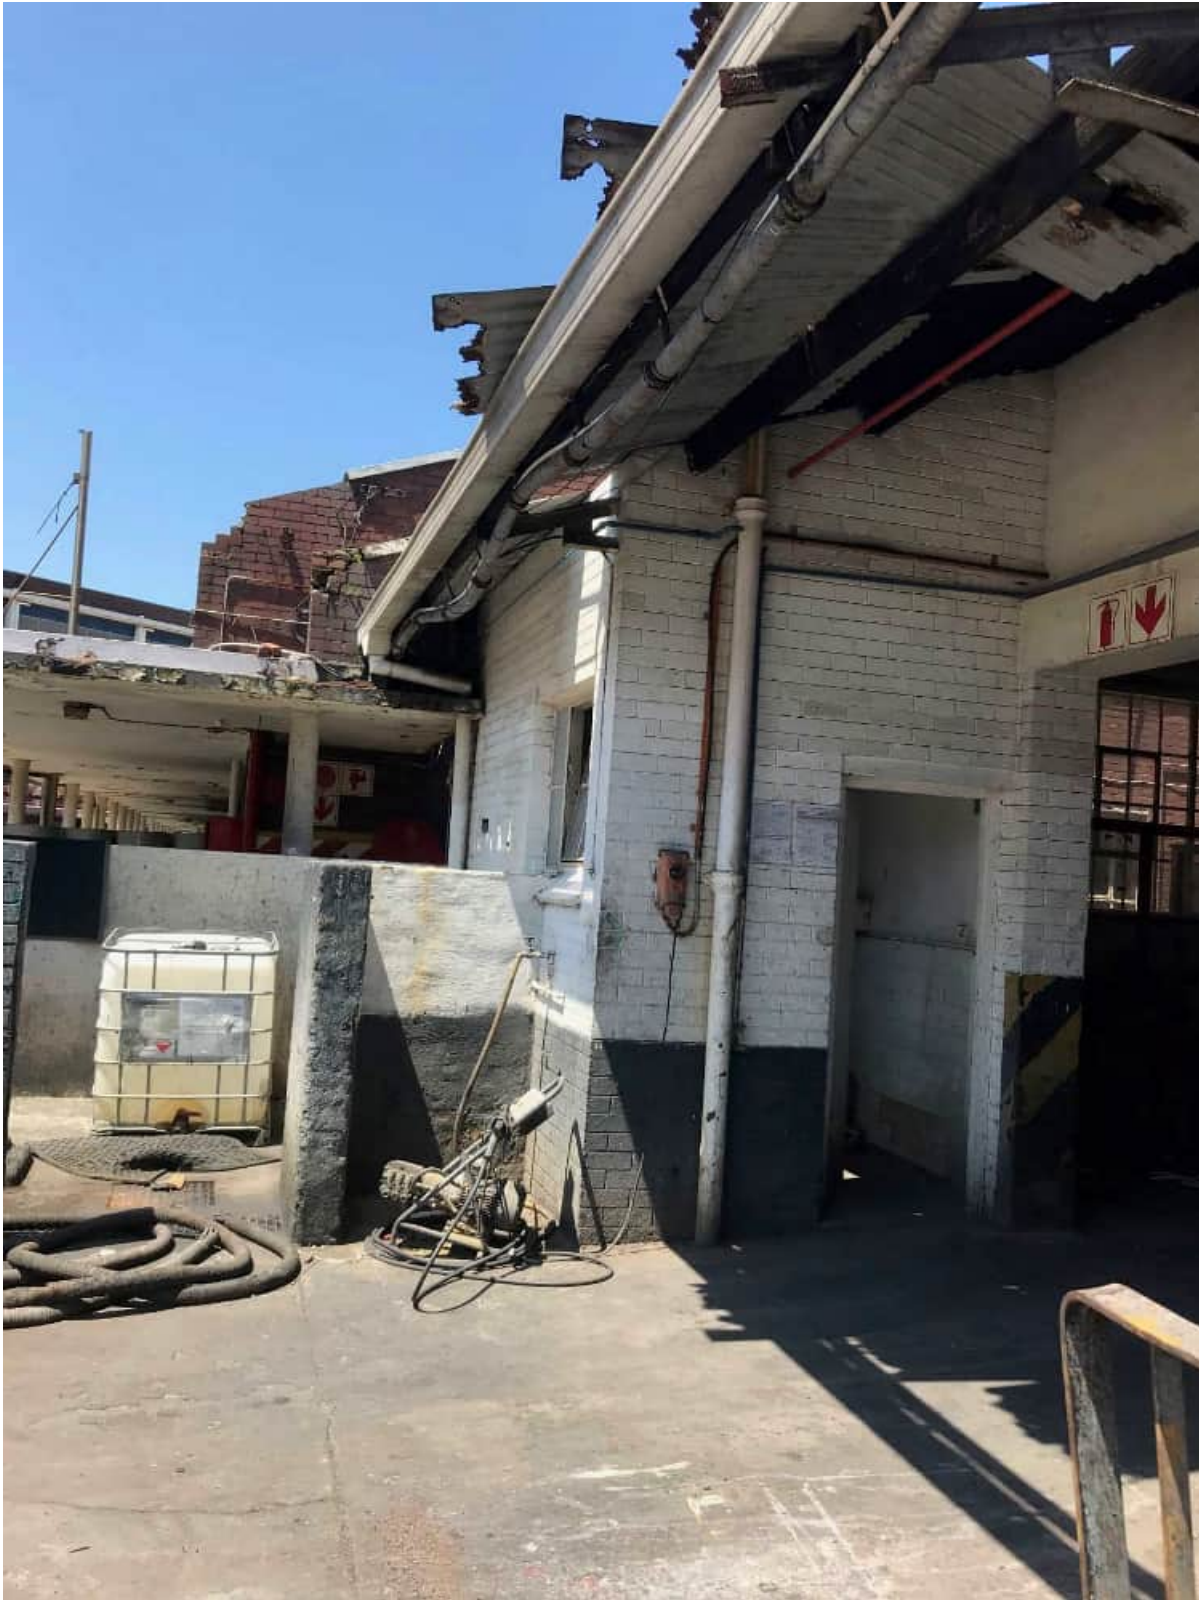
Figure 45.) View illustrating the internals of the garage Store, ablutions and adjacent office building canopy. Refer to plans for list of additions, alterations & proposed demolition.

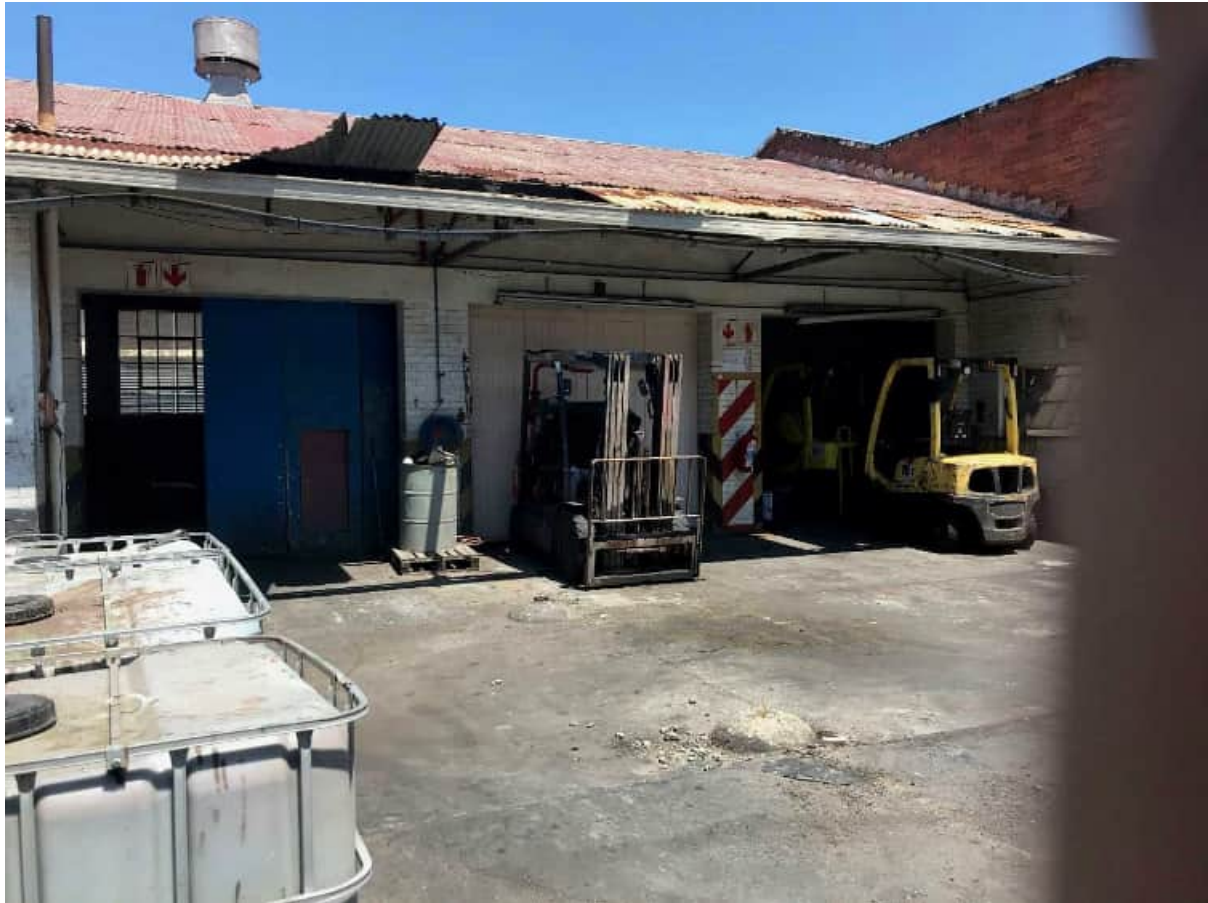
Figure 46.) View illustrating the front facade of the garage bays. Refer to plans for list of additions, alterations & proposed demolition.
