AMAFA PHOTOGRAPHIC REPORT FOR PROPOSED ADDITIONS AND ALTERATIONS TO 1236 SOUTH COAST ROAD, MOBENI, DURBAN

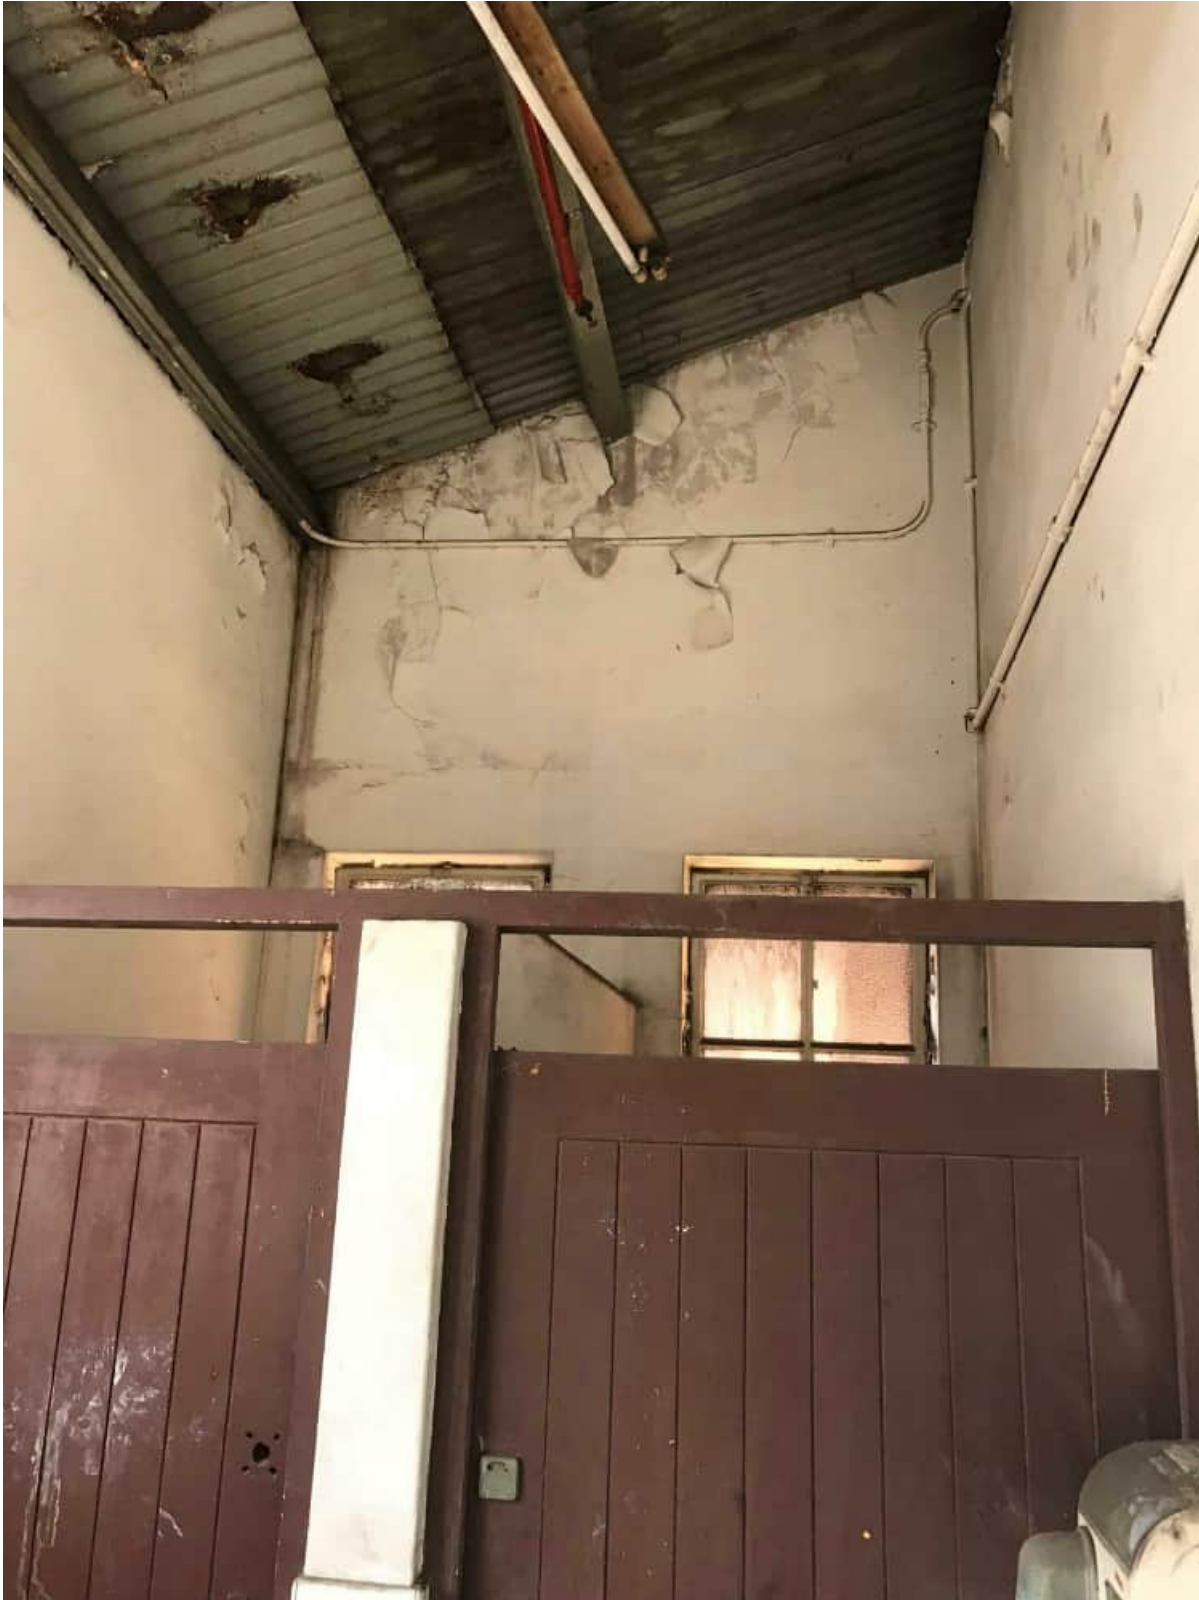
Figure 47.) View illustrating the internals of the ablutions. Refer to plans for list of additions, alterations & proposed demolition.

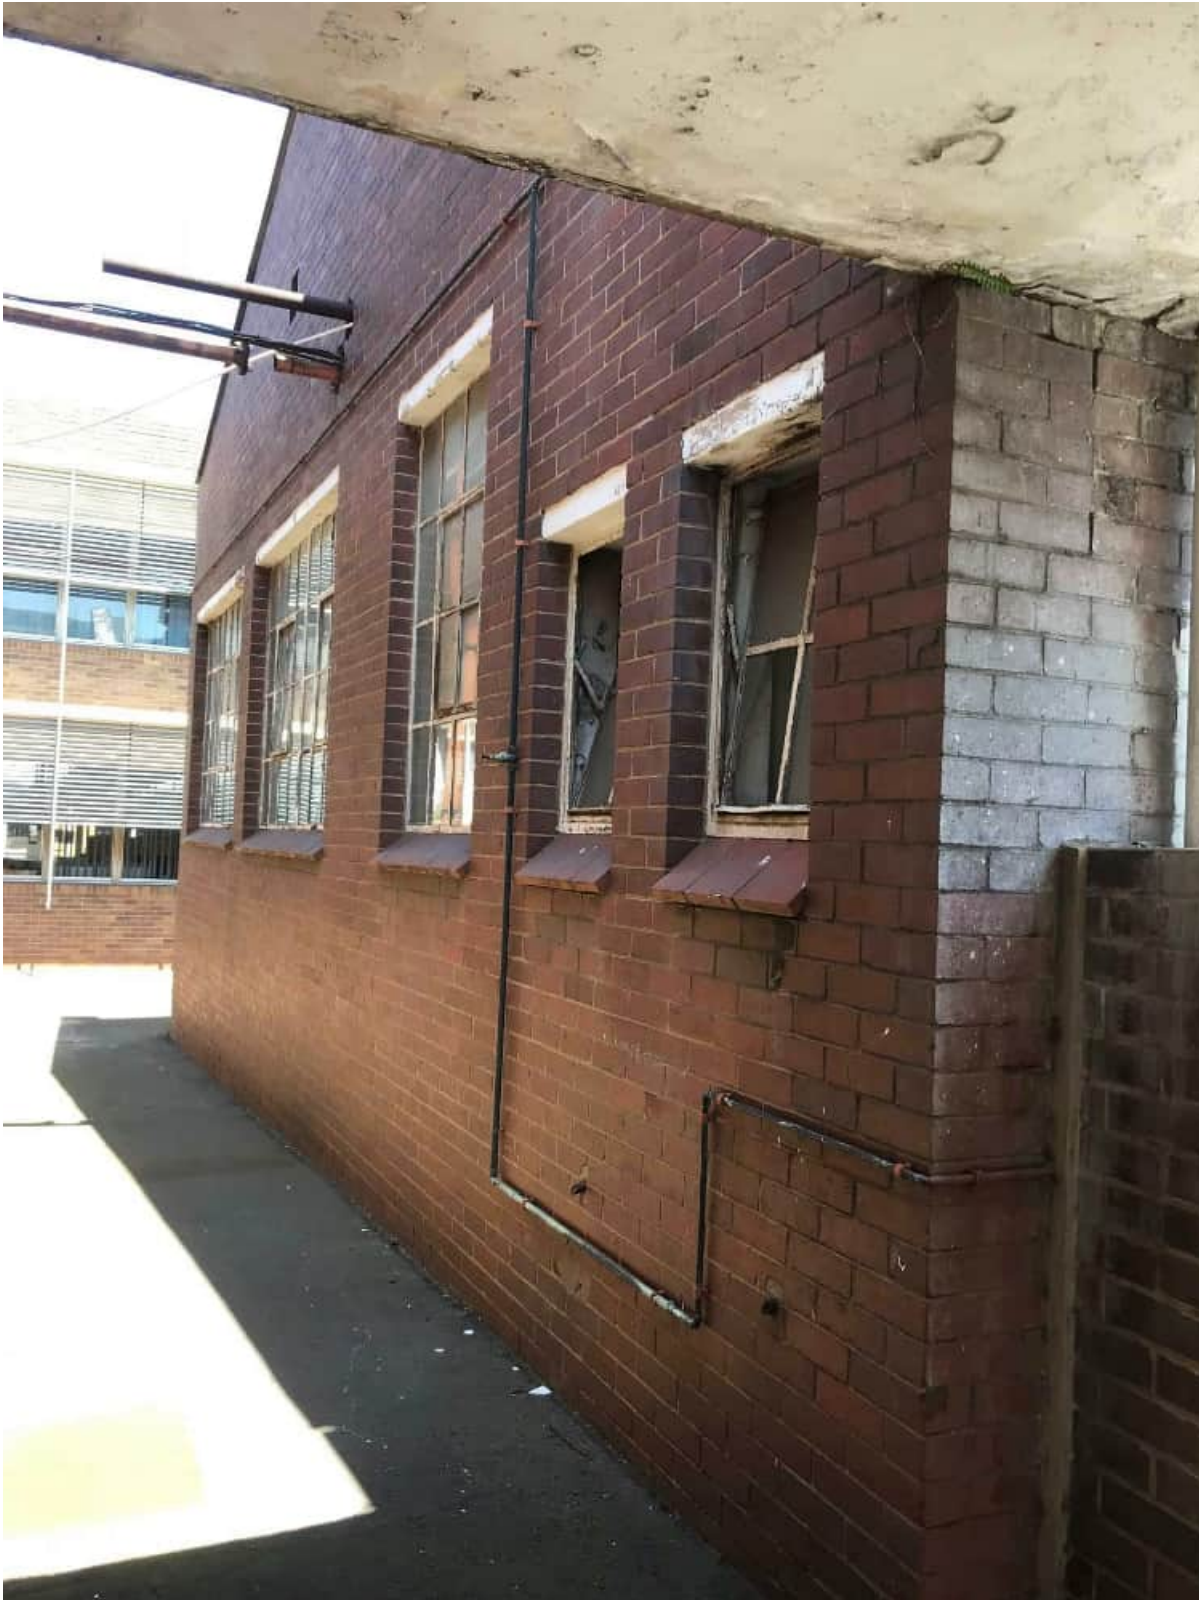
Figure 48.) View illustrating Eastern façade of the garage and storerooms. Refer to plans for list of additions, alterations & proposed demolition.

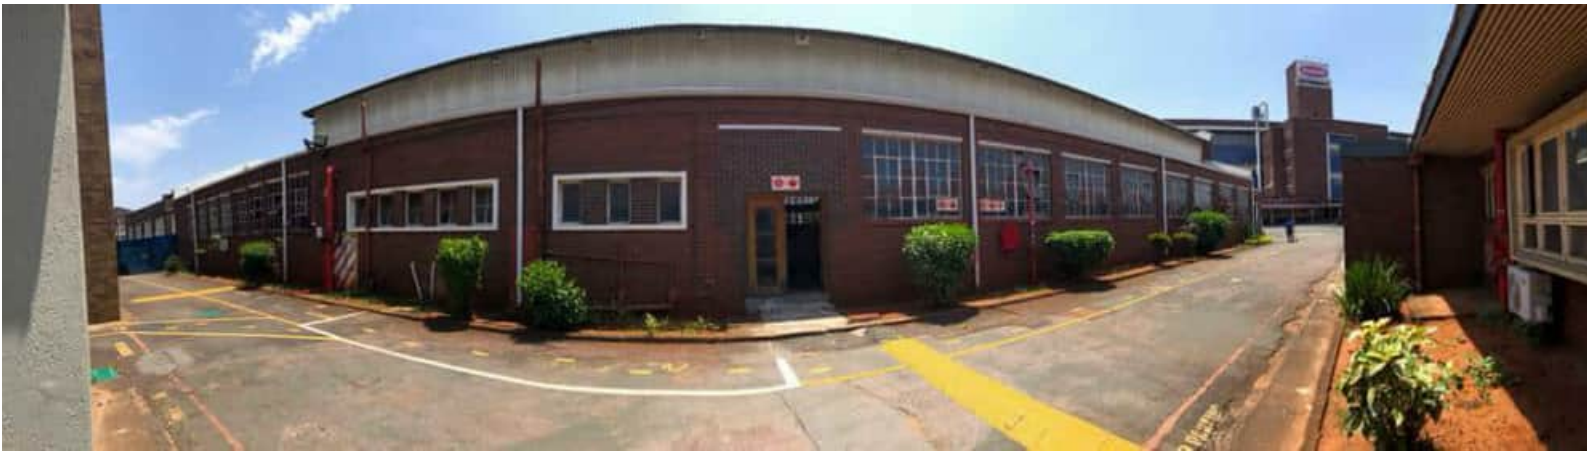
Figure 49.) View illustrating the wide-angle view of the garage Store, and office building. Refer to plans for list of additions, alterations & proposed demolition.

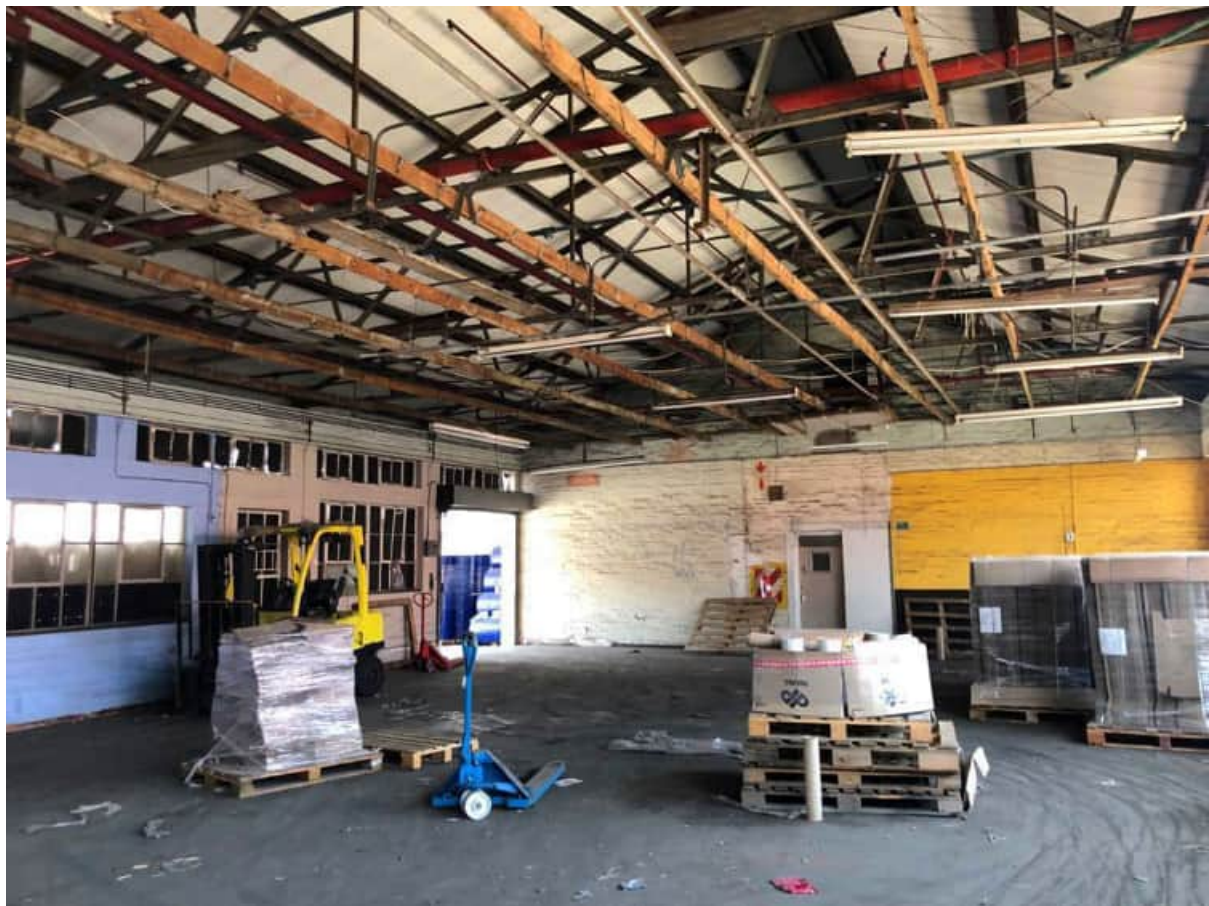
Figure 50.) View illustrating the internals of the office building and store. Refer to plans for list of additions, alterations & proposed demolition.

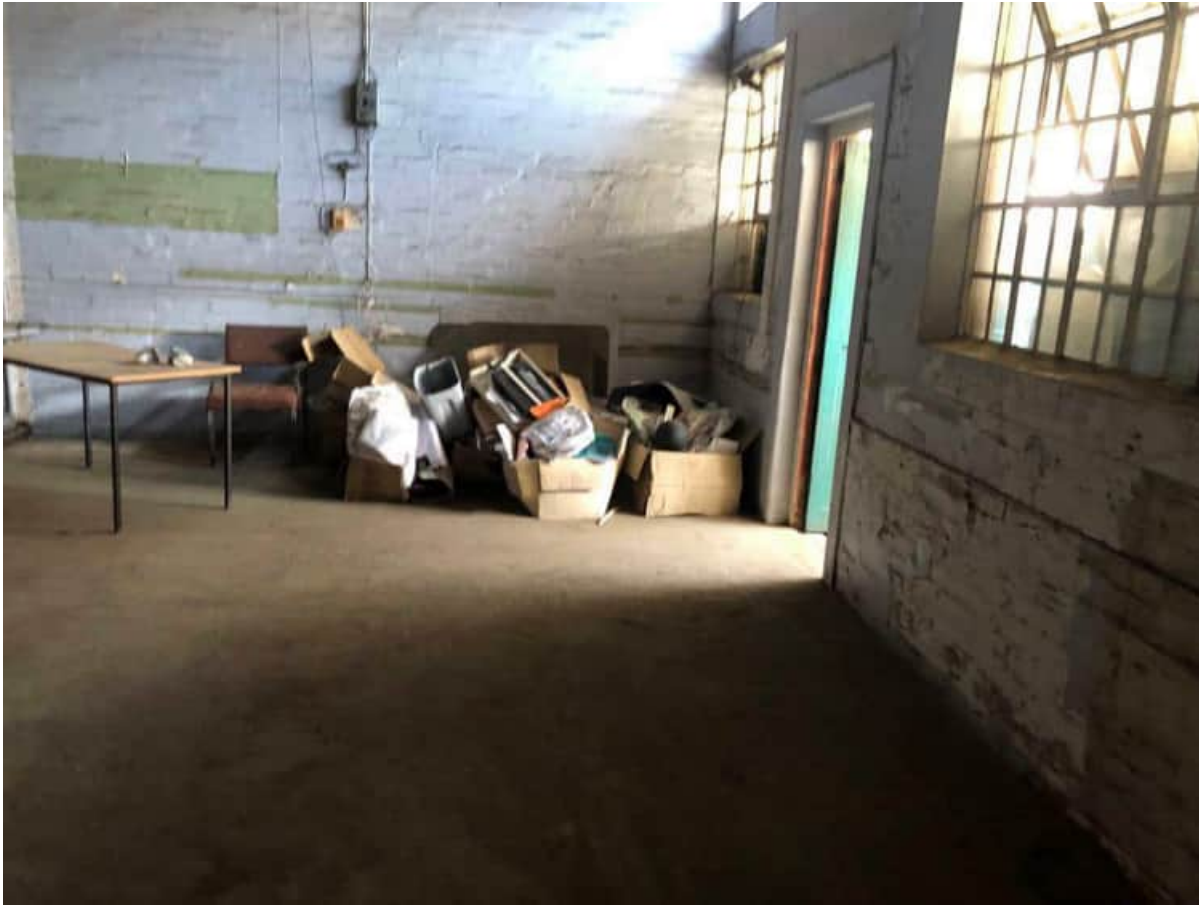
Figure 51.) View illustrating the internals of the office building and store. Refer to plans for list of additions, alterations & proposed demolition.

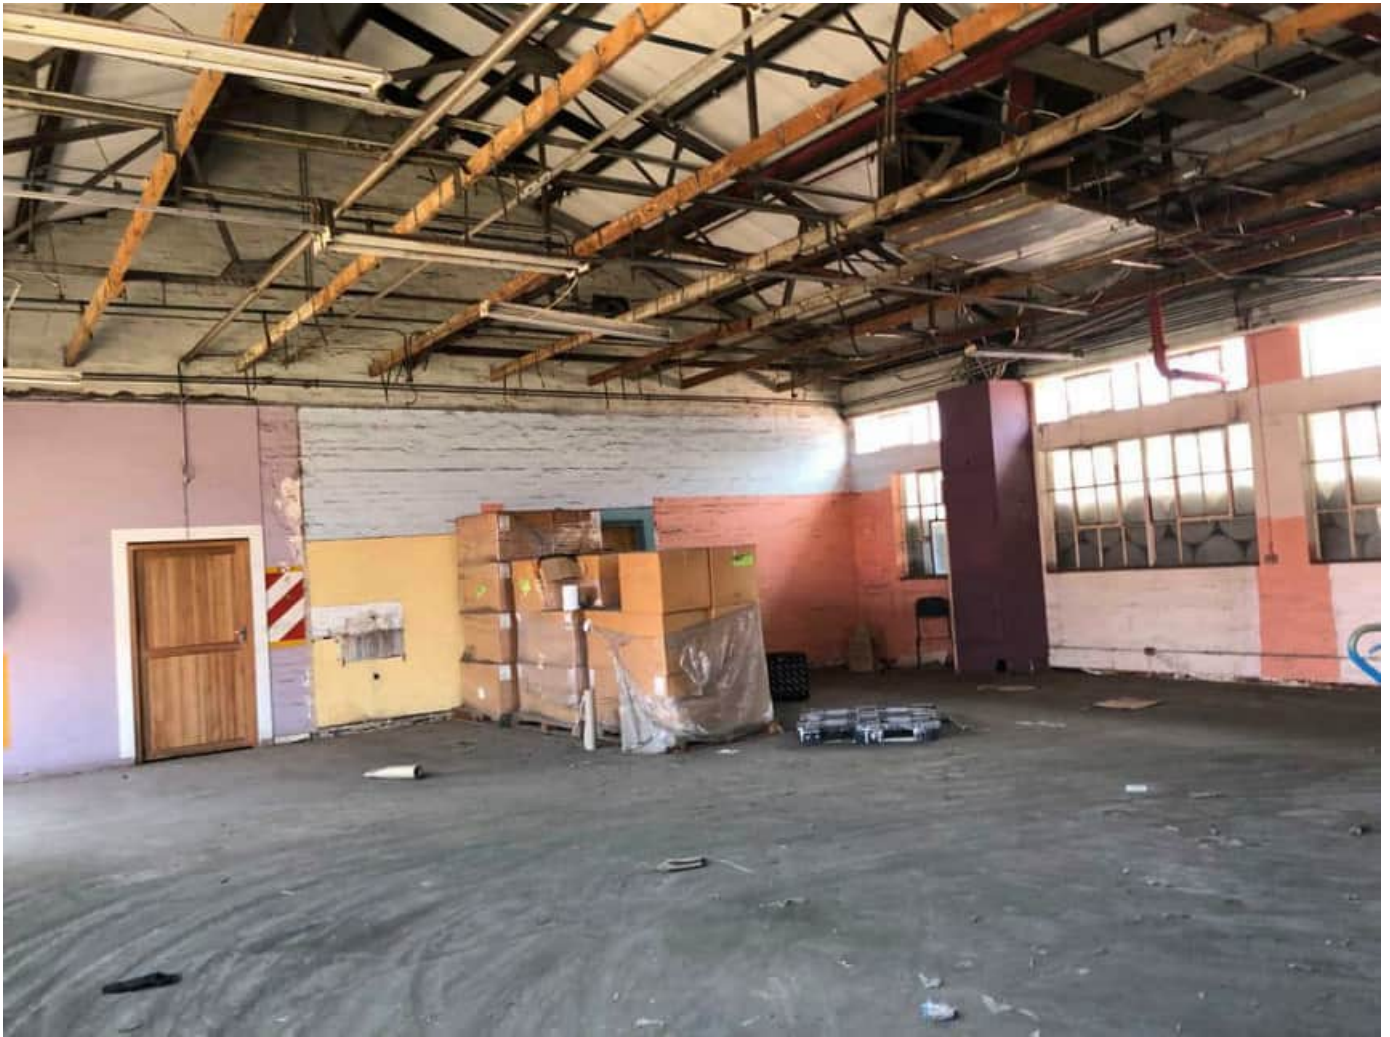
Figure 52.) View illustrating the internals of the office building and store. Refer to plans for list of additions, alterations & proposed demolition.

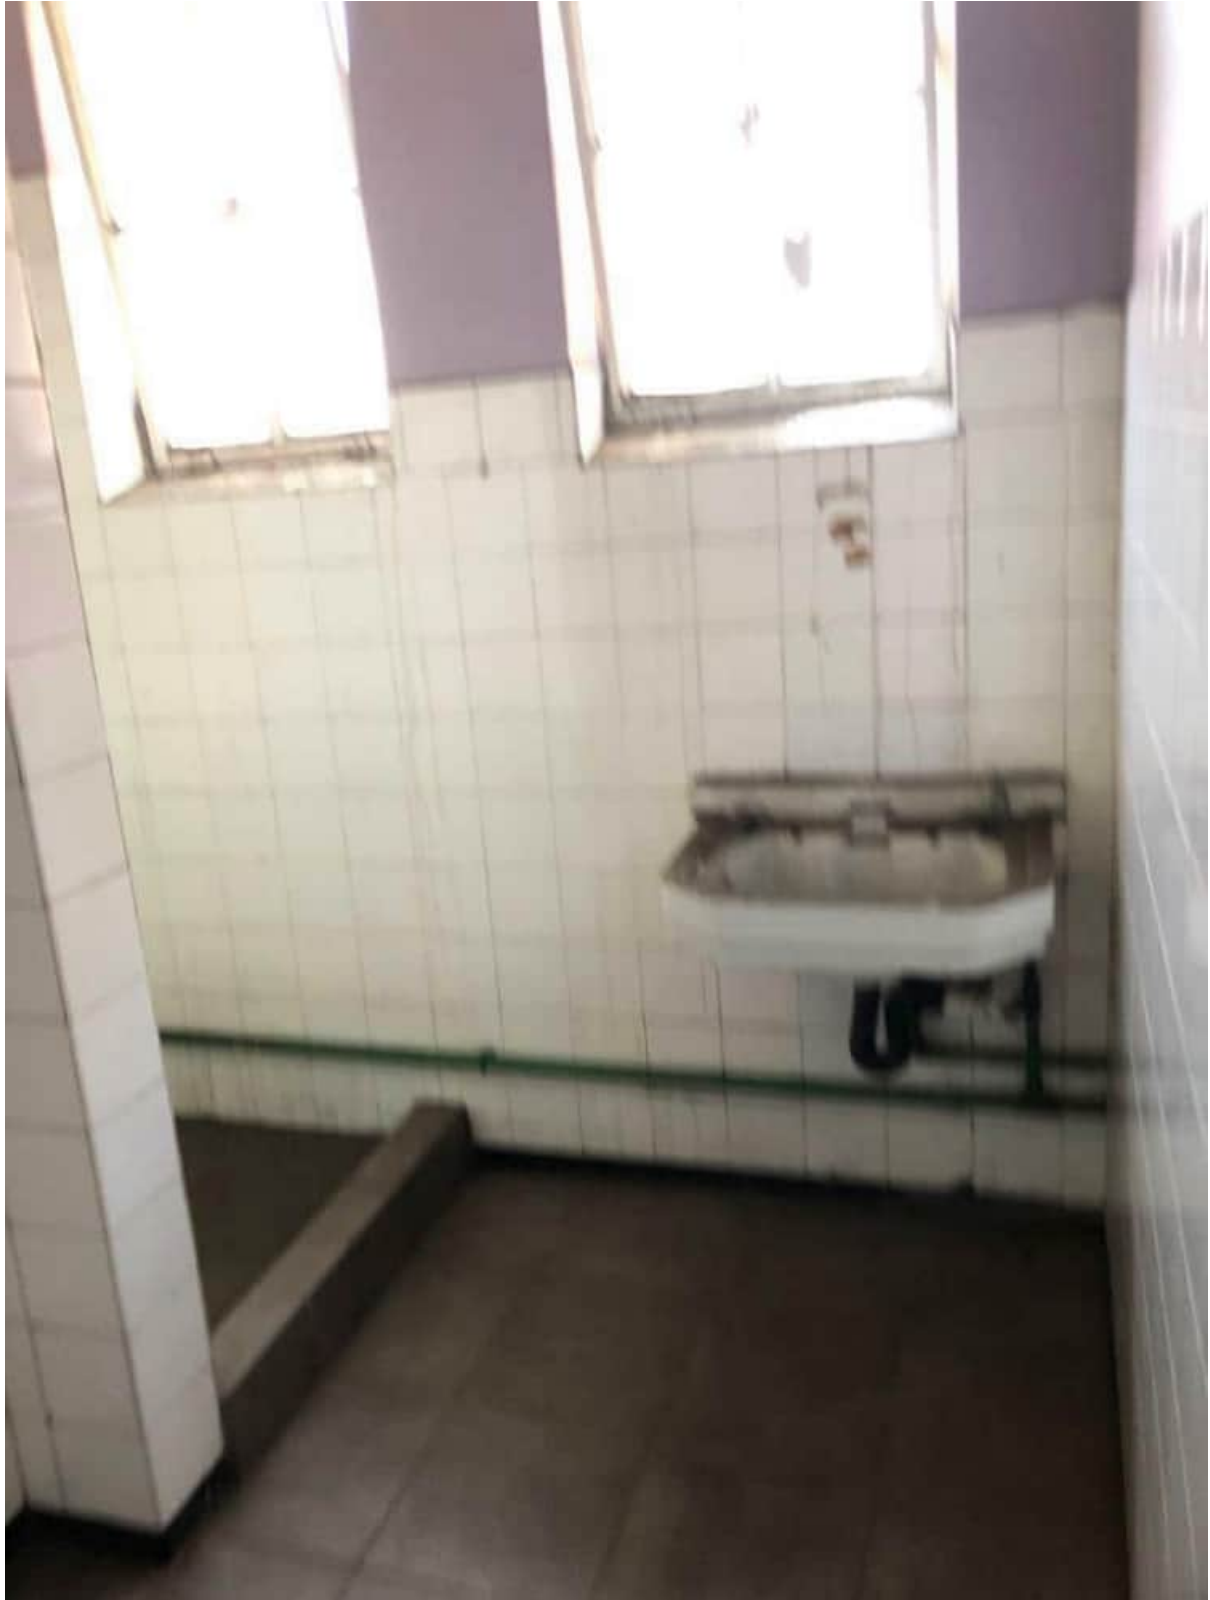
Figure 53.) View illustrating the internals of the office building and store. Refer to plans for list of additions, alterations & proposed demolition.

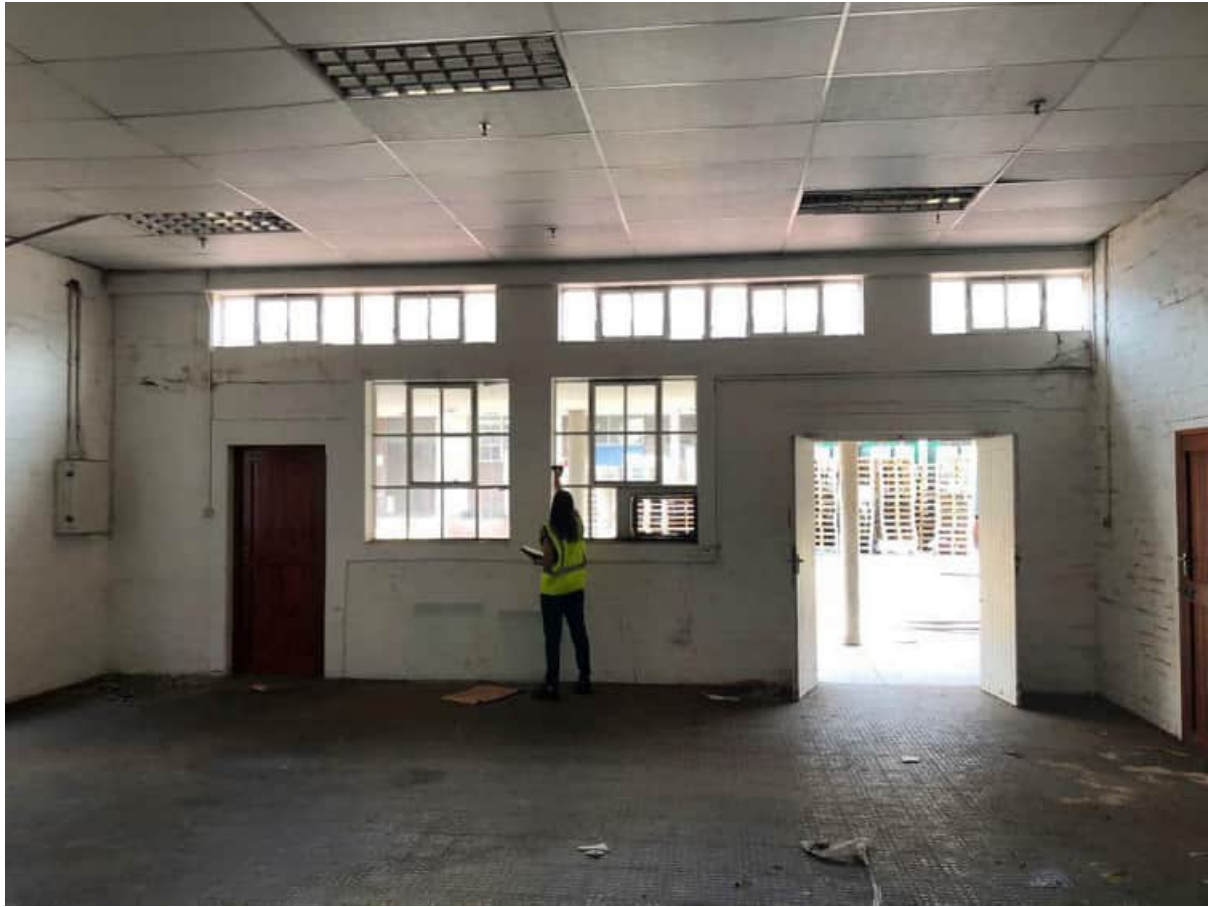
Figure 54.) View illustrating the internals of the office building and store. Refer to plans for list of additions, alterations & proposed demolition.

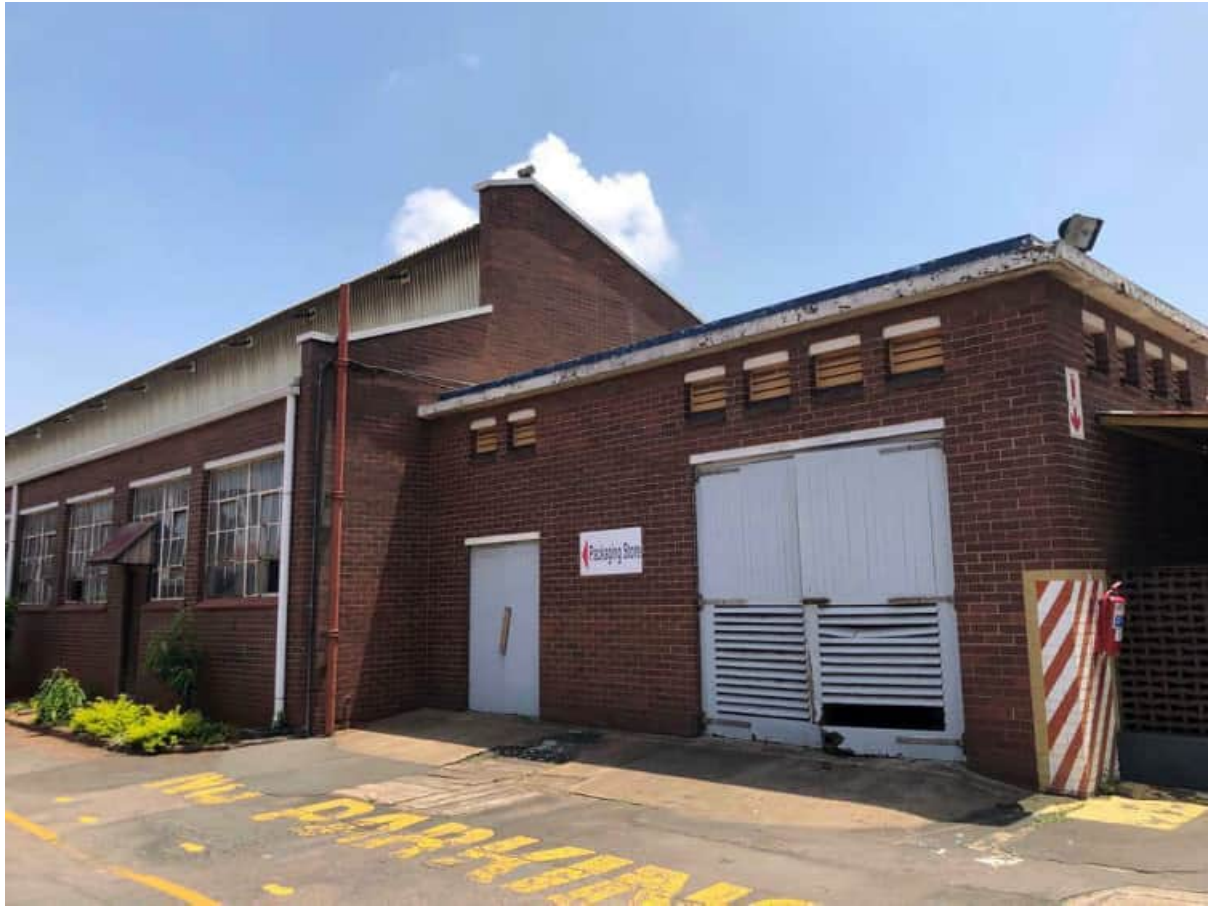
Figure 55.) View illustrating the south eastern façade of the office building and transformer room. Refer to plans for list of additions, alterations & proposed demolition.

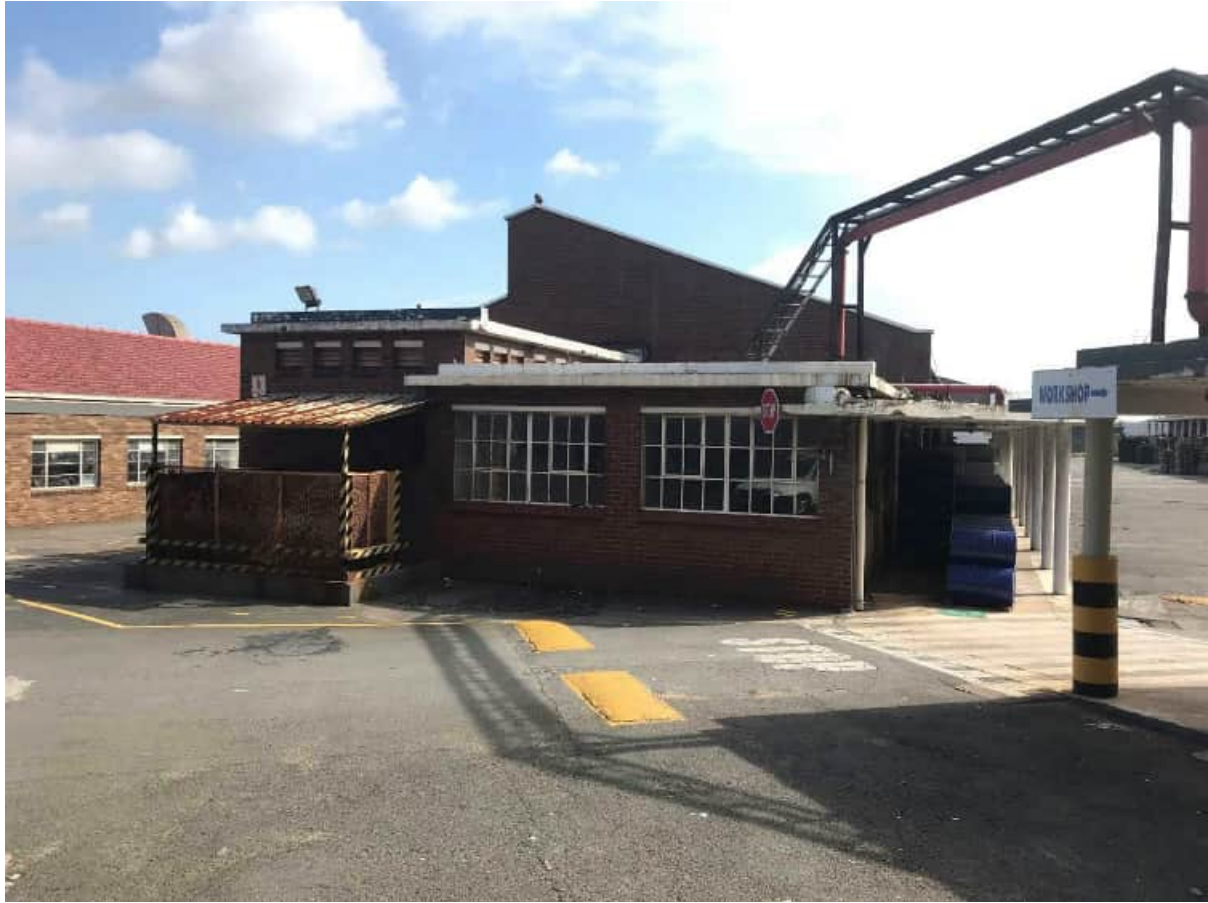
Figure 55.) View illustrating the eastern façade of the office building and transformer room. Refer to plans for list of additions, alterations & proposed demolition.
