**ANNEX A : PHOTOGRAPHS
IN REFERENCE TO MOTIVATION AND DRAWINGS PROVIDED**

**PROPOSAL: ALTERATIONS TO EXISTING RESTAURANT
AT 18 LILIAN NGOYI ROAD
WINDERMERE, DURBAN**

PORTION 50 (of 38) of ERF 1368 DURBAN

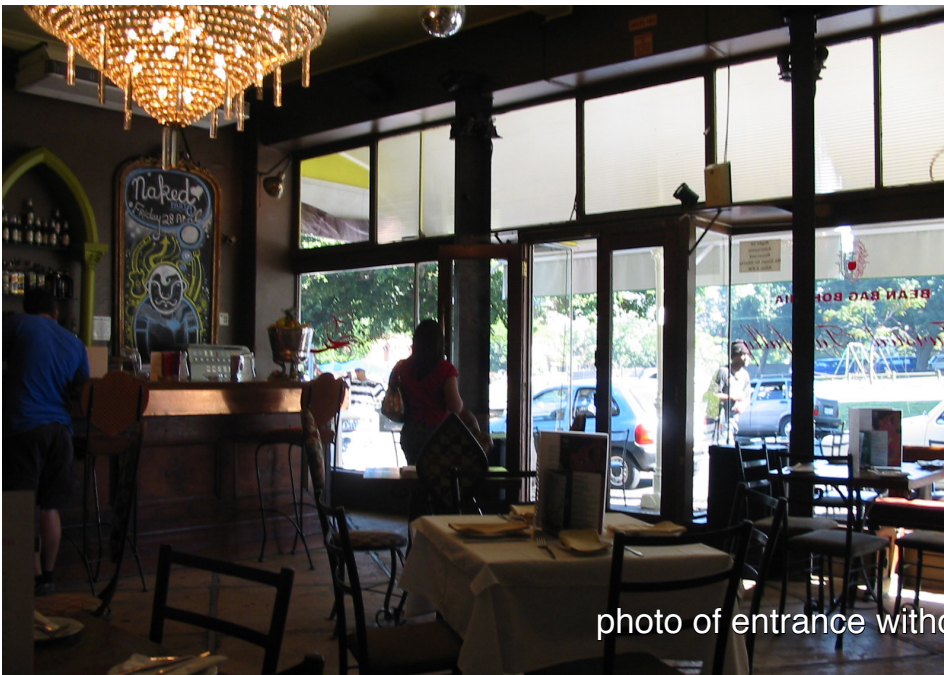
photo of entrance without posts. no double volume voids
24/05/2004

2 round steel posts at the groundfloor level were installed circa 2021/2022 to support double volume voids in the floor above. The posts and voids are not historical features and do not enhance the historical character of the building.

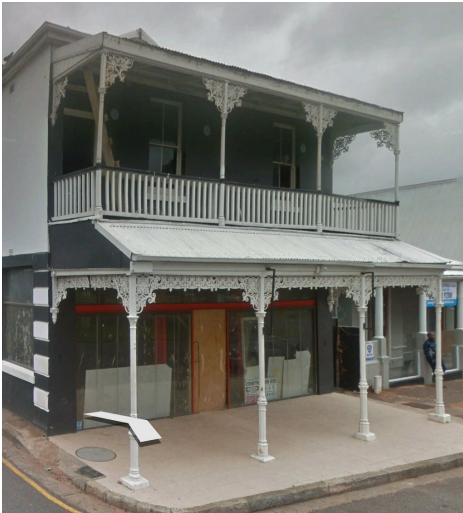
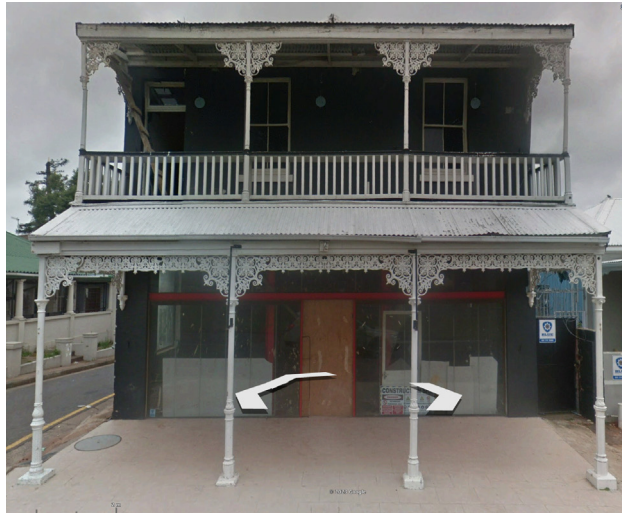
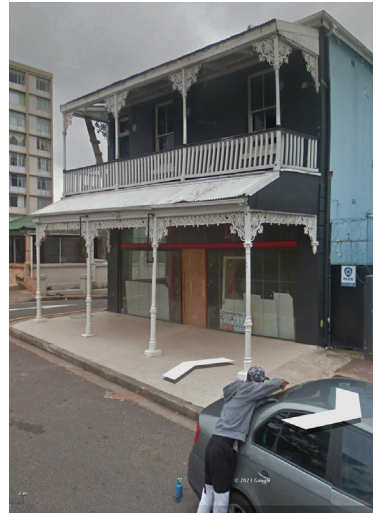
google earth photo of original balustrade
11/2017

Existing wrought iron balcony balustrade is to be removed and a timber balustrade to match the original is to be installed. New stainless steel handrail to be installed as per previous approved drawings to achieve SANS 1m height compliance
