IZIKO MUSEUMS | **EXISTING BUILDING CONDITION REPORT**

REF. CSM/Architects/12/2015

BO-KAAP MUSEUM

DATE: APRIL 2018 | **STATUS:** FINAL

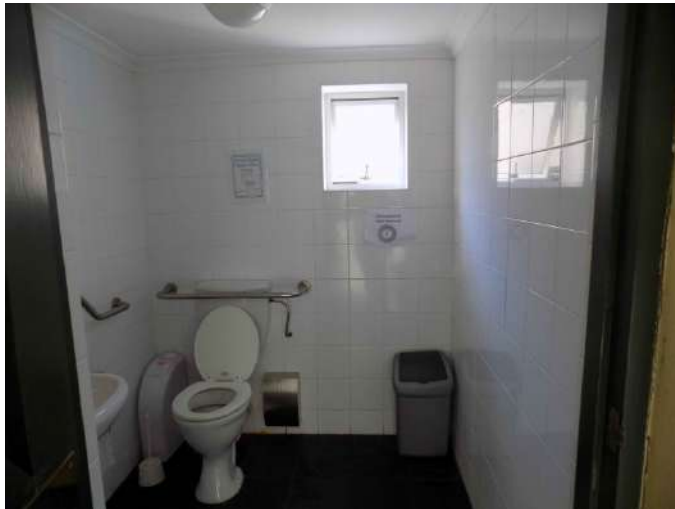
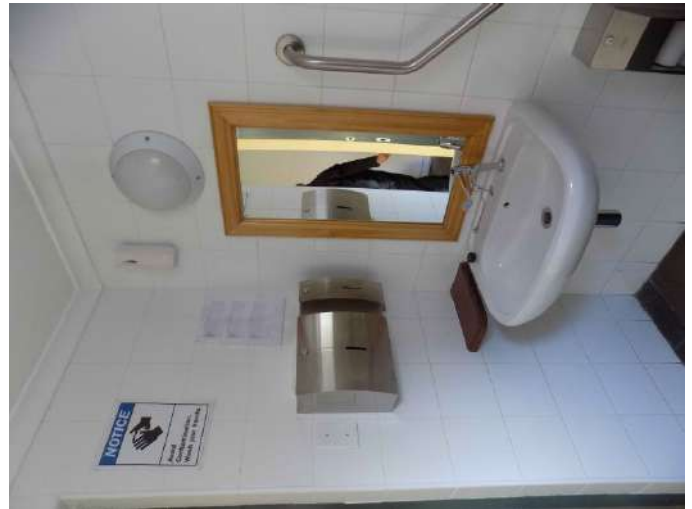
PROJECT	IZIKO MUSEUMS OF SOUTH AFRICA: EXISTING CONDITION BUILDING REPORTS AND 5-YEAR MAINTENANCE PLANS		
BUILDING	BO KAAP MUSEUM		
DOCUMENT	DATA SHEET		
	AREA	INTERNAL ROOMS	
		ROOM NUMBER	109
		ROOM NAME	FEMALE TOILET

Item	Description	Condition
Floor	Construction & finish	Slate tiles with clear finish on concrete surface bed.	Floor in good condition.
	Skirting	None.	Not applicable.
	Services	None.	Not applicable.
Walls	Construction & finish	Ceramic tiles to ceiling height	Tiles in good condition
	Openings	None.	Not applicable.
	Dado	None.	Not applicable.
	Services	X1 bulkhead light fitting	See applicable services report.
Ceiling	Construction & finish	Gypsum ceiling board with paint finish.	See structural report. Ceiling visually in good condition.
	Cornice	Coved gypsum board cornice with paint finish.	Cornice requires sealing at some areas.
	Services	X1 bulkhead light fitting	See applicable services report.
Door 111	Size & description	935 x 2,020 hinged timber single door with paint finish.	
	Frame & architrave	70 x 114 timber frame paint finish.	Frame in good condition.
	Door	Framed, braced and ledged panel single door with paint finish and bronze signage.	Door in good condition.

Threshold	None.	Not applicable.
	Glazing	None.	Not applicable.
	Ironmongery	bronze hinged door hinges and paraplegic signage	Ironmongery in good condition.
	Window 109	Size & description	470 x 575 aluminium casement Window with natural anodized powder coated finish.
Frame		160 x 100 aluminium casement frame with natural anodized powder coated finish.	Frame in good condition.
Opener/s		Aluminium casement framework with natural anodized powder coated finish.	Casement in good condition.
Louvre/s		None.	Not applicable.
Internal sill		Ceramic wall tiles	Internal Window sill in good condition.
External sill		None.	Not applicable.
Glazing		Clear frosted float glass.	Glazing in good condition.
Ironmongery		Casement Window ironmongery.	Ironmongery in good condition.
Equipment & fixtures		Electrical	Various electrical services
	Mechanical	None.	Not applicable.
	Other	WC Wash hand basin Paraplegic grab rails Toilet roll holder Paper towel holder Framed mirror Soap dispenser Air freshener	All in order and in good condition

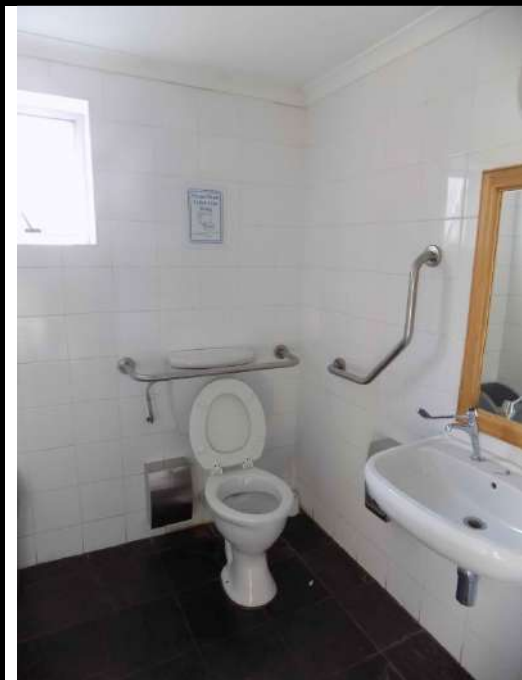
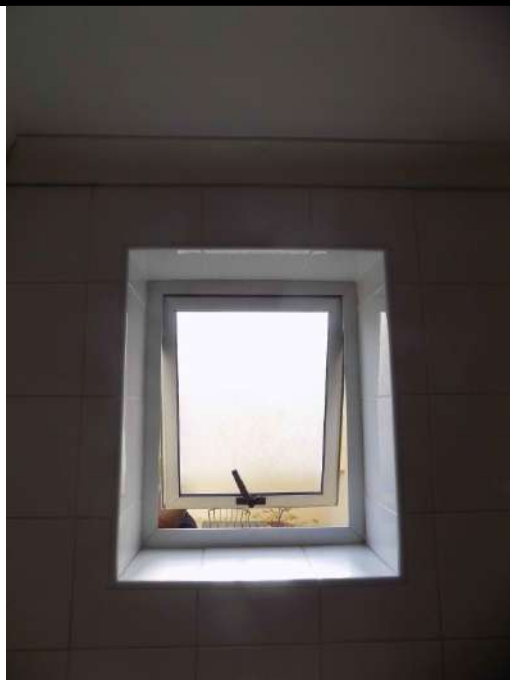
PROJECT	IZIKO MUSEUMS OF SOUTH AFRICA: EXISTING CONDITION BUILDING REPORTS AND 5-YEAR MAINTENANCE PLANS		
BUILDING	BO KAAP MUSEUM		
DOCUMENT	DATA SHEET		
	AREA	INTERNAL ROOMS	
		ROOM NUMBER	110
		ROOM NAME	MALE TOILET

Item	Description	Condition
Floor	Construction & finish	Slate tiles with clear finish on concrete surface bed.	Floor in good condition.
	Skirting	None.	Not applicable.
	Services	None.	Not applicable.
Walls	Construction & finish	Ceramic tiles to ceiling height	Tiles in good condition
	Openings	None.	Not applicable.
	Dado	None.	Not applicable.
	Services	X1 bulkhead light fitting	See applicable services report.
Ceiling	Construction & finish	Gypsum ceiling board with paint finish.	See structural report. Ceiling visually in good condition.
	Cornice	Coved gypsum board cornice with paint finish.	Cornice requires sealing at some areas.
	Services	X1 bulkhead light fitting	See applicable services report.
Door 112	Size & description	935 x 2,020 hinged timber single door with paint finish.	
	Frame & architrave	70 x 114 timber frame paint finish.	Frame in good condition.
	Door	Framed, braced and ledged panel single door with paint finish and bronze signage.	Door in good condition.

Threshold	None.	Not applicable.
	Glazing	None.	Not applicable.
	Ironmongery	bronze hinged door hinges and paraplegic signage	Ironmongery in good condition.
Window 110	Size & description	470 x 575 aluminium casement Window with natural anodized powder coated finish.	
	Frame	Aluminium casement frame with natural anodized powder coated finish.	Frame in good condition.
	Opener/s	Aluminium casement framework with natural anodized powder coated finish.	Casement in good condition.
	Louvre/s	None.	Not applicable.
	Internal sill	Ceramic wall tiles	Internal Window sill in good condition.
	External sill	None.	Not applicable.
	Glazing	Clear frosted float glass.	Glazing in good condition.
	Ironmongery	Casement Window ironmongery.	Ironmongery in good condition.
Equipment & fixtures	Electrical	Various electrical services	See applicable services report.
	Mechanical	None.	Not applicable.
	Other	WC Wash hand basin Paraplegic grab rails Toilet roll holder Paper towel holder Framed mirror Soap dispenser Air freshener	All in order and in good condition

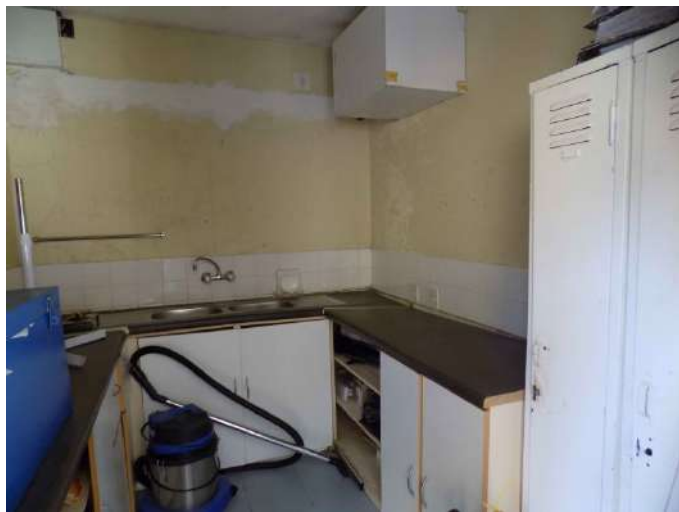
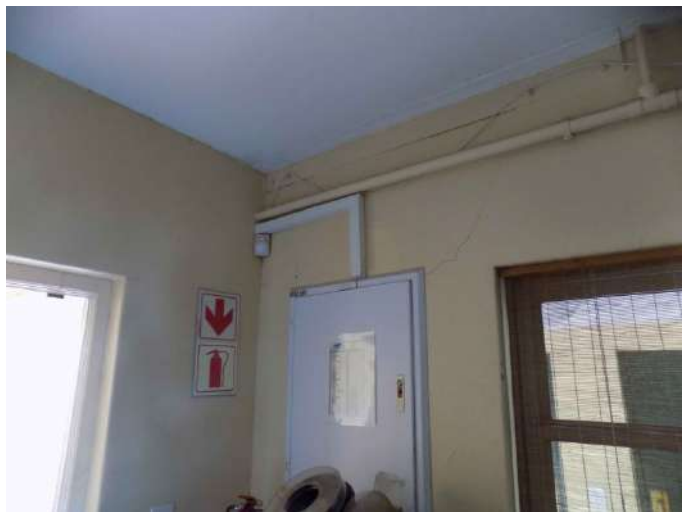
PROJECT	IZIKO MUSEUMS OF SOUTH AFRICA: EXISTING CONDITION BUILDING REPORTS AND 5-YEAR MAINTENANCE PLANS		
BUILDING	BO KAAP MUSEUM		
DOCUMENT	DATA SHEET		
	AREA	INTERNAL ROOMS	
		ROOM NUMBER	111
		ROOM NAME	KITCHEN

Item	Description	Condition
Floor	Construction & finish	Vinyl floor tiles cement screed and concrete surface bed..	Floor in good condition.
	Skirting	75mm bullnose timber skirting with paint finish.	Skirting in fair condition.
	Services	None.	Not applicable.
Walls	Construction & finish	Plastered masonry with paint finish. White ceramic wall tiles.	Plaster & paint in fair condition. Areas requiring painting.
	Openings	None.	Not applicable.
	Dado	None.	Not applicable.
	Services	Various electrical services	See applicable services report.
Ceiling	Construction & finish	Skimmed concrete slab with paint finished.	See structural report. Ceiling visually in good condition.
	Cornice	None.	Not applicable.
	Services	Fluorescent light point.	See applicable services report.
Door 113	Size & description	985 x 2,095 hinged timber single stable door with internal clear finish and external paint finish.	
	Frame & architrave	70 x 114 timber frame with internal clear finish and external paint finish.	Frame in fair condition.

Door	Framed, braced and ledged panel single stable door with internal clear finish and external paint finish.	Door in fair condition.
	Threshold	Timber threshold with paint finish.	Timber threshold is in fair condition, but worn through.
	Glazing	None.	Not applicable.
	Ironmongery	Standard hinged door hinges and latches	Ironmongery in fair condition.
Window 111	Size & description	720 x 1,195 timber sash Windows with glass and internal roller blinds.	
	Frame	160 x 100 Timber sash frame with clear finish.	Frame in good condition.
	Opener/s	38 x 45 timber sash framework with 38 x 19 timber glazing divisions with paint finish.	Sash in good condition. Internal and external clear finish in good condition.
	Shutter/s	None.	Not applicable.
	Internal sill	Ceramic wall tiles	Internal Window sill in good condition.
	External sill	None.	Not applicable.
	Glazing	Float glass.	Glazing in good condition.
	Ironmongery	Sash Window ironmongery.	All ironmongery in fair condition.

Equipment & fixtures	Electrical	Wall mounted geyser.	See applicable services report.
	Mechanical	Fire escape signage.	See applicable services report.
	Other	Sink, built-in cupboards, airbricks	Fixtures in good condition.

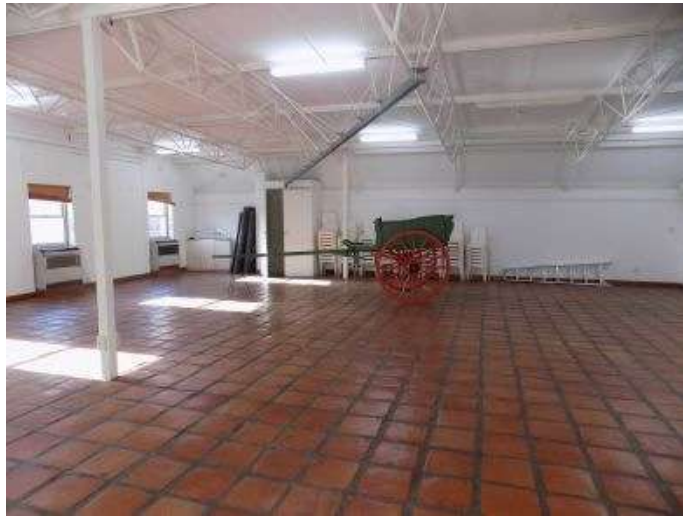
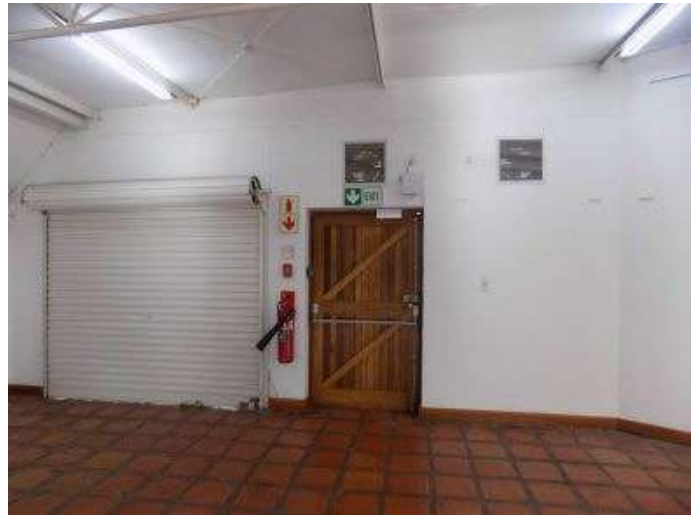
PROJECT	IZIKO MUSEUMS OF SOUTH AFRICA: EXISTING CONDITION BUILDING REPORTS AND 5-YEAR MAINTENANCE PLANS		
BUILDING	BO KAAP MUSEUM		
DOCUMENT	DATA SHEET		
	AREA	INTERNAL ROOMS	
		ROOM NUMBER	201
		ROOM NAME	COMMUNITY HALL

Item	Description	Condition
Floor	Construction & finish	Terracotta tiles with clear sealant and cement grout on concrete slab.	Floor in good condition.
	Skirting	100 mm high bullnose skirting, varnished.	Skirting in good condition.
	Services	None.	Not applicable.
Walls	Construction & finish	Plastered masonry with paint finish.	Walls in reasonable condition.
	Openings	3,580 x 2,285 rectangular opening. 2 x extractor fan openings with louvres over.	Openings in good condition.
	Dado	None.	Not applicable.
	Services	Various electrical services	See applicable services report.
Ceiling	Construction & finish	Ceiling panels on exposed metal girder trusses with paint finish	
	Cornice	None.	Not applicable.
	Services	Fluorescent light fittings	See applicable services report.
Door 201	Size & description	2043 x 2570 Metal roller door with security gate.	
	Frame & architrave	Steel frame and track for sectional door	Frame in good condition.

Door	Metal sectional roll-up garage with paint finish.	Door in good condition
	Threshold	None.	Not applicable.
	Glazing	None.	Not applicable.
	Ironmongery	Door contact Dead bolt with pad lock Steel hinges (gate) Dead bolt with pad lock (gate)	Ironmongery in good condition.
Door 202	Size & description	1,185 x 2,052 Modern timber FLB door with paint finish on outside and varnish on the inside. Door closed off on exterior with painted panel.	
	Frame & architrave	70 x 114 timber frame with internal clear finish and external paint finish.	Frame in good condition.
	Door	Framed, braced and ledged panel single stable door with internal clear finish and external paint finish.	Door in good condition.
	Threshold	Timber threshold with paint finish.	Timber threshold is in fair condition, but worn through.
	Glazing	None.	Not applicable.
	Ironmongery	Electric lock Door contact Dead bolt with pad lock Aluminium panic bar Electric lock with emergency override	Ironmongery in good condition.

Opener/s	Aluminium sash framework with natural anodized powder coated finish.	Sash in good condition.
	Louvre/s	Aluminium louvre framework on bottom part of Window with natural anodized powder coated finish.	Louvres in good condition.
	Internal sill	None.	Not applicable.
	External sill	None.	Not applicable.
	Glazing	Clear float glass.	Glazing in good condition.
	Ironmongery	Sash Window and louvre ironmongery. A/C units attached to Window.	All ironmongery in good condition.
Equipment & fixtures	Electrical	Various electrical services	See applicable services report.
	Mechanical	Various mechanical services	See applicable services report.
	Other	Built-in cupboards Movable partition system on hanging rails.	All in good condition.

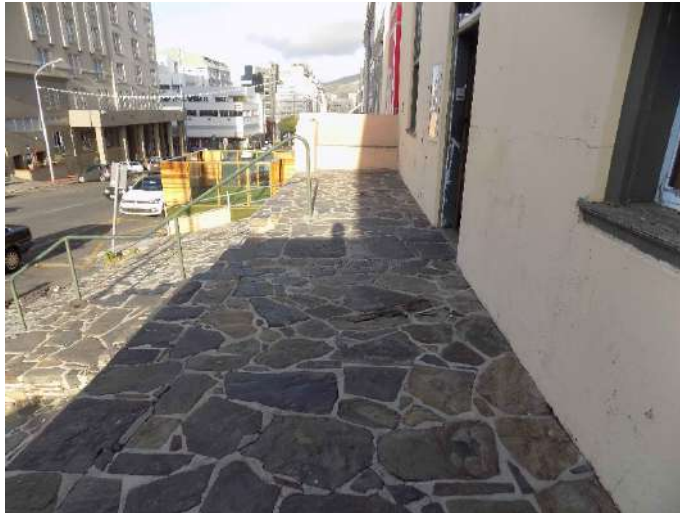
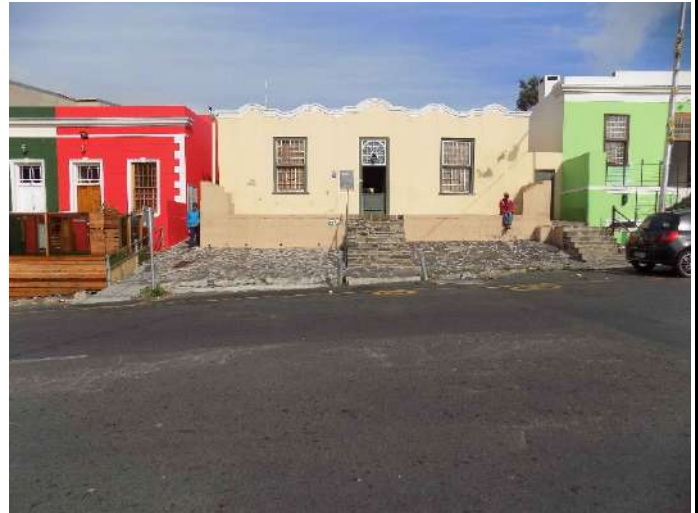
PROJECT	IZIKO MUSEUMS OF SOUTH AFRICA: EXISTING CONDITION BUILDING REPORTS AND 5-YEAR MAINTENANCE PLANS		
BUILDING	BO KAAP MUSEUM		
DOCUMENT	DATA SHEET		
	AREA	EXTERNAL AREAS	
		AREA NUMBER	301
		AREA NAME	ENTRANCE PORCH

Item	Description	Condition
Paving & roadways	Construction & finish	Slate paving with non-slip rough finish	Floor in good condition.
	Kerbs	None.	Not applicable.
	Services	Stormwater pipes, manholes and	See applicable services report.
Structures & walls	Construction & finish	Plastered masonry with paint finish.	Walls in reasonable condition.
	Openings	None.	Not applicable.
	Mouldings	None.	Not applicable.
	Services	Various stormwater and electrical services	See applicable services report.
Gates	Size & description	None.	
	Frame	None.	Not applicable.
	Gate	None.	Not applicable.
	Ironmongery	None.	Not applicable.
Fences	Position & description	None.	
	Posts	None.	Not applicable.
	Fencing	None.	Not applicable.
Equipment & fixtures	Electrical	None.	Not applicable.
	Mechanical	Paraplegic and fire escape route signage.	Signage missing.
	Other	Retrofitted stairs and balustrade	In fair condition. Paint worn out.

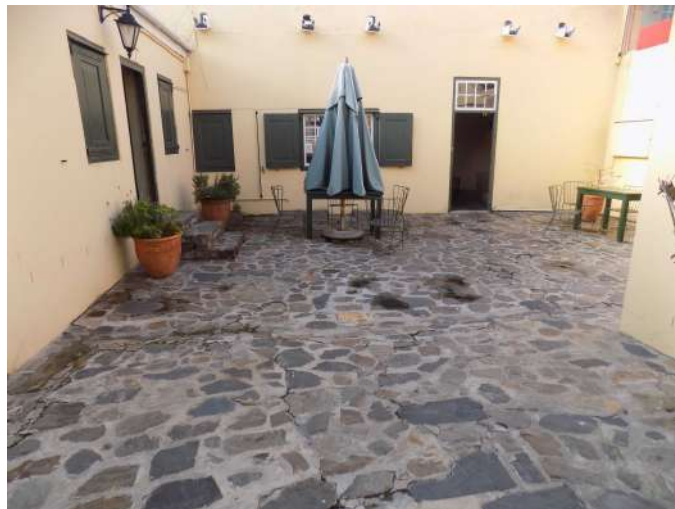
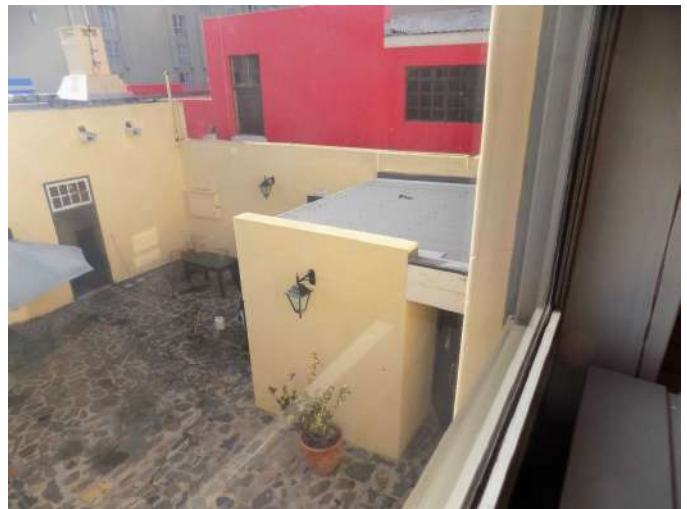
PROJECT	IZIKO MUSEUMS OF SOUTH AFRICA: EXISTING CONDITION BUILDING REPORTS AND 5-YEAR MAINTENANCE PLANS		
BUILDING	BO KAAP MUSEUM		
DOCUMENT	DATA SHEET		
	AREA	EXTERNAL AREAS	
		AREA NUMBER	302
		AREA NAME	COURTYARD

Item	Description	Condition
Paving & roadways	Construction & finish	Slate paving with non-slip rough finish	Floor in good condition.
	Kerbs	None.	Not applicable.
	Services	Stormwater pipes, manholes and channels	See applicable services report.
Structures & walls	Construction & finish	Plastered masonry with paint finish.	Walls in reasonable condition.
	Openings	Rain water spouts	In fair condition.
	Mouldings	None.	Not applicable.
	Services	Various stormwater and electrical services	See applicable services report.
Gates	Size & description	1,360 steel hinged single gate with paint finish.	
	Frame	50 x 50 steel posts with paint finish	Frame in fair condition.
	Gate	1,360 steel hinged single gate with paint finish.	Gate in fair condition. Paint wearing out.
	Ironmongery	Steel gate hinges and barrel bolt	Ironmongery in good condition.
Fences	Position & description	None.	
	Posts	None.	Not applicable.
	Fencing	None.	Not applicable.

Equipment & fixtures	Electrical	None.	Not applicable.
	Mechanical	None.	Not applicable.
	Other	Retrofitted stairs and handrail	In fair condition. Paint on handrail worn out.

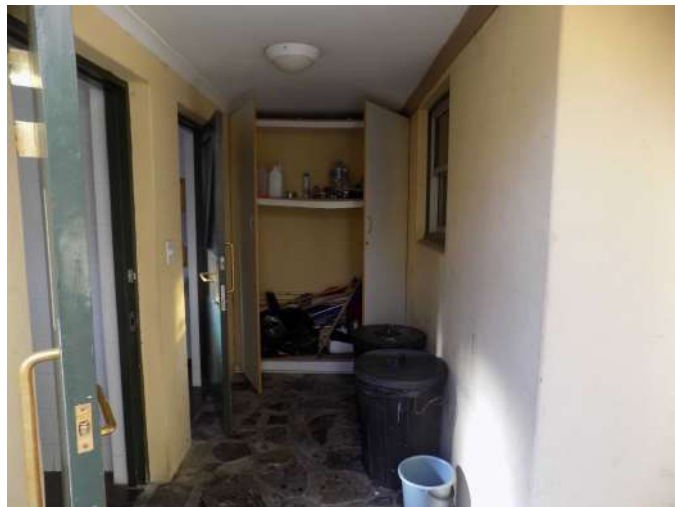
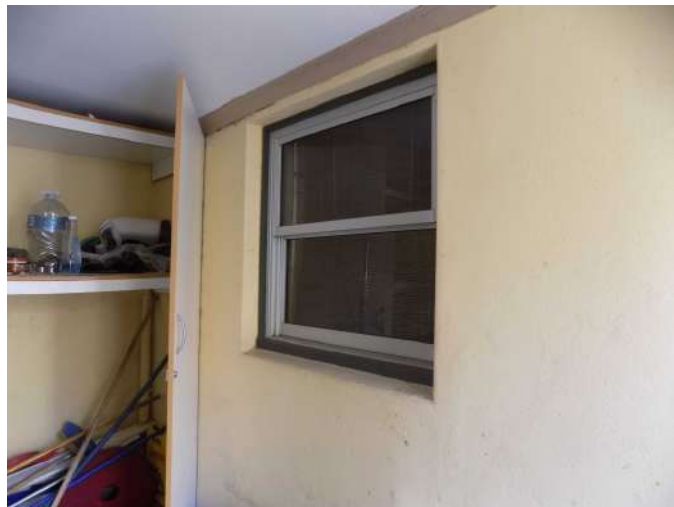
PROJECT	IZIKO MUSEUMS OF SOUTH AFRICA: EXISTING CONDITION BUILDING REPORTS AND 5-YEAR MAINTENANCE PLANS		
BUILDING	BO KAAP MUSEUM		
DOCUMENT	DATA SHEET		
	AREA	EXTERNAL AREAS	
		AREA NUMBER	303
		AREA NAME	PASSAGE

Item	Description	Condition
Paving & roadways	Construction & finish	Slate paving with non-slip rough finish	Floor in good condition.
	Kerbs	None.	Not applicable.
	Services	None.	Not applicable.
Structures & walls	Construction & finish	Plastered masonry with paint finish.	Walls in reasonable condition.
	Openings	None.	Not applicable.
	Mouldings	None.	Not applicable.
	Services	None.	Not applicable.
Gates	Size & description	None.	
	Frame	None.	Not applicable.
	Gate	None.	Not applicable.
	Ironmongery	None.	Not applicable.
Fences	Position & description	None.	
	Posts	None.	Not applicable.
	Fencing	None.	Not applicable.
Equipment & fixtures	Electrical	None.	Not applicable.
	Mechanical	None.	Not applicable.
	Other	Built-in cupboard and shelving.	Fixtures in fair condition

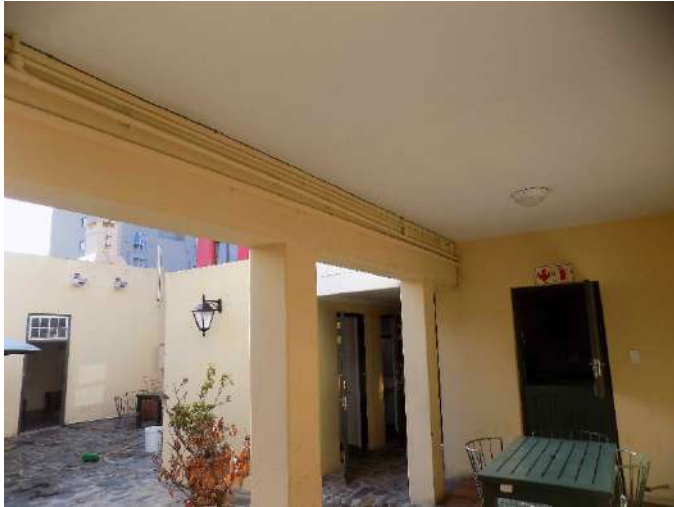
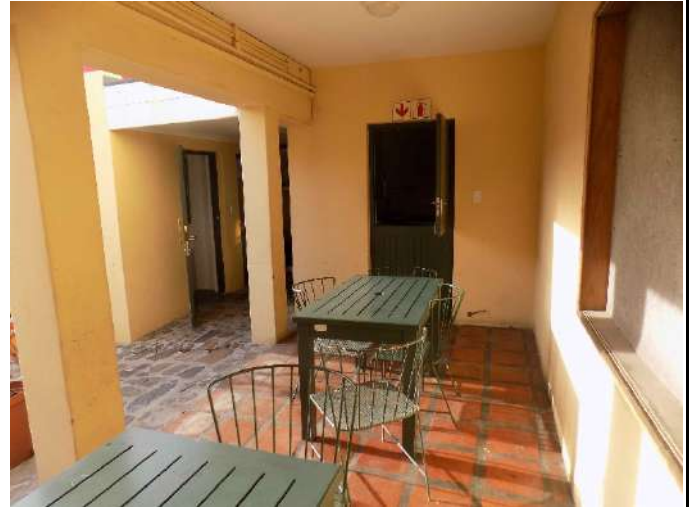
PROJECT	IZIKO MUSEUMS OF SOUTH AFRICA: EXISTING CONDITION BUILDING REPORTS AND 5-YEAR MAINTENANCE PLANS		
BUILDING	BO KAAP MUSEUM		
DOCUMENT	DATA SHEET		
	AREA	EXTERNAL AREAS	
		AREA NUMBER	304
		AREA NAME	COVERED PATIO

Item	Description	Condition
Paving & roadways	Construction & finish	Terracotta tiles with clear sealant and cement grout on concrete slab.	Floor in good condition.
	Kerbs	None.	Not applicable.
	Services	None.	Not applicable.
Structures & walls	Construction & finish	Plastered masonry with paint finish.	Walls in reasonable condition.
	Openings	None.	Not applicable.
	Mouldings	Timber framed notice board	Fixture in fair condition.
	Services	None.	Not applicable.
Gates	Size & description	None.	
	Frame	None.	Not applicable.
	Gate	None.	Not applicable.
	Ironmongery	None.	Not applicable.
Fences	Position & description	None.	
	Posts	None.	Not applicable.
	Fencing	None.	Not applicable.
Equipment & fixtures	Electrical	None.	Not applicable.
	Mechanical	Paraplegic and fire escape route signage.	Signage in fair condition.
	Other	Paraplegic lift.	See applicable services report.

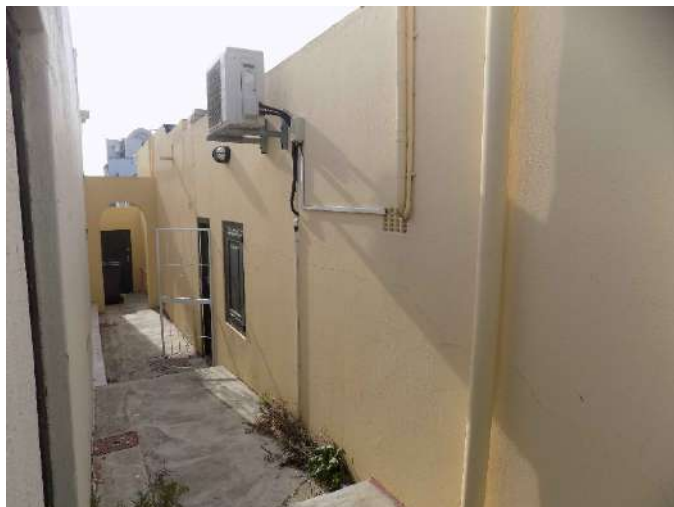
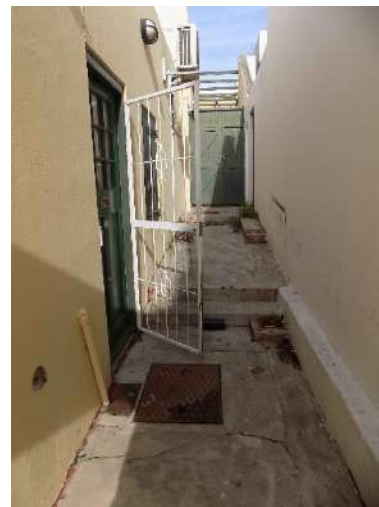
PROJECT	IZIKO MUSEUMS OF SOUTH AFRICA: EXISTING CONDITION BUILDING REPORTS AND 5-YEAR MAINTENANCE PLANS		
BUILDING	BO KAAP MUSEUM		
DOCUMENT	DATA SHEET		
	AREA	EXTERNAL AREAS	
		AREA NUMBER	305
		AREA NAME	PASSAGE 1

Item	Description	Condition
Paving & roadways	Construction & finish	Screed on concrete surface bed. Floor steps down	Floor in fair condition.
	Kerbs	None.	Not applicable.
	Services	Stormwater pipes, manholes and electrical infrastructure.	See applicable services report.
Structures & walls	Construction & finish	Plastered masonry with paint finish.	Walls in reasonable condition.
	Openings	None.	Not applicable.
	Mouldings	None.	Not applicable.
	Services	Various stormwater and electrical services	See applicable services report.
Door 114	Size & description	935 timber hinged single door with fixed timber infill panel and paint finish.	
	Frame	70 x 114 timber frame with paint finish.	Frame in fair condition.
	Gate	Framed, braced and ledged panel single door with paint finish.	Door in good condition.
	Ironmongery	Hinged door ironmongery	Ironmongery in good condition.
Door 115	Size & description	935 timber hinged single door with paint finish.

Frame	70 x 114 timber frame with paint finish.	Frame in fair condition.
	Gate	Framed, braced and ledged panel single door with paint finish.	Door in good condition.
	Ironmongery	Hinged door ironmongery	Ironmongery in good condition.
Fences	Position & description	None.	
	Posts	None.	Not applicable.
	Fencing	None.	Not applicable.
Equipment & fixtures	Electrical	CCTV	See applicable services report.
	Mechanical	A/C Unit .	See applicable services report.
	Other	None.	Not applicable.

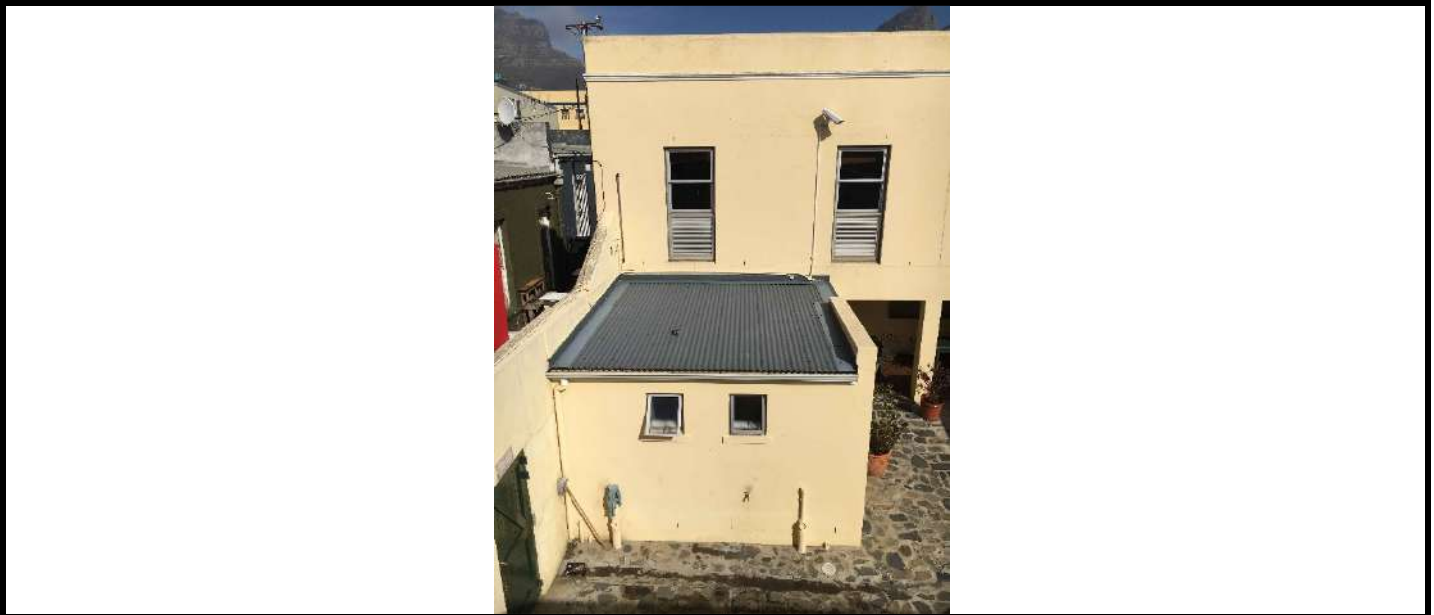
PROJECT	IZIKO MUSEUMS OF SOUTH AFRICA: EXISTING CONDITION BUILDING REPORTS AND 5-YEAR MAINTENANCE PLANS		
BUILDING	BO KAAP MUSEUM		
DOCUMENT	DATA SHEET		
	AREA	ROOFS	
		ROOF NUMBER	403
		ROOF NAME	ROOF OVER TOILETS

Item	Description	Condition
Roofs	Construction & finish	Galvanised IBR roof sheets	Sheeting in good condition.
	Flashings	Steel counter flashing over	Flashing in good condition.
	Rainwater equipment	Metal Gutters and downpipe.	Equipment in good condition.
Walls	Type	Plastered masonry with paint finish.	Parapets in good condition.
	Openings	None.	Not applicable.
	Services	None.	Not applicable.
Door	See room 000 [Note: For all doors listed in rooms].		
Door	Size & description	[Note: For all doors not listed in rooms. If no description of additional Windows required, delete this section completely].	
	Frame & architrave		
	Door		
	Threshold		
	Glazing		
Skylights & roof Windows	Ironmongery		
	Size & description		
	Frame	None.	Not applicable.
	Opener	None.	Not applicable.
	Flashing	None.	Not applicable.
Equipment & fixtures	Glazing	None.	Not applicable.
	Ironmongery	None.	Not applicable.
	Electrical	None.	Not applicable.

Mechanical	None.	Not applicable.
	Other	None.	Not applicable.

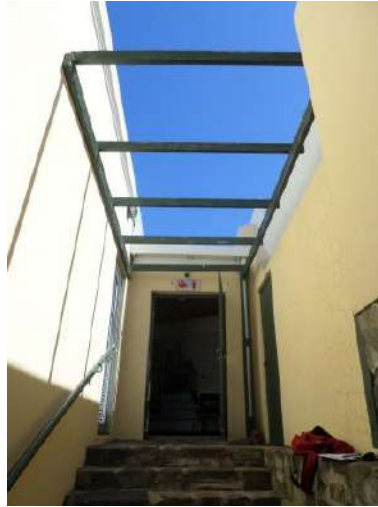
PROJECT	IZIKO MUSEUMS OF SOUTH AFRICA: EXISTING CONDITION BUILDING REPORTS AND 5-YEAR MAINTENANCE PLANS		
BUILDING	BO KAAP MUSEUM		
DOCUMENT	DATA SHEET		
	AREA	ROOFS	
		ROOF NUMBER	405
		ROOF NAME	ROOF OVER COMMUNITY HALL ENTRANCE

Item	Description	Condition
Roofs	Construction & finish	Timber pergola fixed on to wall and with paint finish.	Timber in poor condition. Paint peeling off and worn through.
	Flashings	None.	Not applicable.
	Rainwater equipment	None.	Not applicable.
Walls	Type	Plastered masonry with paint finish.	Parapets in poor condition. Water seepage evident.
	Openings	None.	Not applicable.
	Services	None.	Not applicable.
Skylights & roof Windows	Size & description		
	Frame	None.	Not applicable.
	Opener	None.	Not applicable.
	Flashing	None.	Not applicable.
	Glazing	None.	Not applicable.
	Ironmongery	None.	Not applicable.
Equipment & fixtures	Electrical	None.	Not applicable.
	Mechanical	None.	Not applicable.
	Other	None.	Not applicable.

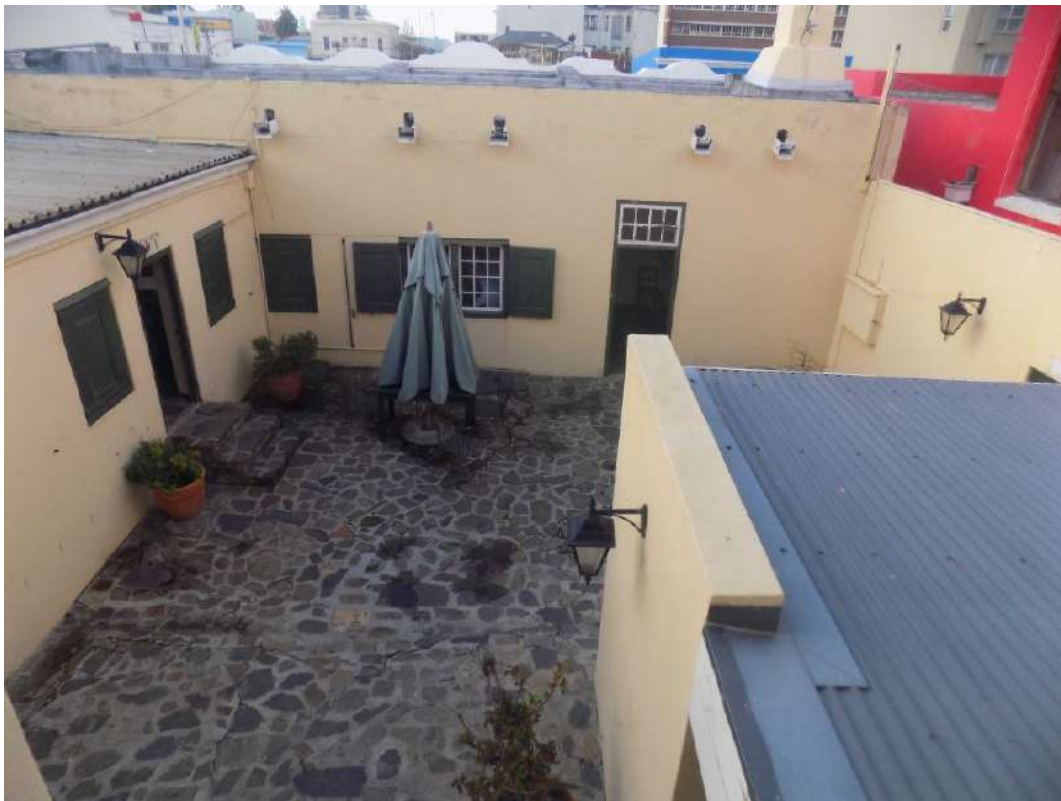
PROJECT	IZIKO MUSEUMS OF SOUTH AFRICA: EXISTING CONDITION BUILDING REPORTS AND 5-YEAR MAINTENANCE PLANS		
BUILDING	BO KAAP MUSEUM		
DOCUMENT	DATA SHEET		
	AREA	FACADES	
		FACADE NUMBER	502
		FACADE NAME	HISTORIC HOUSE SOUTH WEST SECTIONAL ELEVATION

Item	Description	Condition
Floor	Construction & finish	Slate paving with non-slip rough finish	Floor in good condition.
	Skirting	None.	Not applicable.
	Services	Stormwater pipes, manholes and channels	See applicable services report.
Walls	Construction & finish	Plastered masonry with paint finish.	Walls in reasonable condition.
	Openings	Rain water spouts	In fair condition.
	Mouldings	None.	Not applicable.
	Services	Various stormwater and electrical services	See applicable services report.
Door	See room 103, 104 and 105		
Window	See room 103 and 104		
Equipment & fixtures	Electrical	Distribution board External light fittings	See applicable services report.
	Mechanical	Rain water spouts	Spouts in fair condition.
	Other	Staircase and balustrade	In fair condition.

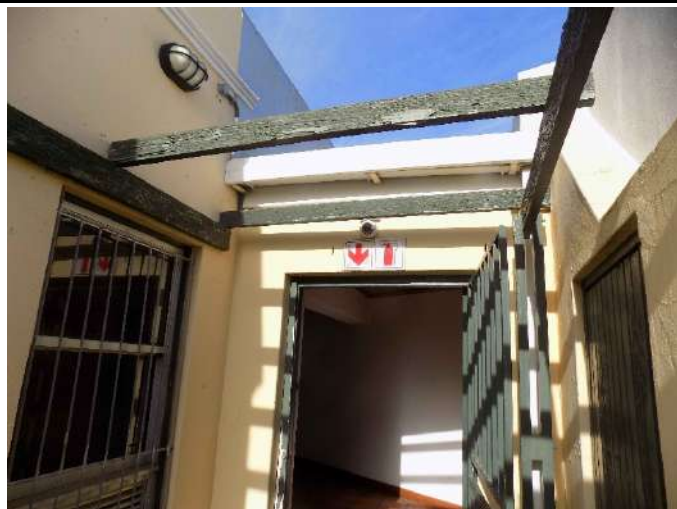
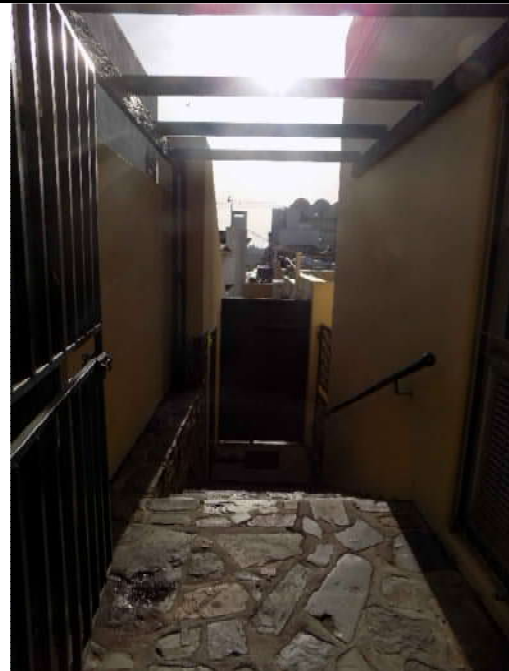
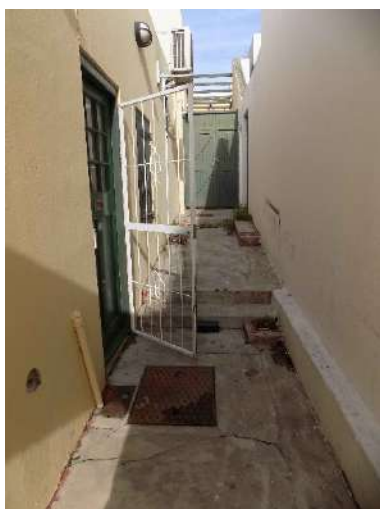
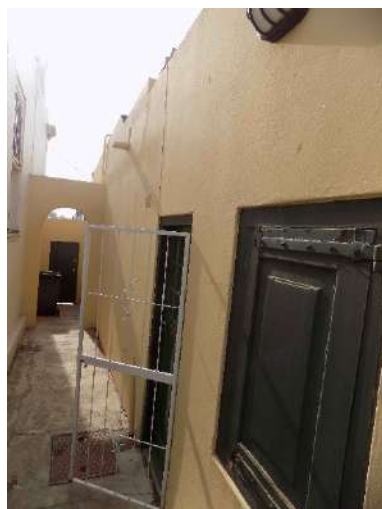
PROJECT	IZIKO MUSEUMS OF SOUTH AFRICA: EXISTING CONDITION BUILDING REPORTS AND 5-YEAR MAINTENANCE PLANS		
BUILDING	BO KAAP MUSEUM		
DOCUMENT	DATA SHEET		
	AREA	FACADES	
		FACADE NUMBER	503
		FACADE NAME	NORTH WEST ELEVATION

Item	Description	Condition
Floor	Construction & finish	Slate paving with non-slip rough finish Screed on concrete floor surface bed.	Floor in good condition.
	Skirting	None.	Not applicable.
	Services	Various stormwater and electrical services	See applicable services report.
Walls	Construction & finish	Plastered masonry with paint finish.	Walls in reasonable condition.
	Openings	935 arched opening	Opening in good condition.
	Mouldings	None.	Not applicable.
	Services	Various stormwater and electrical services	See applicable services report.
Door	See room 106 and area 305.		
Window	See room 106.		
Equipment & fixtures	Electrical	External light fittings	See applicable services report.
	Mechanical	Rain water spouts	Spouts in fair condition.
	Other	Staircase and handrail	In fair condition.

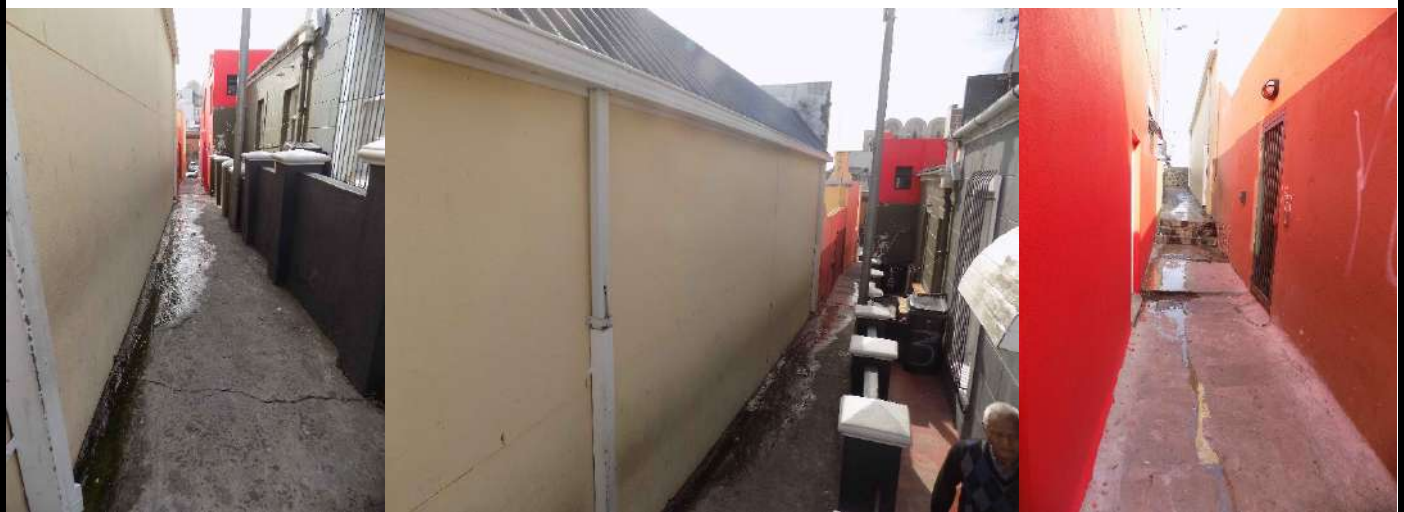
PROJECT	IZIKO MUSEUMS OF SOUTH AFRICA: EXISTING CONDITION BUILDING REPORTS AND 5-YEAR MAINTENANCE PLANS		
BUILDING	BO KAAP MUSEUM		
DOCUMENT	DATA SHEET		
	AREA	FACADES	
		FACADE NUMBER	504
		FACADE NAME	SOUTH EAST ELEVATION

Item	Description	Condition
Floor	Construction & finish	Slate paving with non-slip rough finish Screed on concrete floor surface bed.	Floor in good condition.
	Skirting	None.	Not applicable.
	Services	Stormwater pipes, manholes and channels	See applicable services report.
Walls	Construction & finish	Plastered masonry with paint finish.	Walls in reasonable condition.
	Openings	Metal gutters and downpipes.	In fair condition.
	Mouldings	None.	Not applicable.
	Services	Various stormwater and electrical services	See applicable services report.
Door	Size & description	940 X 2,095 timber hinged single door with steel gate on exterior with paint finish.	
	Frame & architrave	70 x 114 timber frame with paint finish.	Frame in fair condition.
	Door	Framed, braced and ledged panel single door with paint finish.	Door in good condition.
	Threshold	Hinged door ironmongery	Ironmongery in good condition.
	Glazing	None.	Not applicable.

Ironmongery	Latch lock and standard hinged door ironmongery.	Ironmongery in fair condition.
Door	None.		
Window	None.		
Equipment & fixtures	Electrical	External light fittings	See applicable services report.
	Mechanical	None.	Not applicable.
	Other	Change in floor level.	In fair condition.

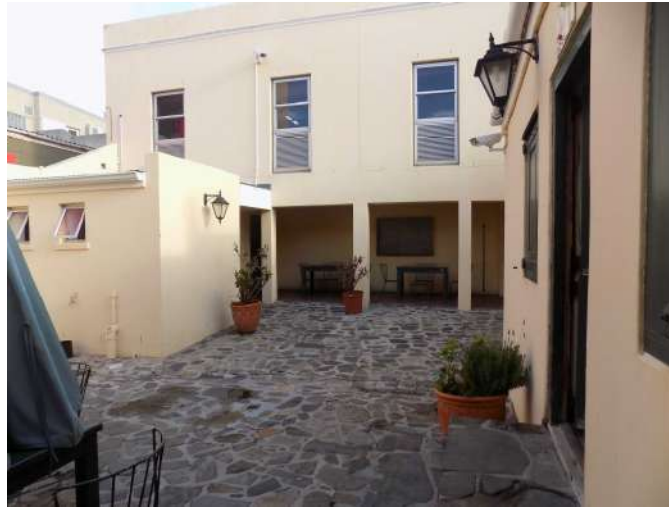
PROJECT	IZIKO MUSEUMS OF SOUTH AFRICA: EXISTING CONDITION BUILDING REPORTS AND 5-YEAR MAINTENANCE PLANS		
BUILDING	BO KAAP MUSEUM		
DOCUMENT	DATA SHEET		
	AREA	FACADES	
		FACADE NUMBER	505
		FACADE NAME	COMMUNITY HALL NORTH WEST ELEVATION

Item	Description	Condition
Floor	Construction & finish	Slate paving with non-slip rough finish Screed on concrete floor surface bed.	Floor in good condition.
	Skirting	None.	Not applicable.
	Services	Stormwater pipes, manholes and channels	See applicable services report.
Walls	Construction & finish	Plastered masonry with paint finish.	Walls in reasonable condition.
	Openings	Metal gutters and downpipes.	In fair condition.
	Mouldings	None.	Not applicable.
	Services	Various stormwater and electrical services	See applicable services report.
Door	See room 103, 104 and 105		
Window	See room 103 and 104		
Equipment & fixtures	Electrical	External light fittings	See applicable services report.
	Mechanical	None.	Not applicable.
	Other	Change in floor level.	In fair condition.

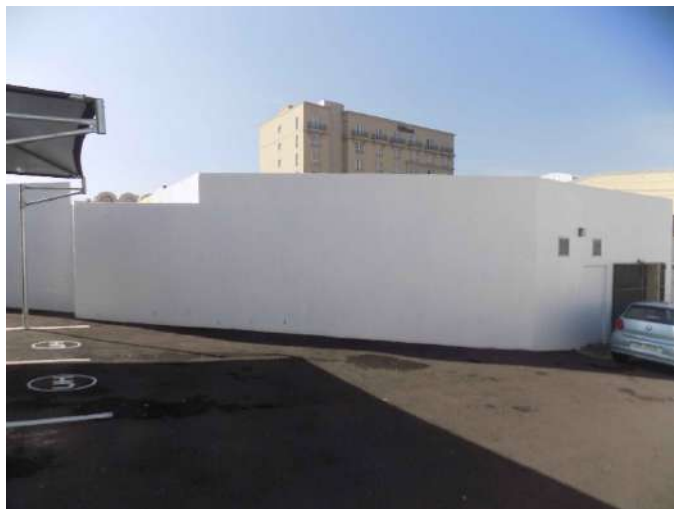
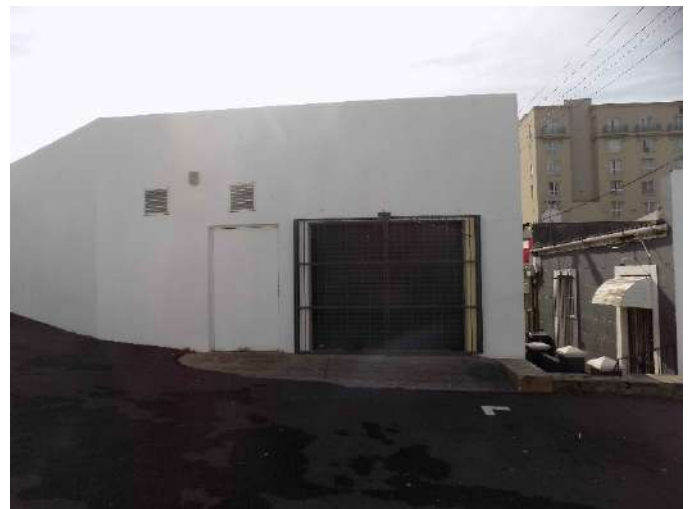
PROJECT	IZIKO MUSEUMS OF SOUTH AFRICA: EXISTING CONDITION BUILDING REPORTS AND 5-YEAR MAINTENANCE PLANS		
BUILDING	BO KAAP MUSEUM		
DOCUMENT	DATA SHEET		
	AREA	FACADES	
		FACADE NUMBER	506
		FACADE NAME	COMMUNITY HALL SOUTH WEST ELEVATION

Item	Description	Condition
Floor	Construction & finish	Tarmac driveway.	Floor in good condition.
	Skirting	None.	Not applicable.
	Services	None.	Not applicable.
Walls	Construction & finish	Plastered masonry with paint finish.	Walls in good condition.
	Openings	None.	Not applicable.
	Mouldings	None.	Not applicable.
	Services	None.	Not applicable.
Door	See room 201		
Window	None.		
Equipment & fixtures	Electrical	External light fitting	See applicable services report.
	Mechanical	See room 201	See applicable services report.
	Other	None.	Not applicable.

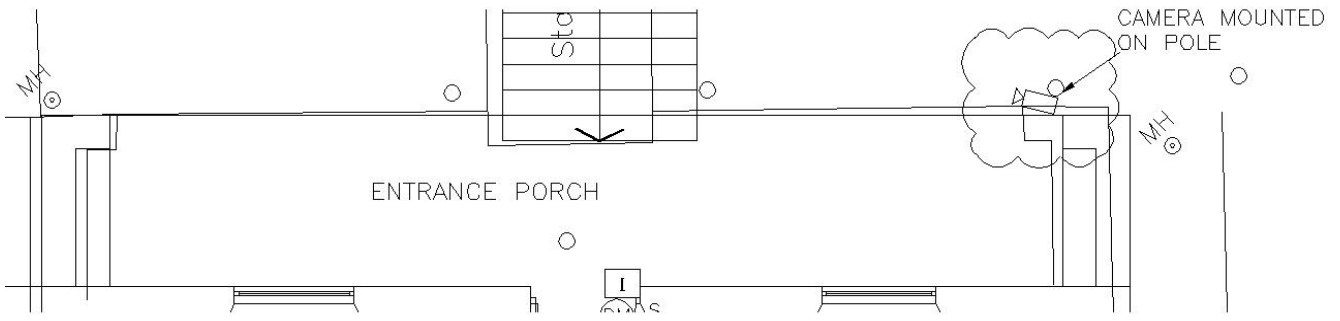
NOTES		
PLUGS	Condition	N/A
	Recommendation	N/A
	Type of plugs	N/A
	Wiring	N/A
LIGHTING	Existing Lighting	There is one existing Lantern.
	Wiring	To be insulation tested and replaced based on typed report.
	Recommendation	Re-lamp existing lantern.
ACCESS CONTROL	Condition	There is no access control at the entrance, no intercom or bell only an camera that covers the entrance door.
	Recommendation	N/A
FIRE DETECTION	Existing Equipment	N/A
	Recommendation	N/A

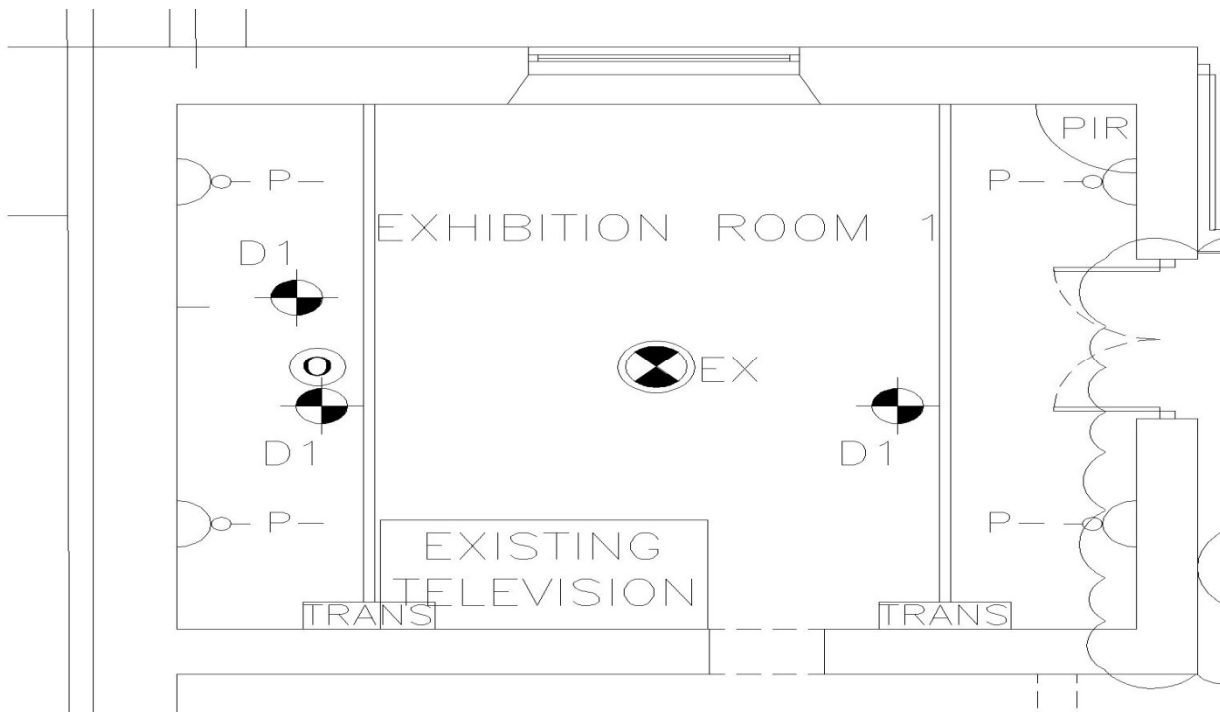
PLUGS	Condition	The plugs are in a reasonable state. Surface electrical wiring connected directly from the plugs. Extension cords installed alongside wooden floor skirting.
	Recommendation	All plugs and surface wiring in this area will have to be removed and chased-in via conduiting. All plugs to be replaced afterwards.
	Type of plugs	4x4 16A Single SSO
	Wiring	To be insulation tested and replaced based on typed report. Extension cords to be removed and a new plug socket to be chased-in closer to the desired point of consumption.
LIGHTING	Existing Lighting	One pendant light fitting and open wire halogen down light system with exposed transformers. Lighting (lux) levels in this room seems adequate.
	Wiring	To be insulation tested and replaced based on typed report.
	Recommendation	Existing pendant light fittings to remain but should be re-lamped with energy efficient lamp. Remove existing open wire down light system and replace with LED track down light system.

ACCESS CONTROL	Condition	The entire access control / alarm & CCTV installation are done in surface wiring glued along the walls or via Ega ducting.
	Recommendation	All alarm & CCTV cabling and equipment to be removed safely kept aside by Iziko Museum's technician. Wire ways to be chased -in walls via 25mm uPVC conduiting or greater size conduiting as required on site. Wire ways to be coordinated with Iziko Museum's technician. Once all wire ways are chased-in, Iziko Museum's technician must re-connect and commission entire installation. Budgetary allowance to be made for any equipment that might be damaged during construction stage.
	Existing Equipment	Equipment indicated as per layout of rooms. Address labels missing on some devices.

Recommendation	<p>The existing fire detection installation is done in surface Ega-ducting. All surface wire ways to be chased-in where permissible. All other areas where cabling cannot be done recessed must be coordinated and installed surface via uPVC or galvanized conduiting fixed to the wall with metal fixings as per the regulations.</p> <p>Allowances must be made for testing of each device and submitting a typed report. Typed report must state which devices must be replaced. Address labels to be installed on all devices old and new.</p> <p>New cabling to be installed from device to device where new wire ways were chased-in.</p>
----------------	--

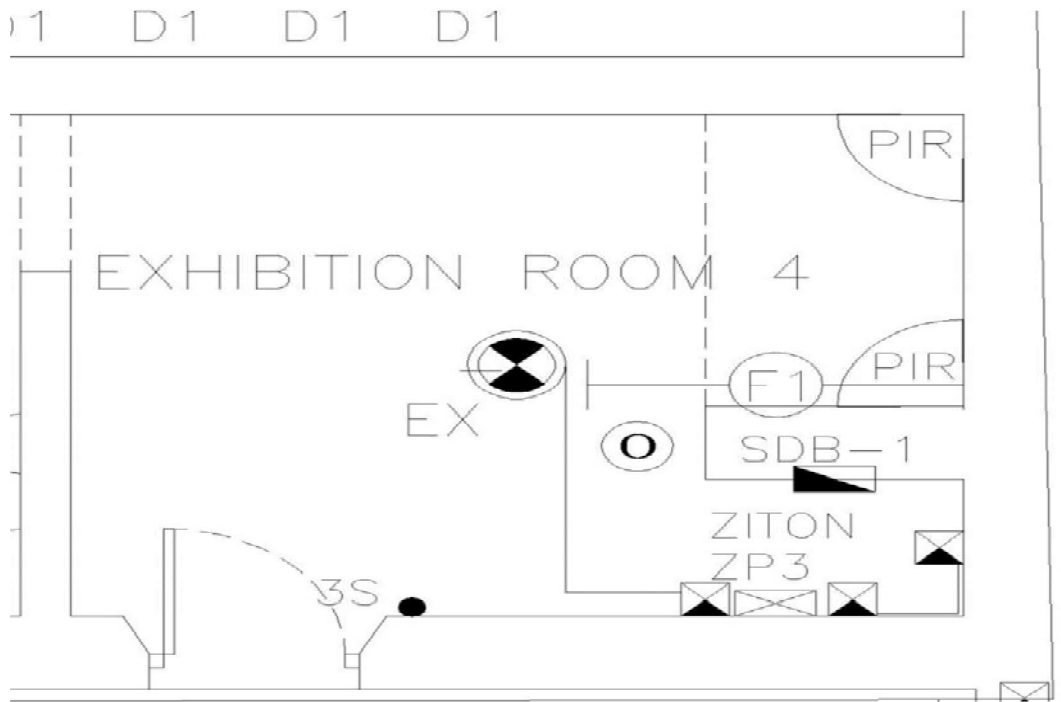
PLUGS	Condition	Main Electrical Distribution board – The current electrical distribution board seems in a fair state, however: <ul style="list-style-type: none"> • Cabling at the bottom of the DB enters without any glands or any proper wire way. • There is no Nameplate on the board indicating fault current rating, manufacturer details and where the board is fed from. • Fault current on some circuit breakers does not meet the minimum requirements of DPW. • There are jointed cables inside the DB. • More than one neutral in a terminal. Extra neutral bar required.
	Recommendation	Attend to all issues as mentioned
	Type of plugs	N/A
	Wiring	N/A
LIGHTING	Existing Lighting	There is one pendant and an open channel fluorescent light fitting.. The lighting (lux) level in this room seems to be sufficient.
	Wiring	To be insulation tested and replaced based on typed report.
	Recommendation	Remove and replace the open channel light fitting and install an pendant to match the existing one for aesthetic purposes.

ACCESS CONTROL	Condition	The entire access control / alarm & CCTV installation are done in surface wiring glued along the walls or via Ega ducting.
	Recommendation	All alarm & CCTV cabling and equipment to be removed safely kept aside by Iziko Museum's technician. Wire ways to be chased-in walls via 25mm uPVC conduiting or greater size conduiting as required on site. Wire ways to be coordinated with Iziko Museum's technician. Once all wire ways are chased-in, Iziko Museum's technician must re-connect and commission entire installation. Budgetary allowance to be made for any equipment that might be damaged during construction stage.

FIRE DETECTION	Existing Equipment	<p>Equipment indicated as per layout of rooms. Address labels missing on some devices.</p> <p>The Main Fire detection panel is also located in this room. The main panel also does not have an isolator.</p>
	Recommendation	<p>The existing fire detection installation is done in surface Ega-ducting. All surface wire ways to be chased-in where permissible. All other areas where cabling cannot be done recessed must be coordinated and installed surface via uPVC or galvanized conduiting fixed to the wall with metal fixings as per the regulations.</p> <p>Allowances must be made for testing of each device and submitting a typed report. Typed report must state which devices must be replaced. Address labels to be installed on all devices old and new.</p> <p>New cabling to be installed from device to device where new wire ways were chased-in.</p>

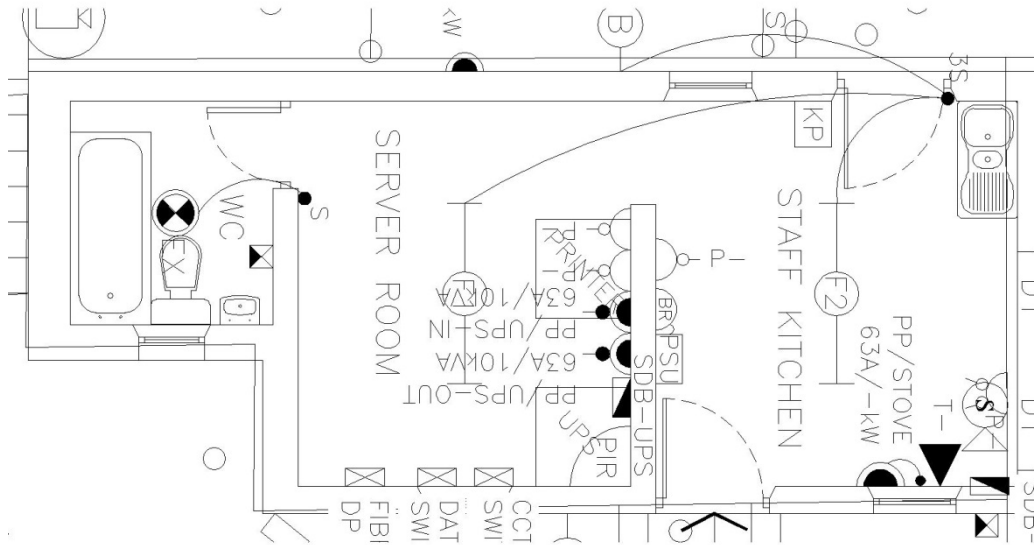
PLUGS & Distribution Board	Condition	<p>SDB-UPS – Name plate missing and door to be earthed.</p> <p>SDB-Unknown – This DB is in a poor state. There are a number of factors contributing to the poor state of the DB.</p> <ul style="list-style-type: none"> • There are cables entering the DB from the side with no proper wire ways into the DB tray. • There is no Nameplate on the board indicating fault current rating, manufacturer details and where the board is fed from. • Fault current on circuit breakers are not the recommended sizes of that of DPW. • There are jointed cables inside the DB. • Blank cover spaces missing. • Visible arc flashing marks on stove breaker. <p>Some plugs have extension cords connected to them. Most plugs sockets are in a poor state.</p> <p>Data and telephone cabling loose and surface alongside walls.</p>
	Recommendation	<p>SDB –UPS to remain only name plate to be installed.</p> <p>SDB-Unknown to be removed and replaced with new DB.</p> <p>All plug sockets and data outlets to be removed and replaced. Wire ways to be chased-in where permissible.</p>

Type of plugs	N/A
	Wiring	To be removed and replaced.
LIGHTING	Existing Lighting	<p>Bathroom – light fitting diffuser missing.</p> <p>Server and Staff room – 1 x 36W Open channel light fittings.</p>
	Wiring	To be insulation tested and replaced based on typed report.

Recommendation	Bathroom light fitting to be replaced with IP65 rated bulkhead light fitting. Server and Staff room open channel light fittings to be replaced with 2x28W T5 Open channel light fittings.
ACCESS CONTROL	Condition	The entire access control / alarm & CCTV installation are done in surface wiring glued along the walls or via Ega ducting.
	Recommendation	All alarm & CCTV cabling and equipment to be removed safely kept aside by Iziko Museum's technician. Wire ways to be chased-in walls via 25mm uPVC conduiting or greater size conduiting as required on site. Wire ways to be coordinated with Iziko Museum's technician. Once all wire ways are chased-in, Iziko Museum's technician must re-connect and commission entire installation. Budgetary allowance to be made for any equipment that might be damaged during construction stage.
FIRE DETECTION	Existing Equipment	No Fire detection in this area.

Recommendation	It is highly recommended that fire detection be installed in this area. The following is recommended: <ul style="list-style-type: none"> • gas suppression system • An addressable output relay must be installed in order to shut the AC unit down under fire conditions • Break Glass unit be installed
