IZIKO MUSEUMS | **EXISTING BUILDING CONDITION REPORT**

REF. CSM/Architects/12/2015

BO-KAAP MUSEUM

DATE: APRIL 2018 | **STATUS:** FINAL

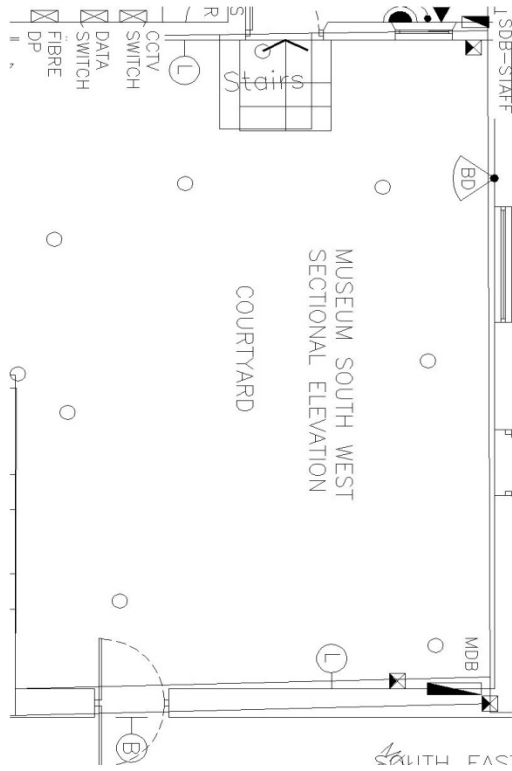
**ROOM No:
COURTYARD**

PLUGS	Condition	Council DB -. This cubicle is still in a reasonable state but do have visible rust in the arch tray. No Surge protection
	Recommendation	Rusted areas to be treated properly and re-sprayed. Class 1 Surge Protection to be installed.
	Type of plugs	N/A
	Wiring	Existing supply cable from Council to SDB-1 to be insulation tested.
LIGHTING	Existing Lighting	Courtyard Lanterns in good condition.
	Wiring	To be insulation tested and replaced based on typed report.
	Recommendation	N/A
ACCESS CONTROL	Condition	The entire access control / alarm & CCTV installation are done in surface wiring glued along the walls or via Ega ducting.
	Recommendation	All alarm & CCTV cabling and equipment to be removed safely kept aside by Iziko Museum's technician. Wire ways to be chased-in walls via 25mm uPVC conduiting or greater size conduiting as required on site. Wire ways to be coordinated with Iziko Museum's technician. Once all wire ways are chased-in, Iziko Museum's technician must re-connect and commission entire installation. Budgetary allowance to be made for any equipment that might be damaged during construction stage.

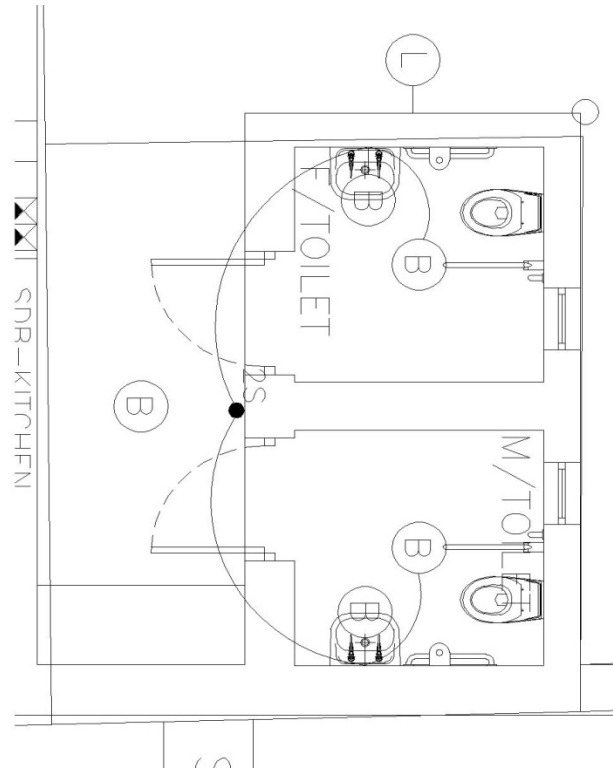
NOTES		
PLUGS	Condition	N/A
	Recommendation	N/A
	Type of plugs	N/A
	Wiring	N/A
LIGHTING	Existing Lighting	Lighting lux levels in these rooms are more than adequate. Existing bulkheads in toilets as indicated
	Wiring	To be insulation tested and replaced based on typed report.
	Recommendation	Excessive lighting in bathrooms. Save electricity by removing one bulkhead in each bath room or install two extra light switches for the other two lights to be switched on separately.
ACCESS CONTROL	Condition	The entire access control / alarm & CCTV installation are done in surface wiring glued along the walls or via Ega ducting.
	Recommendation	All alarm & CCTV cabling and equipment to be removed safely kept aside by Iziko Museum's technician. Wire ways to be chased-in walls via 25mm uPVC conduiting or greater size conduiting as required on site. Wire ways to be coordinated with Iziko Museum's technician. Once all wire ways are chased-in, Iziko Museum's technician must re-connect and commission entire installation. Budgetary allowance to be made for any equipment that might be damaged during construction stage.

FIRE DETECTION	Existing Equipment	Equipment indicated as per layout of rooms.
	Recommendation	The existing fire detection installation is done in surface Ega-ducting. All surface wire ways to be chased-in where permissible. All other areas where cabling cannot be done recessed must be coordinated and installed surface via uPVC or galvanized conduiting fixed to the wall with metal fixings as per the regulations. Allowances must be made for testing of each device and submitting a typed report. Typed report must state which devices must be replaced. Address labels to be installed on all devices old and new. New cabling to be installed from device to device where new wire ways were chased-in.

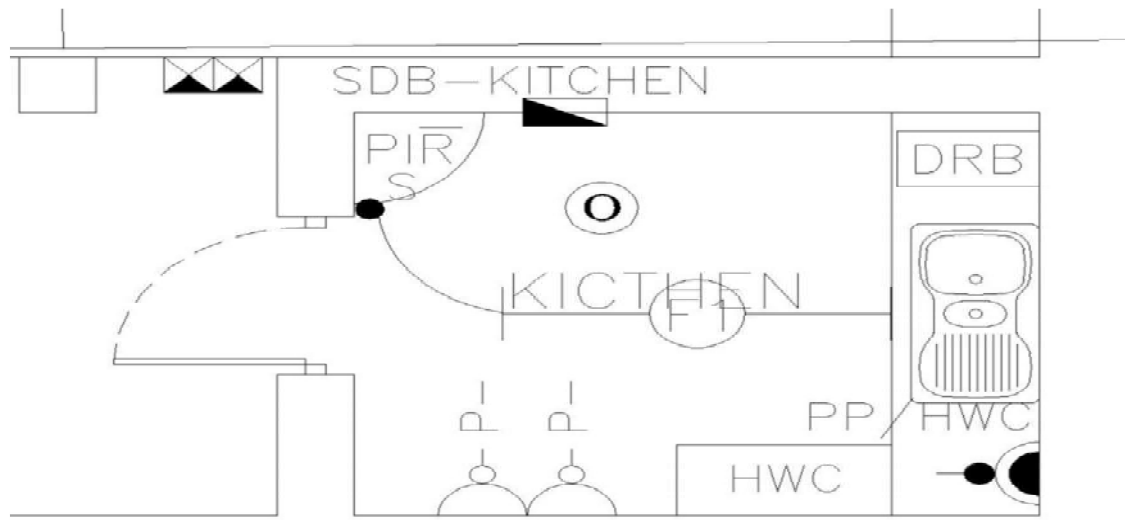
**ROOM No:
EXTERNAL
KITCHEN**

Condition	Plugs in this area are in a poor state. HWC isolator in reasonable state SDB-Kitchen <ul style="list-style-type: none"> • Remove jointed cables • No nameplate. • Some breakers rated less than 5kA. • Some breakers obsolete.
Recommendation	Replace all plugs and attend to problems at DB as mentioned above.
Type of plugs	4x4 16A Single SSO
Wiring	To be insulation tested and replaced based on typed report.

Existing Lighting	This area has one open channel light fittings. Lighting (lux) levels in this area is adequate.
Wiring	To be insulation tested and replaced based on typed report.
Recommendation	Remove open channel light fitting as it is inappropriate for a kitchen area and install an enclosed diffused light fitting for example Vapour proof fittings or prismatic diffused light fitting.

Condition	The entire access control / alarm & CCTV installation are done in surface wiring glued along the walls or via Ega ducting.
Recommendation	All alarm & CCTV cabling and equipment to be removed safely kept aside by Iziko Museum's technician. Wire ways to be chased-in walls via 25mm uPVC conduiting or greater size conduiting as required on site. Wire ways to be coordinated with Iziko Museum's technician. Once all wire ways are chased-in, Iziko Museum's technician must re-connect and commission entire installation. Budgetary allowance to be made for any equipment that might be damaged during construction stage.

FIRE DETECTION	Existing Equipment	Equipment indicated as per layout of rooms.
	Recommendation	<p>Smoke detector to be removed and Heat detector and Break Glass Unit to be installed.</p> <p>The existing fire detection installation is done in surface Ega-ducting. All surface wire ways to be chased-in where permissible. All other areas where cabling cannot be done recessed must be coordinated and installed surface via uPVC or galvanized conduiting fixed to the wall with metal fixings as per the regulations.</p> <p>Allowances must be made for testing of each device and submitting a typed report. Typed report must state which devices must be replaced. Address labels to be installed on all devices old and new.</p> <p>New cabling to be installed from device to device where new wire ways were chased-in.</p>

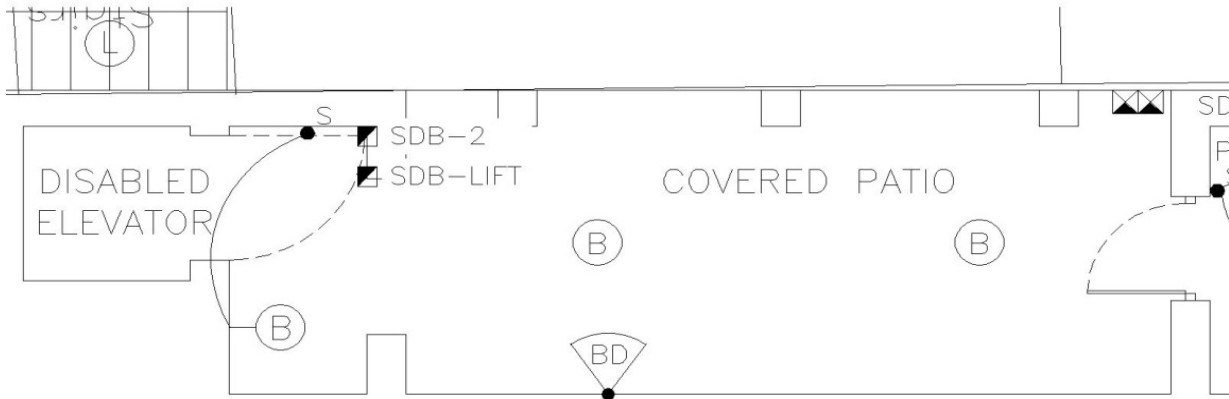
**ROOM No:
COVERED PATIO**

PLUGS	Condition	Distribution Boards height must be checked. Db name plates to be installed.
	Recommendation	DB boards must be mounted lower than 2.2 meters. Nameplates to be installed.
	Type of plugs	N/A
	Wiring	To be replaced if DB's must be lowered.
LIGHTING	Existing Lighting	Bulkhead light fittings as indicated.
	Wiring	To be insulation tested and replaced based on typed report.
	Recommendation	To remain, none functional lamps to be replaced.
ACCESS CONTROL	Condition	The entire access control / alarm & CCTV installation are done in surface wiring glued along the walls or via Ega ducting.
	Recommendation	All alarm & CCTV cabling and equipment to be removed safely kept aside by Iziko Museum's technician. Wire ways to be chased-in walls via 25mm uPVC conduiting or greater size conduiting as required on site. Wire ways to be coordinated with Iziko Museum's technician. Once all wire ways are chased-in, Iziko Museum's technician must re-connect and commission entire installation. Budgetary allowance to be made for any equipment that might be damaged during construction stage.
