APMH HERITAGE SITE AND CONSERVATION MANAGEMENT PLAN

ROBBEN ISLAND HOUSE NUMBER 85

COURSE CODE: MHS724

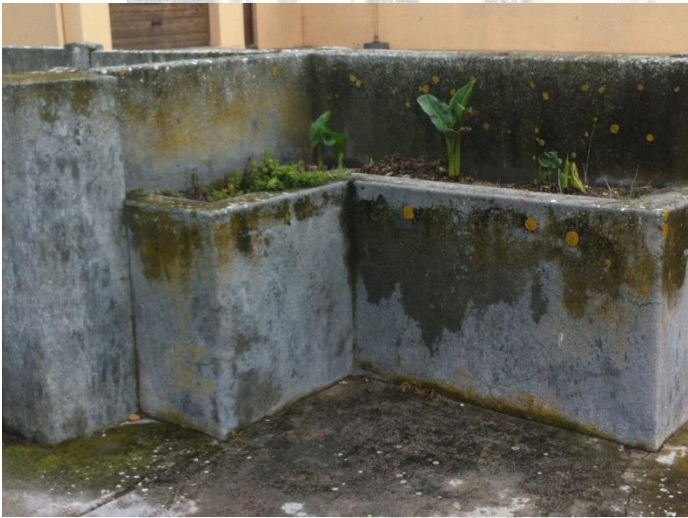
Wall running around the house and car entrance/driveway
