## Lindsay Napier architect

02 October 2023

### **ADDITIONAL MOTIVATION : PROPOSED DEMOLITION OF THE CHAPEL AT 96 JABU NDLOVU ST, PIETERMARITZBURG NEW KZN MUSUEM AND ARCHIVES (REVISED) PROPOSAL**

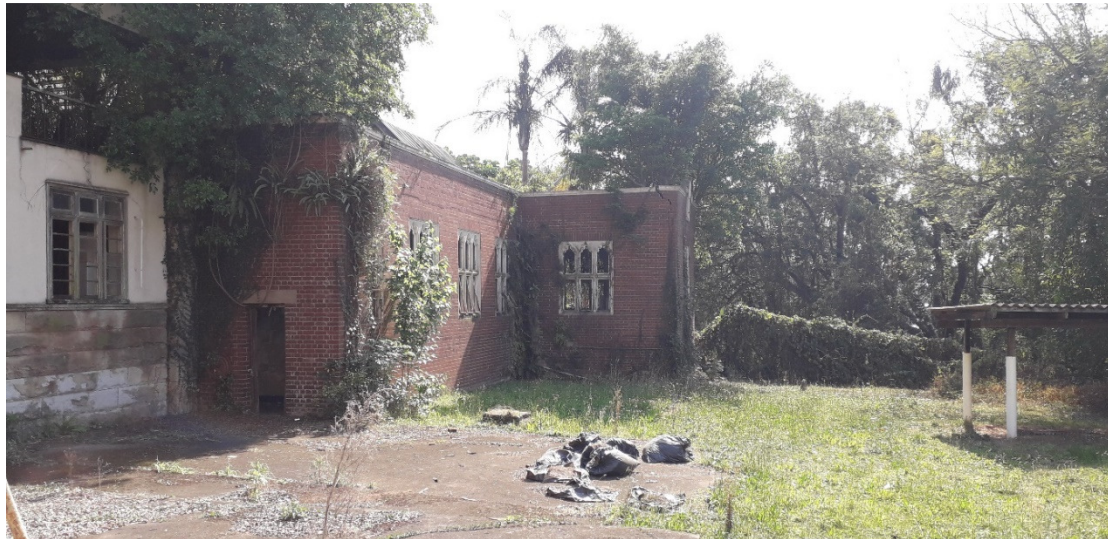
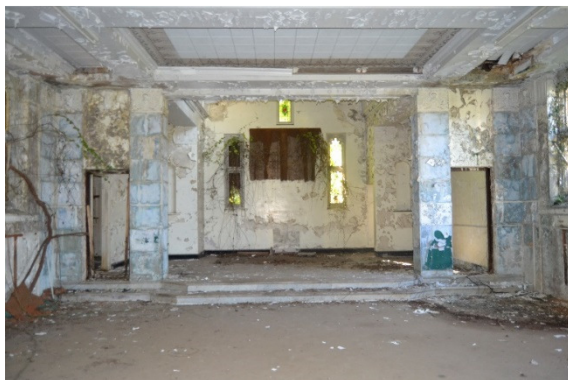
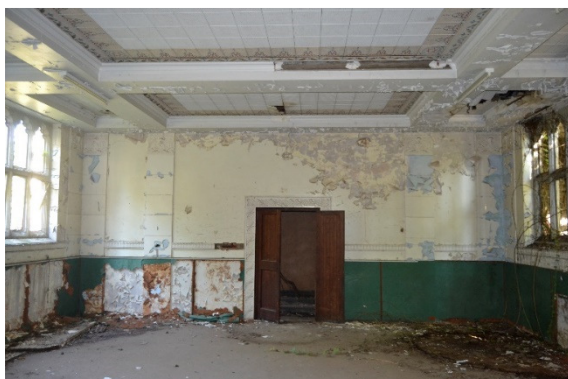
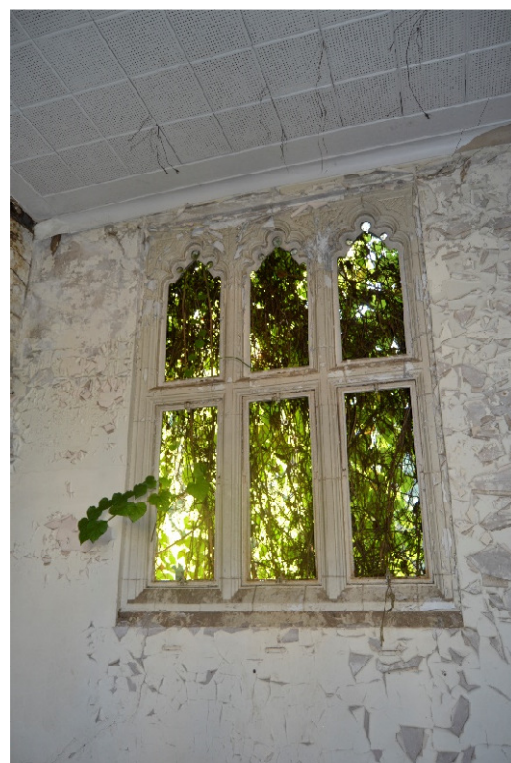
At a special meeting with the Amafa HOC, an additional motivation was requested for the demolition of the existing chapel. The motivation below is based on the consideration of the tangible and intangible heritage significances associated with the building within the overall site of the old St. Annes hospital. See photographs below taken in 2021.

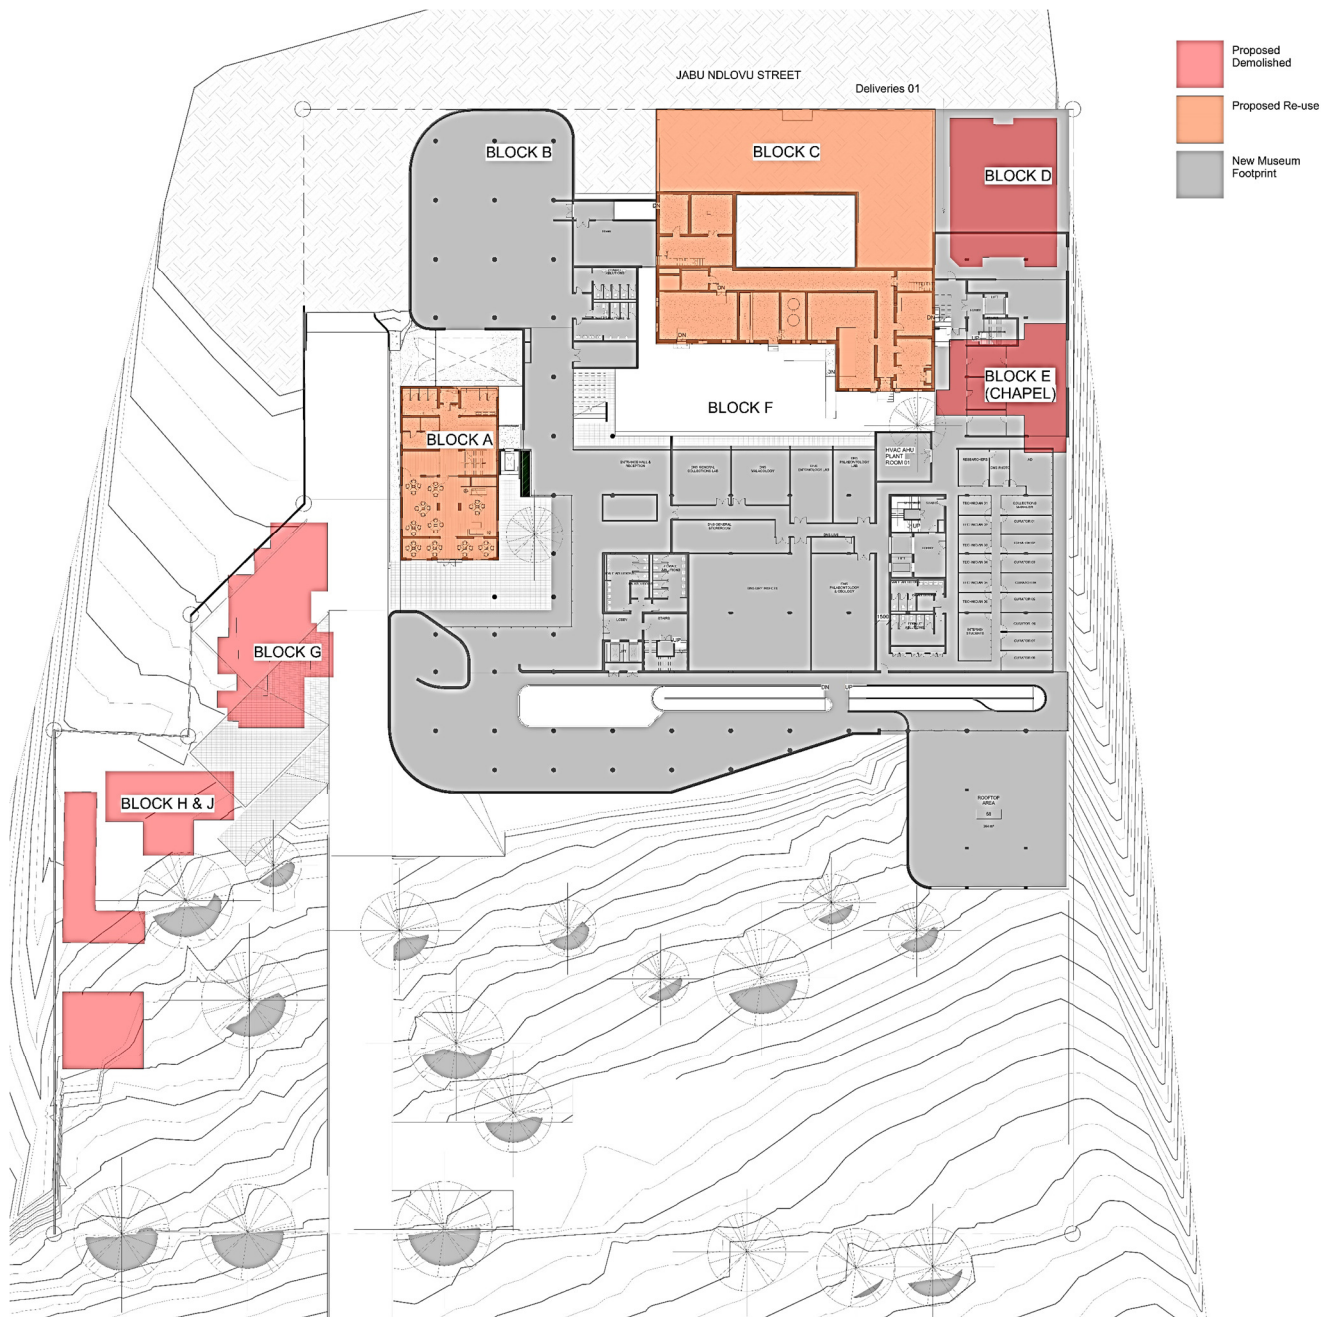
Figure 5 : SITE PLAN – Chape Highlighted in RED

The Chapel is located behind the (Block D) Nurses home. The Nurses home was approved to be demolished to allow for a new Workshop and service area, including a service passage specifically designed for delivery and movement of large vehicles and large exhibits into the back of the Museum. The Chapel is located in the direct line of the passage.

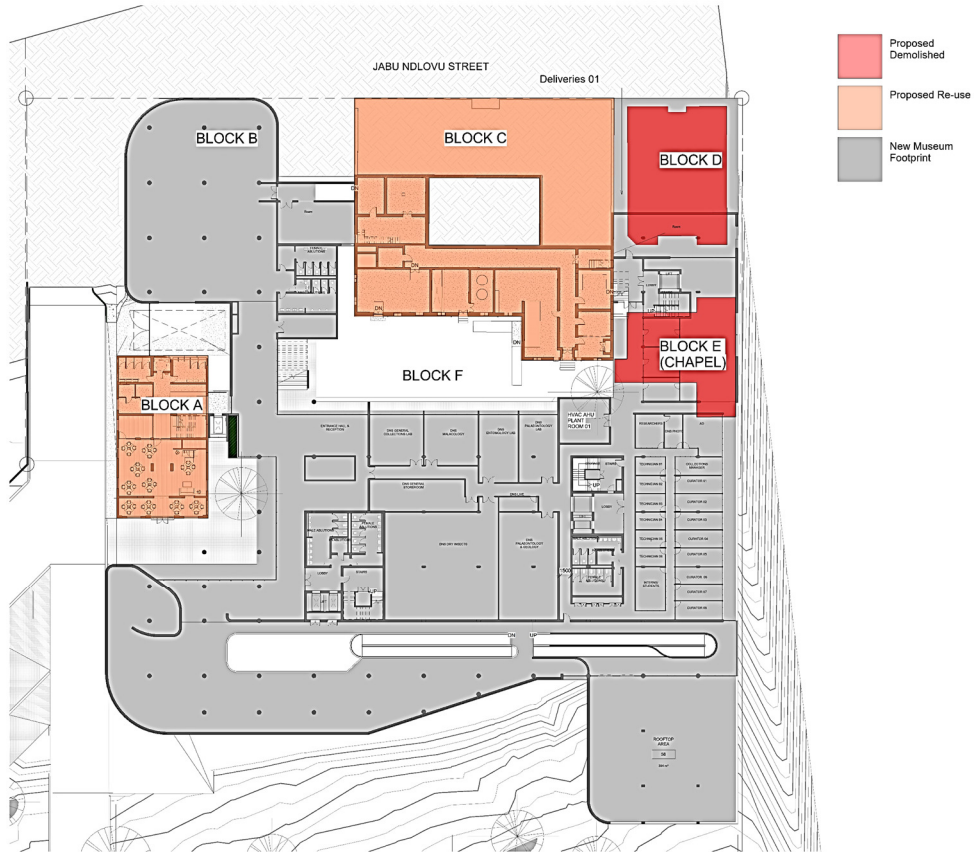
Figure 6 : Museum Footprint with Block A, C, D & E :

The Exhibitions and technical departments, collections and laboratories and offices associated with the collections are zoned for the Northern side of the site. These functions are not public, therefore the location was ideal. The chapel and existing parking are situated one-storey below the road, this extra-storey is taken advantage of in the design of the collections department accommodating the heaviest artefacts on the lowest storey. Since the collections rooms have restricted access and must remain secure, it made sense to consolidate the departments in one 4-storey building. The current location of the chapel would cut the the accommodation in half and prevent access between departments – this is illustrated in Figures 6-8.

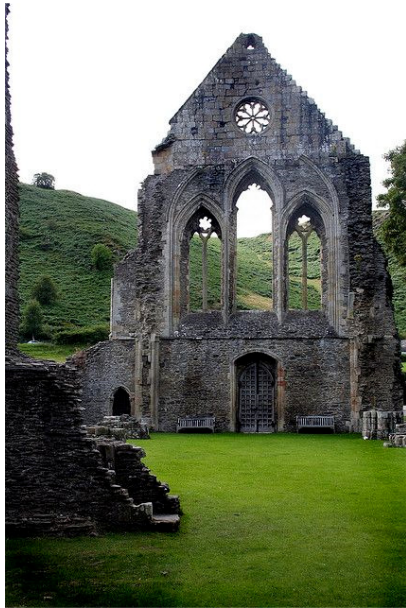
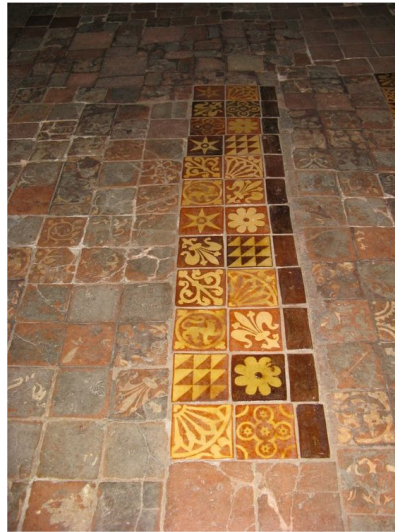
See examples below of the above approaches :

1. Make use of the elements within the new structure in appropriate locations that relate to the remaining historical structures – this is common practice internationally with historical sites. Alternatively make use of the elements in an outdoor enclosure as part of the landscape design.
2. A permanent exhibition that could contain artefacts and records designed and curated by the Museum. The intangible heritage ie. social memory of the hospital and it's founders would be commemorated.
3. The site of the chapel and its form be commemorated in the ground floor of the replacement building with stone or bricks demarcating the base of the walls in the floor.
4. Reconstruction of the chapel in the park to form part of the landscaped space and places to visit. Recreate a serene and contemplative space. It could serve a function or be part of the Park facilities.

The client favours options 1 and 3 as the best way to integrate the intangible heritage with the new functions of the space, these approaches will provide flexibility for the use of the spaces while visually commemorating and creating a connection with the original buildings.
