Reference No: DJH059-R01

REVIEW OF DAM SAFETY RISK AND PROPOSED REMEDIAL WORK ASSOCIATED WITH CATEGORY 3 NGODWANA DAM, MBOMBELA

Ngodwana Dam is a 41 m high zoned earthfill Category III Dam. The dam is located on a tributary of the Elands River, Mpumalanga Province, directly upstream from the N4 highway and the Ngodwana Paper Mill, 40 km from Mbombela. The layout of the dam is shown in **Figure 1**.

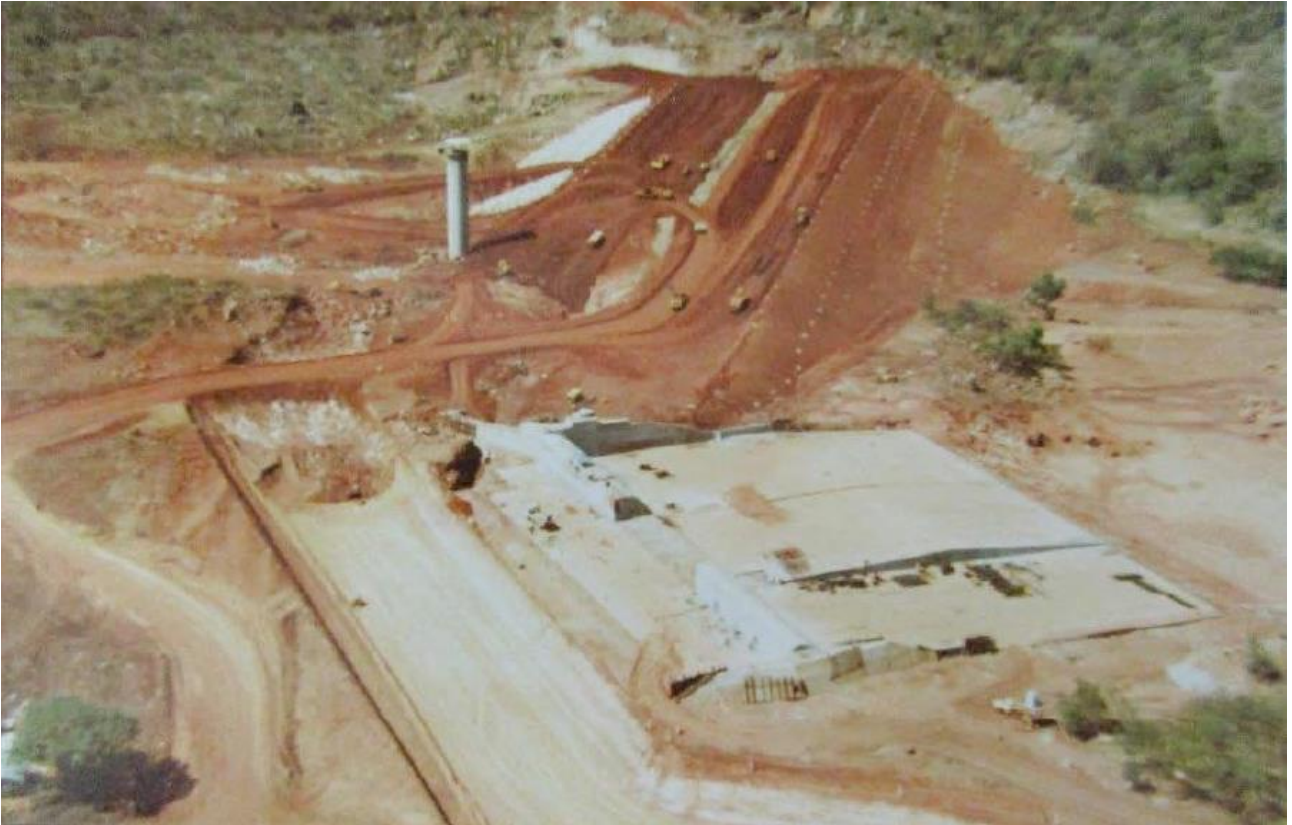
Figure 3: Embankment zoning during construction

An original construction photo of the dam zoning is shown in **Figure 3**. The darker red colour impervious zone, light colour gravel layer and light red coloured downstream shell zone can be seen from upstream to downstream.

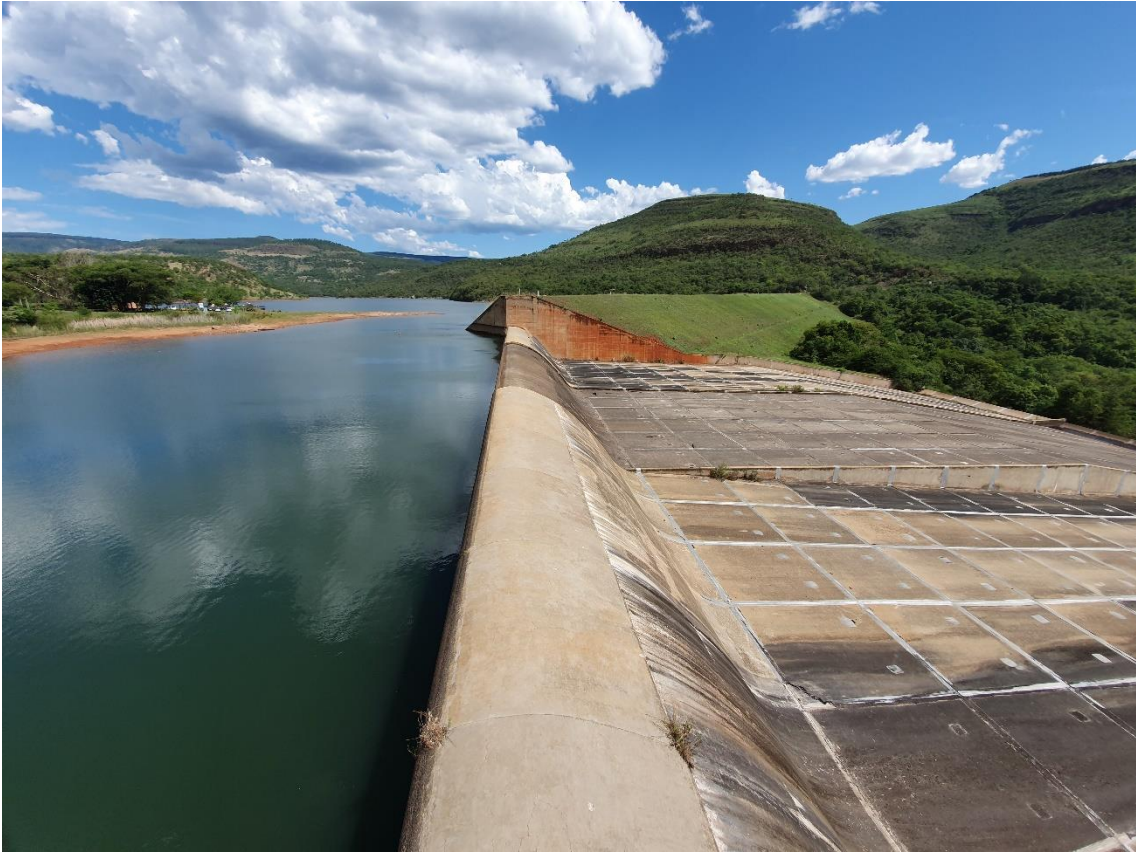
Photo 1: General view of spillway and dam embankment from right flank (19 November 2019).

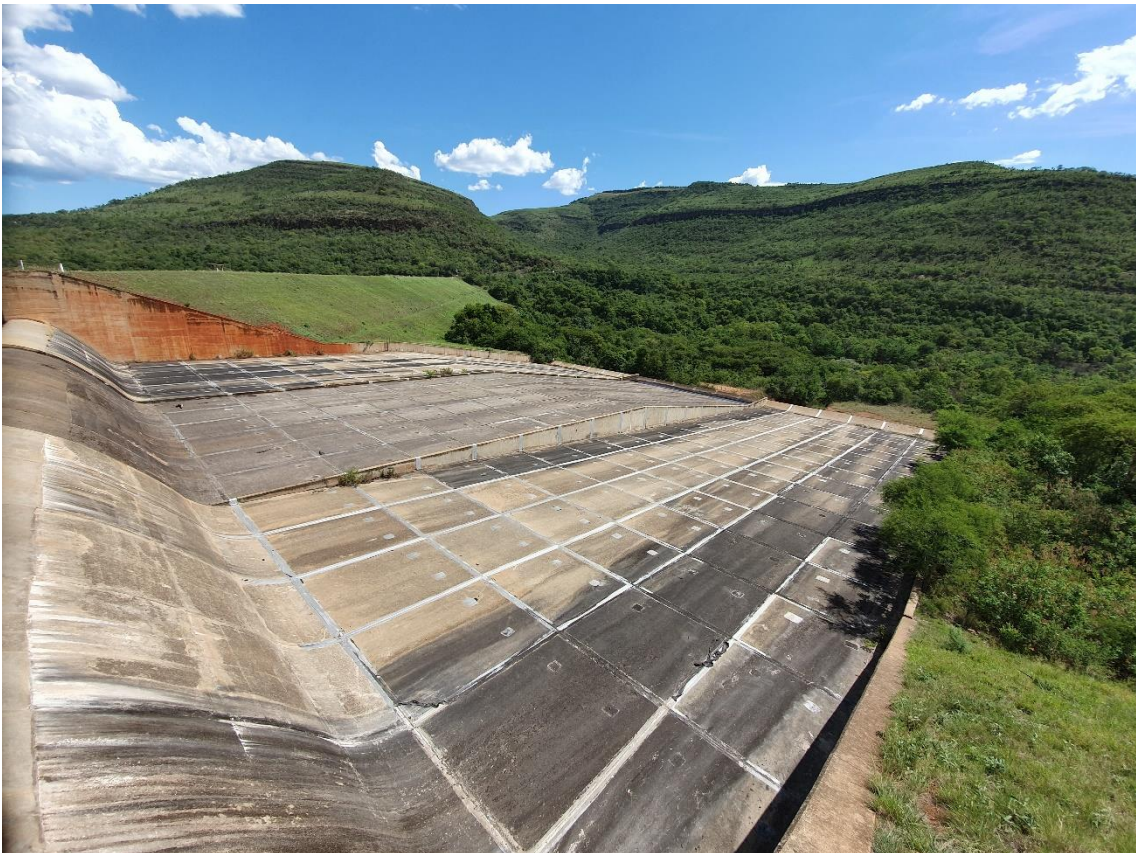
Photo 2: Spillway discharge channel looking downstream from right flank (19 November 2019).

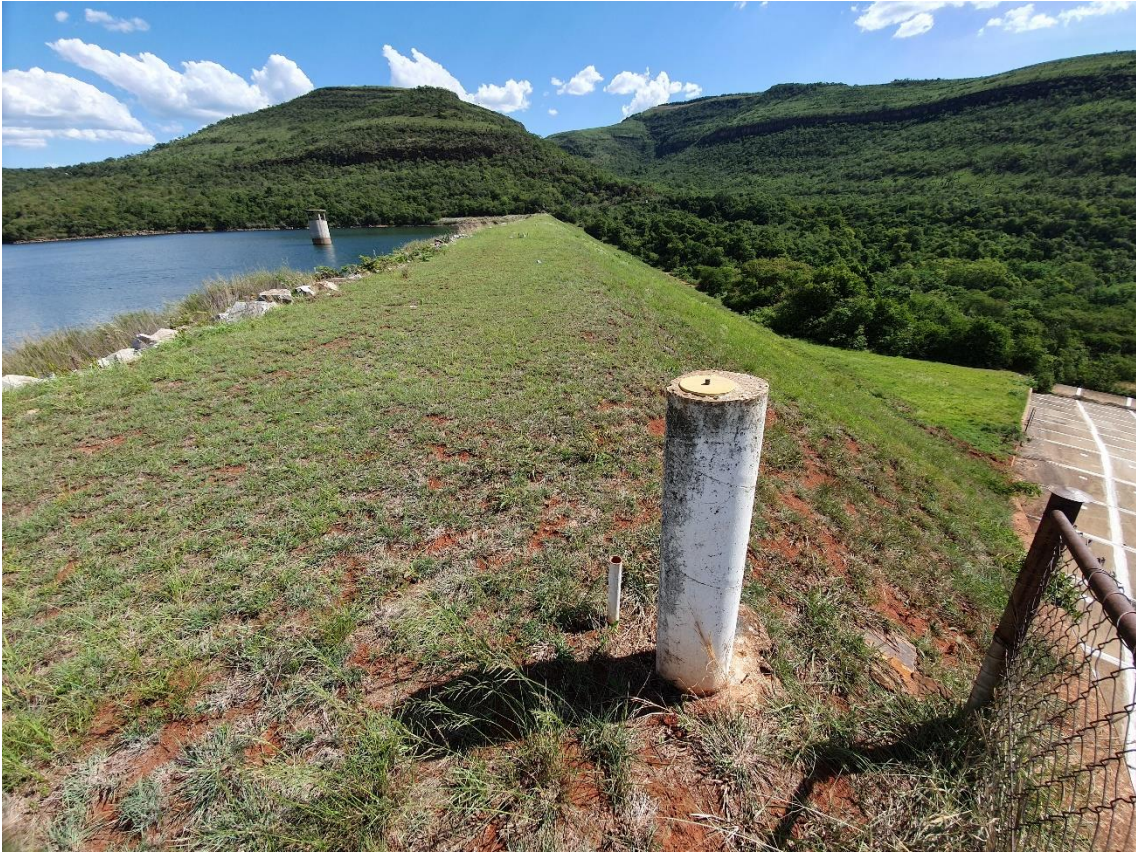
Photo 3: Embankment crest from end of right flank (19 November 2019). Note survey fixed station for movement monitoring.

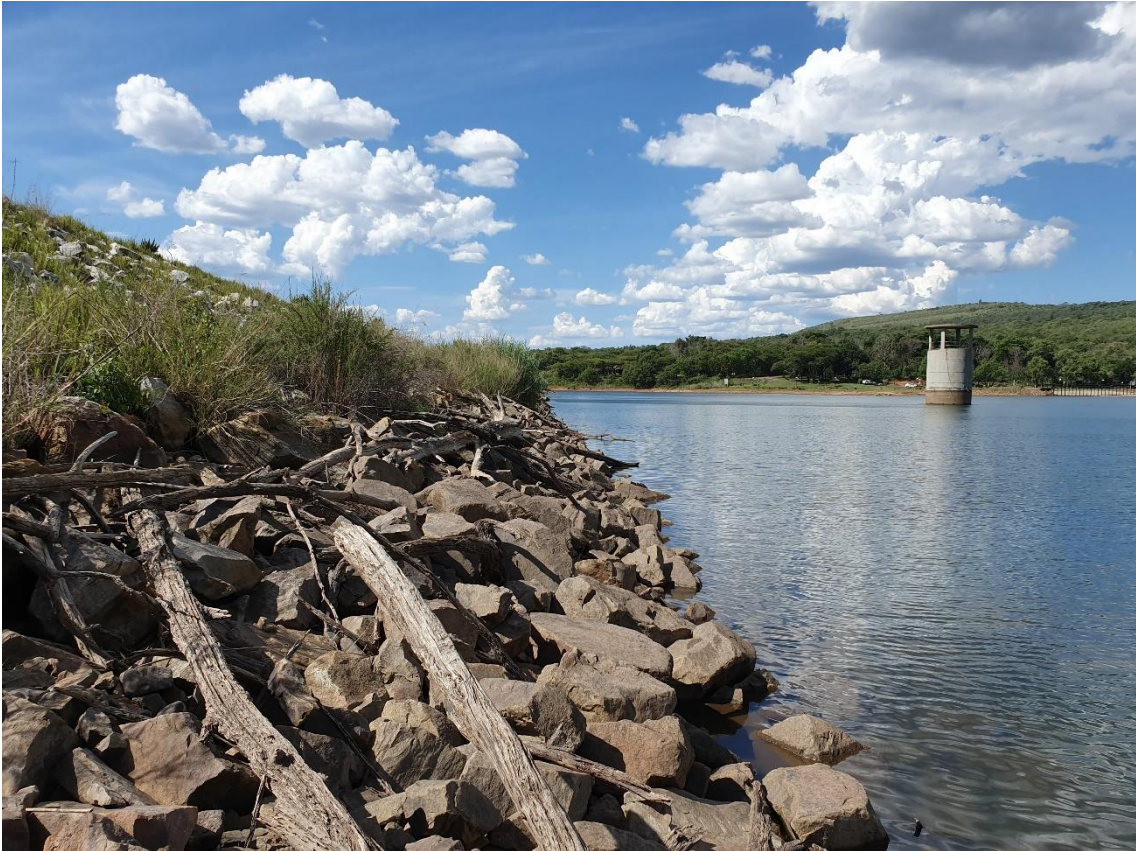
Photo 4: Lower upstream face of embankment showing good rip-rap upstream slope protection (19 November 2019).

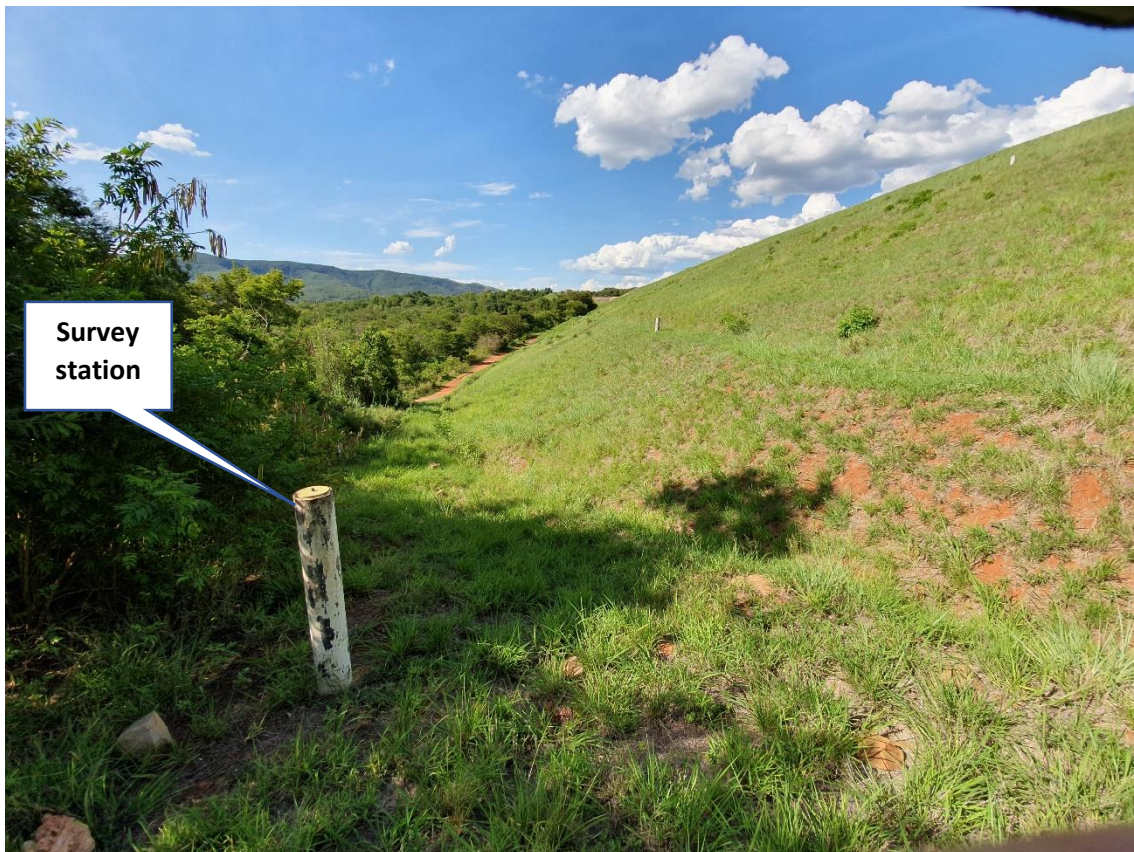
Photo 5: Lower downstream face from end of left flank (19 November 2019). Note survey fixed station for movement monitoring.

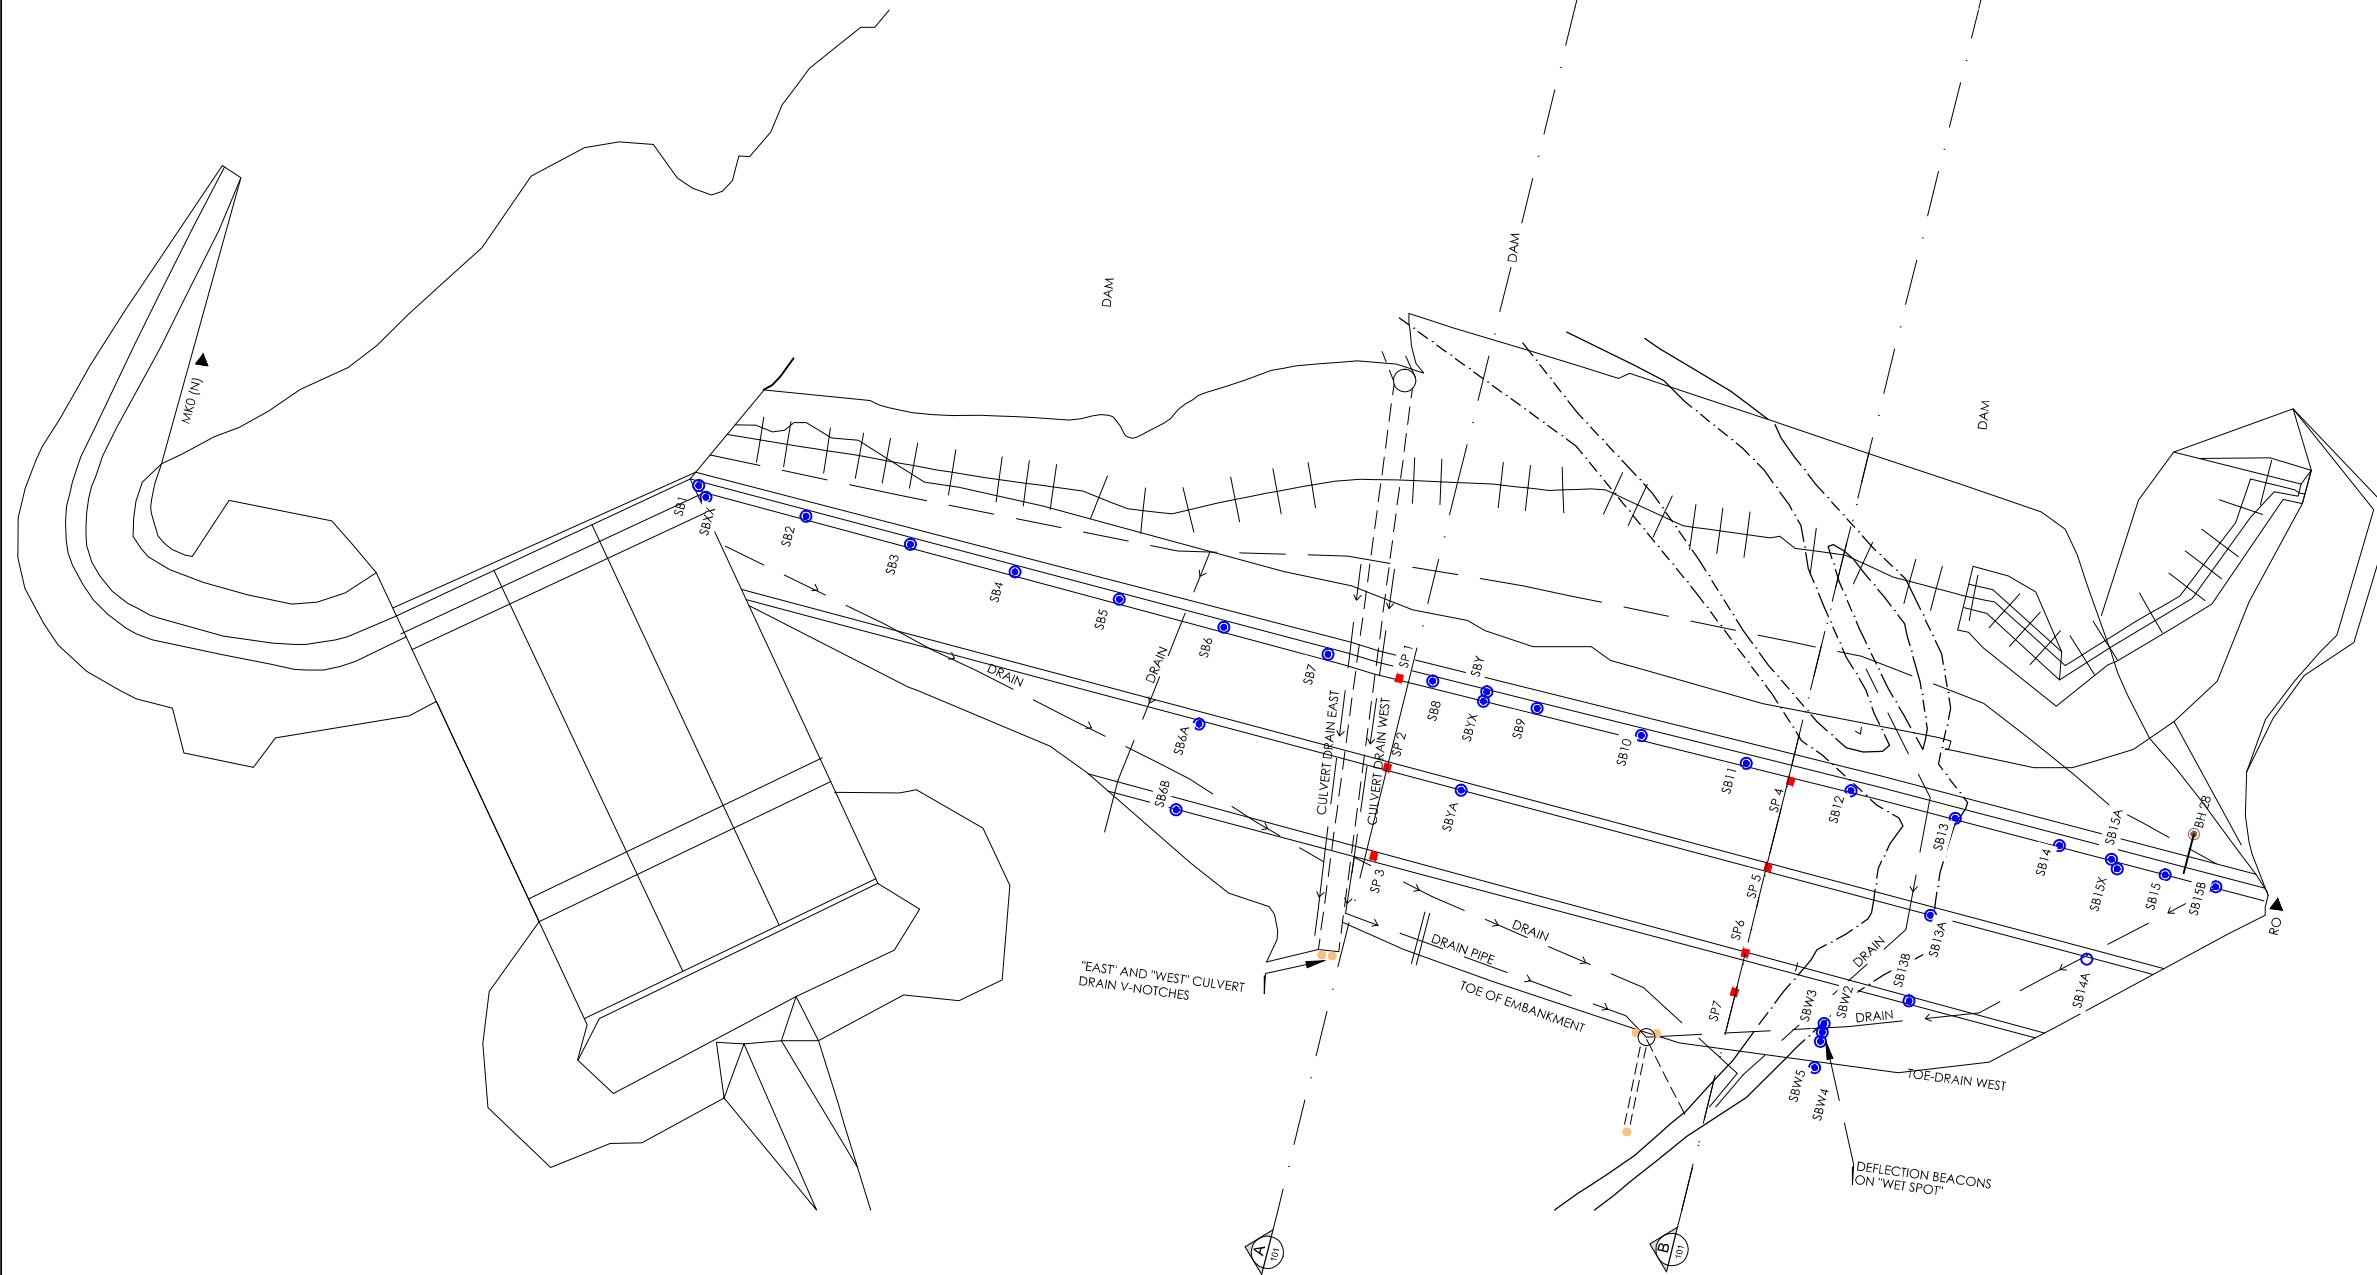
SETTLEMENT MONITORING BEACON SURVEY DATA - August 2018

- The portion of the embankment between the riverbed and the left flank foundation contact showed significant erratic movements over the past 5 years, e.g. beacon SB15 on the crest near the foundation contact show vertical settlement of 22 mm and horizontal (downstream) movement of 12 mm.

- Horizontal movement of the dam crest (downstream) under the hydrostatic water load, followed the vertical settlement pattern. Total maximum horizontal movement (Beacon 6) is currently 246 mm, having stabilised to only 20 mm horizontal movement over the past 15 years (2004-2019).

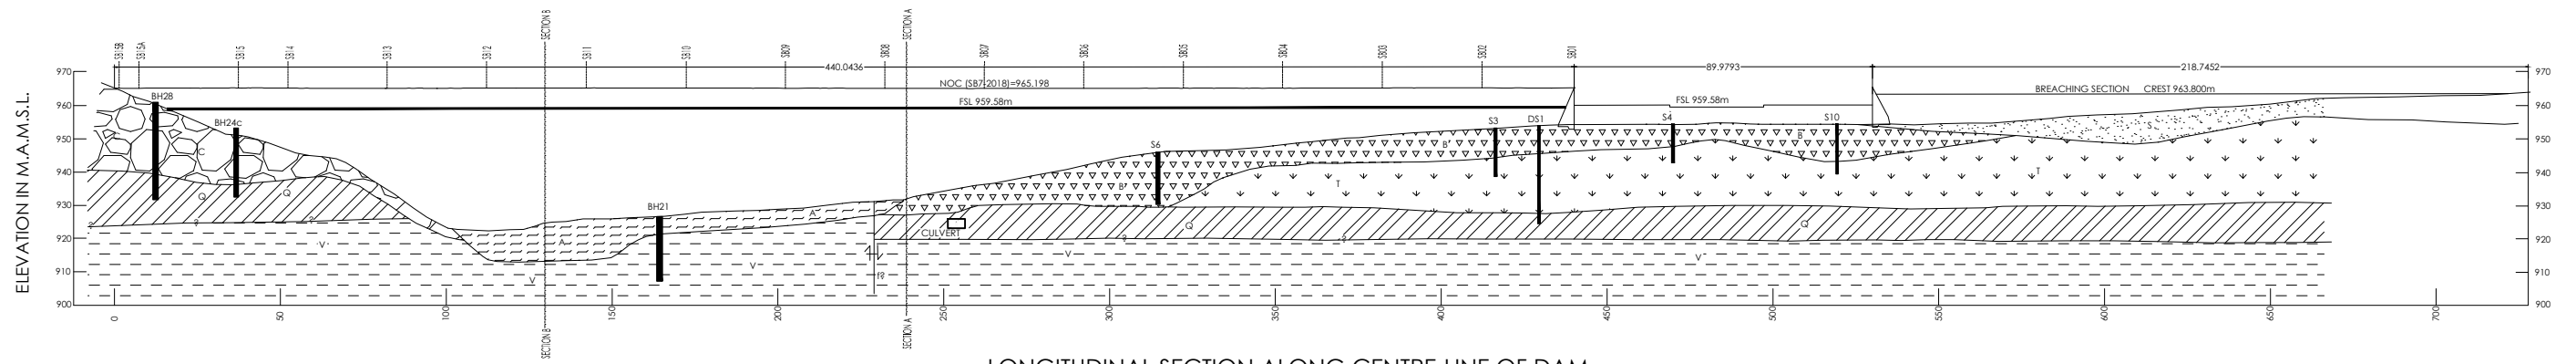
LONGITUDINAL SECTION ALONG CENTRE-LINE OF DAM
Scale 1:1000

The site geology is extremely complex due to the occurrence of a variety of sedimentary, volcanic and metamorphic rocks, unconformities in the sedimentary succession, faulting, variable weathering, thick alluvium in the river section, colluvium on the left flank and large dislodged quartzite blocks on the right flank. Although the embankment flanks are founded on some of these low strength materials, most of the embankment core cut-off trench was founded on the underlying quartzite bedrock. The upper part of the left flank core trench was extended upstream and was founded on weak tuff and partly cemented colluvium. Parts of the right flank was founded on weak tuff, tuffaceous shale and agglomerate.
