Client: **Ngodwana Mill - SAPPI Paper and Paper Packaging
SAPPI Southern Africa Ltd**

Project Description: **2019 ANNUAL DAM SAFETY INSPECTION**

Date: **30 September 2019**

NGODWANA DAM ANNUAL DAM SAFETY REPORT 30 September 2019

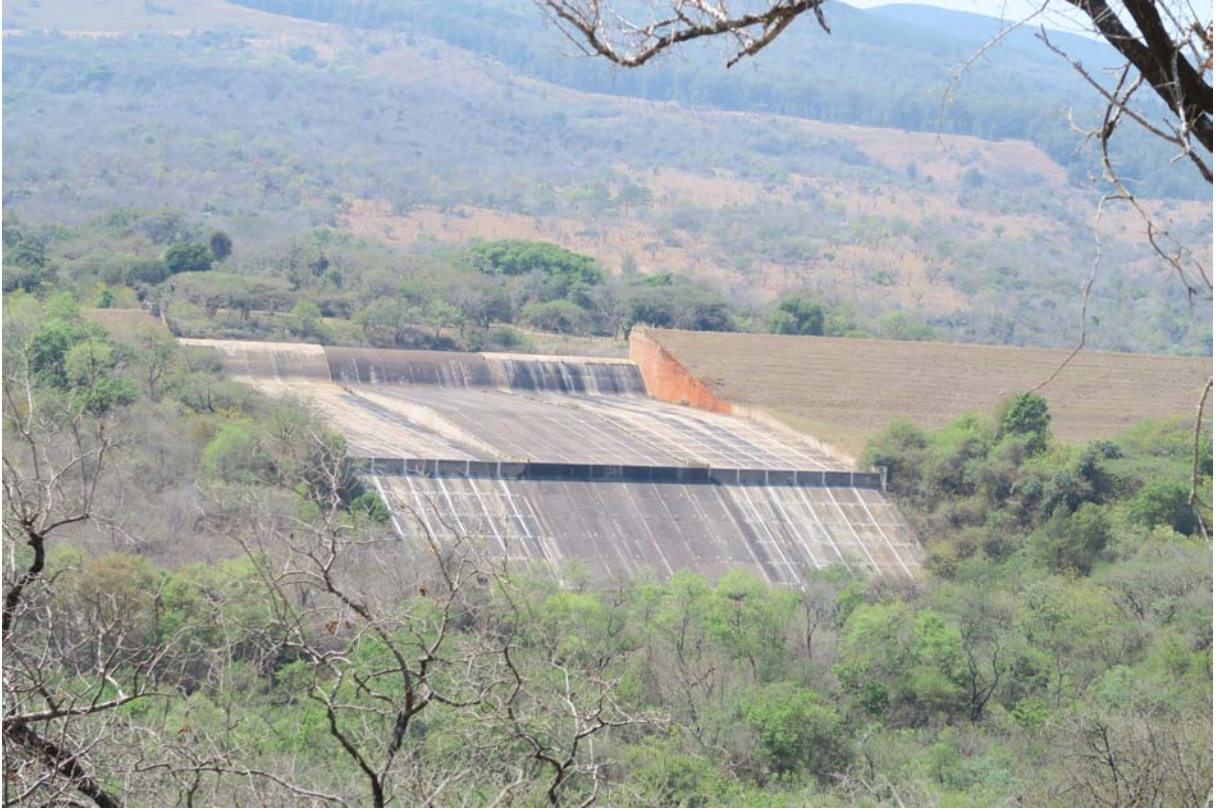
PLATE 1:- Ngodwana Dam spillway and dam wall viewed from downstream

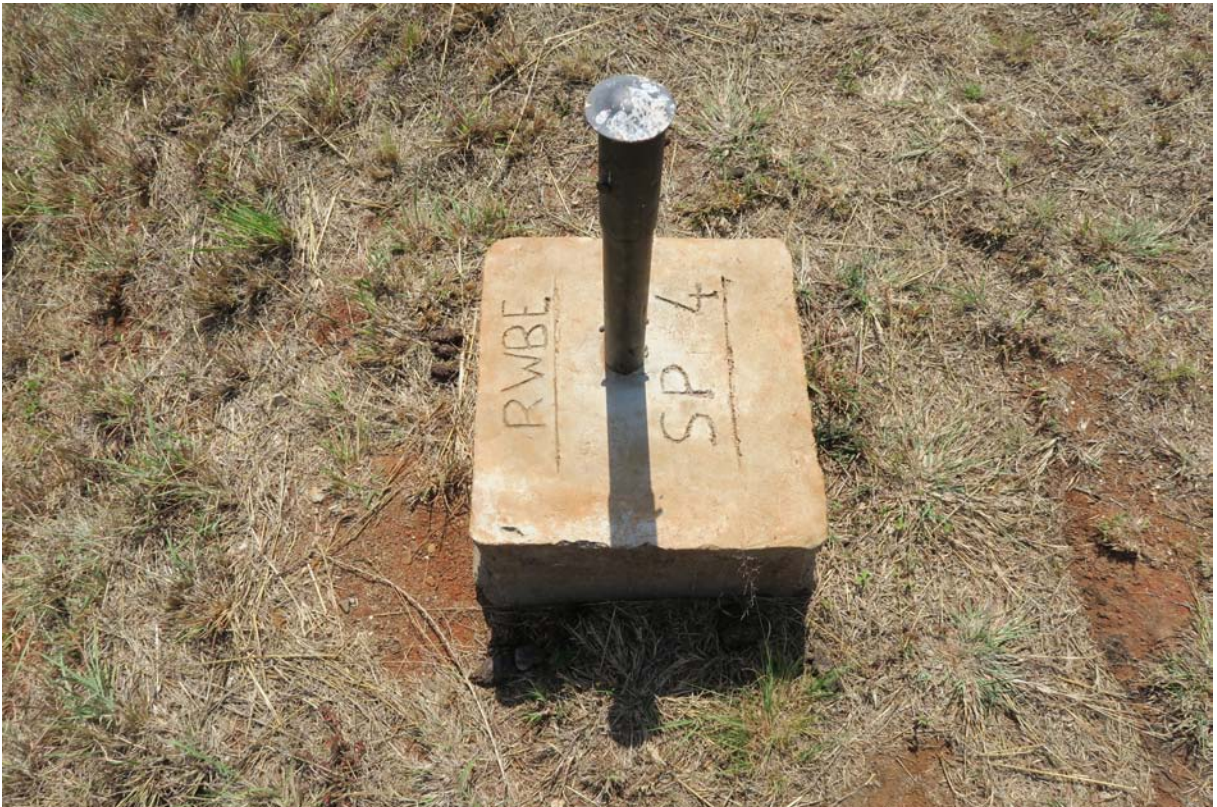
PLATE 2:- Standpipe piezometer SP4 on dam crest at “riverbed” section.

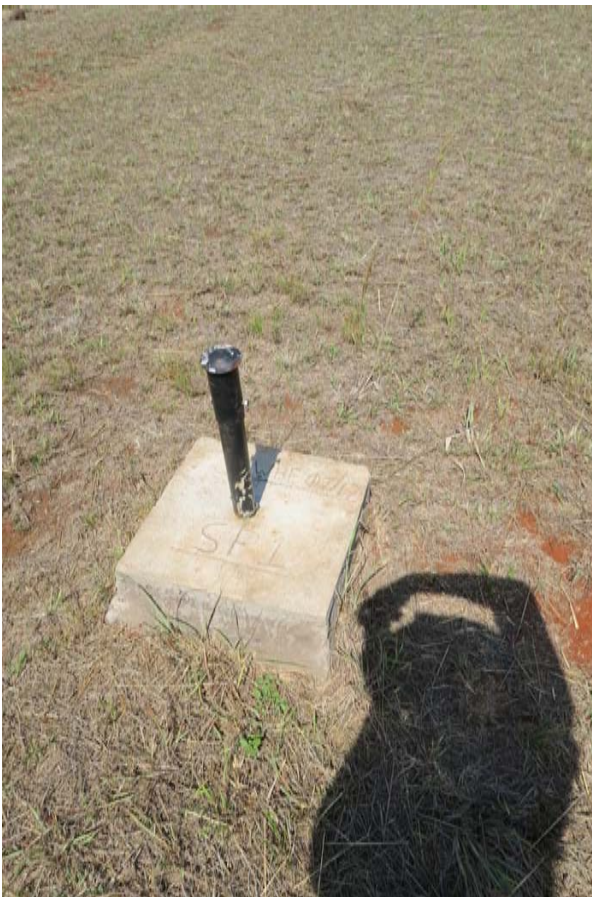
PLATE 4:- Standpipe piezometer SP1 on dam wall crest at “culvert” section

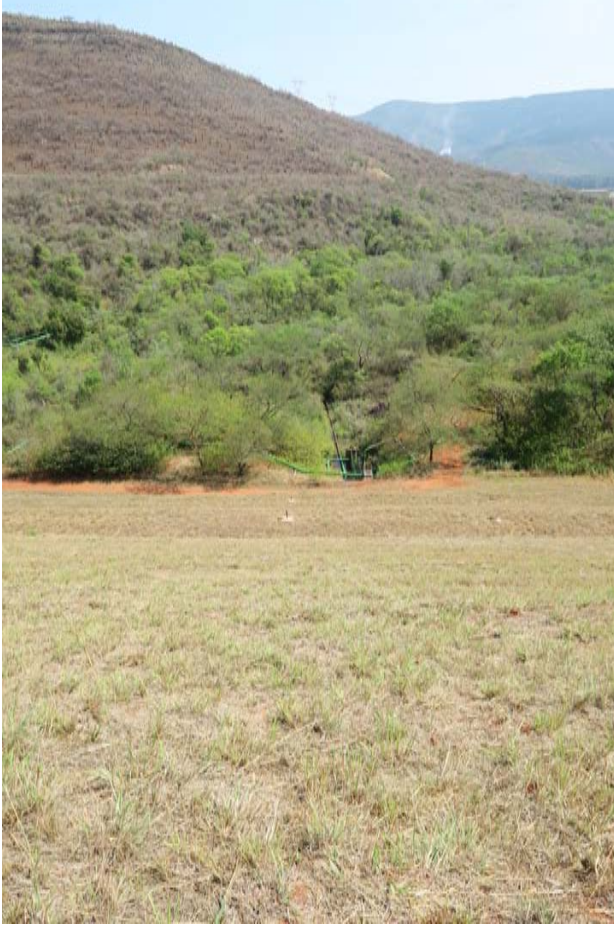
PLATE 5:- Standpipe piezometers SP1-3 along “culvert” section

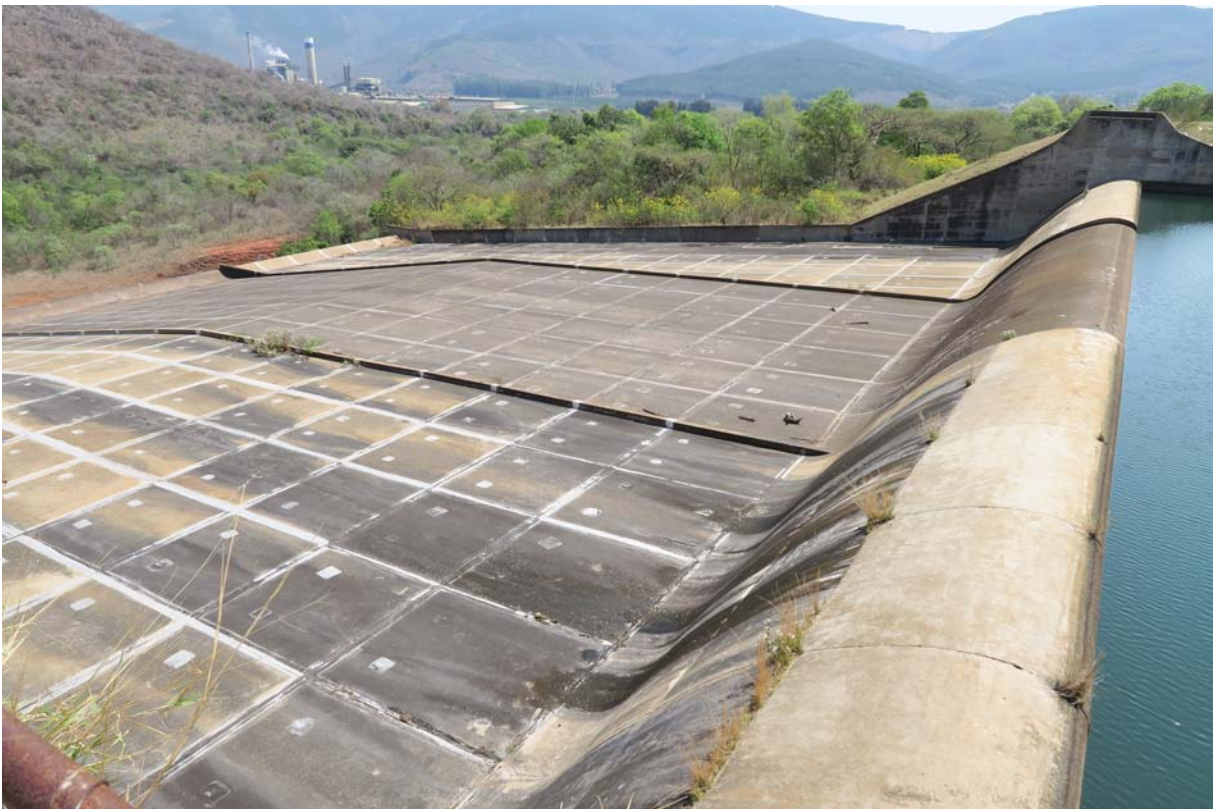
OGEE Condition	Good – some grass growing in Ogee construction joints. See Appendix F - Photographic Record - Plates 8 & 9.
Return Channel Condition	Good - joint sealants between cill slabs of spillway discharge chute were repaired. See Appendix F – Photographic Record, Plates 6-8.
Flank Walls Condition	Retaining wall on left flank displayed movements as evidenced by opening joints – probable cause is foundation settlement, but no cause for stability concern. See Appendix D – Structural Report.
Emergency Spillway Condition	Good

PLATE 8:- Spillway OGEE control structure and return channel

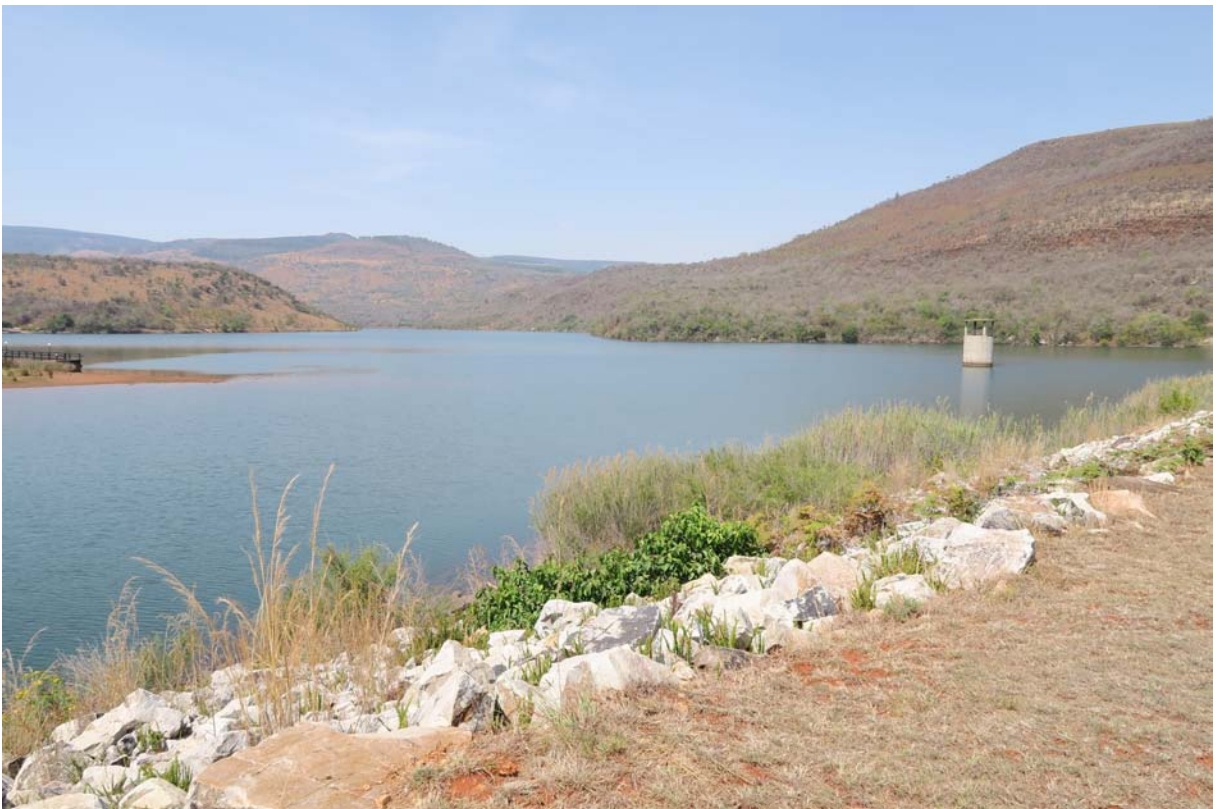
PLATE 12:- Dam basin and intake tower
