Client: **SAPPI Southern Africa Ltd - Ngodwana Mill**
Ref #: **Order # PO 2105-052852**
Project Description: **NGODWANA DAM – SAFETY INSPECTION**
Date: **9 September 2016**

**NGODWANA DAM
COMPULSORY 7-YEARLY DAM SAFETY REPORT
9 September 2016**

Title: **SAPPI Southern Africa Ltd - Ngodwana Mill**
Order # PO PO 2105-052852
Ngodwana Dam:- Compulsory 7-Yearly Dam Safety
Report – 9 September 2016

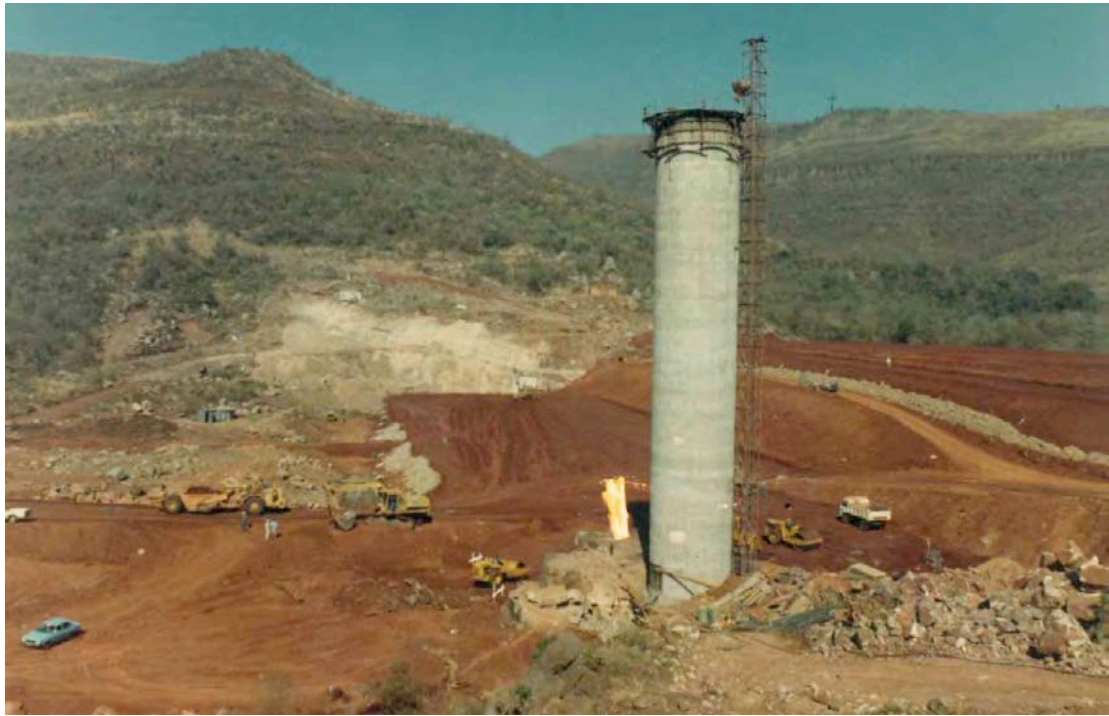
Plate 3:- View towards left flank, showing partly constructed embankment and exposed left bank foundations comprising a cover of partly recemented (calcified) talus blocks in a matrix of soil, resting upon a layer of completely weathered very weak tuff and agglomerate

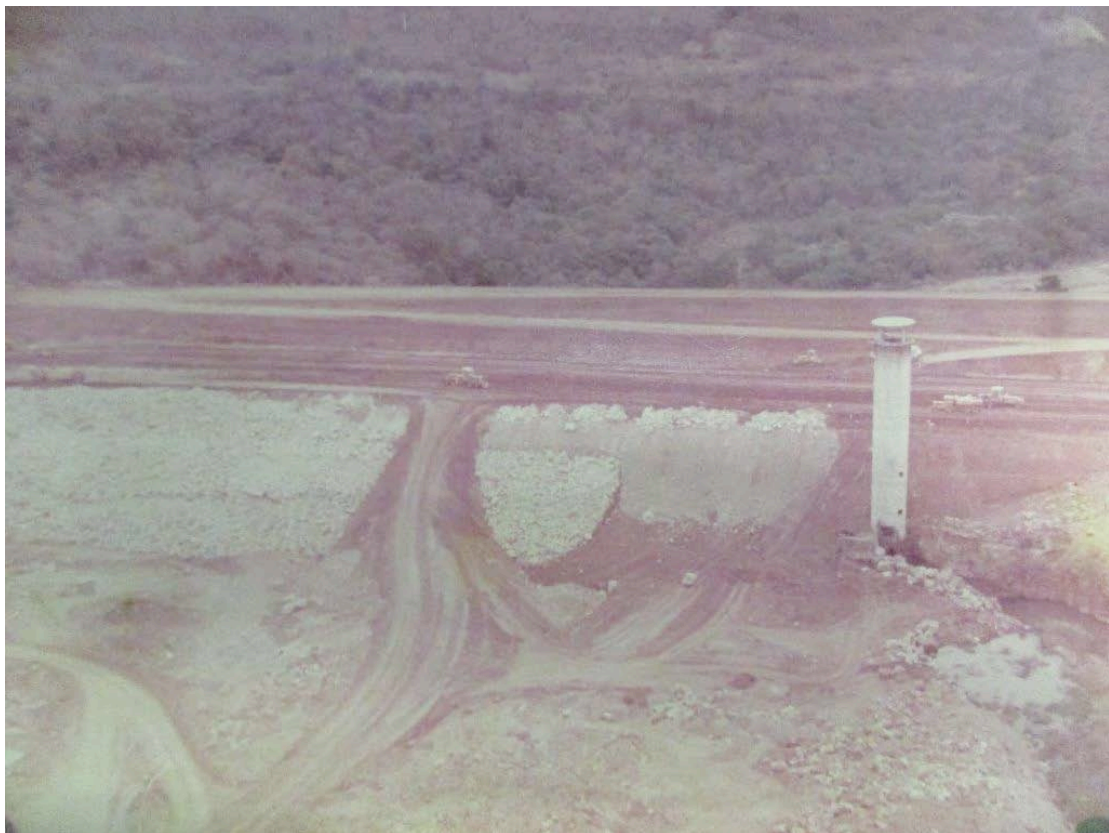
Plate 4:- Downstream view from inside dam basin. Note rock cuts adjacent to inlet tower indicating good founding conditions.

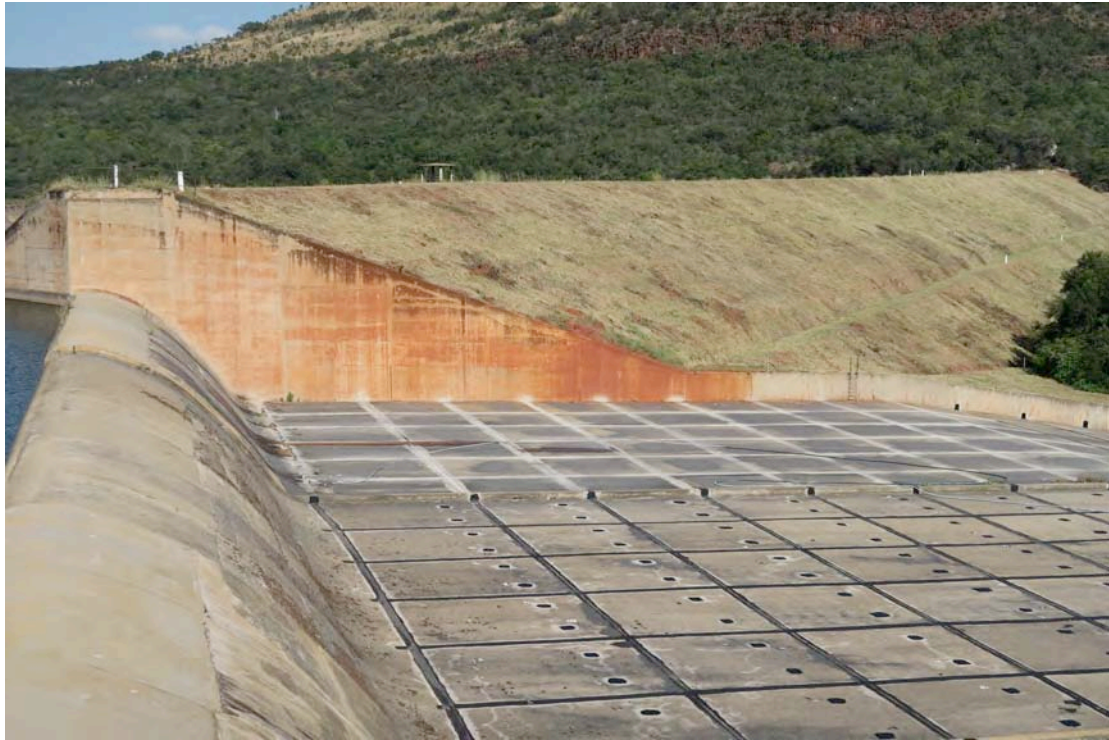
Plate 7:- View from right bank emergency breaching section across service spillway in foreground (2016-05-10)

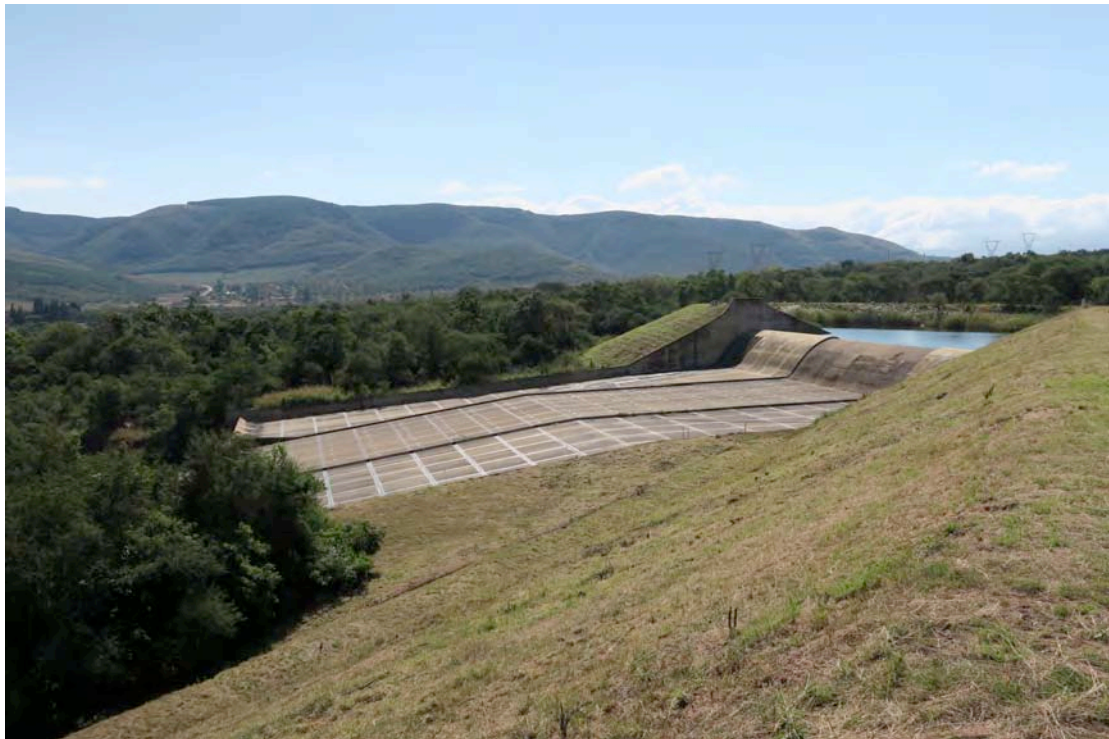
Plate 8:- View from left bank with emergency breaching section in far right background (2016-05-10)

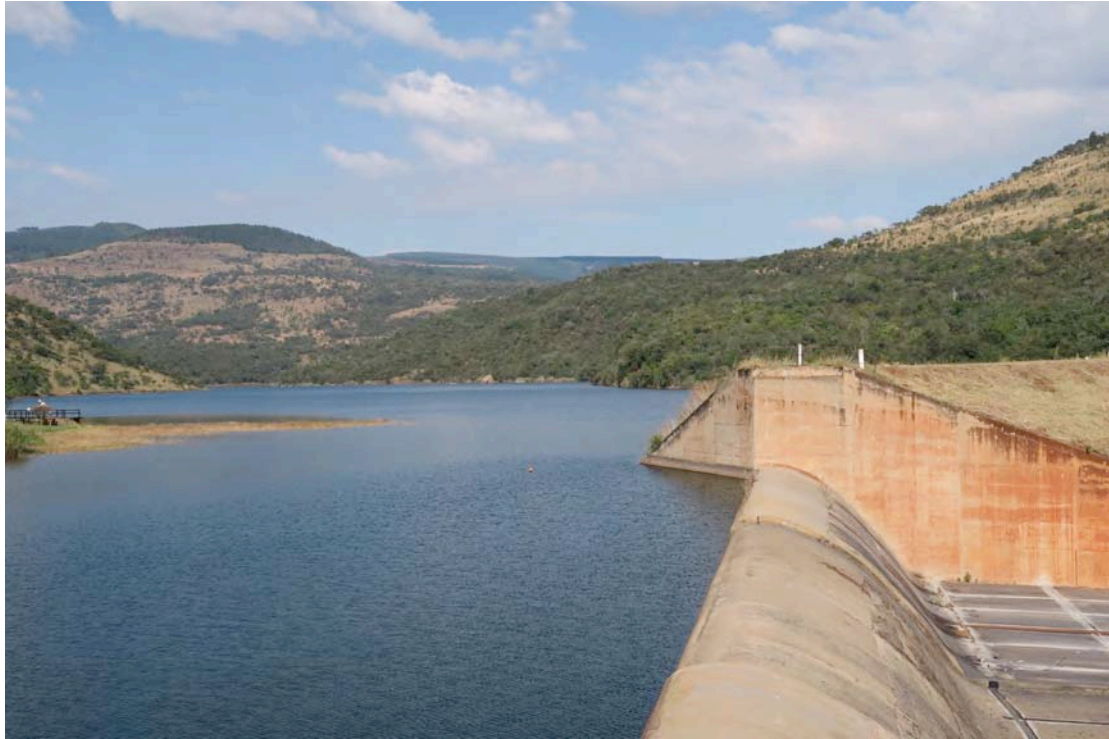
Plate 9:- Service spillway OGEE control structure (2016-05-10)

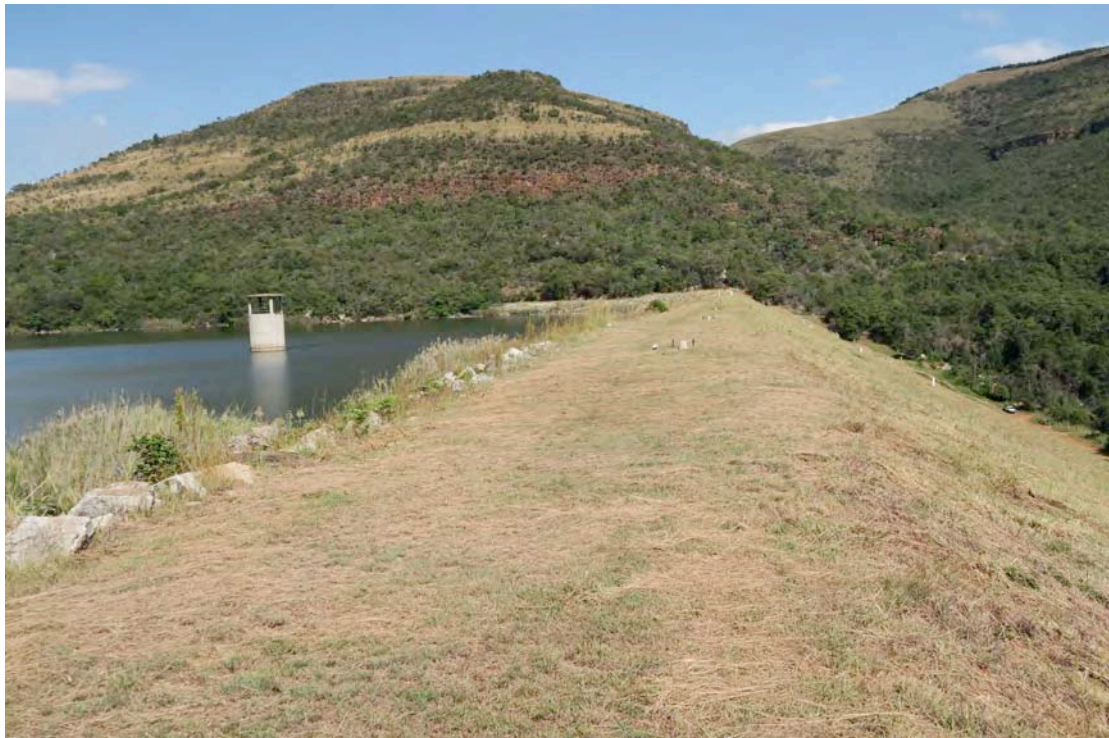
Plate 12:- Dry intake tower and embankment crest viewed from right bank / spillway (2016-05-10)

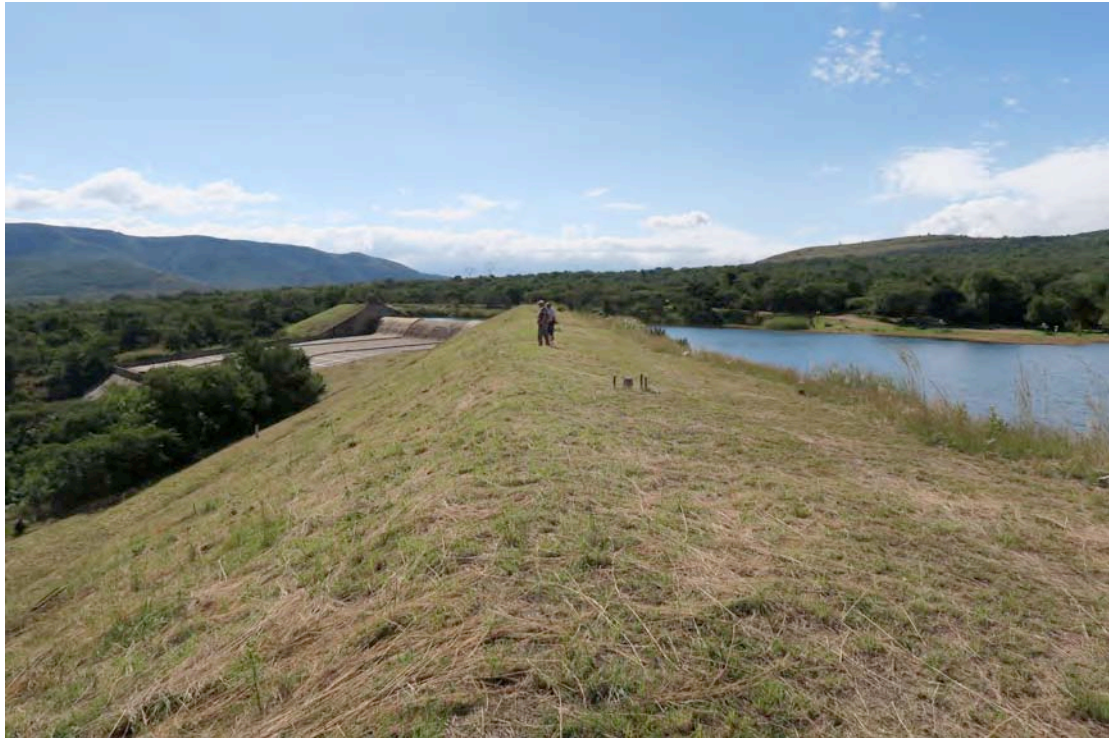
Plate 13:- Survey beacons on crest of dam wall, viewed from left flank (2016-05-10)

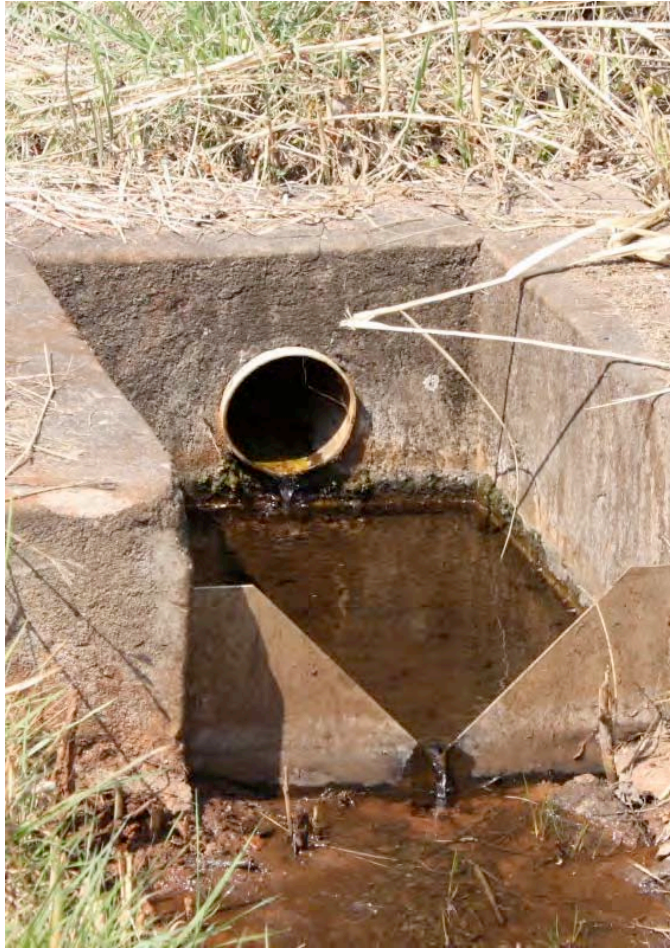
- V-notches at “Culvert Drains East and West” that measure flow from parts of the chimney drain and from along the culvert.
- A V-notch that measures flow from “Toe Drains East and West”. “Toe Drain East” never had any flow.
- A V-notch in a weir in the river that measures “Seepage 1” from the Internal Drains will in future be discontinued because most of this gauged flow results from ingress of water from sources other than seepage, thus providing grossly inflated seepage measurements. See Appendix F – Photographic Record, plates 17 and 18.

Plate 17:- V-notch gauge at outlet for combined “toe-drain East and toe-drain West” (2016-05-10)

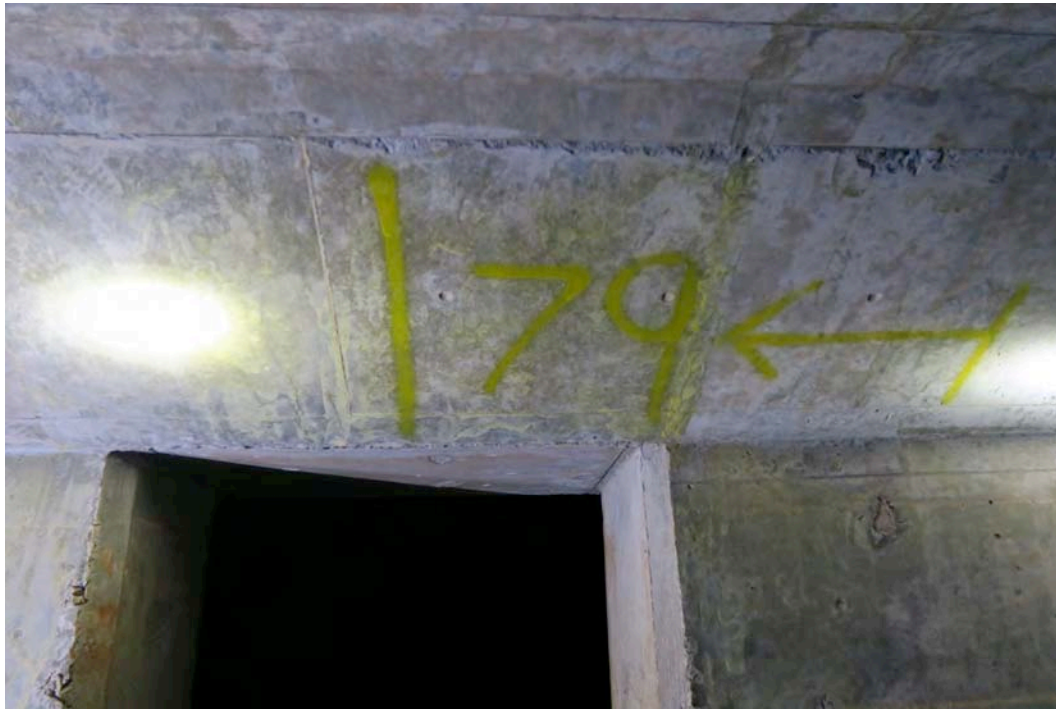
Plate 21:- Outlet conduit:- left-side compartment, right wall, 79 m from intake tower:- access opening into right-side compartment (2016-07-12)
