SAPPI NGODWANA MILL

PRELIMINARY ASSESSMENT OF HAUL ROADS FOR SAPPI, NGODWANA DAM REHABILITATION

PROJECT 20828

AUGUST 2020

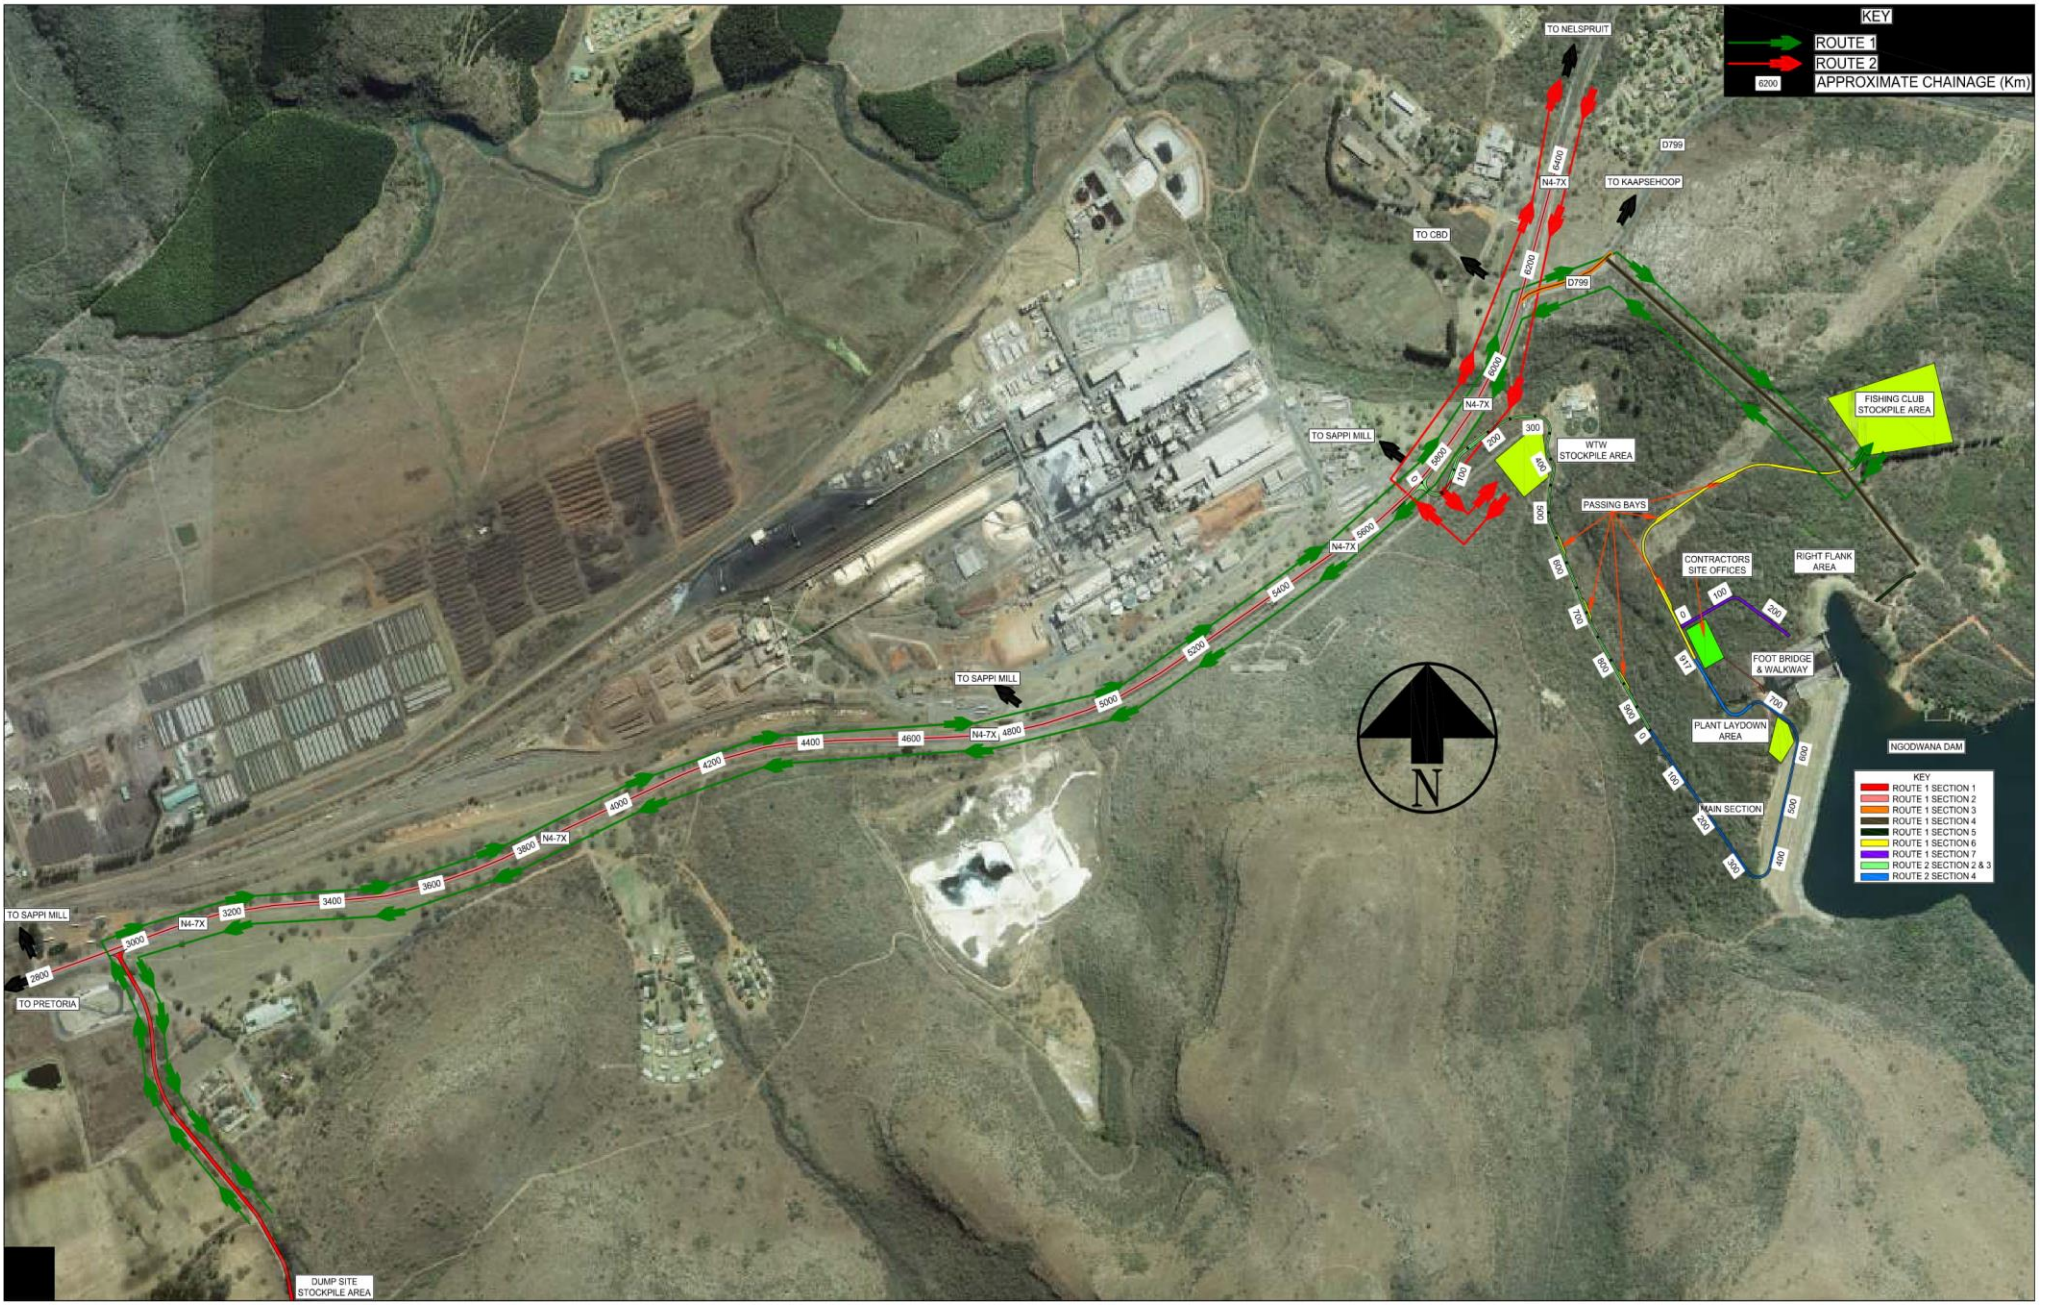
FIGURE 1

A site inspection was done on 27 July 2020. Mr. Carel vd Merwe from SAPPI accompanied Mr. Paul Nicholson and Steyn de Wet to indicate haul routes and to give input on SAPPI's requirements regarding the haul routes. The haul routes that were identified are indicated in Figure 1 attached as "Annexure A".

This route (*indicated in green arrows on Figure 1*) starts at the SAPPI dumpsite stockpile area and continues to the N4. Access to the N4 for the material hauled for the upgrading of the haul roads and raised right flank ($\pm 29,000\text{m}^3$) will be obtained at the existing intersection at the weigh bridge ($\pm \text{km } 3.0 \text{ W}$) which provides access to SAPPI's dumpsite and material stockpiles (*Route 1, Road 1 indicated in red on Figure 1*) with a right turn movement onto the N4. This material will then be hauled Eastward along the N4 in 18m³ tip trucks (normal road haulers and not ADT's) up to the Kaapsehoop intersection ($\pm \text{km } 6.2 \text{ W}$), where trucks will turn right onto the Kaapsehoop road (D799), travel for $\pm 200\text{m}$ along this road and turn right towards the Ngodwana Dam onto the existing fishing club access which is a surfaced access road. A material stockpile area located approximately 600m along this road is the destination of this material. Trucks returning will turn left onto Kaapsehoop road (D799), left at the Kaapsehoop N4 intersection ($\pm \text{km } 6.2 \text{ W}$) and left again at the dumpsite access ($\pm \text{km } 3.0 \text{ W}$), at the weighbridge intersection.

Material from the stockpile will be hauled to the point of placement on the North flank along the abovementioned fishing club road and a newly created gravel access is to be constructed (*road indicated in black on Figure 1*). An access route to the contractors site office turns off from the route to the stockpile towards the spillway area (*road indicated in yellow on Figure 1*). This access route will also serve as a haul road for the $\pm 7,500\text{m}^3$ material from the SAPPI stockpiles reserved for the main section of the embankment, as well as the $\pm 10,200\text{m}^3$ material required for the upgrading of haul roads. A link from this road to the Northern spillway retaining wall is required for the clearing of trees along this retaining wall.

Material will be hauled from the WTW stockpile area to the rock toe berm on the main section of the dam on an existing route. It runs along the SAPPI bulk water supply line to the West of the Ngodwana River to the embankment of the central section (*road indicated in green on Figure 1*). A new route (*road indicated in blue on Figure 1*) up the embankment up to the point of placement of the rock toe berm on the main section of the dam will be required due to material delivery requirements and restricted space between the toe and the bulk water pipeline. A foot bridge below the spillway will link the site office area with the contractor's laydown area.

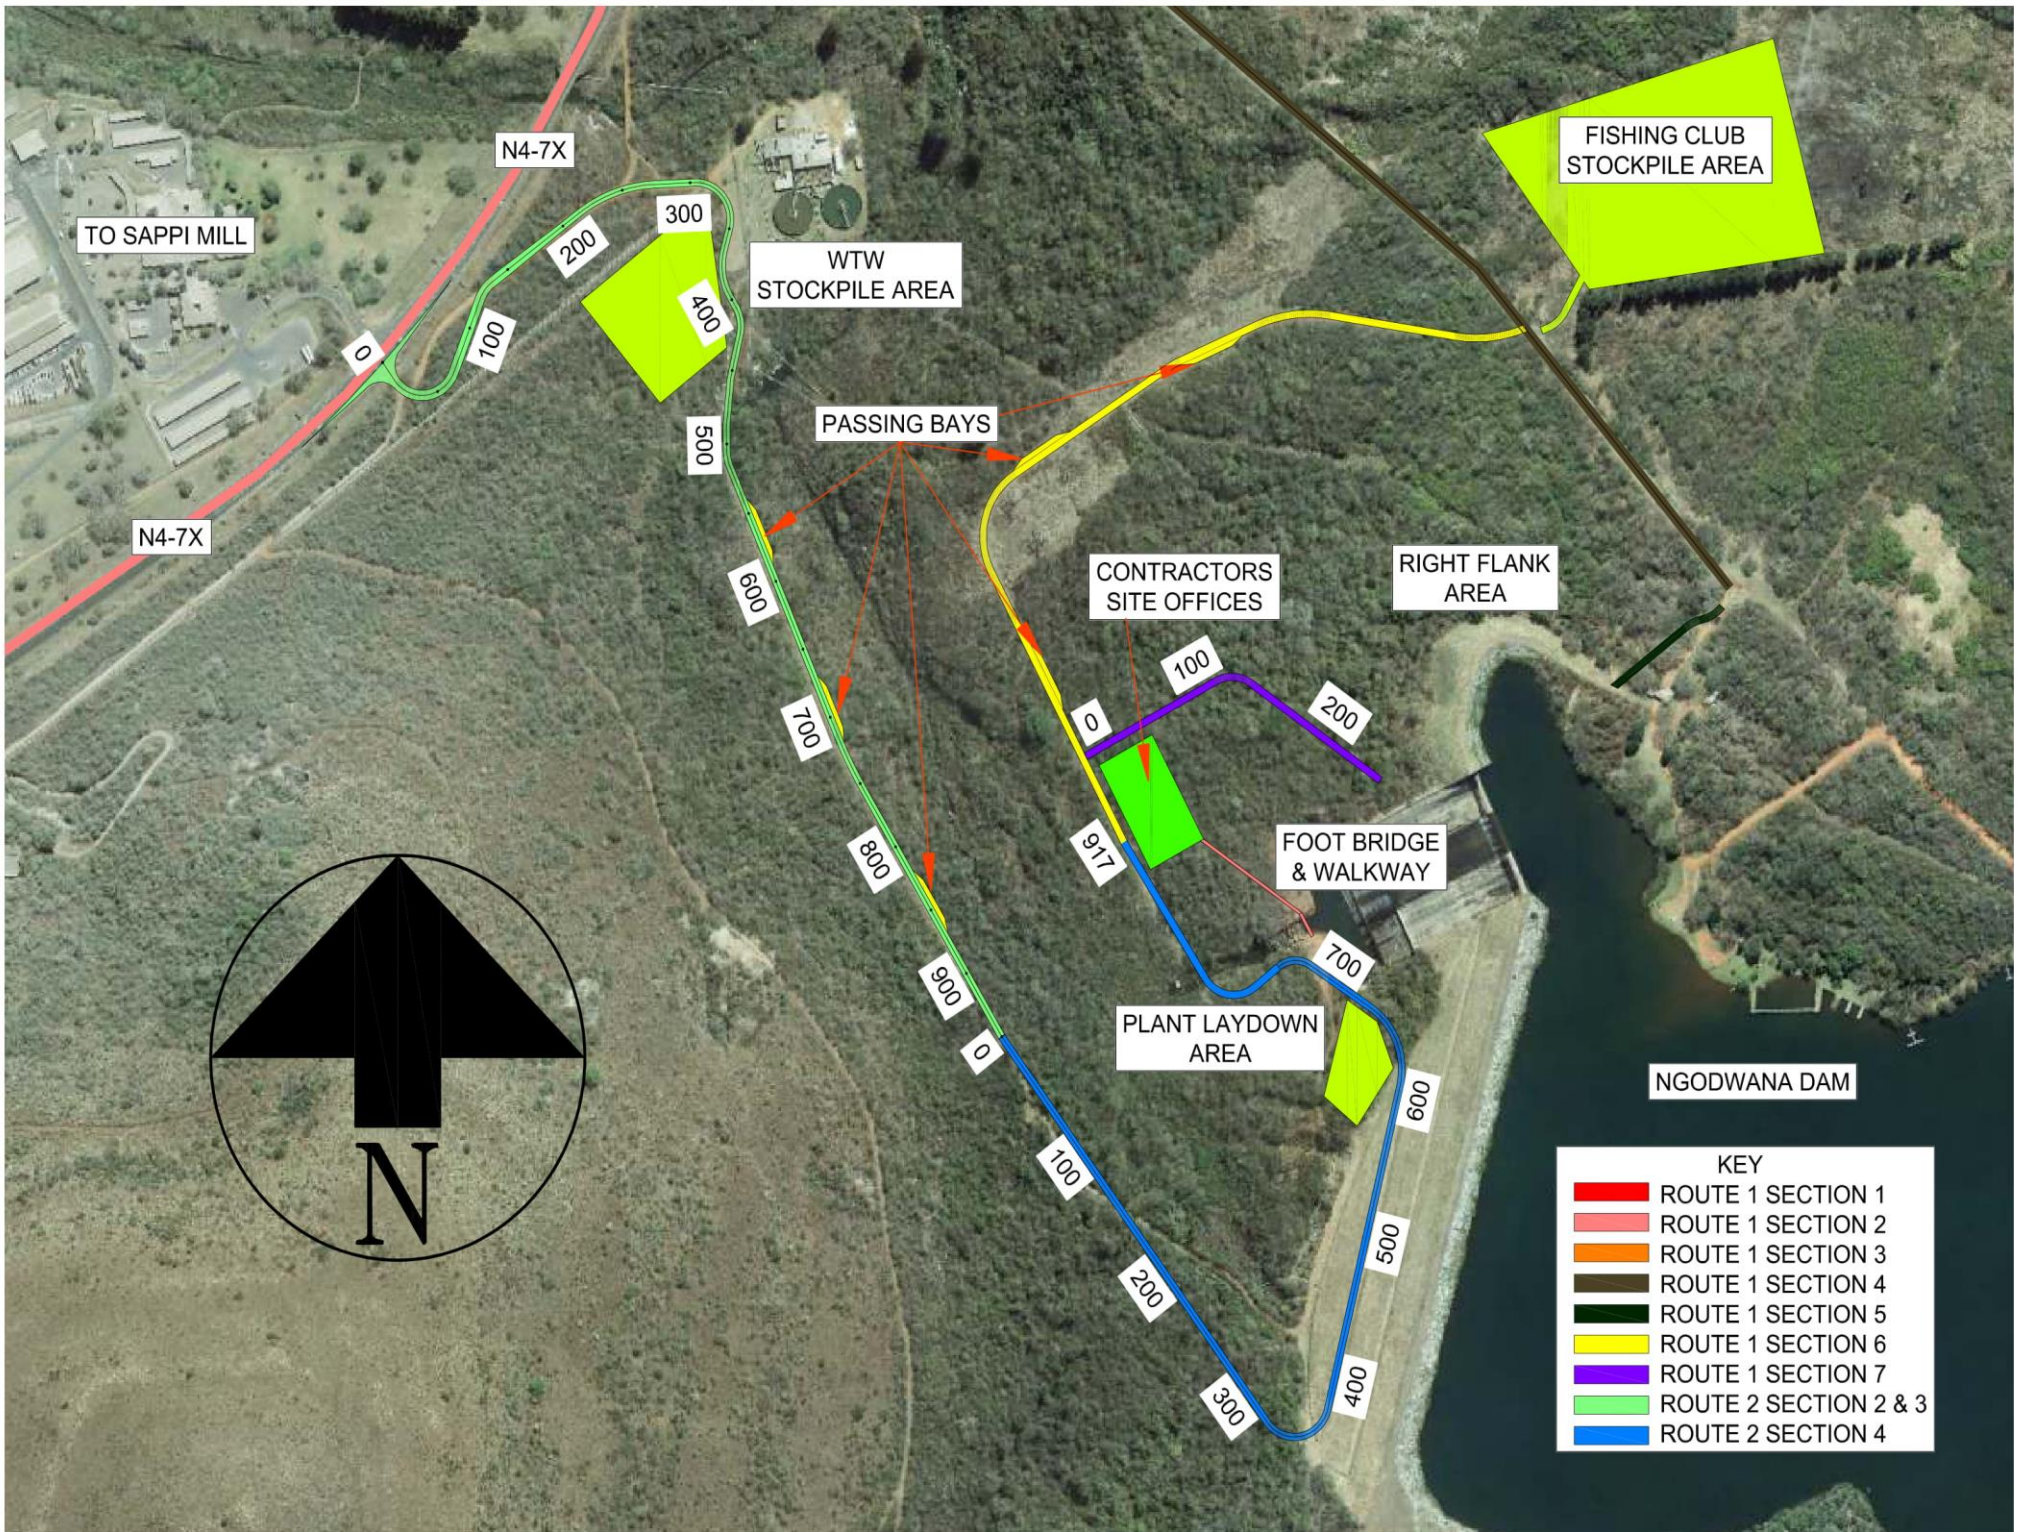
DESIGN LAYOUT

Section 4 will require a 3.9m wide section with a completely new alignment in order to reach the points of placement of the material along the rock toe berm. Restricted space at the bottom of this structure between the pipeline and the toe limits the space available to less than 2m, which is not wide enough for trucks to pass. The final level of material placement is also much higher up the embankment and a new road is required to this point. This new haul road is indicated in blue as Route 2, Section 4 on the layout on Figure 1. It follows the route up the groin of the dam and turns onto the embankment at the existing berm, runs along this berm line along the face of the embankment and then drops down to the plant and equipment laydown area. This route will cross the pipeline at the newly constructed culvert before running uphill to the groin area. Fills will be used to create this route. Once past the equipment laydown area this road will cross the Ngodwana river below the spillway area at a stream crossing before linking with Route 1, Section 6. Geotechnical conditions will determine if the stream
