**Report to Umsunguli Project Management on a Geotechnical Investigation  
carried out for the Proposed Mount Verde Development, Hilton,  
KwaZulu-Natal**

**Project No.: 22-037R01**

**Date Issued: June 2022**

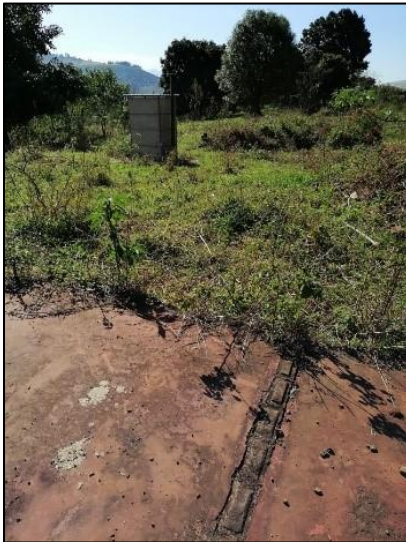
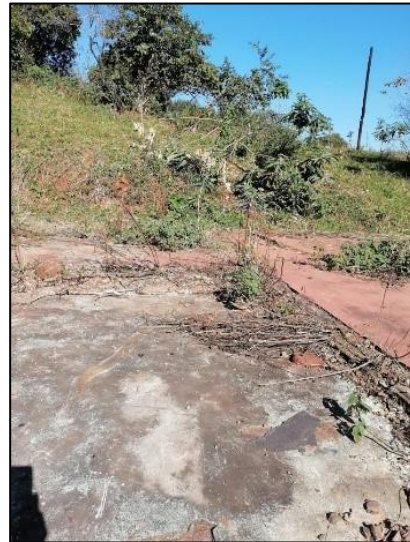
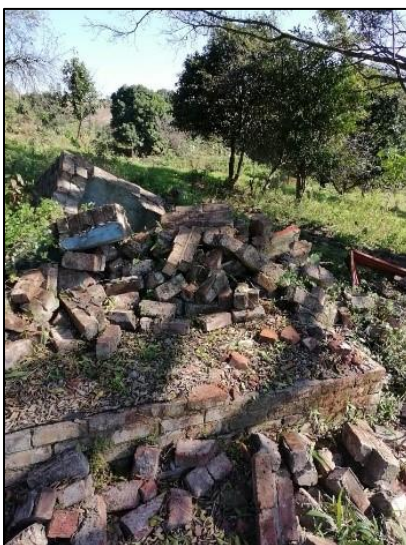
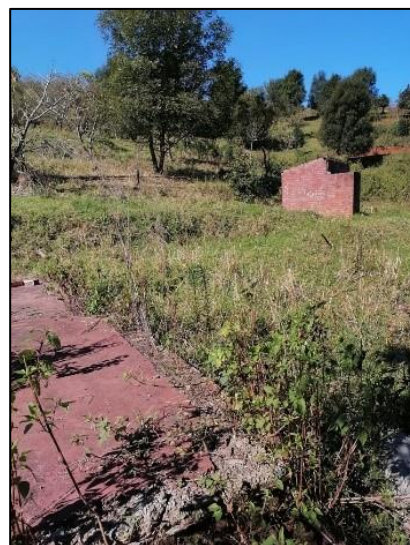
**Plates 7 to 10: Partly demolished farmhouses encountered at the Forest Village site**

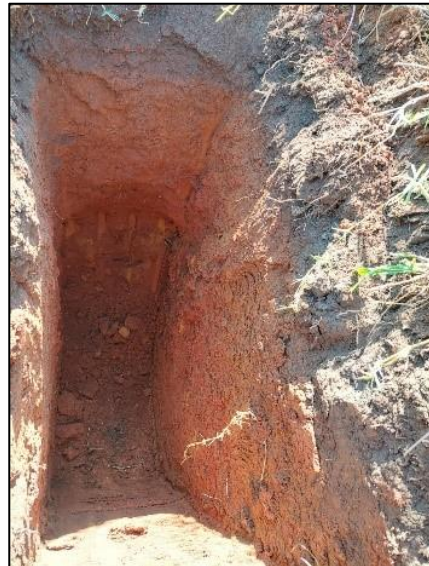
**Plates 24 & 25: Residual Dolerite soils overlying residual sandstone comprising clayey sands**

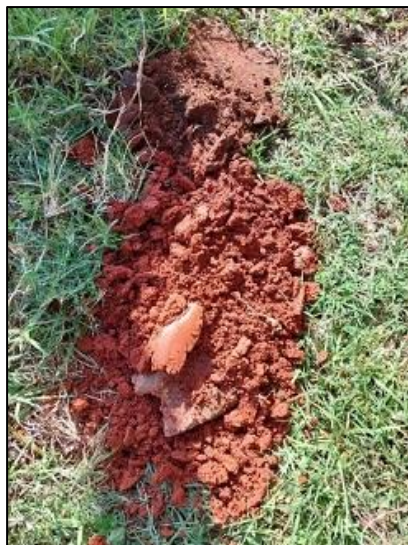
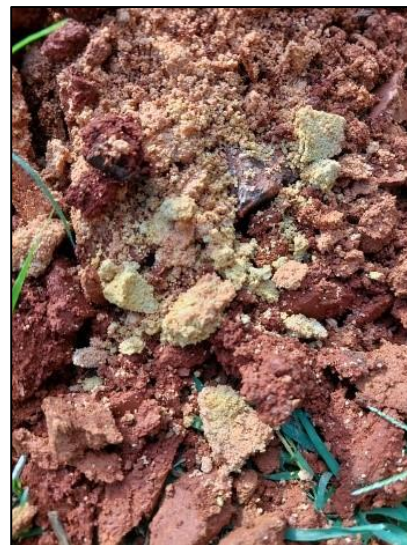
**Plates 29 & 30: Spoils retrieved from AH1 (left) and AH2 (right) showing a thin layer of colluvium (dark brown sandy clays) overlying residual dolerite soils (reddish clays) which further overly residual sandstone soils (light brown sands)**

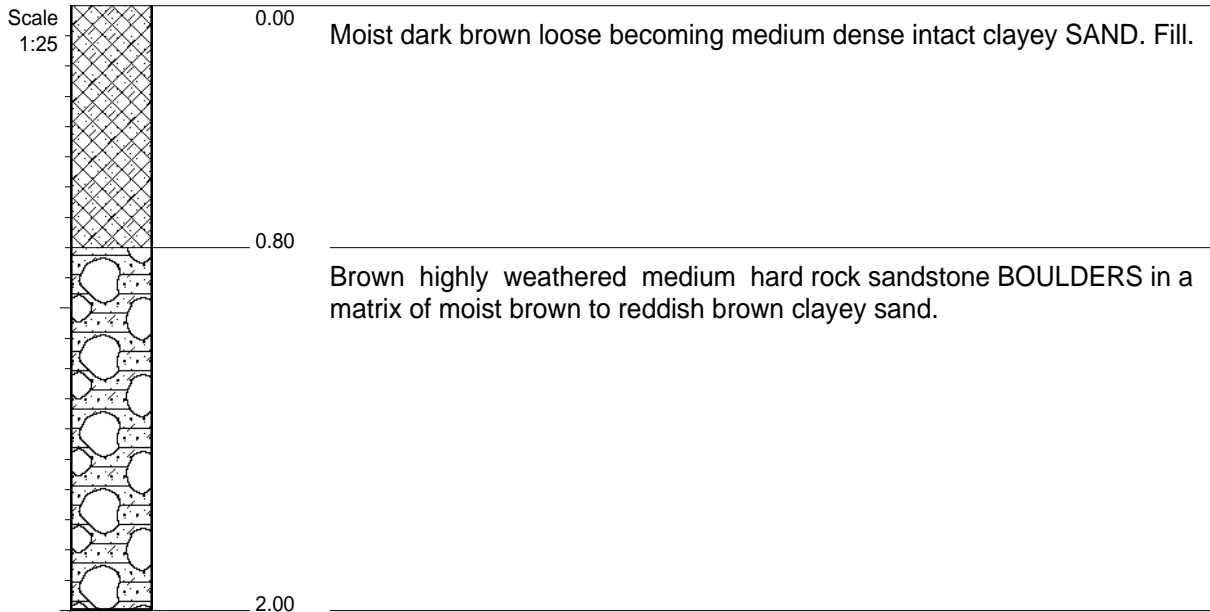
- 1) Final depth at 2.00m. Refusal on large sandstone boulders.
- 2) No groundwater seepage.
- 3) No sidewall collapse.
- 4) No samples taken.
