# Report on Geotechnical and Geohydrological Investigations for the Proposed Decommissioning (Closure) of a Waste Landfill at Utrecht, eMadlangeni Local Municipality, KwaZulu-Natal Province

16 November 2017

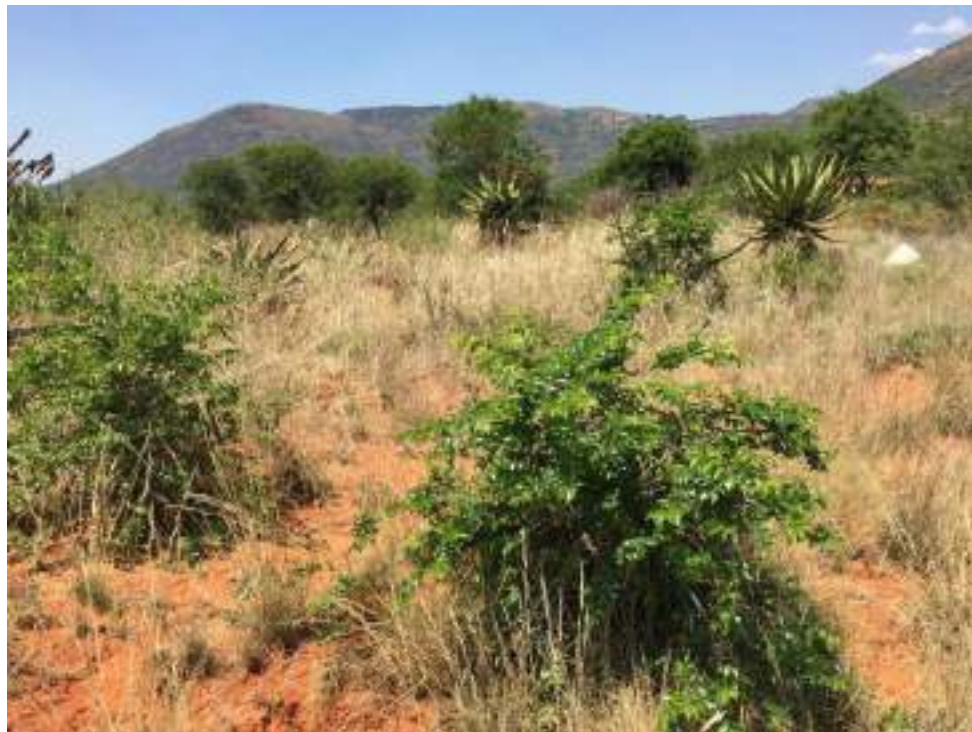
Figure 4: Typical vegetation covering the ‘not yet dumped’ portion of the landfill.

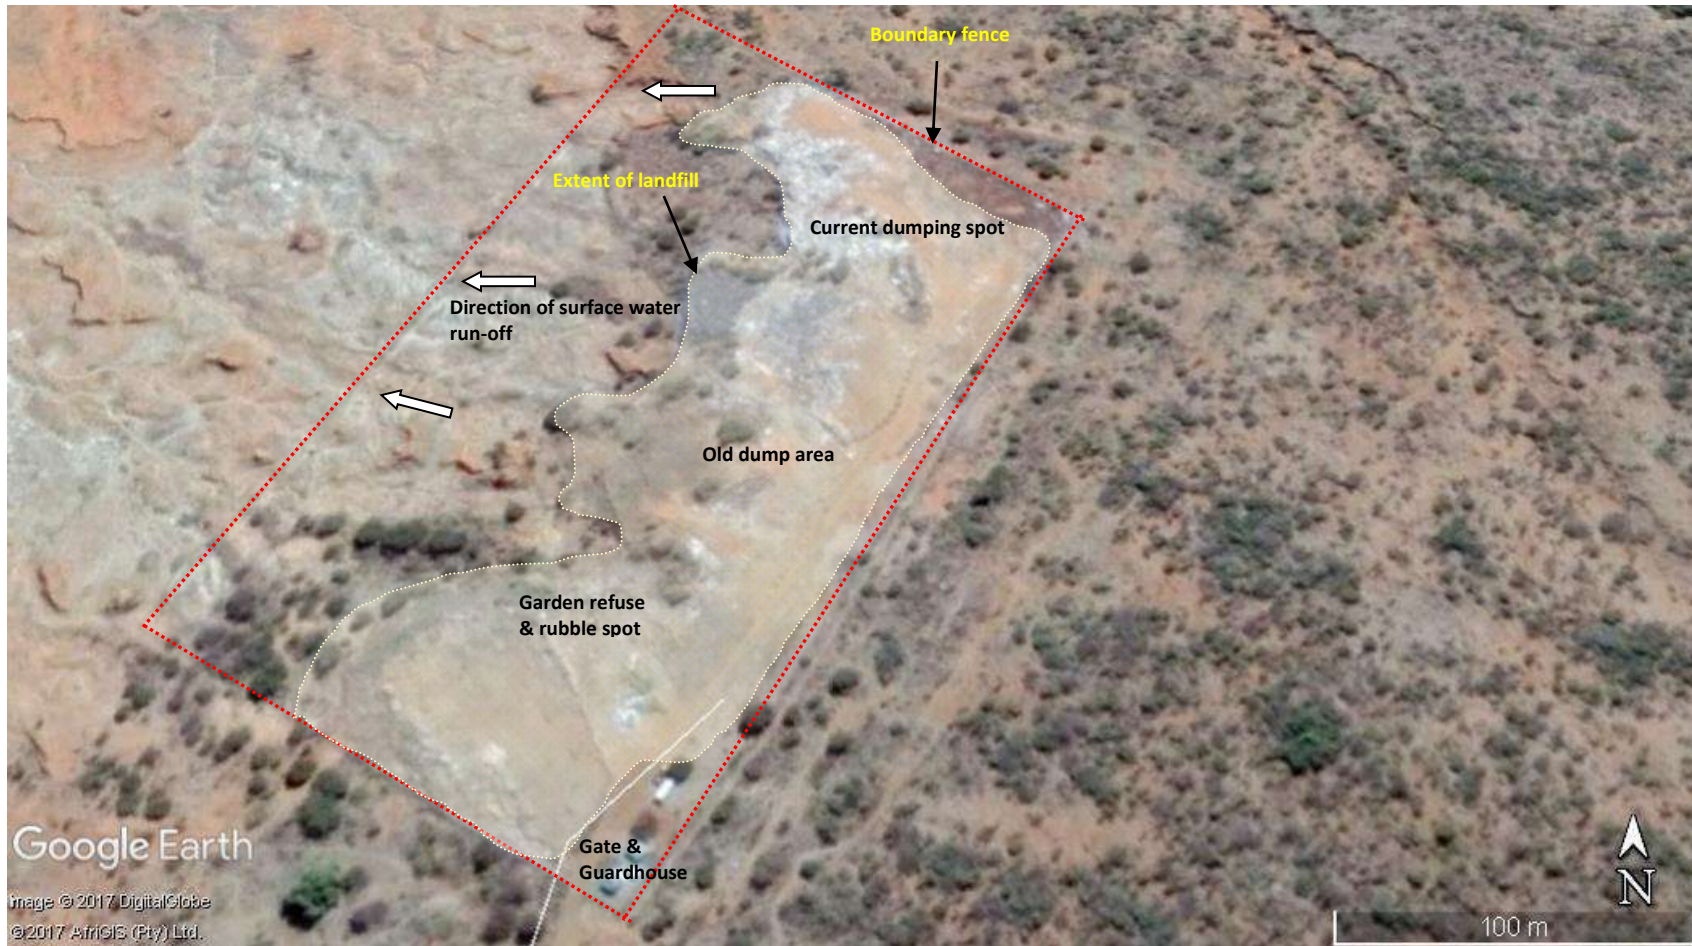
The landfill waste body comprises two parts (cells), a garden refuse/builders' rubble section and a general waste (domestic) section (Figure 13). Some medical waste (bottles) were seen scattered around, worryingly suggesting that hazardous waste could have been dumped in the past. The landfill does not have a basal liner. There is no leachate management system other than a shallow earth stormwater channel that seems to have been dug outside the eastern boundary fence. No concrete stormwater cut-off channels are present. A small portion within the landfill remains unfilled and is still covered in

Figure 13: Planview showing fenced area of the landfill, extent of landfill deposition to date and direction of drainage water flow.

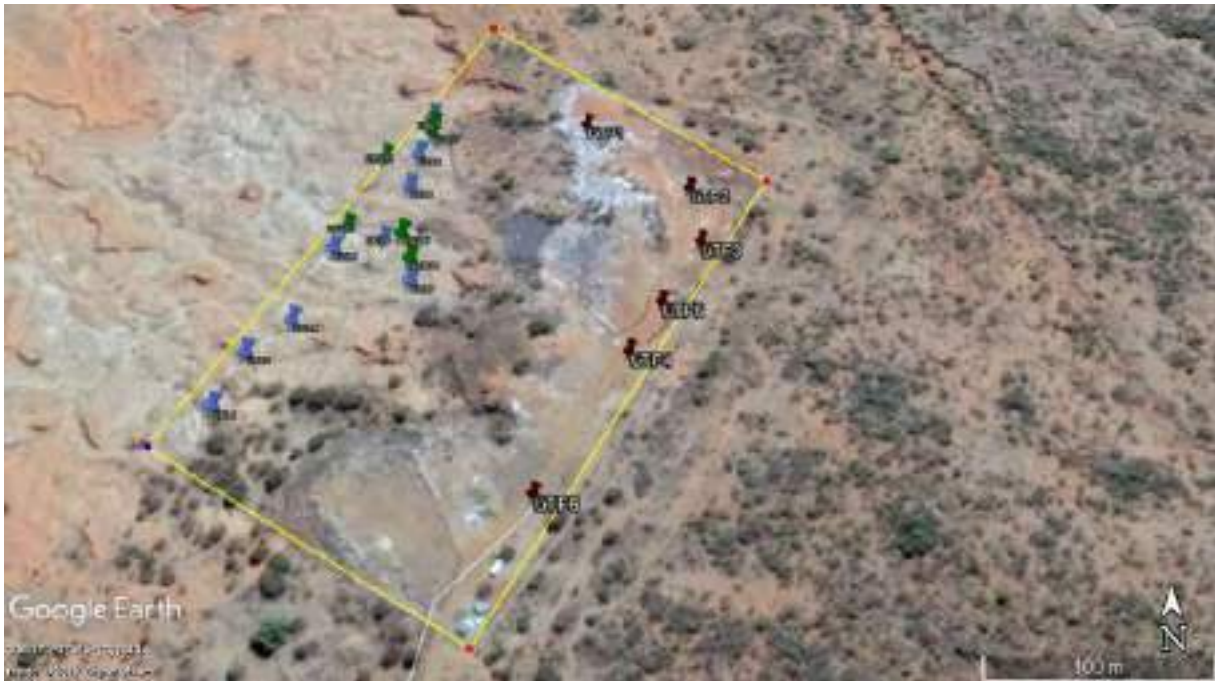
Six (6) test pits (UTP1 to UTP6) were randomly excavated using a Tractor Loader Backhoe (Bell) on 31 October 2017 (Figure 16). The test pit GPS coordinates and related information are presented in Table 4. Test pits UTP1 and UTP4 were excavated and ended in deep red clayey sand while the others (UTP2,3,5 and 6) exposed layers of top soil cover (ranging from 0.5m to 1m depth) underlain by waste. The cover soil typically comprises structureless or intact clayey sand, sandy silt or slightly silty sand over the waste material. The relative density/consistency of the cover soil varies between loose and medium dense/soft and stiff. The waste layers comprise varying quantities of plastics, textiles, bottles and containers, wood, bricks, PVC pipes, tin cans, woven bags, shoes, cardboard, wool, organic matter, glass bottles, ceramic tiles, paper and boulders, etc.

Figure 16: Location of test pits (brown), sandstone (green) rock in-situ exposure and positions of dolerite (blue) boulders mapped against the landfill boundary fence (yellow).

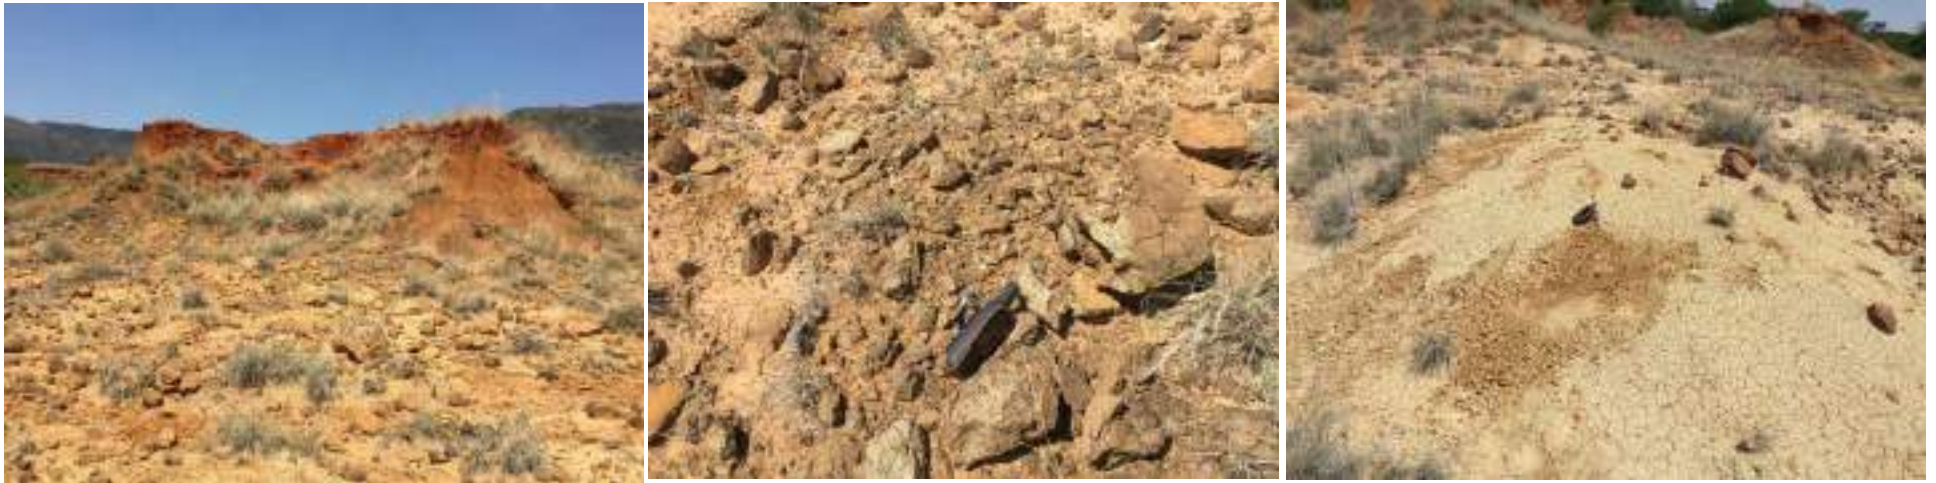
According to the 1:250 000 scale geological map Vryheid 2326, the landfill site is underlain by a sequence of sandstone (Figure 18 and Figure 19) and shale rocks which are overlain by deep red residual sandy soil (Figure 17) derived from dolerite which extends to depths of 3-4m below surface level based on the deep levels of donga erosion observed. Outcrops of sandstones are seen on the western boundary fence where waste dumping has not taken place yet. In essence, this geology has given rise to many of the in-situ characteristics of soils that are found in the area. Erosion has exposed and cut into the sandstone to reveal these outcrops. However, no significant layer of residual sandstone soils have been observed and it would seem it has all been eroded away due to its inherent low clay content and sandy loam textural class. Dolerite boulders ranging from fresh, to partly weathered and to completely weathered soils have been observed and mapped as per Figure 16 below.

Figure 17: Dolerite boulder outcrops (left), weathered (middle) and completely altered dolerite into friable soil (right).

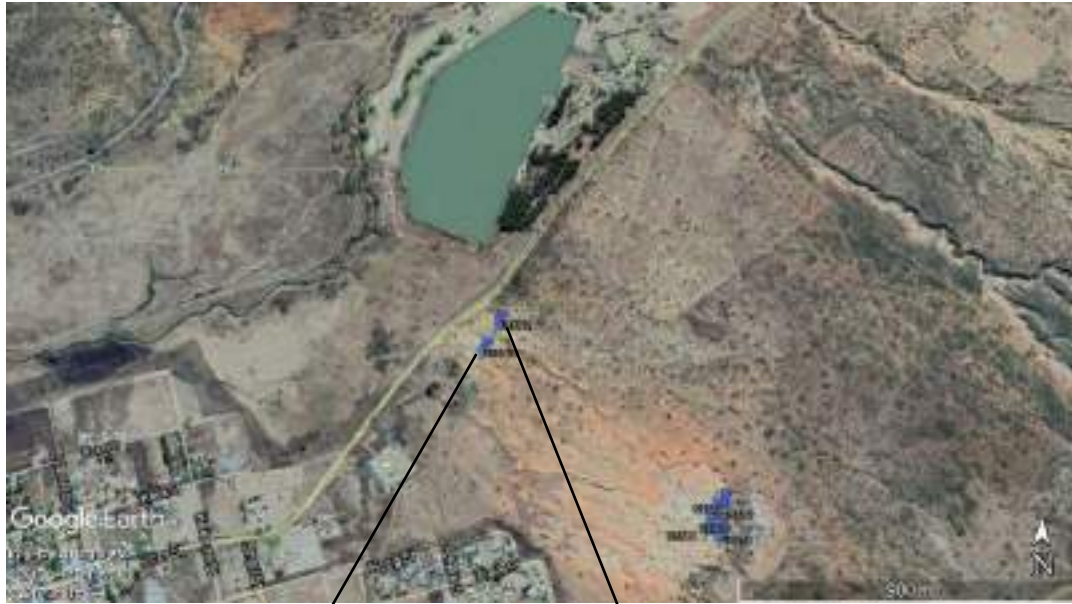
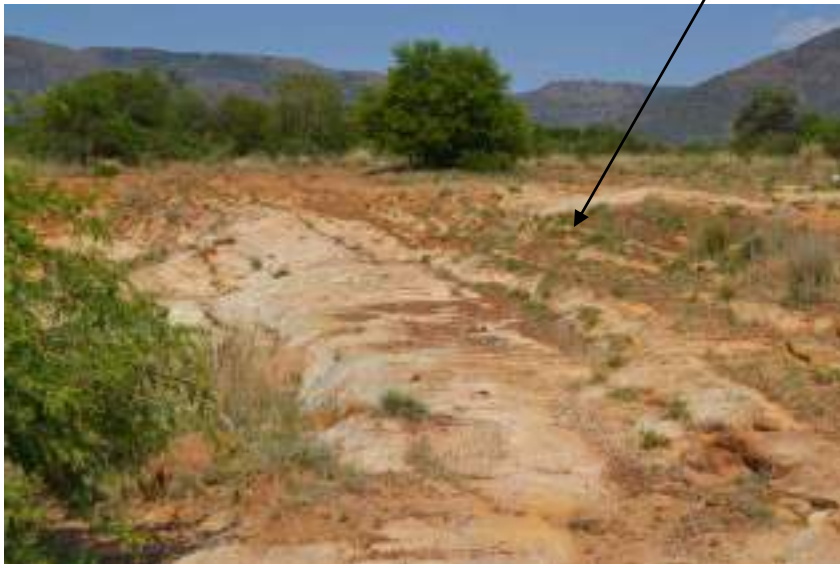
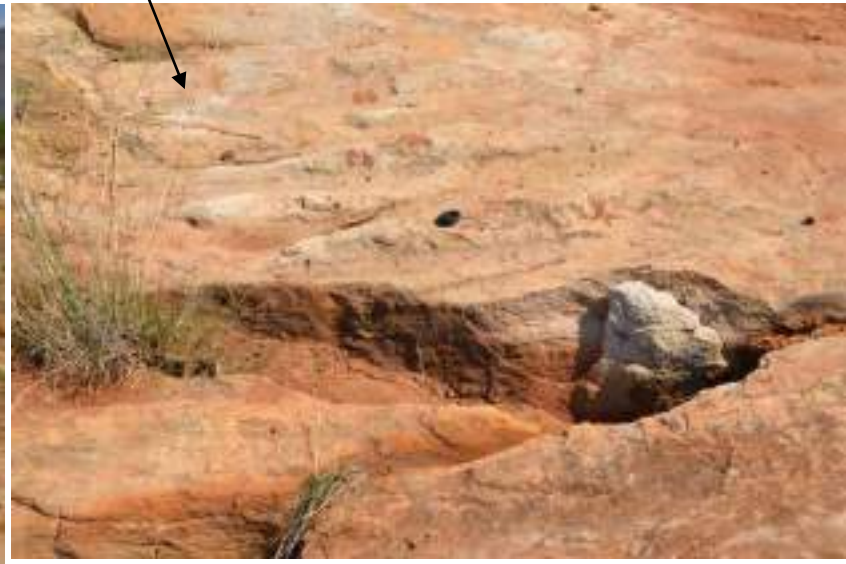
Figure 19: Massive sandstone rock exposures (blue pins) mapped south of the dam as well as at landfill. Direction is looking eastwards upslope towards the landfill.

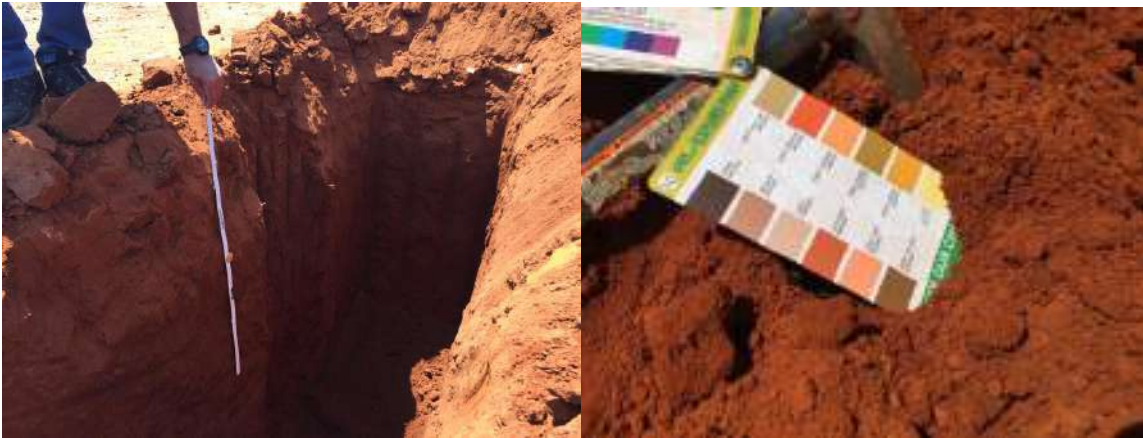
Figure 20: UTP1 test pit profile.

Test Pit ID	Co-ordinate			Depth From (m)	Depth To (m)	Description	Sample collected	Reference to pictures	TLB Equipment used	Date Excavated
	Latitude (S)	Longitude (E)	Elevation (m)							
UTP1	-27,65408	30,34176604	1260	0	2	Moist, deep red fine silty to clayey loosely consolidated residual soil. Top 30cm dry and compacted.	SUTP001	Figure 20	Bell 3189K 4x4	31/10/17
UTP2	-27,654513	30,34235604	1261	0	1	Waste dump material full of textiles and plastic. Some smell, evidence of decomposition taking place.	No sample collected	Figure 21	Bell 3189K 4x4	31/10/17
				1	2	Waste dump material with dark grey colour and less reddish soil				
UTP3	-27,654835	30,342406	1263	0	0.5	Deep red soil cover, up to 1m deep in places	No sample collected	Figure 22	Bell 3189K 4x4	31/10/17

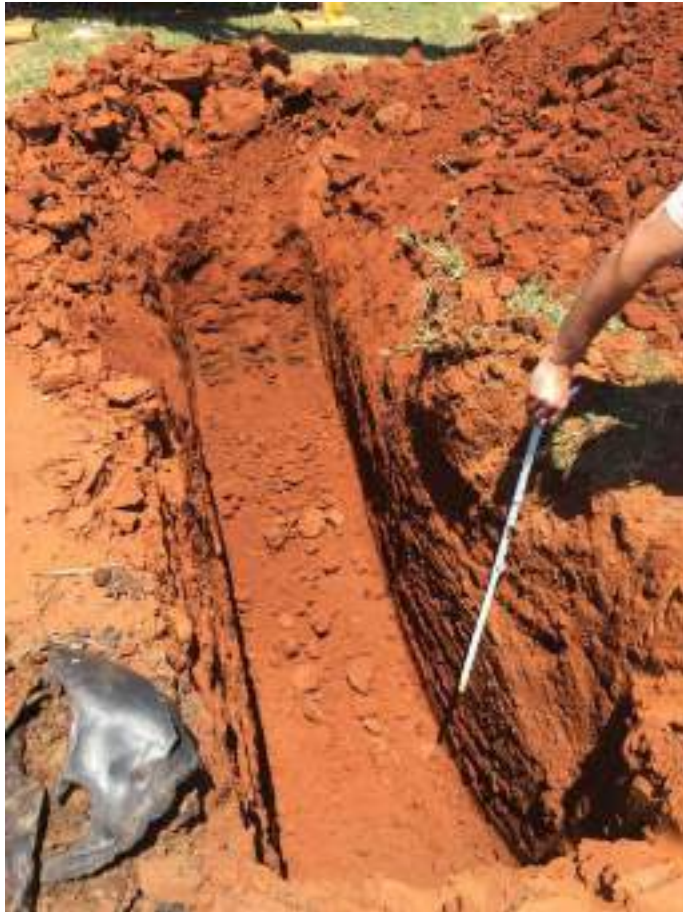
Figure 24: UTP4 test pit profile.

0.5	2	Waste dump material				
UTP4	-27,655431	30,342004	1265	0	2	Moist, deep red fine silty to clayey loosely consolidated soil. Top 30cm dry and compacted	No sample collected	Figure 23	Bell 3189K 4x4	31/10/17
UTP5	-27,655172	30,34218103	1265	0	0.8	Deep red soil cover	No sample collected	Figure 24	Bell 3189K 4x4	31/10/17

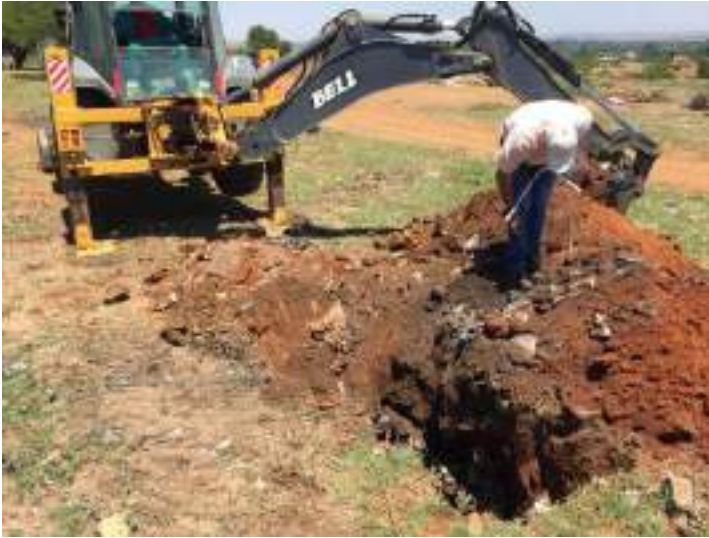
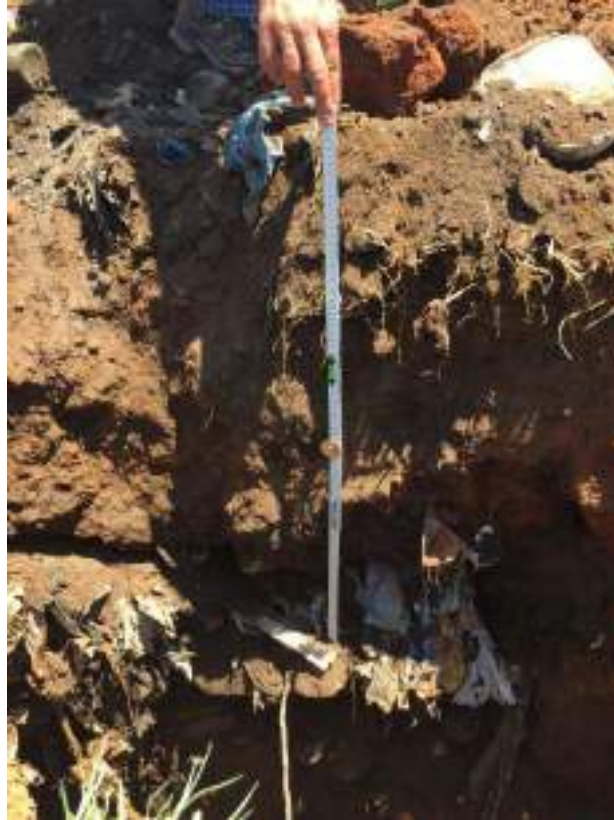
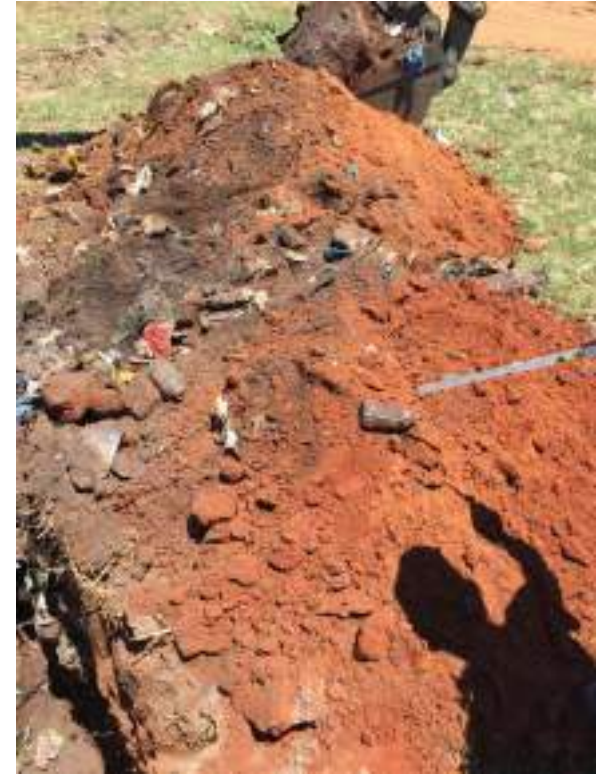
Figure 25: UTP6 test pit profile.

0.8	2	Waste dump material				
UTP6	-27,656121	30,34152204	1264	0	0.9	Deep red soil cover	No sample collected	Figure 25	Bell 3189K 4x4	31/10/17
				0.9	2	Waste dump material
