### **WETLAND STATUS QUO REPORT**

# Alluvial Fan Status Quo Report

Baviaanskloof

6/22/2015

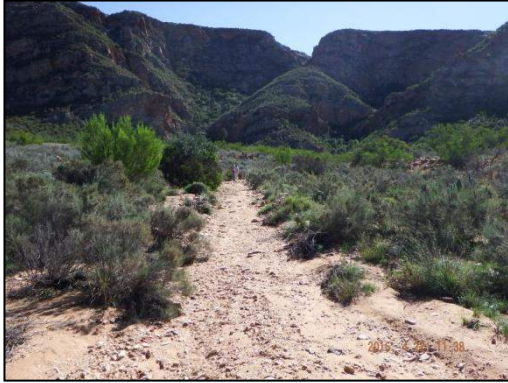
<p>Looking upstream along the ditributary stream on the fan surface</p>
<b>Key impacts</b>	The distal portion of the fan at its junction with the Baviaans River, has been altered. A cut-off berm has been constructed that run along the toe of the fan. Surface flows from the fan are captured by a cut-off berm at its base and the water is lead into an off channel dam (now defunct).

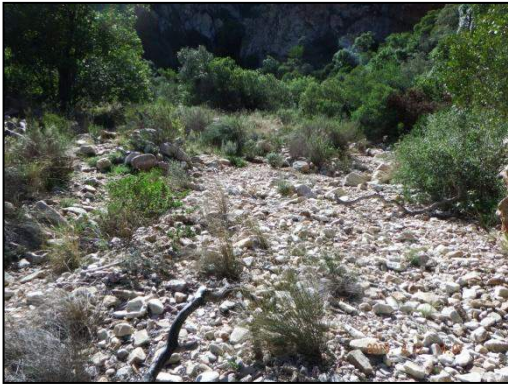
The fan surface and primary stream at the apex of the fan	The primary stream atnd fan surface at the distal end of the fan
<b>Key impacts</b>	<p>The key impacts of the fan:</p> <ul style="list-style-type: none"> <li>• Incision of the trunk stream (Baviaans River) has led to the lowering of the fan base and the incision of the fan along the primary stream.</li> </ul>

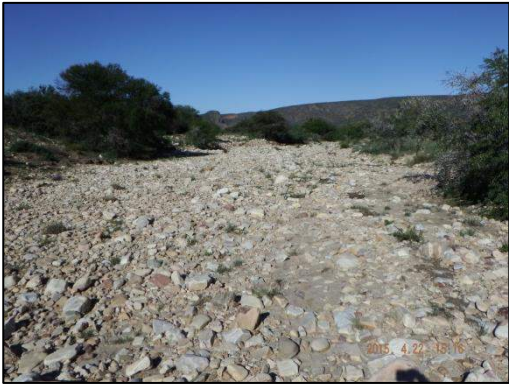
<ul style="list-style-type: none"> <li>• The incision of the stream has been aggravated by channel confinement caused by a berm constructed along the edge of the stream channel in the distal section of the fan.</li> <li>• Cultivation of the fan adjacent to the above-mentioned berms.</li> </ul>
<p><b>Photos of impacts</b></p>

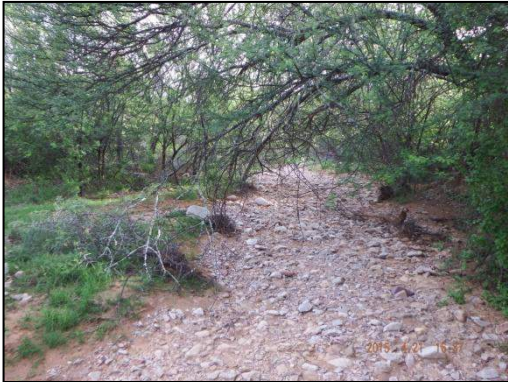
The primary stream on the fan surface near the fan apex.	The distal section of the fan impacted by berms
<b>Key impacts</b>	The key impacts on the fan:

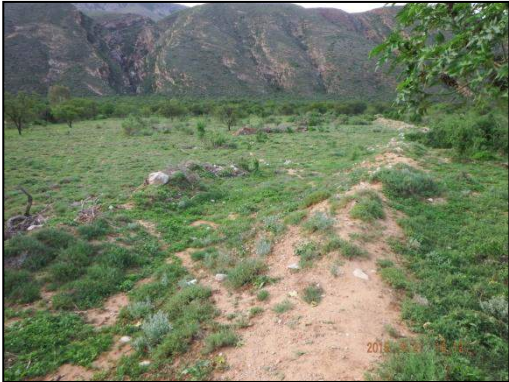
<ul style="list-style-type: none"> <li>• The stream that flows over the fan has been canalized by the construction of berm on both of its banks.</li> <li>• The berms stop flooding in adjacent cultivated lands.</li> <li>• The fan has and is being used for cultivation.</li> </ul>	
<p><b>Photos of impacts</b></p>

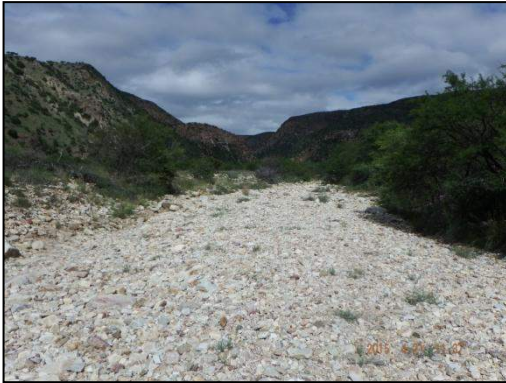
The channel on the proximal reach of the fan near the apex.	The channel on the distal reach of the fan.
<b>Key impacts</b>	<p>The key impacts of the fan:</p> <ul style="list-style-type: none"> <li>• Incision of the trunk stream (Baviaans River) has led to the lowering of the fan base and the incision of the fan along the primary stream.</li> <li>• The incision of the stream has been aggravated by channel confinement caused by berms constructed along the edge of the stream channel in the medial, distal sections of the fan.</li> <li>• Cultivation of the fan adjacent to the above mentioned berms.</li> </ul>
