GEOHYDROLOGICAL SITE ASSESSMENT AND REPORTING LETSEMENG LOCAL MUNICIPALITY LANDFILL SITE DEVELOPMENT

NOVACRAFF GROUNDWATER CONSULTANTS

21 July 2021

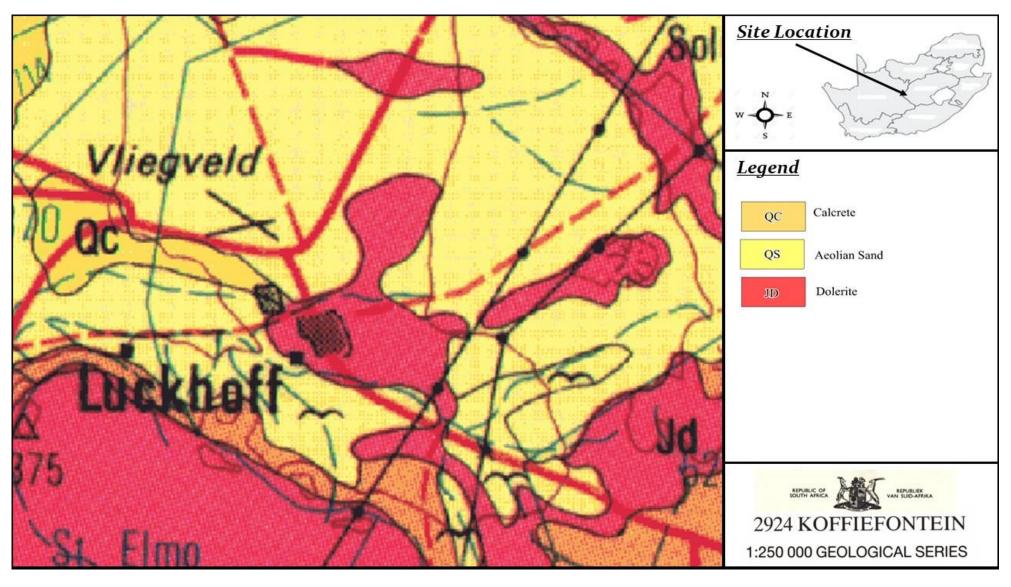
Figure 3. Regional Geology.

The study area under investigation is predominantly underlying by dolerite sills and overlaying Aeolian sand, legend QS and Jd respectively. Occurrence of calcrete is indicated in the local and regional geology under legend QC.

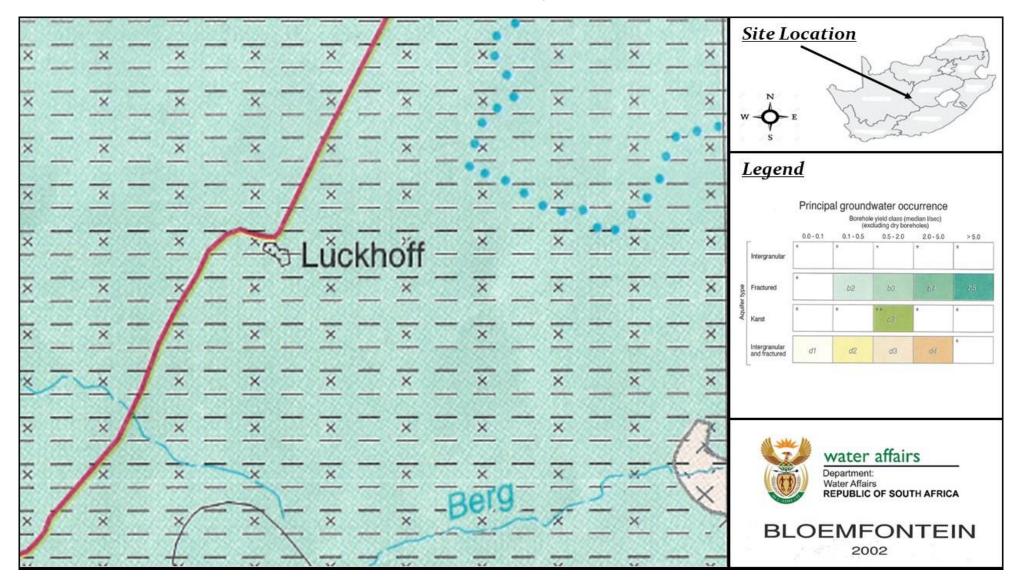
Figure 4. Regional hydrogeological map of potential groundwater in Luckhoff area.

The regional hydrogeological map (Bloemfontein 2002 from the department of water affairs and forestry) is utilised to estimate the principal groundwater occurance of the area. The area under investigation is located within zone b3 incicating possible groundwater occurance of 0.5 - 2 l/s supported by section 4.3.1 indicating a minor aquifer in the local area. This was confirmed during the Hydrocensus field investigation as no major groudwater abstraction was identified within the local area.

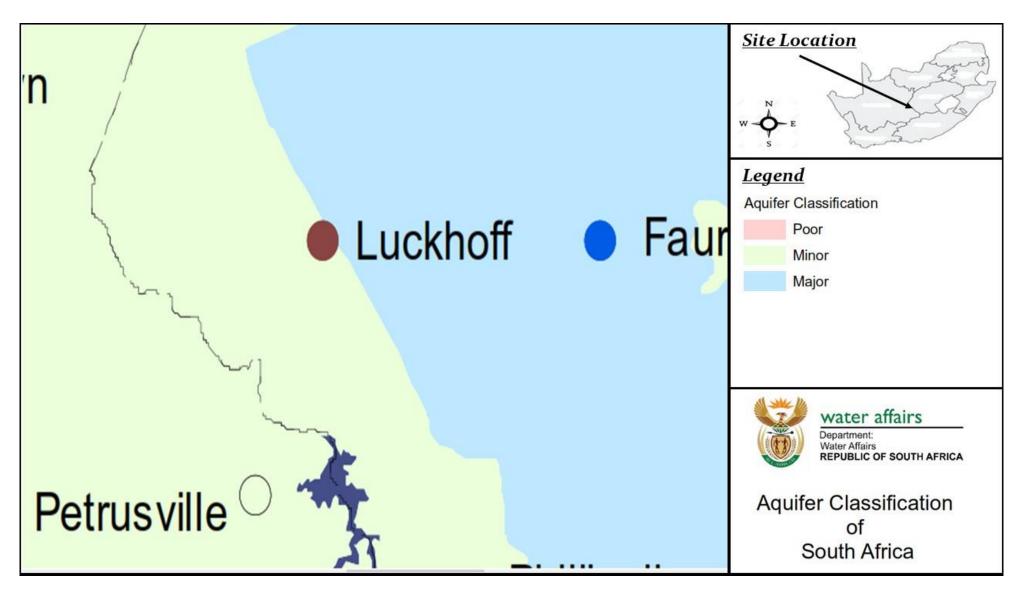
Figure 5. Aquifer classification. Map – Water affairs.

According to the aquifer classification map form the department of water affairs (Figure 5), the aquifer of the area under investigation is classified as a minor aquifer. This is corresponding to the principal groundwater map (Figure 4), indicating possible groundwater occurrence of 0.5 - 2.0L/s for the area under investigation.

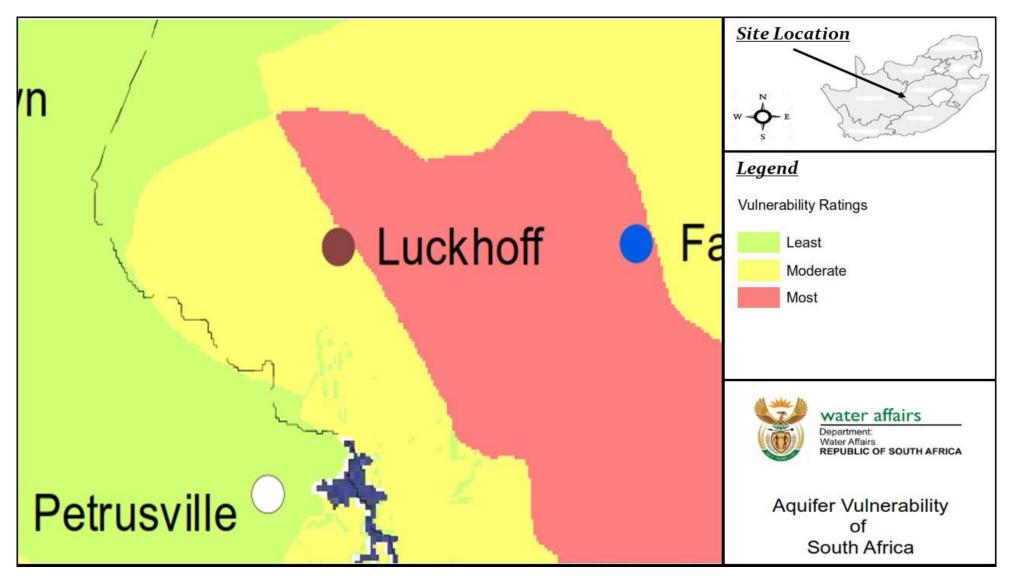
Figure 6. Aquifer vulnerability. Map – Water Affairs.

According to the aquifer vulnerability map form the department of water affairs (Figure 6), the aquifer of the area under investigated is classified as moderately vulnerable.

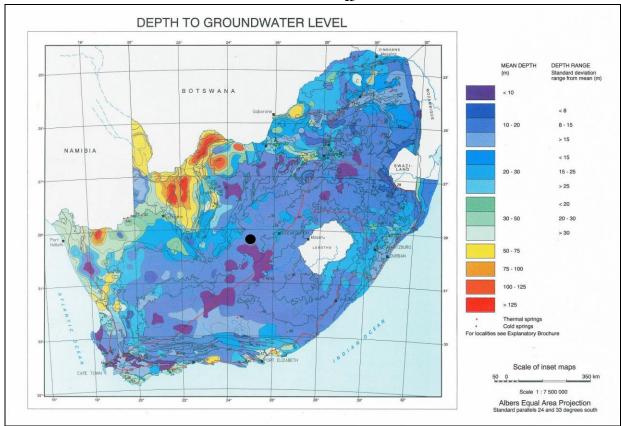
Figure 7. Depth of groundwater level (adapted from the Groundwater Resources of South Africa Map, DWA, 1995). Site location indicated with black circle.

The vulnerability of the underground water source is related to the distance that the contaminant must flow to reach the water table, and the ease with which it can flow through the soil and rock layers above the water table. The water level depth map (Figure 7) indicate a water level depth of approximately 10-20 meters below surface.

The groundwater depth in the study area is approximately 10 - 20 mbgl according to the DWA map, refer to Figure 7. During the hydrocensus investigation, no water level could be measured due to a blocked borehole.

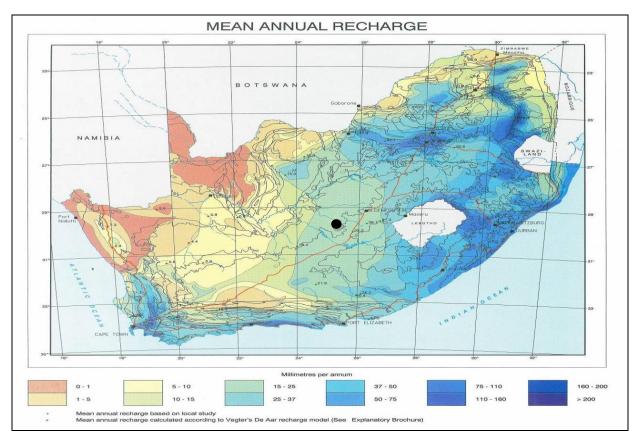
Figure 8. Mean annual recharge (adapted from the Groundwater Resources of South Africa Map, DWA, 1995). Site location indicated with black circle.

The DWA mean annual recharge of the area is between 15 - 25 mm/a and on average 20 mm/a (refer to Figure 8). The Vegter recharge maps estimates the recharge as 20 mm/a (refer to Figure 9). DWA and Vegter data estimates the recharge as 20mm per annum for the area under investigation.

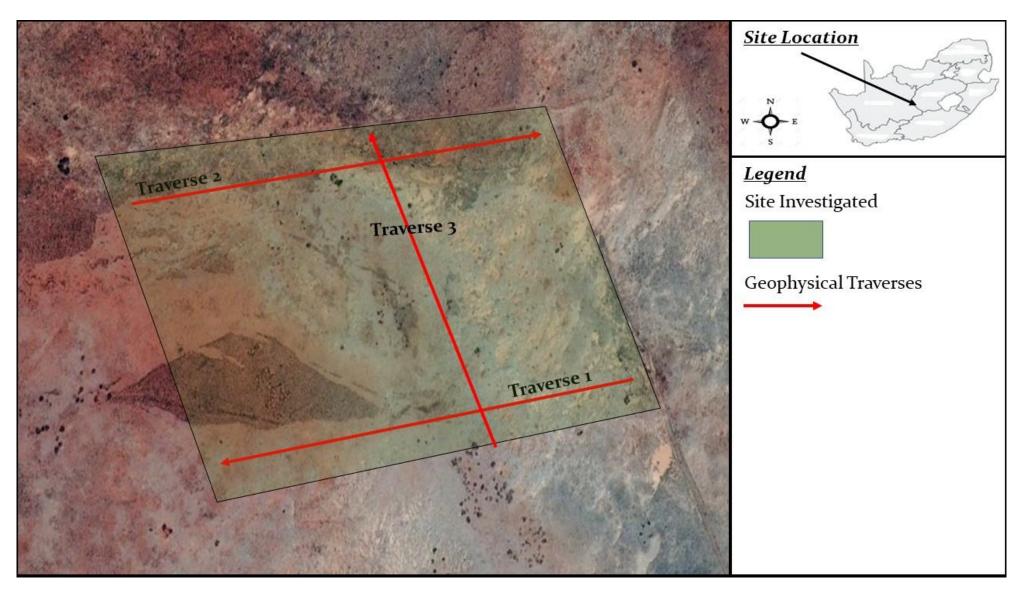
Figure 12. Geophysical Traverses.

The geophysical survey on site was completed with a G5 Proton Magnetometer to determine possible dolerite structures in the local area. The traverse locations can be viewed in Figure 12. According to the data and graphs, a dolerite sill is underlying the the local area. Dolerite outcrops from the dolerite sill was encountered throughout the site under investigation.

These massive sills usually do not contain weathered zones of dimensions significant enough to yield sustainable groundwater in significant or sustainable volumes due to the fact the most weathered zone fractures in these large sills are shallow and do not reach the local water table. Indicating no prominent groundwater flow paths according to the data available.

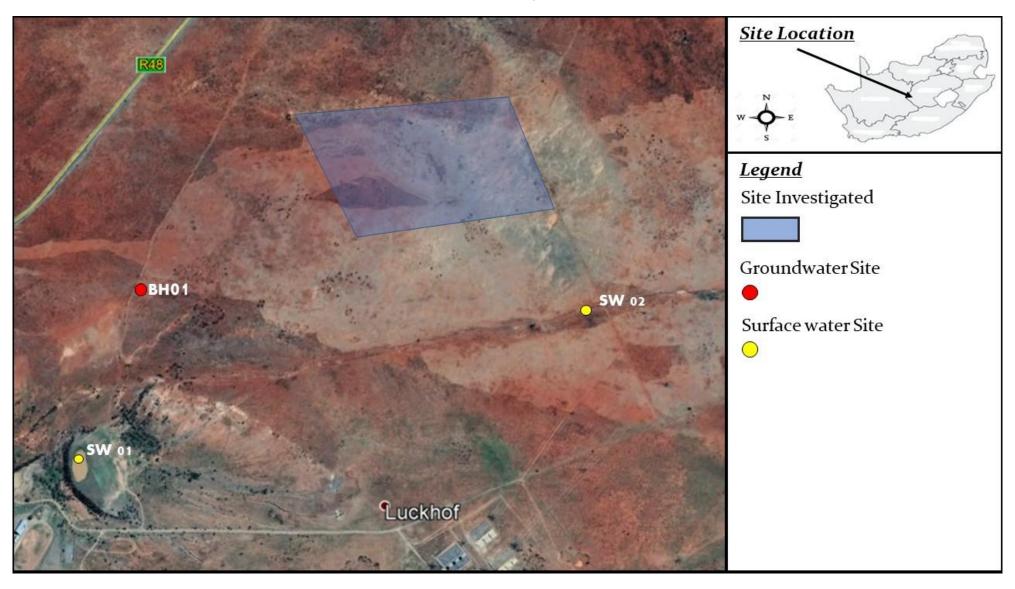
Figure 17. Hydrocensus ground and Surface water site locations.

1 borehole and 2 surface water sites were encountered during the hydrocensus survey, 1 sample was collected, and no water level could be verified as the borehole is blocked. Borehole and surface water site locations can be viewed in Figure 17.

- The Hydrocensus investigation indicate no major groundwater abstraction or groundwater dependence however, borehole BH01 was blocked but is an indication that a feasible groundwater resource is present downstream. Thus, the lining of the site is recommended to ensure no leaching of pollutants into the subsurface.
